# DAW THEATER TAPPAHANNOCK, VA

## Building Analysis

### A. INTRODUCTION

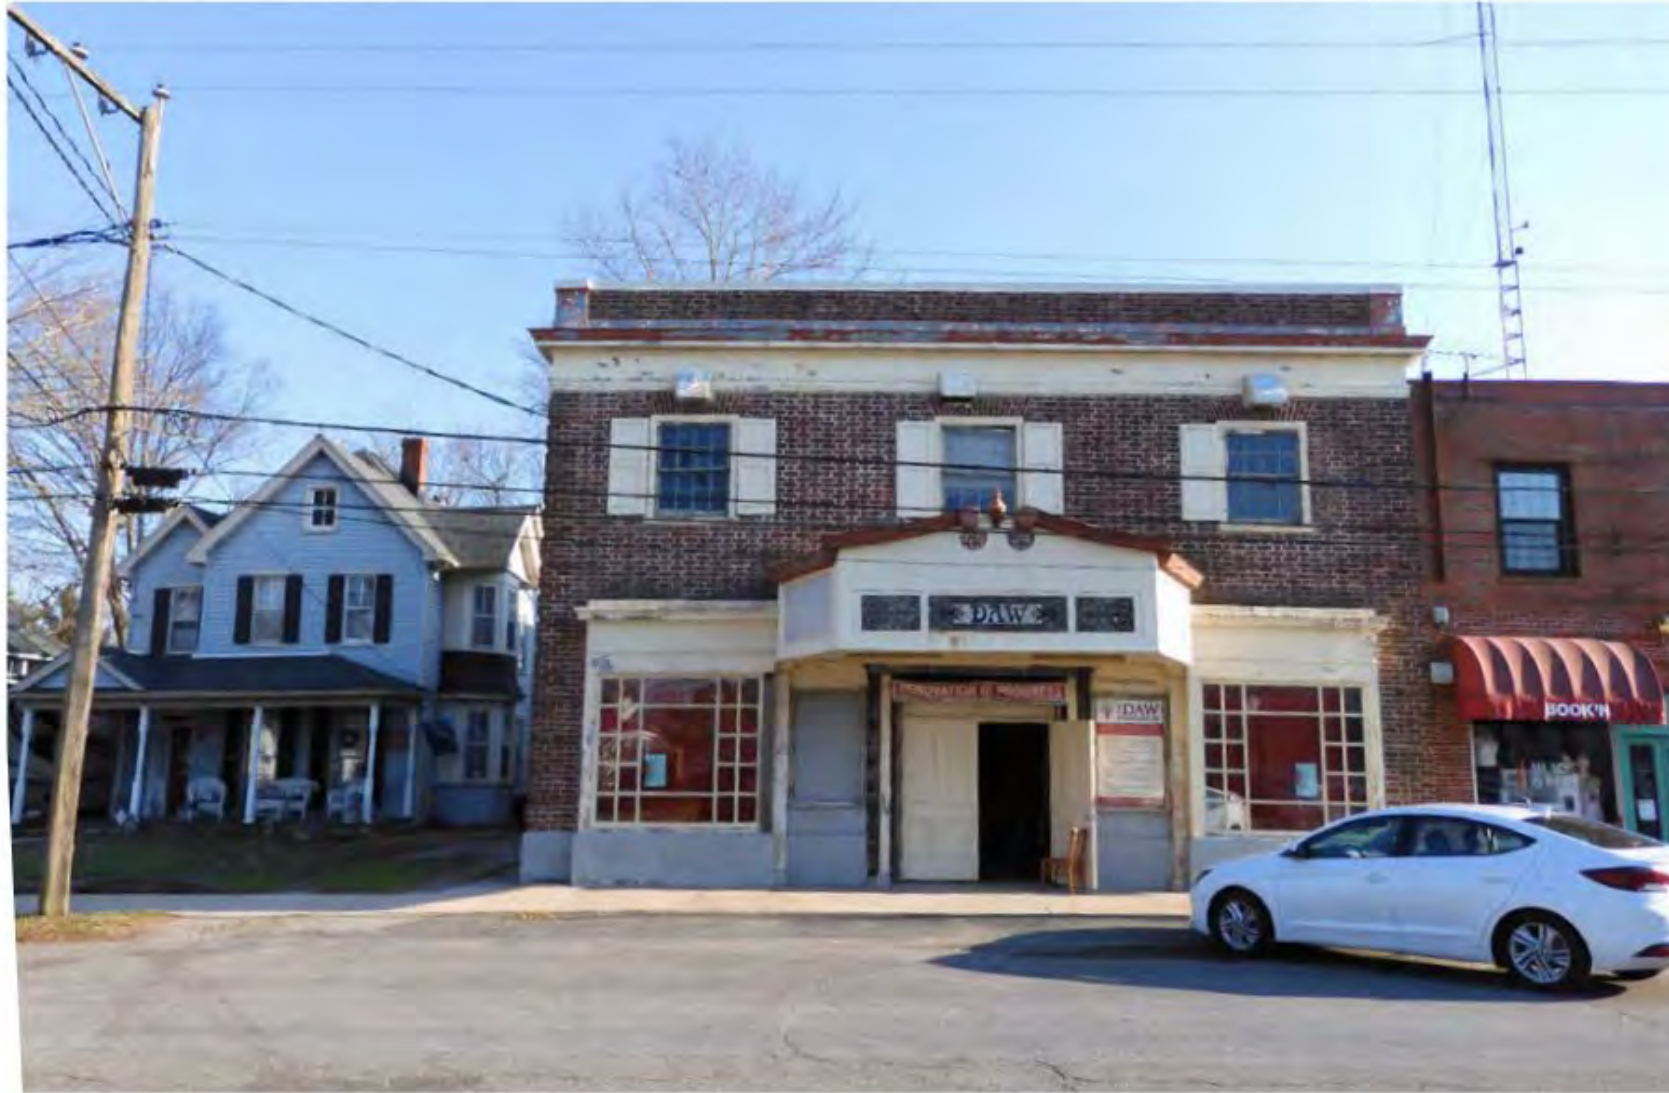
1. View of front facade of the DAW Theater.

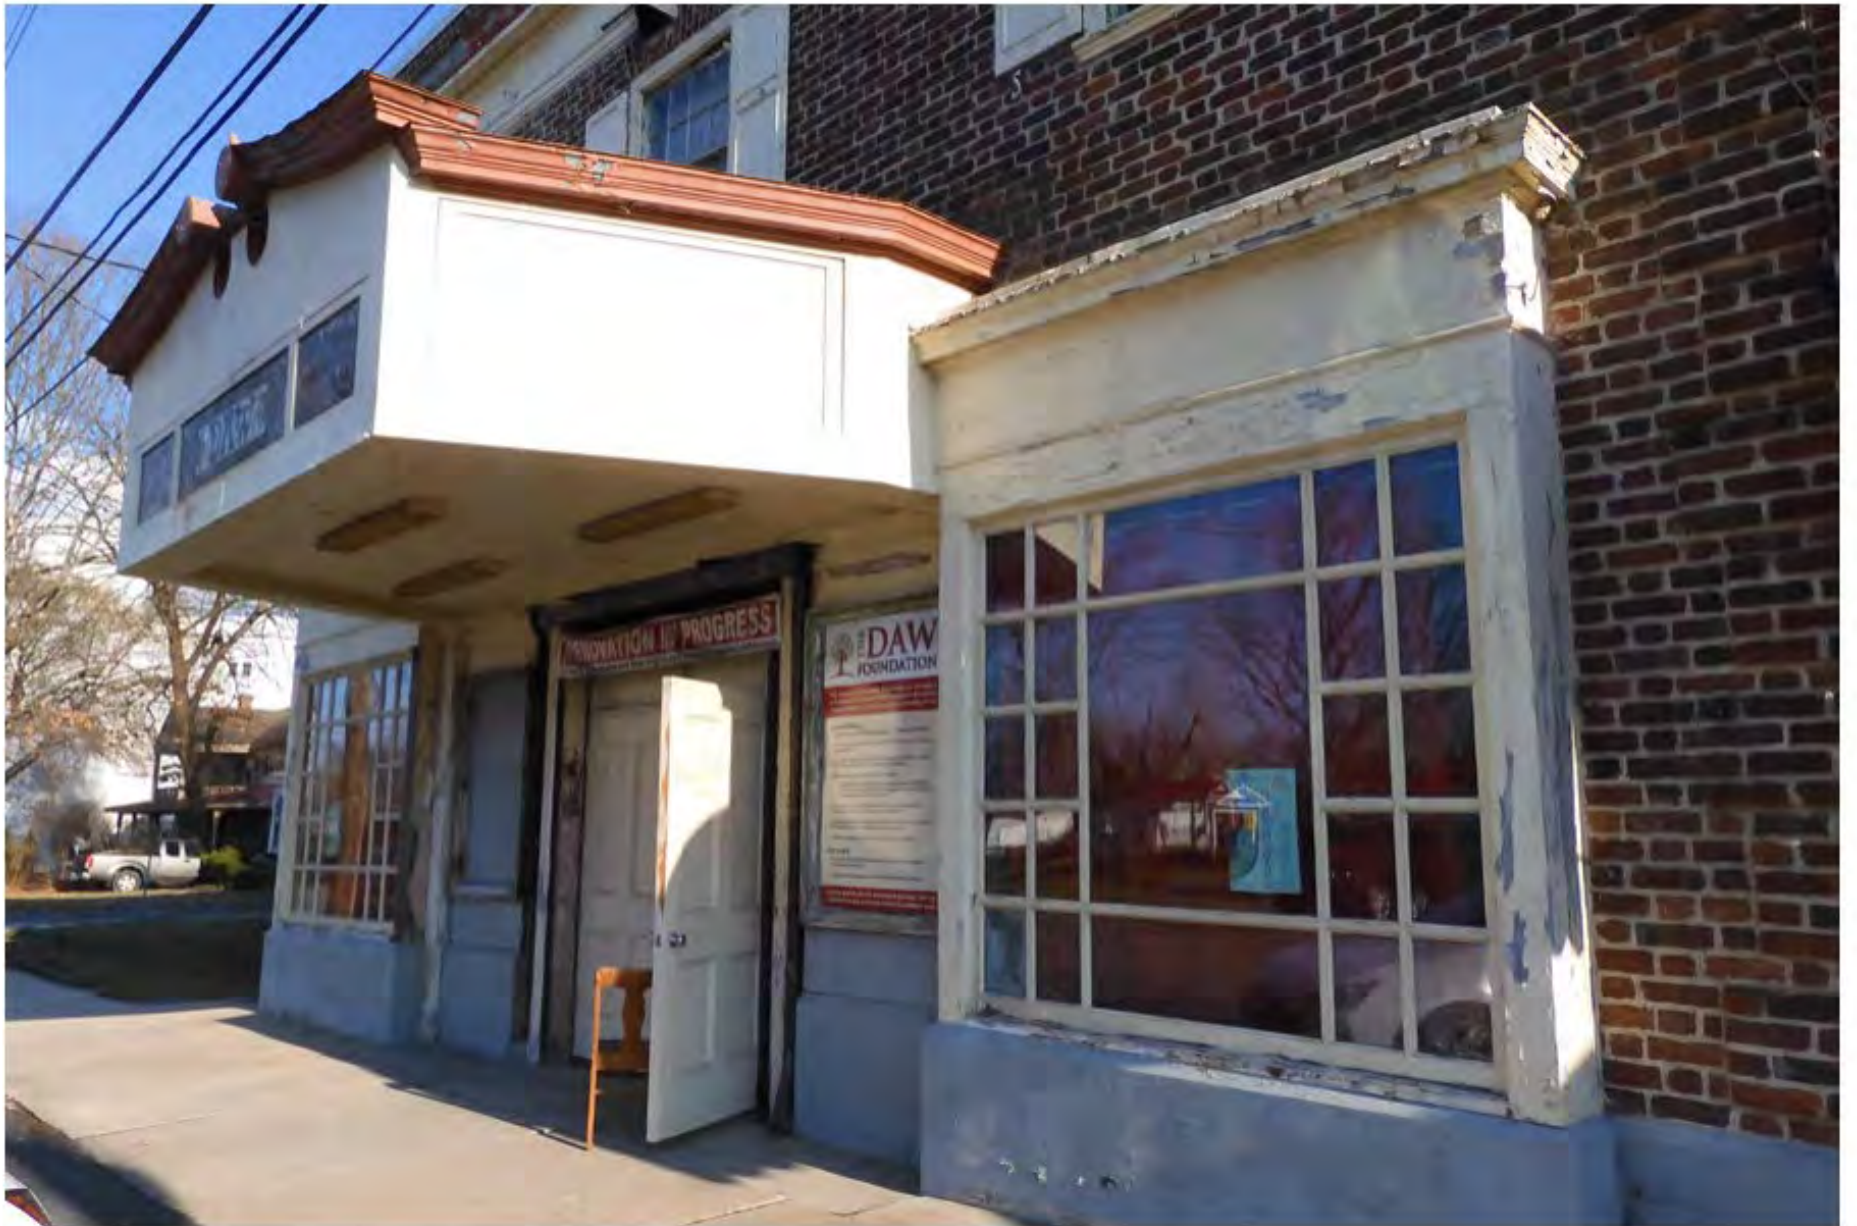
2. Detail view of the marquee, entrance and store-fronts on the front facade.

The front cornice and marquee are part of the exterior character defining historic features. They should be refurbished and retained. Refer to façade drawings for freestanding signage on marquee, lighting recommendations etc.

The original entrance doors and transom have been removed. A design similar to the original as seen in historic photos should be restored. Several of the remaining exterior doors are either missing, or improperly fitted into their openings. These doors should be replaced with appropriate style and size doors.

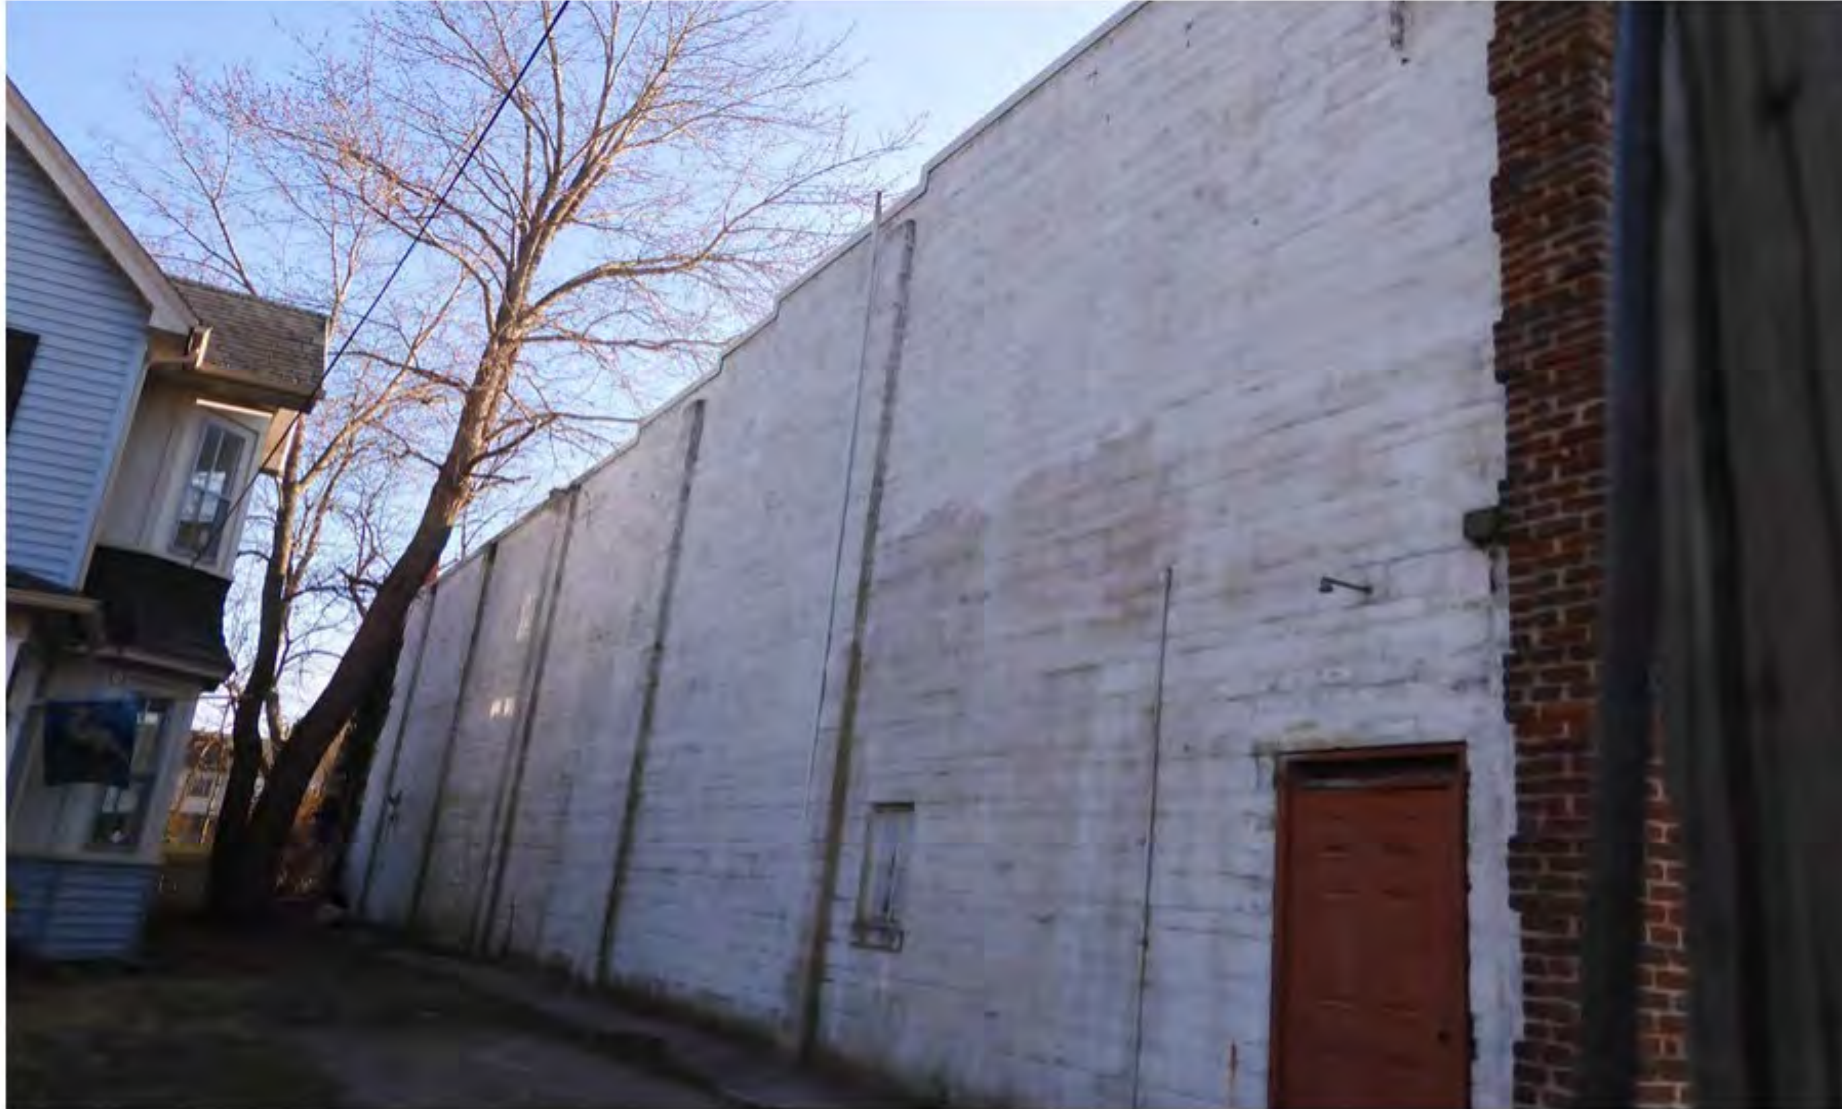
The brick transitions to exposed CMU on the side walls of the theater space. The CMU is laid in a decorative pattern with alternating courses of tall and short blocks. There are numerous cracks and serious deterioration in the exterior CMU. In particular, the CMU pilasters which contain steel columns show significant damage. A structural engineer's evaluation of the entire building, and this condition in particular, is recommended. At a minimum, the CMU should be repaired and repainted.

3. View of painted CMU on east side of building.

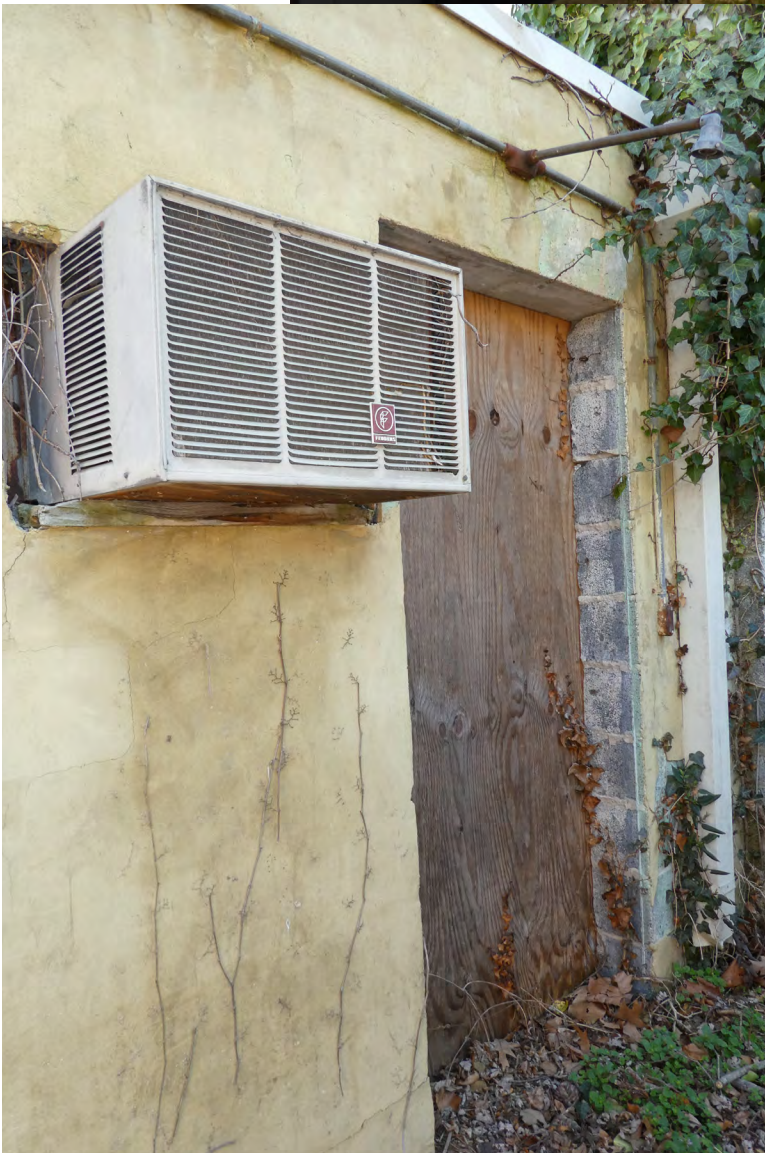
6. View of boarded up entrance on east end of rear addition.

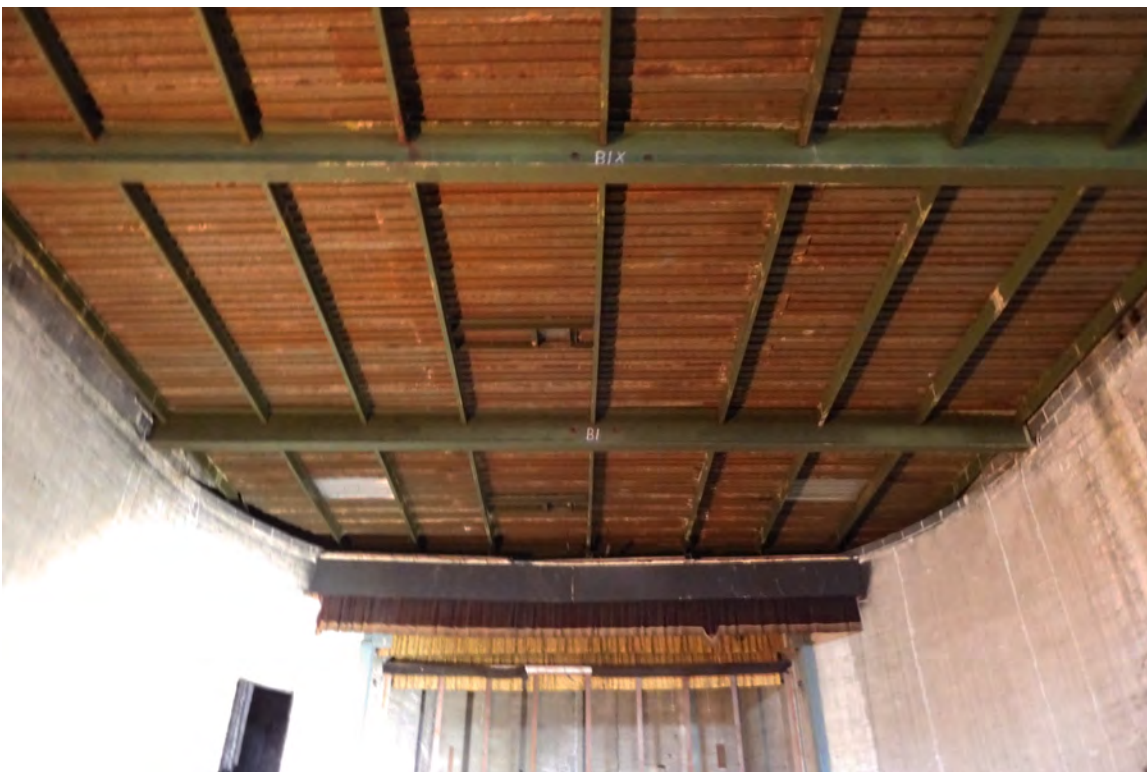
The underside of steel framing and corrugated roof decking is visible in the theater space. Overall, these elements appear to be in fair condition. Maintenance and limited repairs to the roof structure should be anticipated during the building's renovation.

8. View of underside of roof deck.

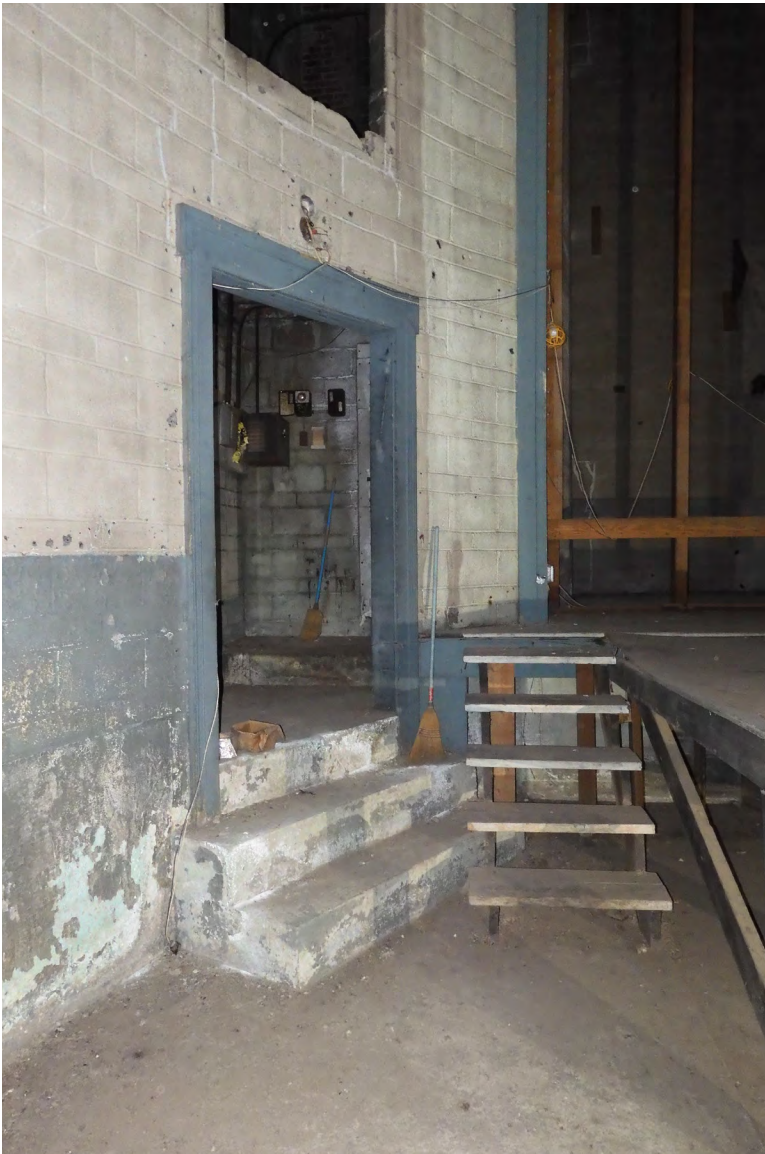
9. Close up view of opening on east side of stage.

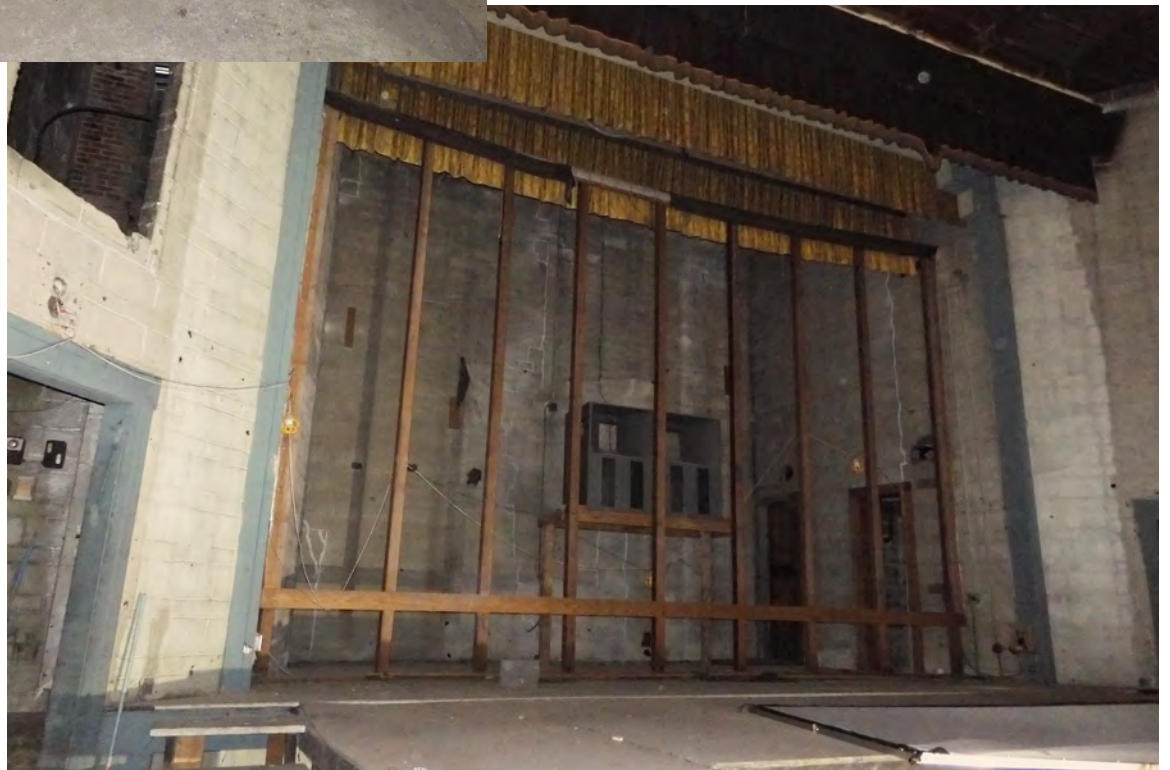
The stage is wood framed with a tongue and groove wood floor. There is evidence of rot where the wood framing has been in contact with the masonry.

10. Close up view of stage.
