# BRUNSWICK COUNTY COURTHOUSE: PHYSICAL ASSESSMENT

# Brunswick County Courthouse: Physical Assessment

WMCAR Project No. 09-18

2010

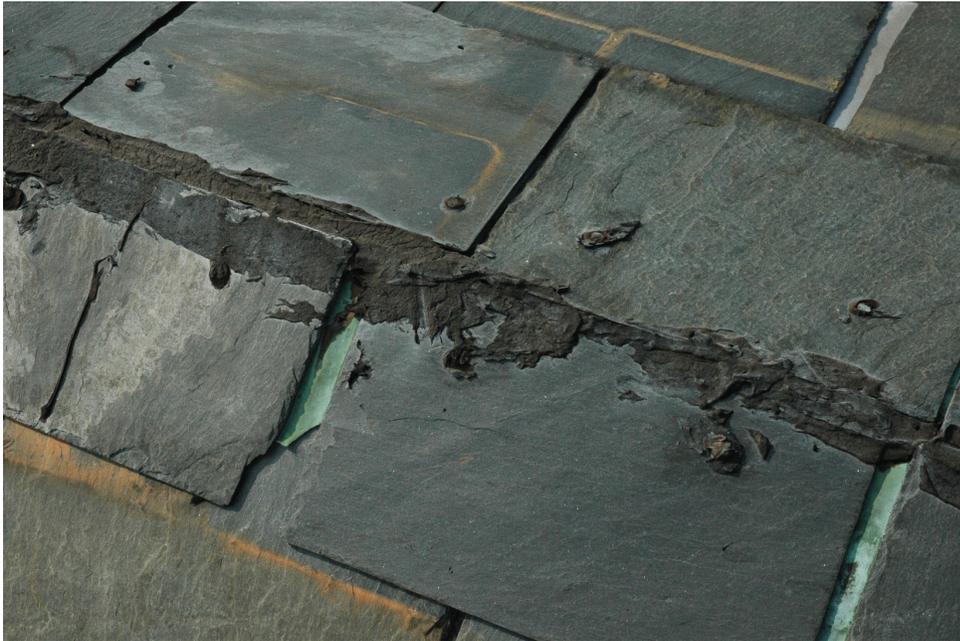
All sloping portions of the roof are covered with thin slates laid with a consistent exposure of approximately 8 inches. Many slates are missing, others are broken with pieces missing, and a good number have been repaired with roofing cement. Still others been replaced, as evidenced by metal clips at the lower edge. The three uppermost courses on the northern slope have been re-laid at some point. The top course is daubed with roofing cement where it combs over the adjacent slope, and the fasteners for this course have been daubed as well (Figure 13).

*Figure 13. Slate roof.*

In view of these problems, we recommend that the entire roof be replaced with a standing-seam metal roof, the covering to be copper traditionally detailed at the ridges and valleys. On the flat deck, we recommend a membrane roof. All slopes should have snow guards.

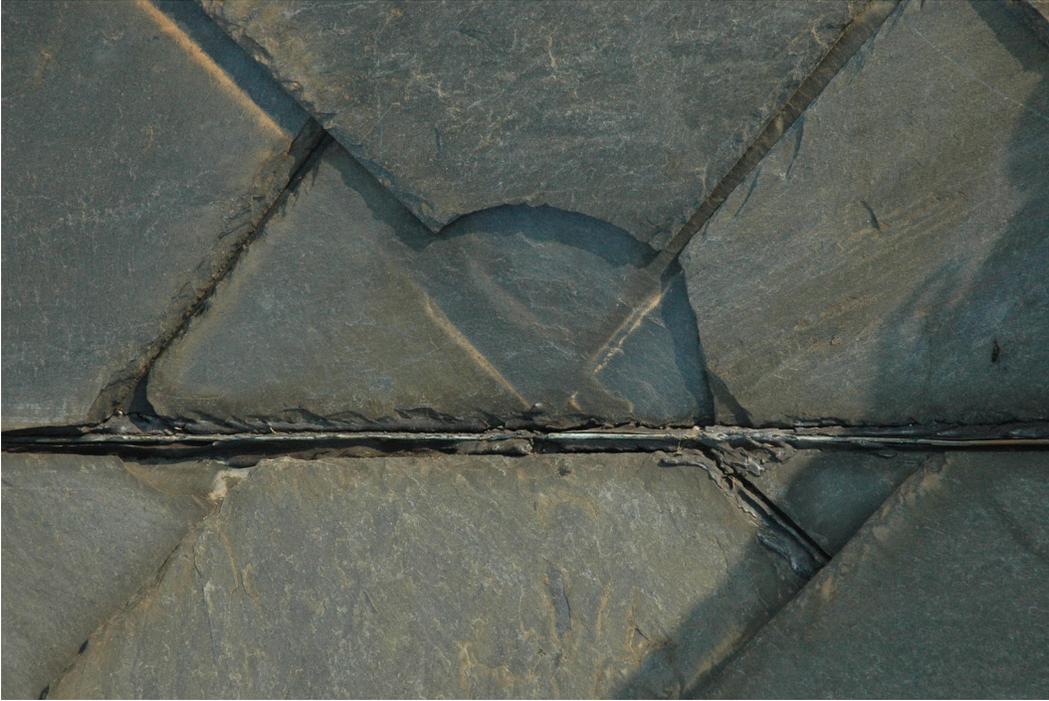
The closed valleys are laid in copper, with a central rib, having no breaks. The slates are laid tight to this rib, so that debris has collected in the resulting crevice, impeding the flow of runoff from the roof (Figure 14).

*Figure 14. Closed valley of slate roof.*

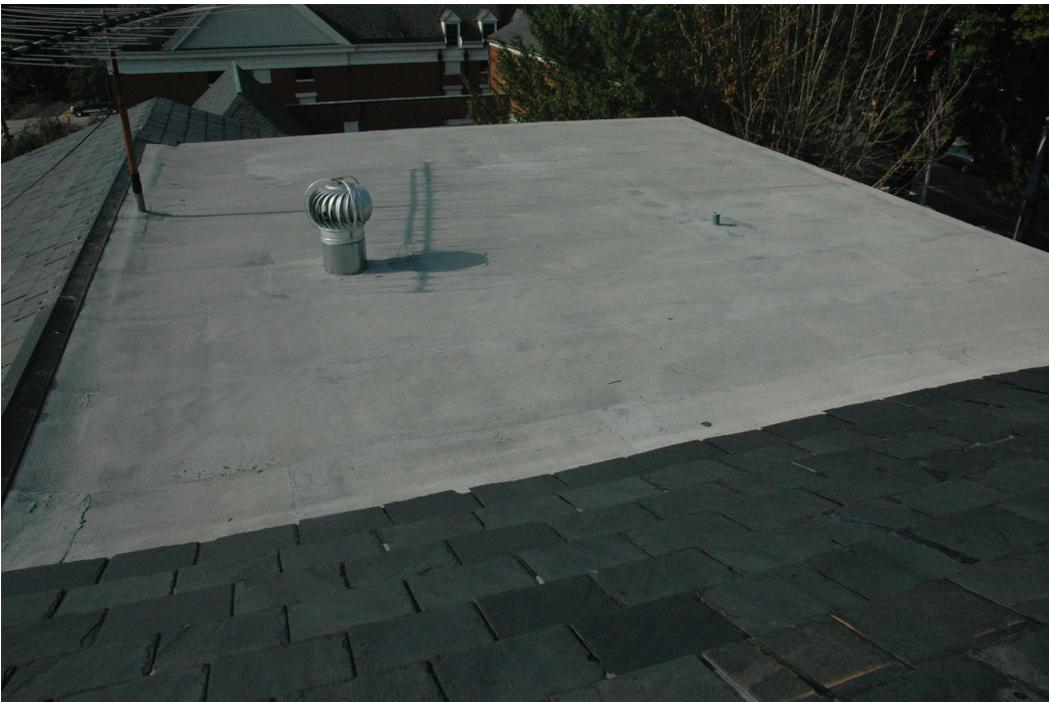
Above the 1976 wing is an area of flat roof now covered with asphalt roll-type roofing (Figure 15). The strips are lapped and hairline cracks are visible at virtually all of these seams. There are three penetrations of this roof—a ventilator for the area closed in by the flat deck, an antenna (no longer functioning), and a vent stack. At present, none of these seems to be admitting water.

This flat portion of the roof was intended to drain over the adjacent front (west) and end (south) slopes of the 1976 roof; however, copper flashing below the edge of this asphalt roofing raises the margin of the deck enough to prevent it. As a result, it appears that water stands on this roof for extended periods of time. At the junction of this deck with the roof ridge of the 1939 rear wing, the substrate is “spongy.” The effects of leaks from this deck are visible on the third floor (Room 301) where the plaster around the elevator shaft exhibits extensive water damage.

*Figure 15. Asphalt roofing on flat deck.*

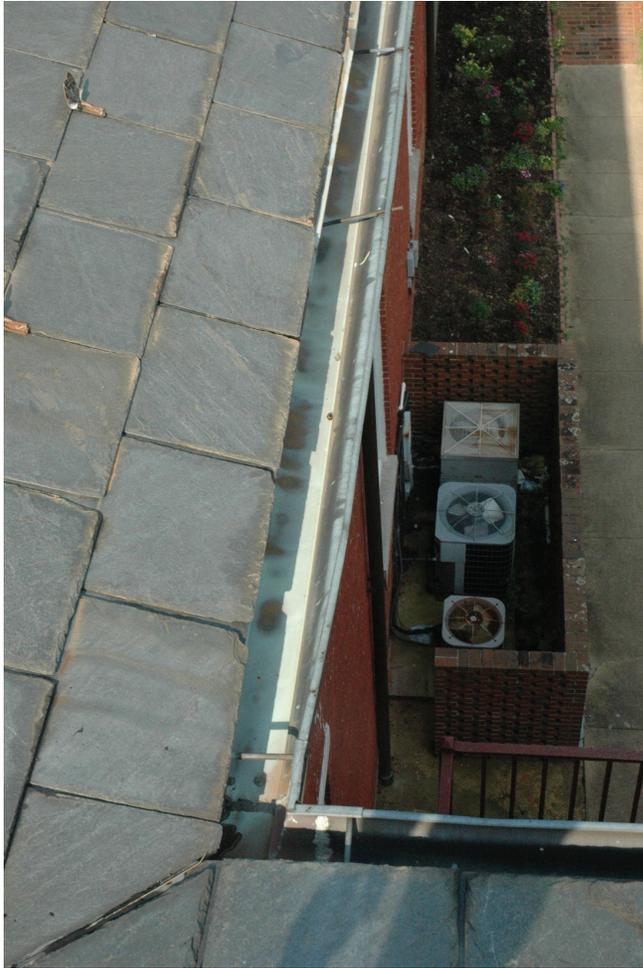
All gutters are of the ogee type, fabricated in copper. They are in poor condition, possibly the result of damage by descending snow. Whatever the cause, the gutter spikes have pulled free in many locations, allowing the fronts of the gutters to roll forward (Figure 16).

*Figure 16. Deformed copper gutter.*

These should be replaced with half-round gutters of copper, suspended from hangers spaced no farther than 32” apart. These hangers should be attached to the roof framing.

As part of this renewal, all rain leaders should be replaced, fitting each with an overflow device at the lower end. This will quickly alert maintenance staff to any blockage below ground.

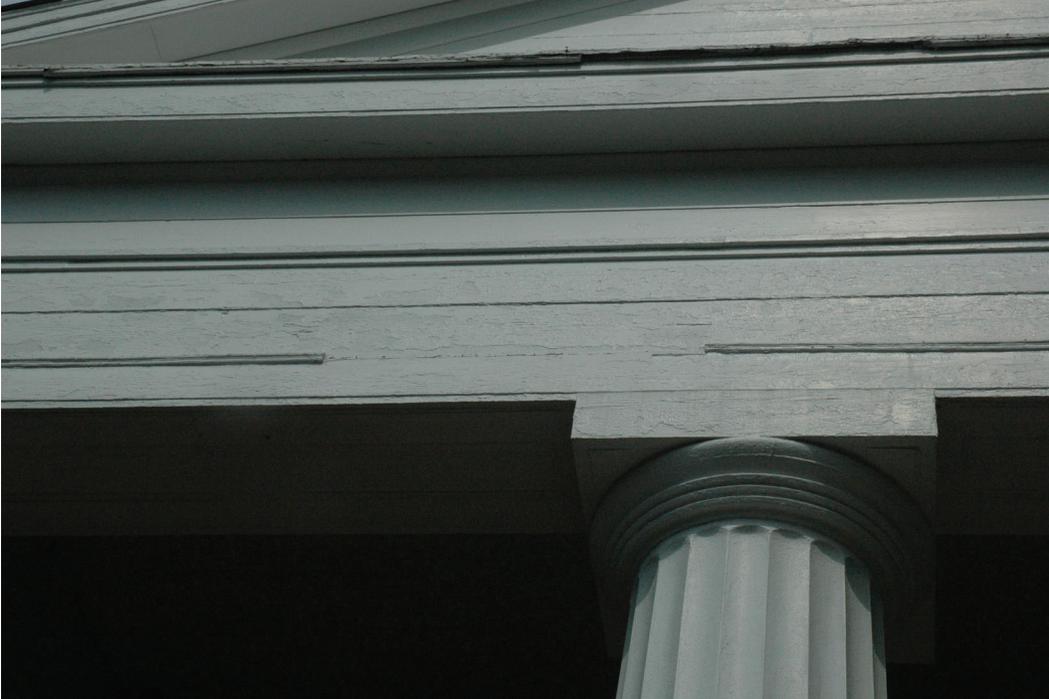
*Entablature.* The entablature is the deep, horizontal element running across the tops of the columns. It appears to be entirely original. The missing piece on the top of the horizontal cornice has already been noted. Also missing is a piece of molding representing the upper edge of the architrave, the lower member of the entablature (Figure 19). Otherwise, this feature appears to be in very good condition.

*Figure 19. Missing section of molding on architrave of portico.*

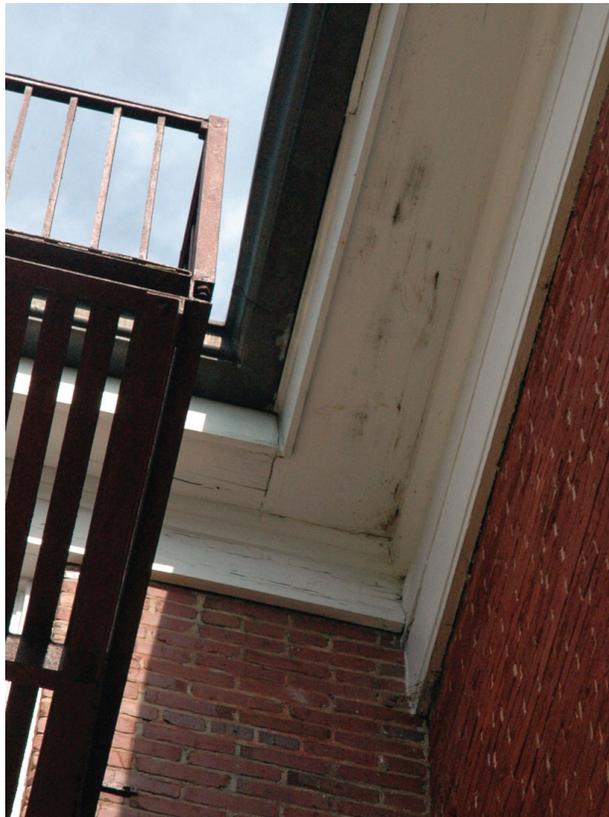
*Figure 22. Damaged cornice on the north façade of 1854 building.*

Damaged portions of the cornice on both sides of the valley should be repaired in old-growth heart pine, replicating all profiles.

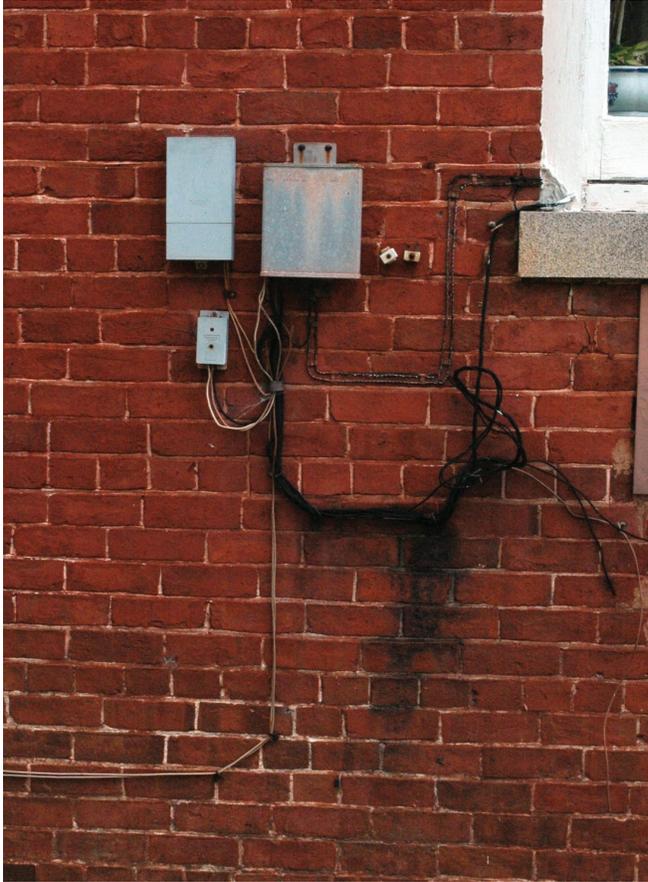
*Figure 23. Communications wiring and equipment on the north façade of the 1854 building.*

Communications wiring and equipment is collected near the sill of the west, first-floor window (Figure 23).

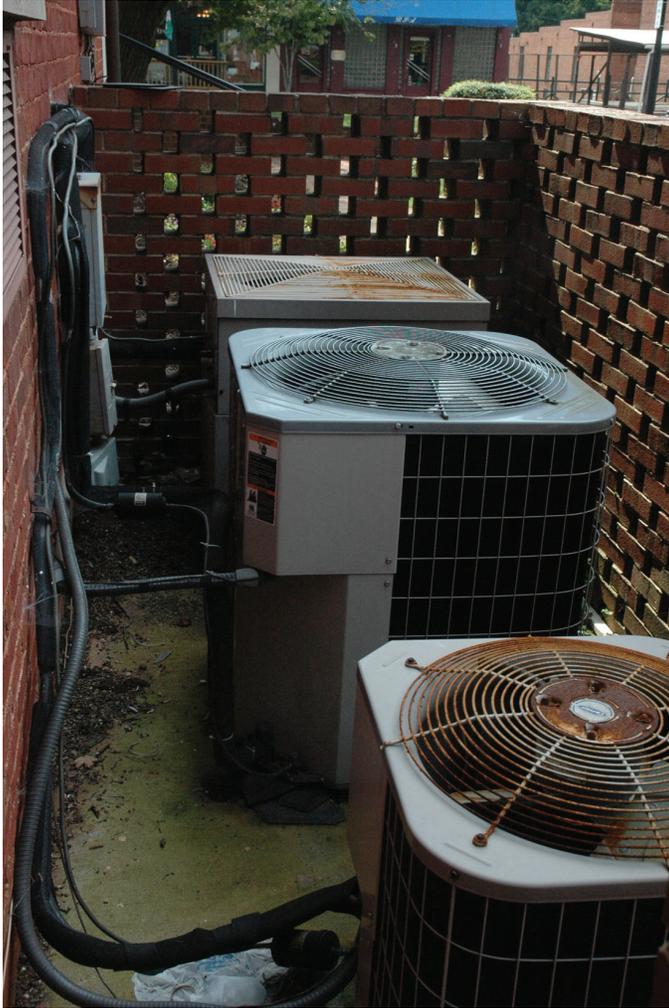
Within a screened brick enclosure, electrical wiring, as well as disconnects and piping for several condensers are also attached to this wall (Figure 24).

*Figure 24. Electrical gear and HVAC piping on north façade of the 1854 building.*

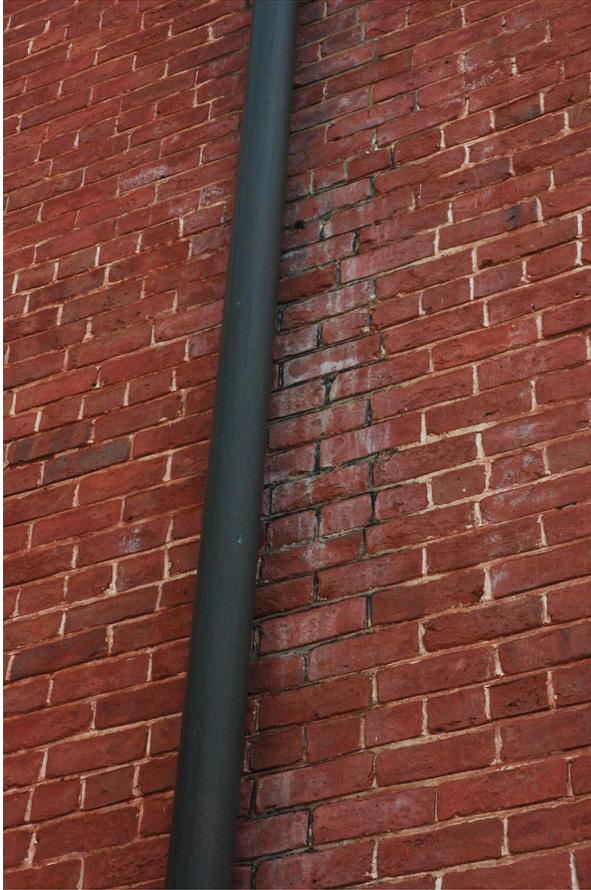
Figure 26. Wall stained by blocked rain leader.

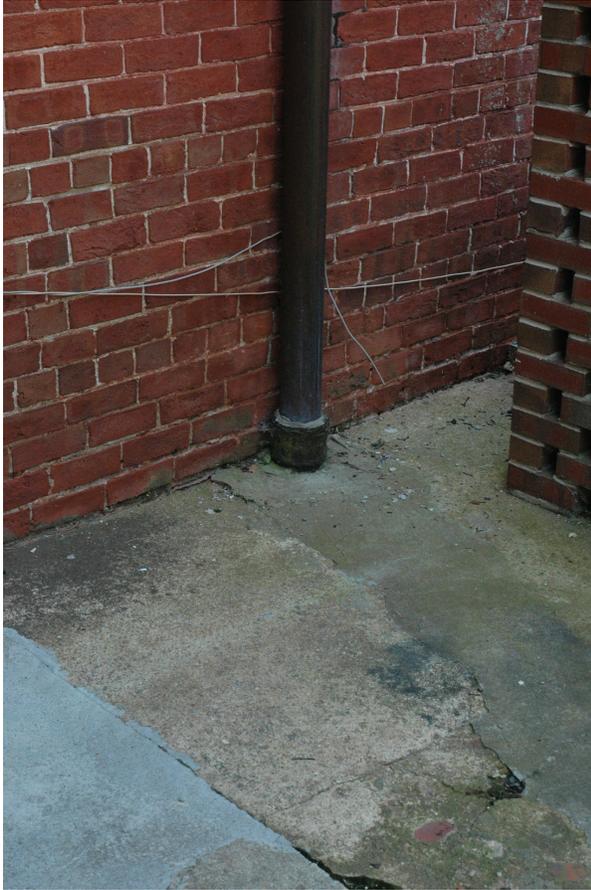
*Figure 27. Cast iron boot of rain leader. Note patch in concrete walk.*

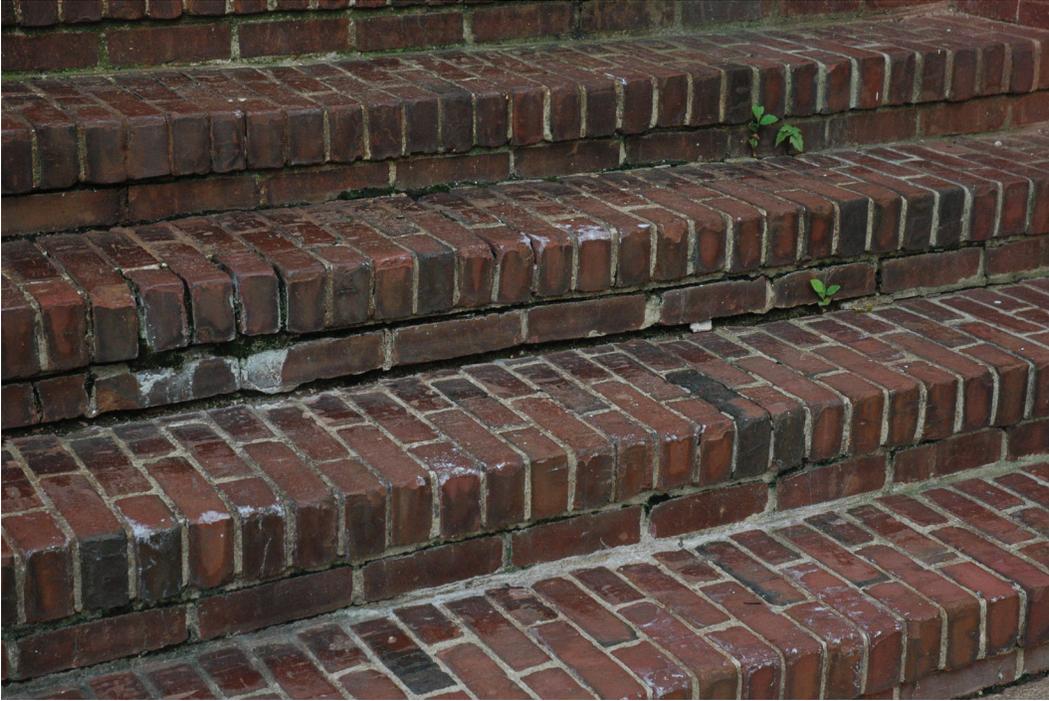
*Figure 29. Failed mortar joints of north porch – 1939 wing.*

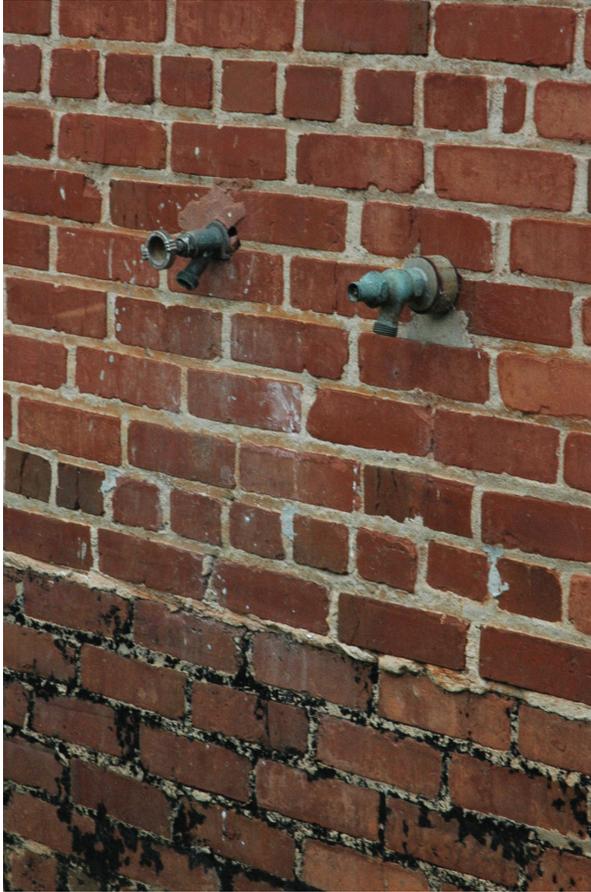
Figure 38. Hose bib missing handle.

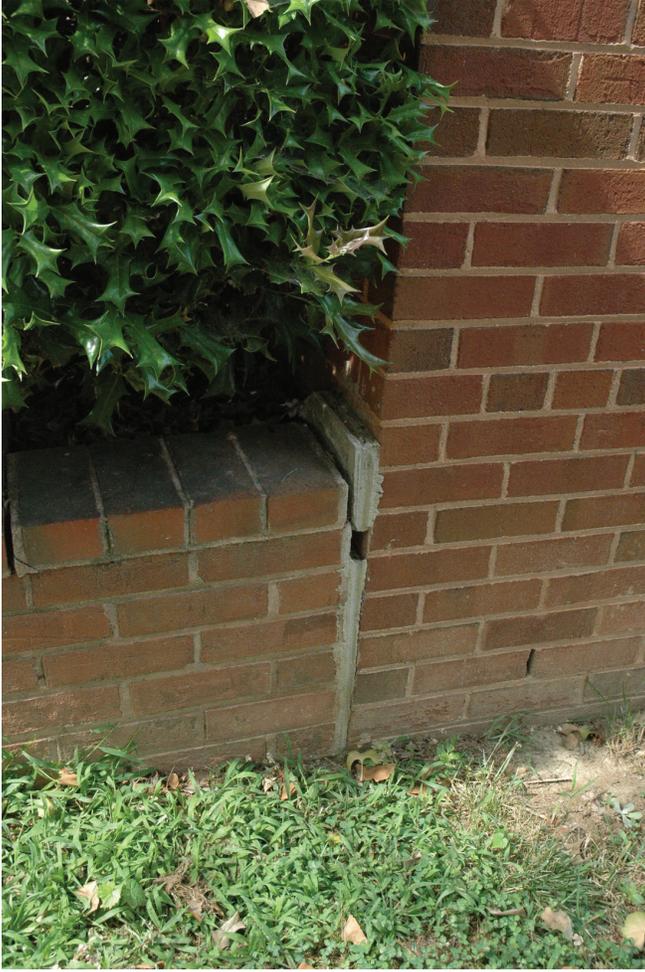
*Figure 44. Planter has rolled away from west face of 1976 addition.*

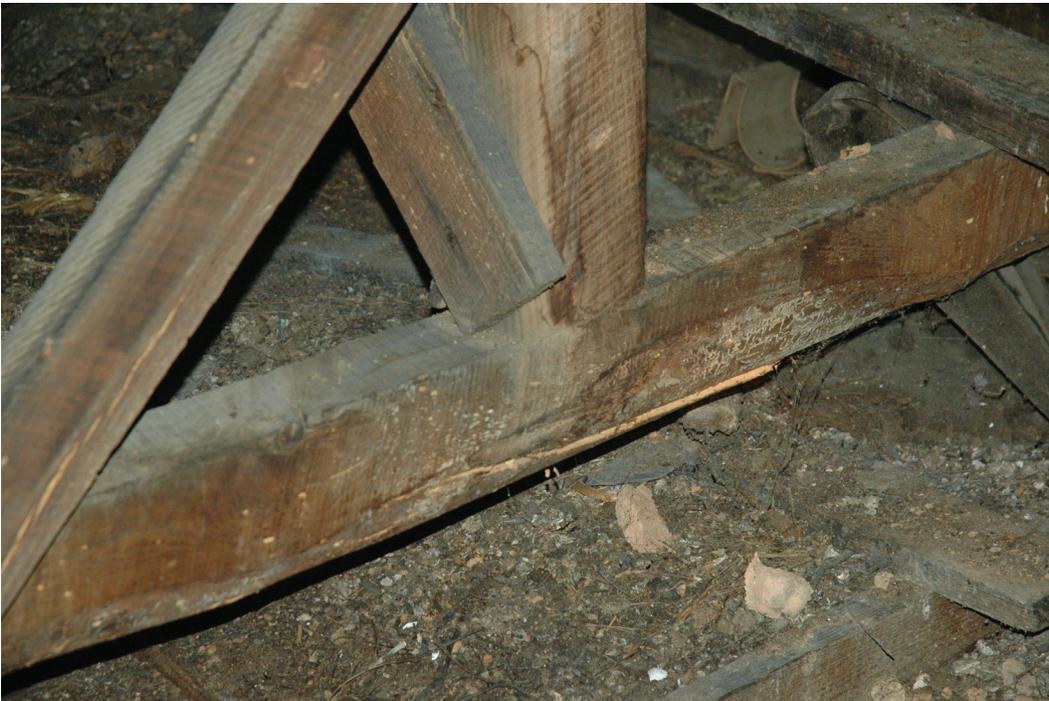
*Figure 48. Sagging girder below northeast corner of the cupola.*

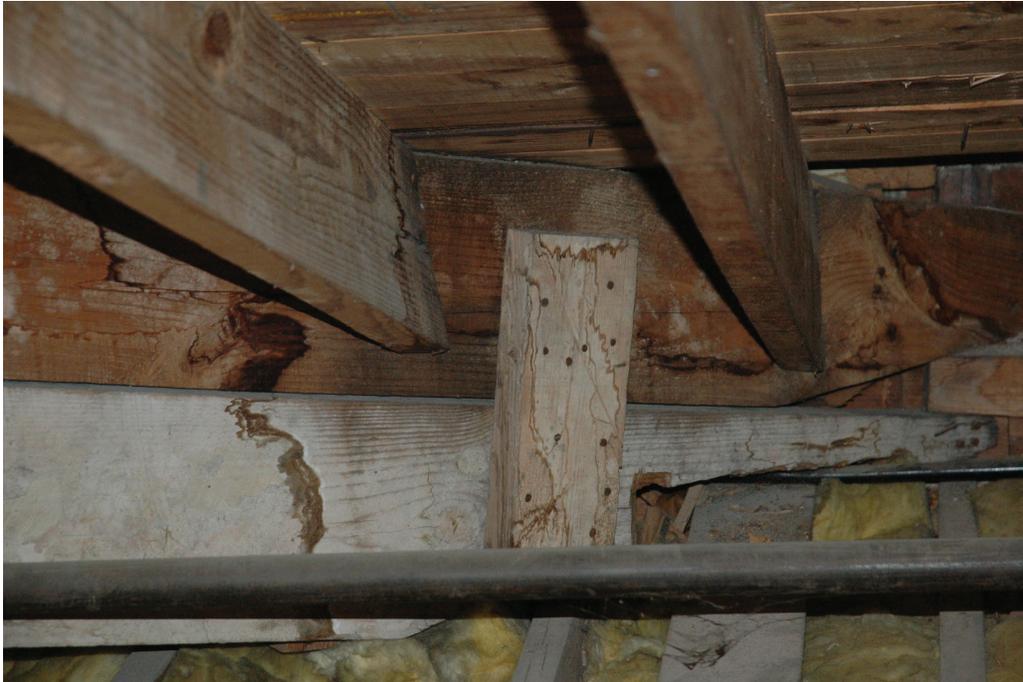
*Figure 52. Evidence of roof leak – 1939 attic.*

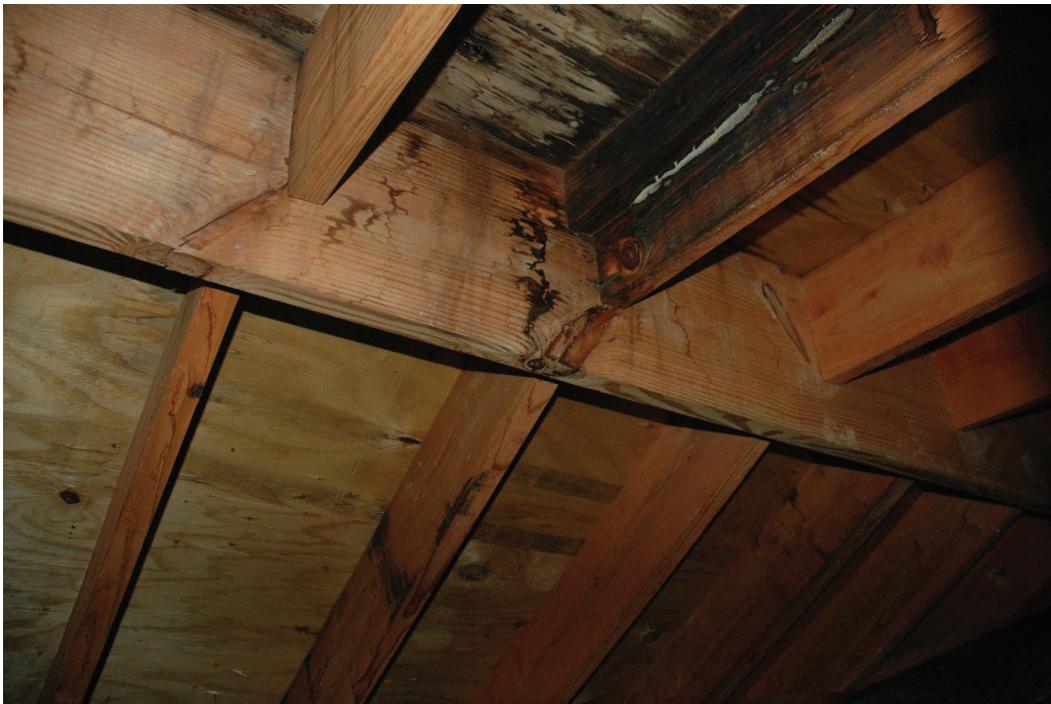
*Figure 53. Damage from leaking at eastern edge of flat roof deck.*

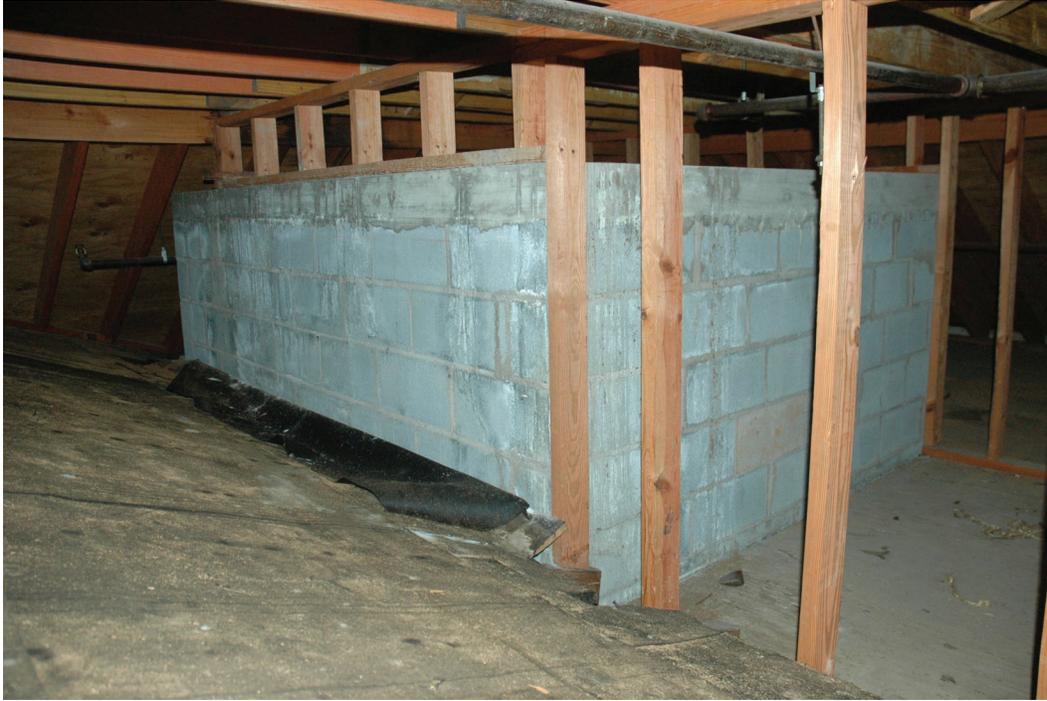
The other leak is in the south edge of the deck, where it passes over the elevator shaft. From this point, water drips onto the top of the shaft, ponding there until it overflows, running down all sides of the shaft (Figure 54).

*Figure 54. Evidence of water running down sides of elevator shaft.*

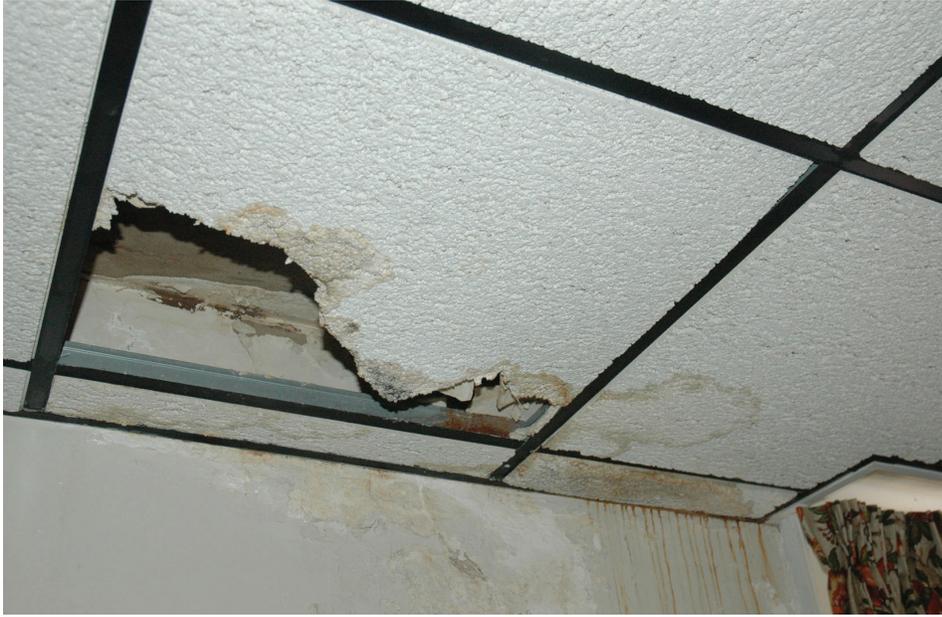
*Figure 55. Damaged ceiling tiles in Room 313.*

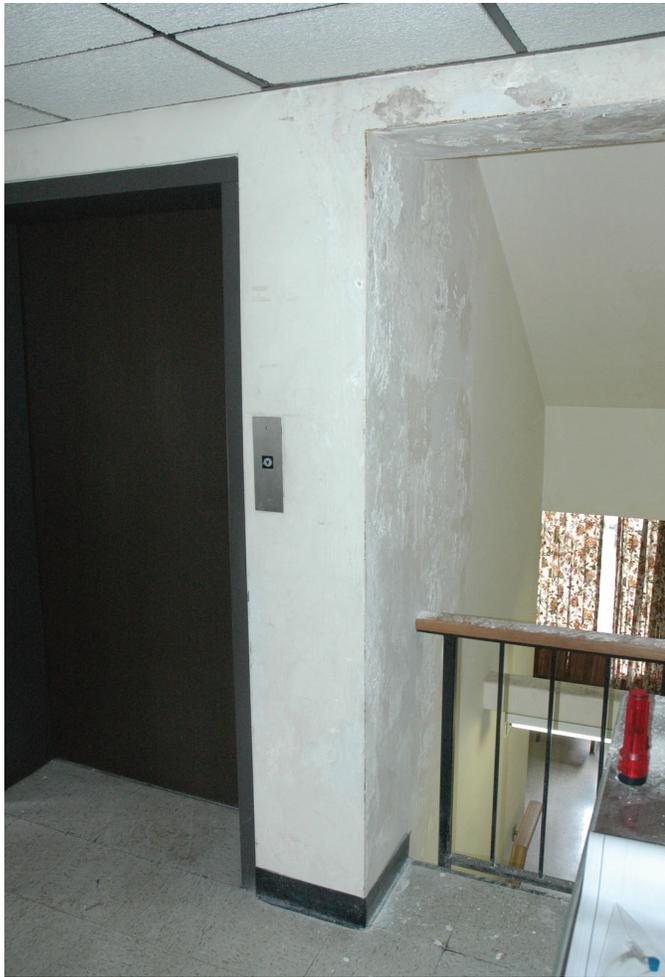
The 1976 plaster around the elevator shaft and on the beam spanning from the shaft to the 1854 building exhibits extensive damage from leaks associated with the flat roof deck. Further damage is visible in Room 313 below where a valley in the slate roof has failed. It is likely that the metal lathing in these badly damaged areas has deteriorated (Figure 56).

*Figure 56. Damaged plaster at the elevator shaft.*

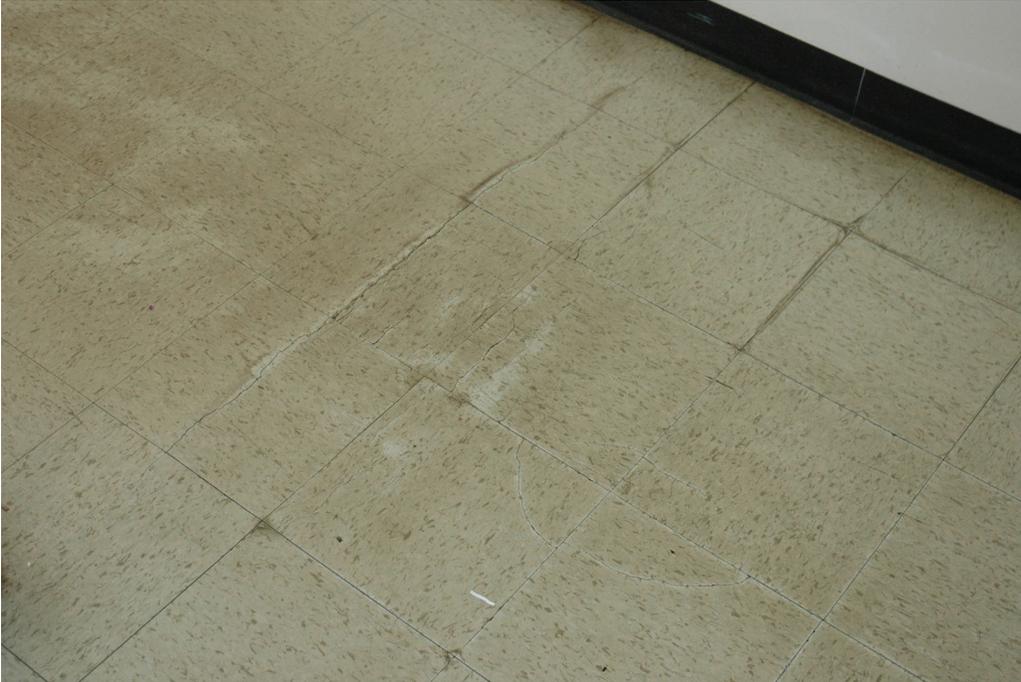
*Figure 57. Failed floor tiles.*

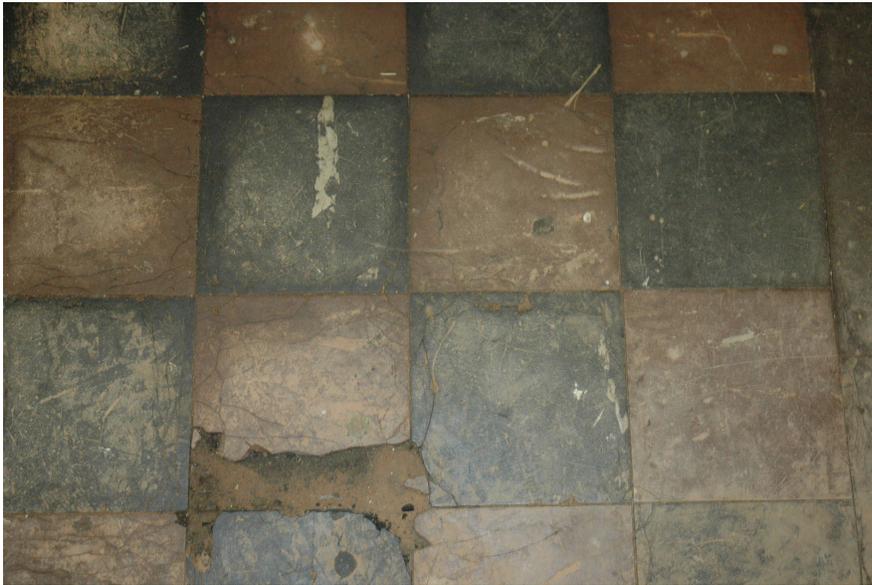
It does not seem likely that this water comes from the failed valley on the front of the 1939 rear wing, since no evidence of water damage is visible at corresponding points on first or second floors. Likewise, it cannot be coming from the electri-

*Figure 62. Destroyed floor tiles in Room B8.*

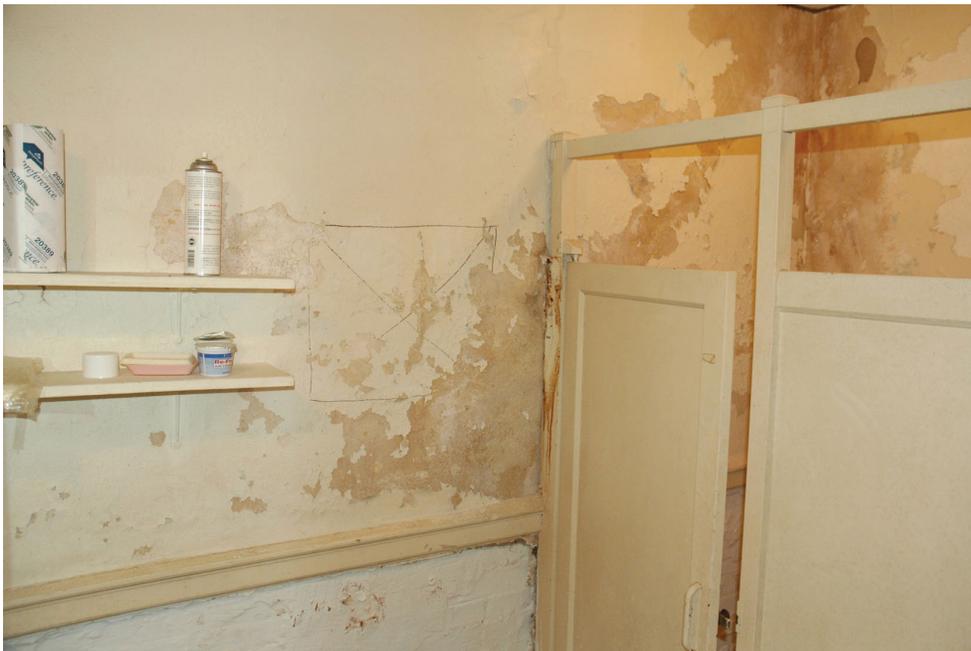
*Figure 63. Damaged plaster on west wall of Room B9.*
