**A RECONNAISSANCE-LEVEL COUNTY-WIDE ARCHITECTURAL SURVEY  
OF POST-BELLUM FARMS (1865-1914)  
STAFFORD COUNTY, VIRGINIA**

**VDHR Project No. 2005-1066**

**May 10, 2011**

**CRI Project No. 1556**

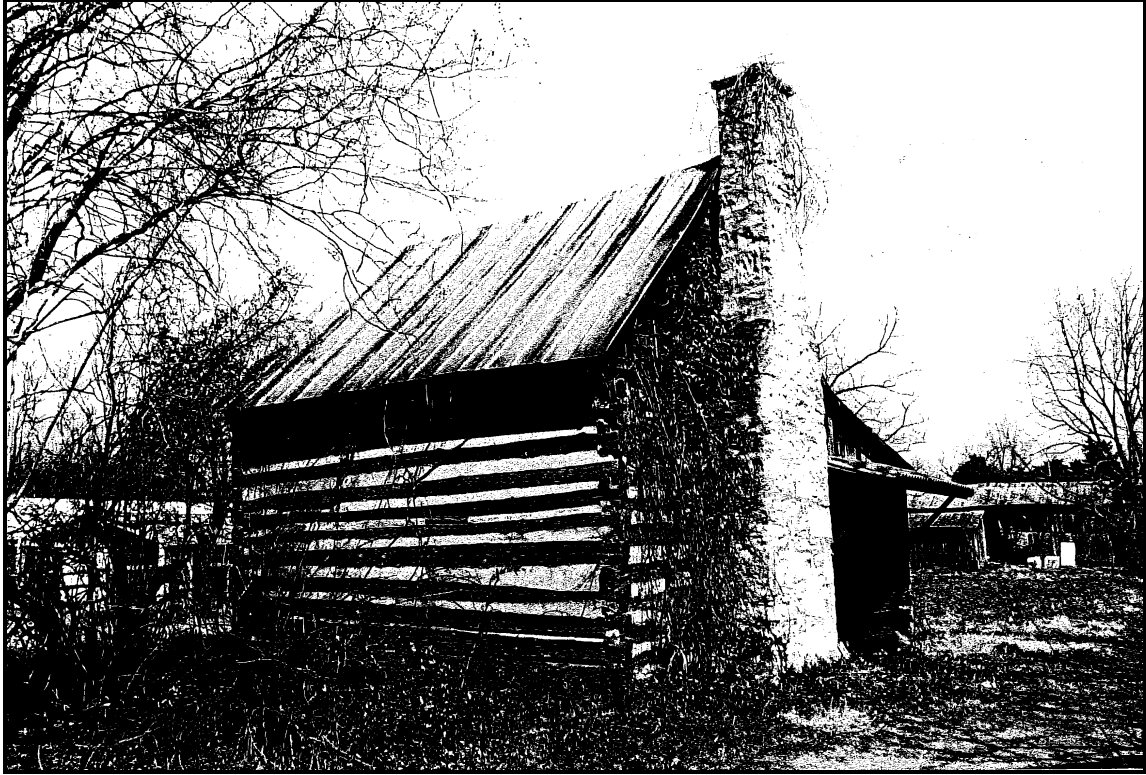
The Bell's Farm complex comprised 11 buildings: a c. 1820 log dwelling, a c. 1890 frame farmhouse, and nine associated outbuildings. Since the log house was constructed during the early nineteenth century during the time period when the chain of title is ephemeral it is therefore unknown who built the original log structure on the property. The one-story, single-bay, one-room building measured 13.5 x 16 feet, with the logs originally joined with a V-cut notch. The house sat upon a stone pier foundation, with a single entry door located on the western elevation. The house was also heated by a large stone chimney, located on the gable end of the structure. The steep, gabled roof was sheathed in metal, and a single window on the north gable end, which provided light for the upper loft area, which was accessed from the interior by a ladder. According to oral history, a family of 13 was raised in this one-room building during the early nineteenth century.

**Figure 3. Log Dwelling at Bell's Farm (VDHR #089-0058), View Looking Northeast.**

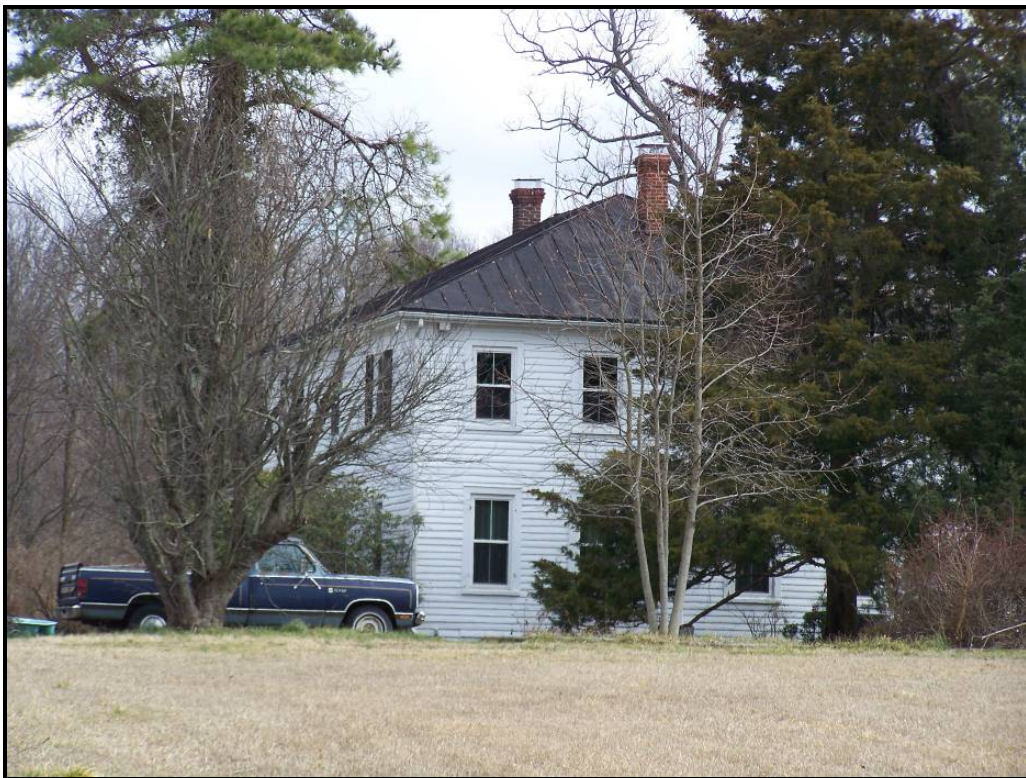
The property of Locust Grove Farm was limited in access; however, it is visually apparent that the house retains a majority of its original architectural features, including the weatherboards, front entry porch and two-over-two wood double-hung sash windows, and remains a well preserved c. 1870 dwelling (Figure 4). Outbuildings noted on the property during the previous survey include a dairy, a foundation, well house, cistern and garage. Since the 1992 survey a shed has been added to the property and is located behind the garage. The dairy has been subsequently demolished. The foundation, well house and cistern were not visible at the time of the current survey due to access issues.

**Figure 4. Locust Grove Farm (VDHR #089-0029), 54 Locust Grove Farm Road, View Looking Southeast.**

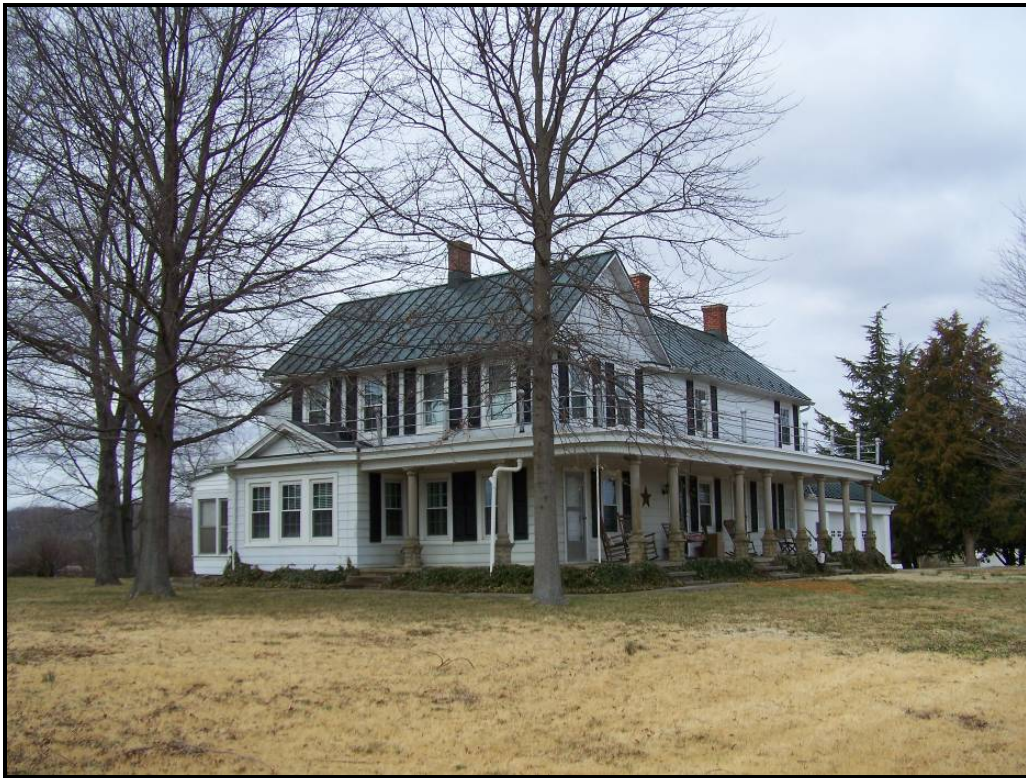
Silver Ridge Farm is a large agricultural complex which still functions as a working farm. Access to a majority of the buildings, particularly the more modern structures, was denied by the current owner. The historic structures immediately surrounding the house had limited access. The house since the 1992 survey, according to the description provided on the DSS form, has had a portion of its wrap-around porch enclosed (Figure 5); however, much of the building's architectural detail has not changed. The sheds and wash house to the southwest of the dwelling and the milk house to the northeast are extant; however, the condition of the three buildings to the southwest has deteriorated significantly since 1992.

**Figure 5. Silver Ridge Farm (VDHR #089-0030), 73 Silver Ridge Lane, View Looking Northwest.**

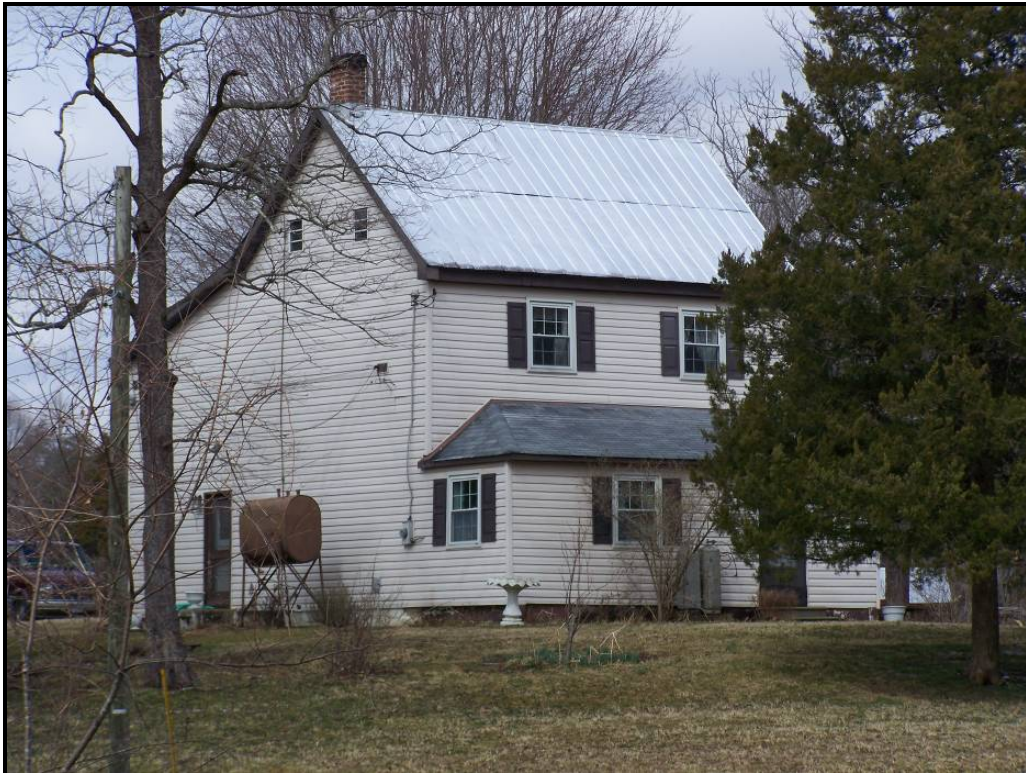
A majority of the changes to Leland Farm have occurred to the primary resource. Since the 1992 survey, the Bricktex has been covered over or replaced with vinyl siding, the front three-bay hipped-roof porch has been enclosed and the wood six-over-six double-hung sash windows have been replaced with six-over-six vinyl double-hung sashes (Figure 6). Outbuildings noted on the original survey included a well, two equipment sheds, a garage/shed, a chicken house and a cemetery. All the secondary resources appear to be extant that were noted on the previous survey. Access to the cemetery was not obtained during the current effort.

**Figure 6. Leland Farm (VDHR #089-0044), 539 Leeland Road, View Looking Northeast.**

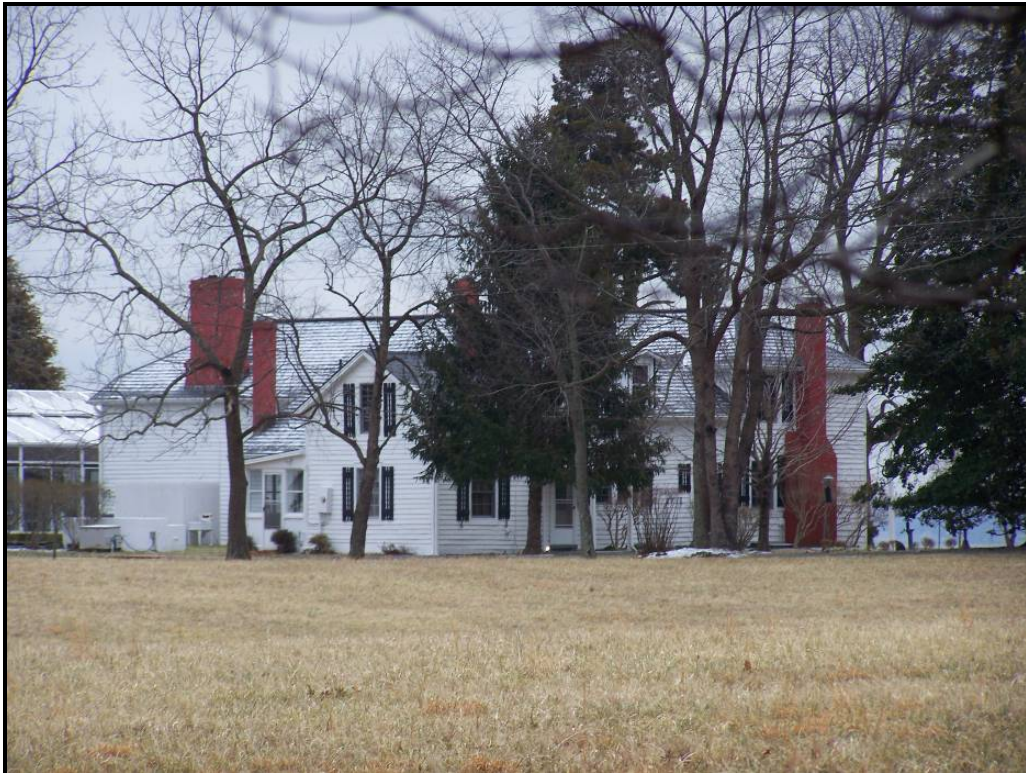
Cedar Ridge Farm was not accessible. The driveway was barred and at its entrance was a number of “no trespassing” signs. Photographs were taken from the public right-of-way (ROW) towards the house and outbuildings (Figure 7). The house appears to have changed little, though the front of the dwelling was not visible to determine if the shingles, as previously noted, are still extant. The only visible addition to the property in terms of outbuildings is a large glass enclosed pool house located to the southeast of the house. The garage, sheds and well noted on the 1992 survey are still extant and retain their architectural features.

**Figure 7. Cedar Ridge Farm (VHDR #089-0074), 1381 Brent Point Road, View Looking Southeast.**

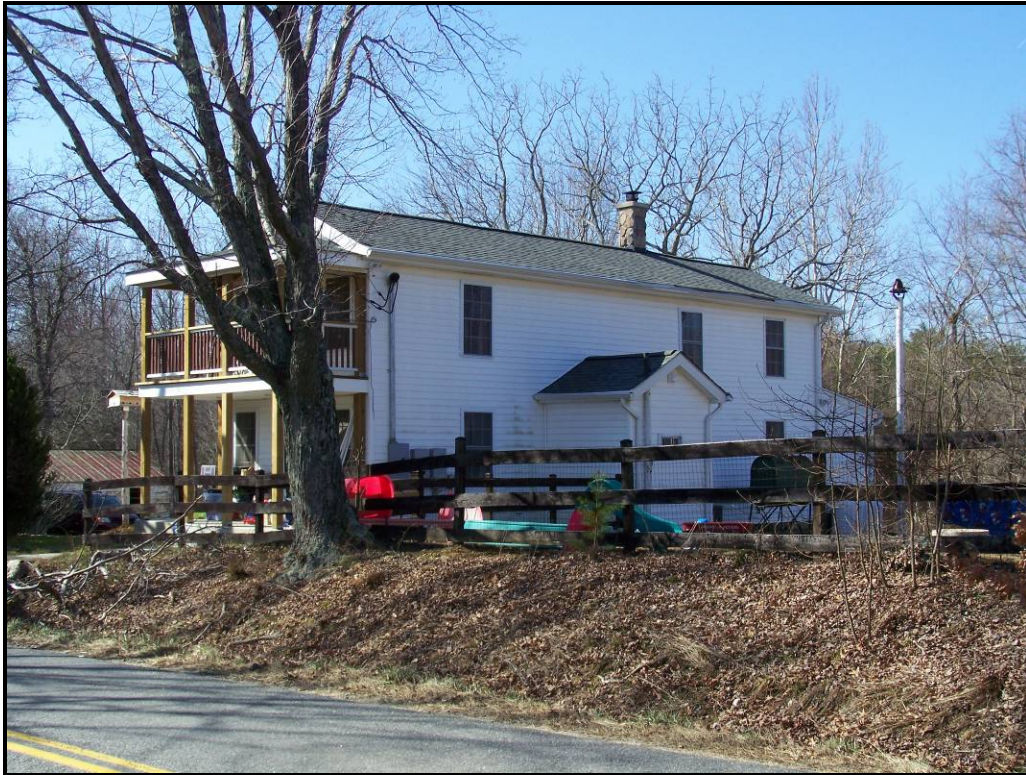
The dwelling located on the property of Cedar Pond Farm has been altered significantly since the previous survey. It's most notable feature, the ornate two-story front porch, has been rebuilt and all the architectural detailing removed, including the scalloped bargeboard in the gable end. In addition the eastern-most flue has been removed above the roofline. The flue towards the western end of the house has been faced with stone veneer (Figure 8). Other alterations include the addition of vinyl siding and the replacement of the original windows with six-over-six vinyl sashes. Outbuildings listed on the property during the initial survey include a garage, two sheds and a chimney. The chimney has been demolished and the western-most shed is in ruins. A contributing barn, located to the south of the dwelling, had not been documented as part of the previous survey, but was recorded during the current effort. The barn does not appear to be utilized for more than just minimal storage.

**Figure 8. Cedar Pond Farm (VDHR #089-0162), 1209 Mountain View Road, View Looking Southwest.**

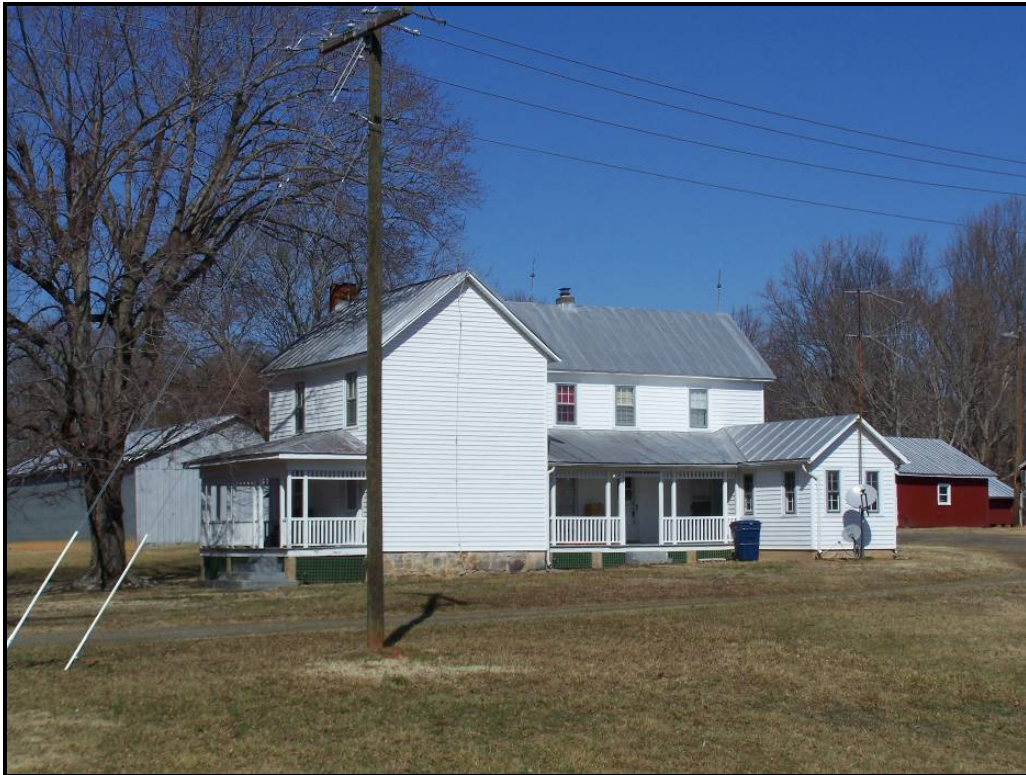
The farm, located at 82 Spotted Tavern Road, is a compact complex containing 20 buildings and structures. It appears little the primary resource has changed little since the previous survey (Figure 9). Thirteen outbuildings are included on the original sketch map and included corn crib, barn, chicken house, machine sheds, a garage and several unspecified sheds. These buildings appear to be still extant. Three barns, granary, workshop, stable, silo and well house are among the additional resources documented during the current survey.

**Figure 9. Farm (VDHR #089-0183), 82 Spotted Tavern Road, View Looking North.**

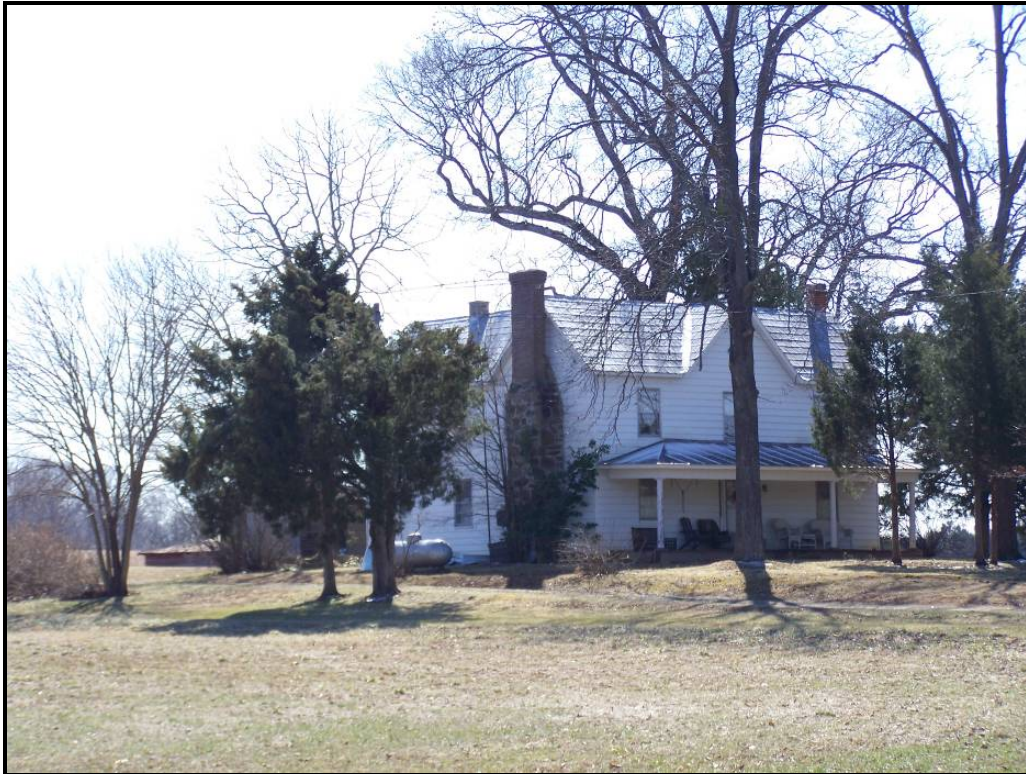
Access was denied to the property; however, in comparison with the earlier survey it does not appear that the resources have been altered to a large extent (Figure 10). The barn to the rear of the property does have structural problems, which according to photographs taken in 1992 does not appear to have been an issue. No new outbuildings appear to have been added to the property.

**Figure 10. Spotted Tavern Farm (VDHR #089-0184), Route 612, View Looking Southwest.**

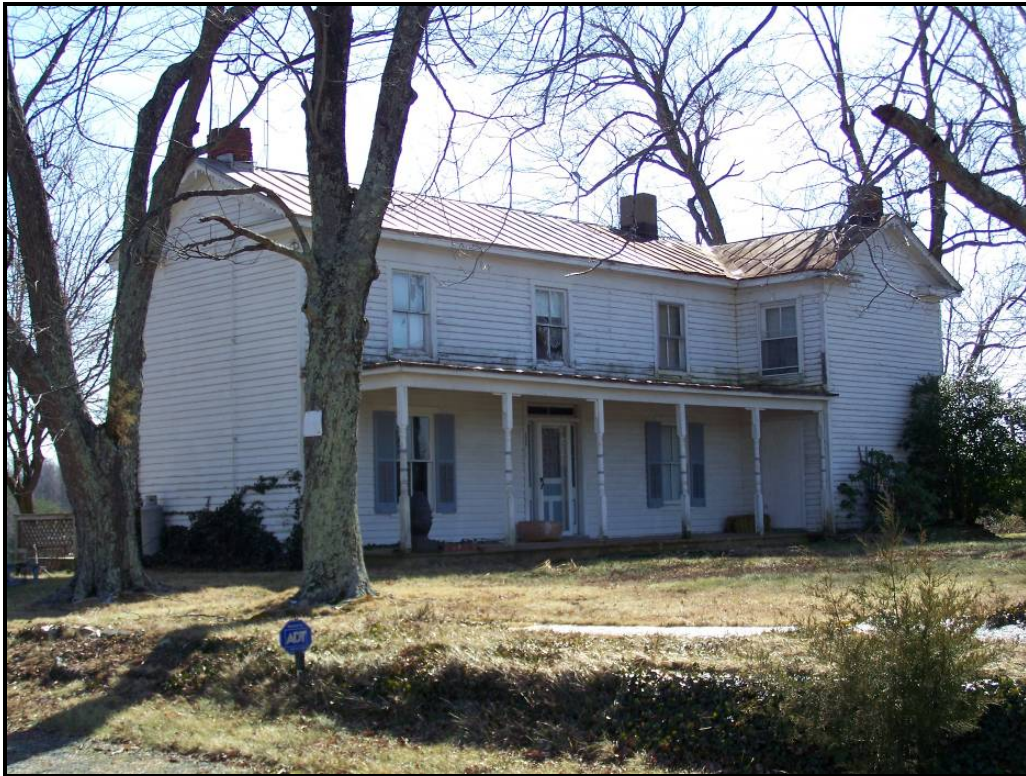
The dwelling at Dodd's Corner Farm retains much of its architectural integrity including many of the architectural details noted in 1992 including its ornate gable end cornice boards and turned porch posts (Figure 11). The landscaping remains largely unchanged as well. The barn documented in 1992; however, has been demolished, though the garage remains. The shed located behind the house was not visible during the current survey due to accessibility issues; however, a second contributing shed is visible to the southeast of the house. A modern outbuilding of unknown function has been constructed to the southeast of the garage.

**Figure 11. Dodd's Corner Farm (VDHR #089-0185), 892 Hartwood Road, View Looking South.**

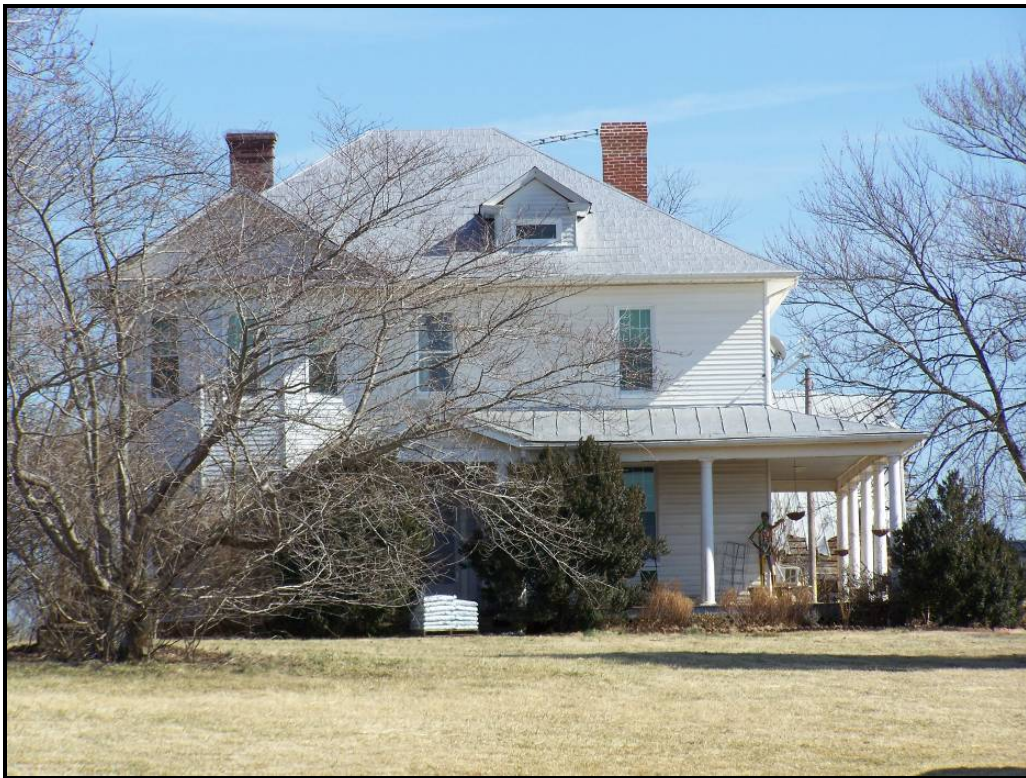
The house at Park Farm has changed little since the previous survey with the exception of the six-over-six vinyl double-hung sash windows, which replaced the one-over-one wood sashes noted previously (Figure 12). Limited access to the property precluded the assessment of any existing buildings behind the dwelling. The roof and part of the structure of the mid-twentieth century barn are; however, partially visible behind the main dwelling. The exterior walls and portions of the roof appear to be in a deteriorated condition. The garage remains extant and continues to retain its original weatherboard siding and exposed rafter ends. The kitchen, located to the southwest of the house; however, has been demolished. The secondary dwelling noted in 1992 was not visible.

**Figure 12. Park Farm (VDHR #089-0186), Park Farm Lane, View Looking Southeast.**

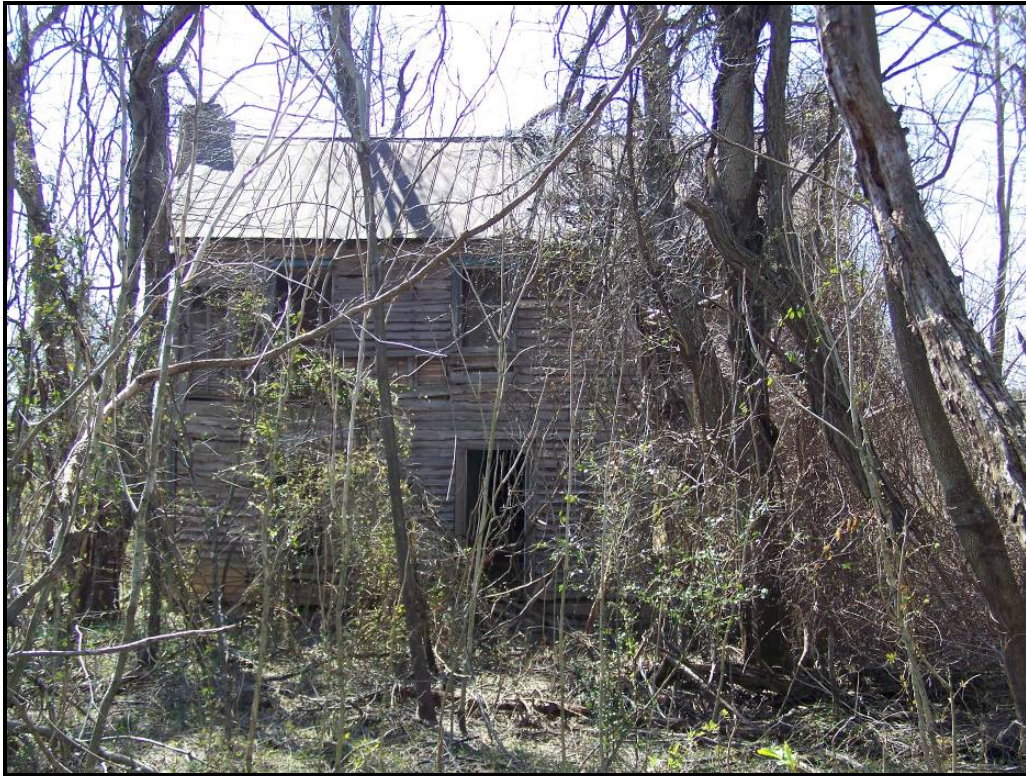
The dwelling at Deep Run Farm, located down a long farm road off of Skyline Drive, is still extant and aside from additional overgrowth and a portion of the western chimney missing, little has changed since the survey in 1992 including the overall condition of the house (Figure 14).

**Figure 13. Deep Run Farm (VDHR #089-0189), 153 Skyline Drive, View Looking South.**

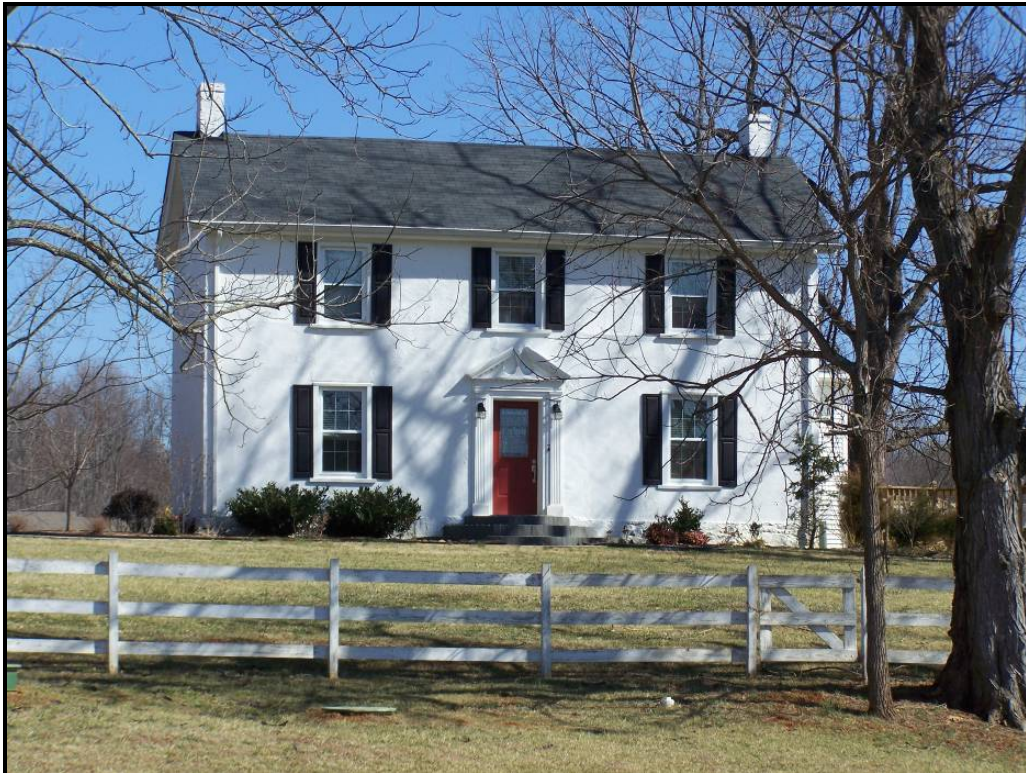
Willowmere in 1992 was a rural farm surrounded by agricultural fields. The house and outbuildings once located off of Mountain View Road down a long dirt driveway are now surrounded by a modern residential development and a new road, Willowmere Pond, has been constructed to access these large residential lots. The house located at Willowmere is largely unchanged since the previous survey (Figure 14); however, the barn and smokehouse have been demolished. The garage and shed remain. Although surrounded by modern development, the property has managed to retain its setting.

**Figure 14. Willowmere (VDHR #089-0191), 80 Willowmere Pond Lane, View Looking East.**

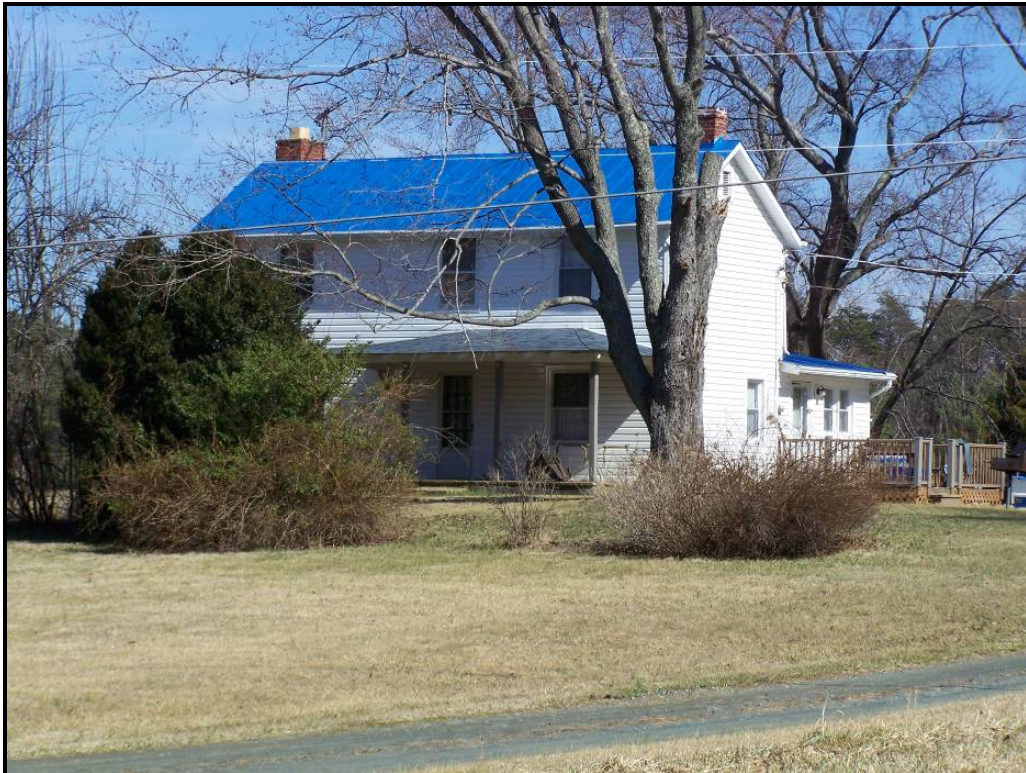
The farm, located at the corner of Mountain View Drive and Joshua Road, in an area known as Skidmore Corner, retains its rural farm setting. Changes to the primary resource are minimal and include the addition of vinyl siding and a new seamed metal roof (Figure 15). The three-over-one and eight-over-eight wood double-hung sashes remain. The outbuildings are also essentially unchanged architecturally; however, several have deteriorated since the previous survey including the large frame barn. A frame outbuilding, which does not appear on the original sketch map, has collapsed making a determination its function difficult.

**Figure 15. Farm (VDHR #089-0192), 2582 Mountain View Road, View Looking East.**

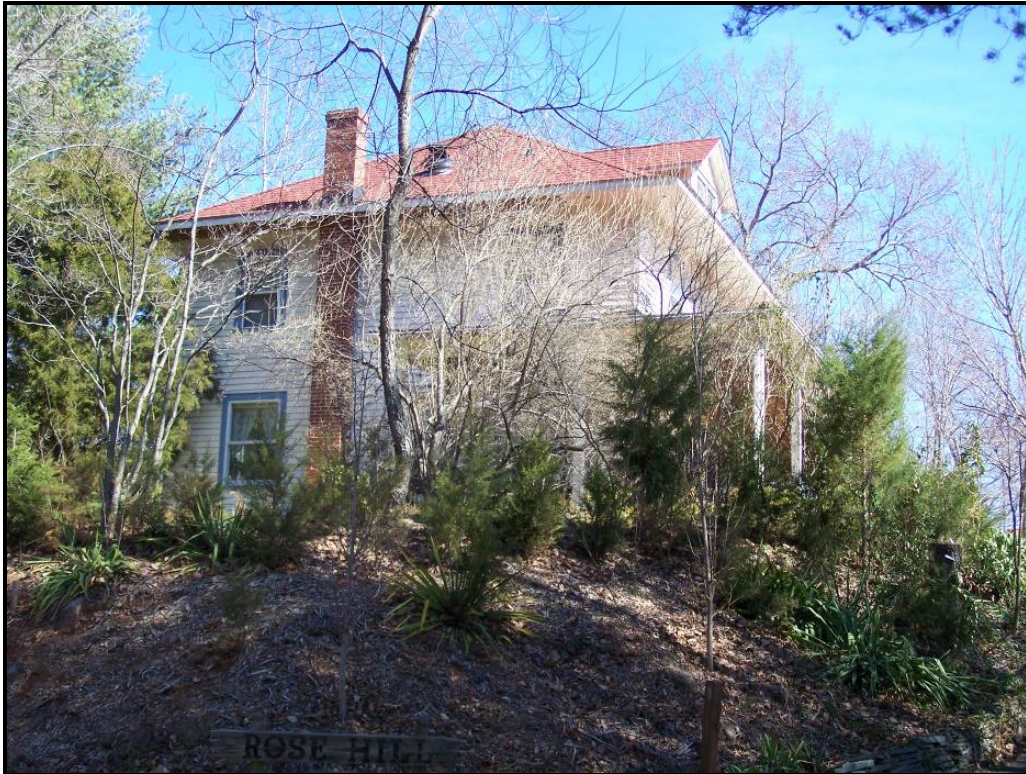
Rose Hill Farm is an early twentieth century American Foursquare with a detached garage (Figure 16). No other agriculturally related outbuildings were initially recorded during the previous survey or visible during the current effort. In comparing the architectural features and characteristics of the dwelling from the 1992 survey to the present it does not appear that the primary resource has been altered.

**Figure 16. Rose Hill Farm (VDHR #089-0193), 36 Clover Hill Drive, View Looking Northeast.**

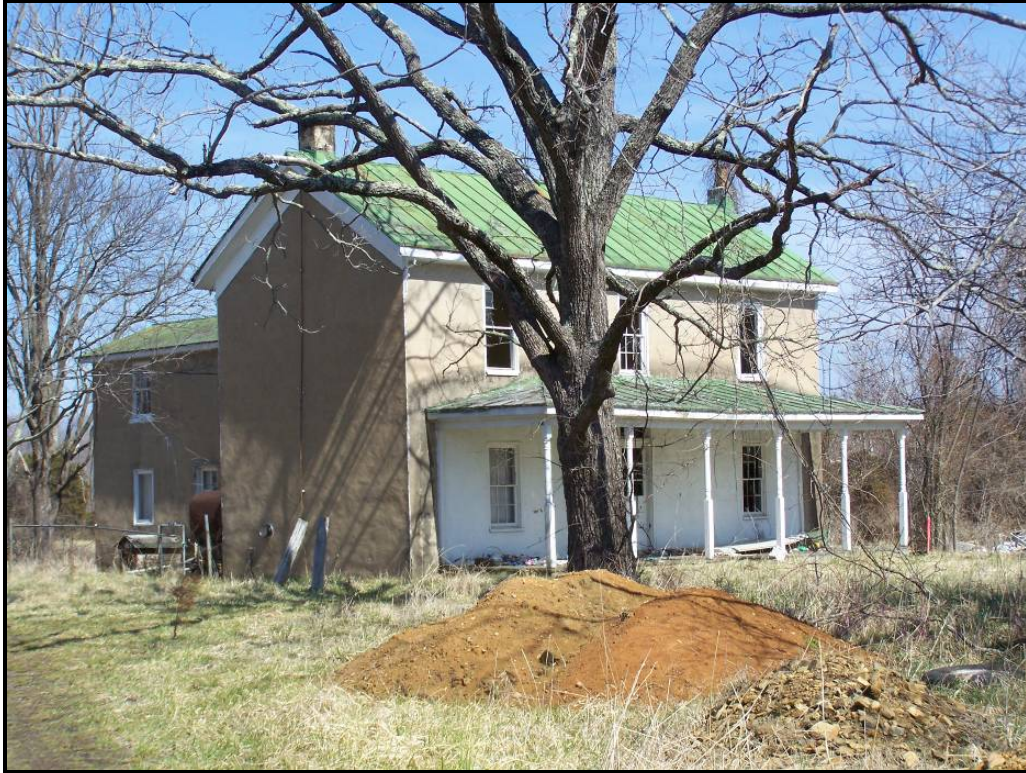
Currently the c. 1890 farm located off Touluca Road is vacant and the property appears slated for either commercial or residential development. In 1992 the property contained the dwelling house, six sheds, two wells and a barn. Presently the dwelling house (Figure 17), one shed and the well house to the southeast of the house remain standing. Remnants of the barn and a shed to the southeast of the barn are visible as well as the foundation of the second well. The remaining four sheds noted during the previous survey are no longer visible.

**Figure 17. Farm (VDHR #089-0198), Touluca Road, View Looking North.**

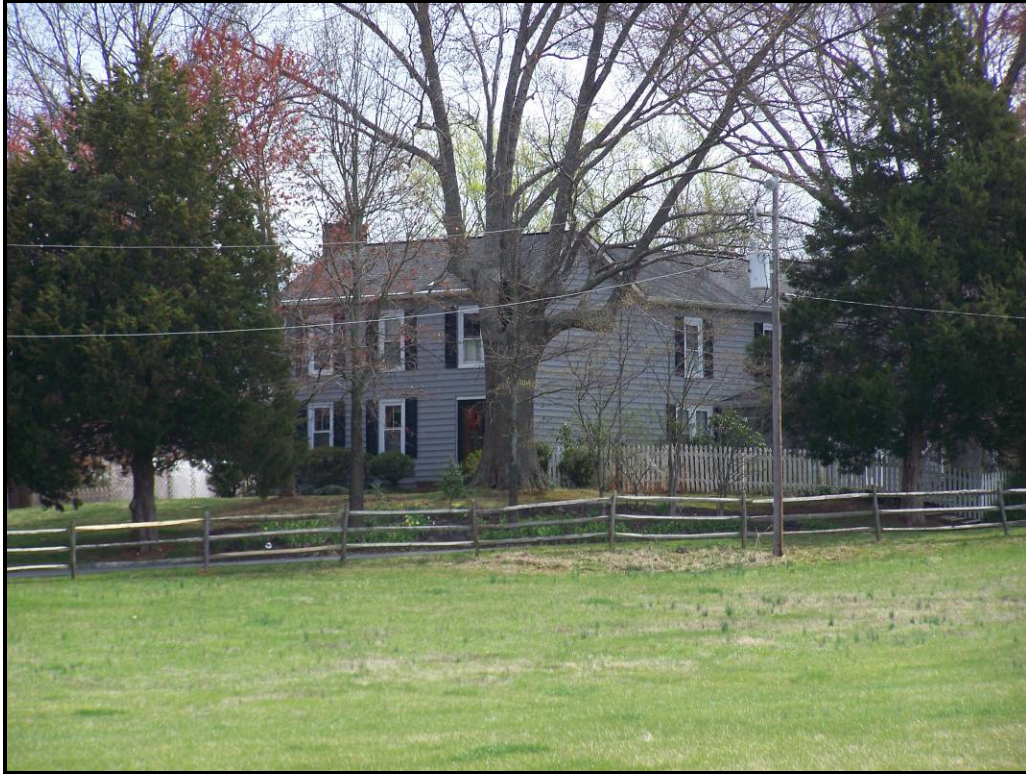
The main dwelling at Concord Farm appears to have changed little since the previous 1992 survey (Figure 18). Secondary resources noted during that year included a smokehouse, well house, four sheds, two stables and a barn. A majority of these resources were visible on the property during the current effort with the exception of the smokehouse, well house and one shed. An additional L-shaped building with a hipped roof has been constructed on the property within the last five years.

**Figure 18. Concord Farm (VDHR #089-0201), 2971 Mountain View Road, View Looking Southeast.**

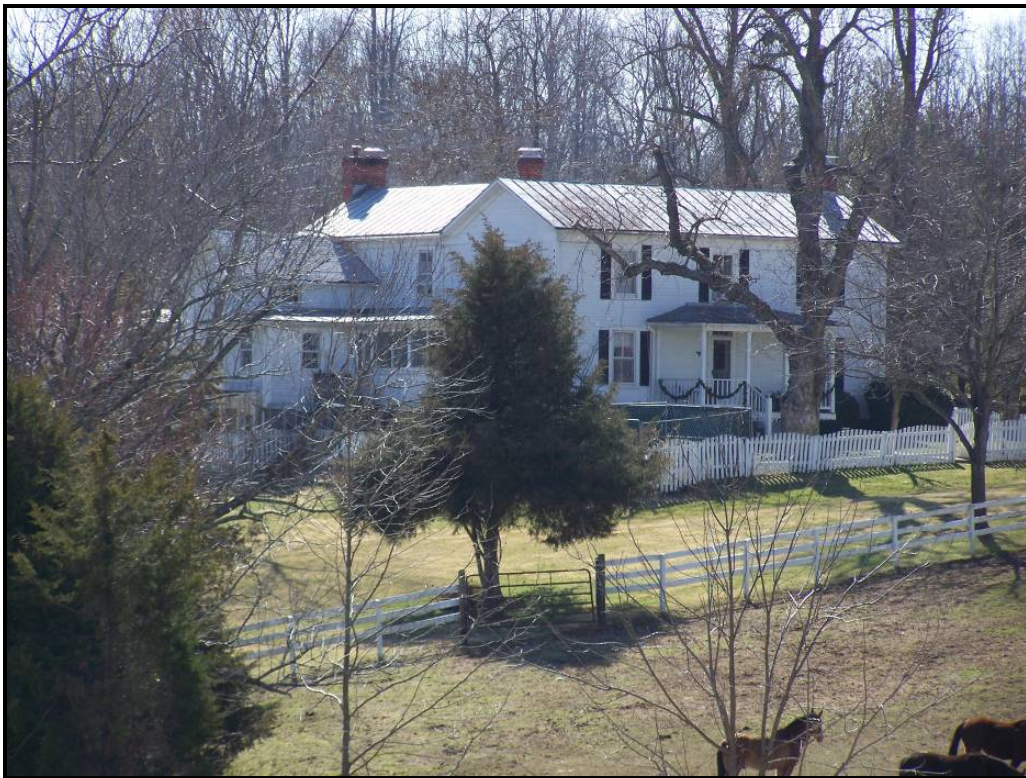
Crown Manor is situated within a modern residential development, although retains a substantial amount of acreage and is still a working farm. Formerly located off Rock Hill Church Road the farm's address is now 93 Crown Manor Drive. The house appears to have changed little since the previous survey (Figure 19). Outbuildings illustrated on the original sketch map include a garage, wood shed, tool house, office, chicken house, a utilitarian shed, dairy barn, equipment shed and crib barn. The chicken house and shed have been demolished and the crib barn has been converted to a garage. The equipment shed appears to function as a stable or small cattle barn instead of vehicle storage. The foundation noted on the sketch map has also been demolished and its site is now be part of the adjacent property.

**Figure 19. Crown Manor (VDHR #089-0202), 93 Crown Manor Drive, View Looking Southwest.**

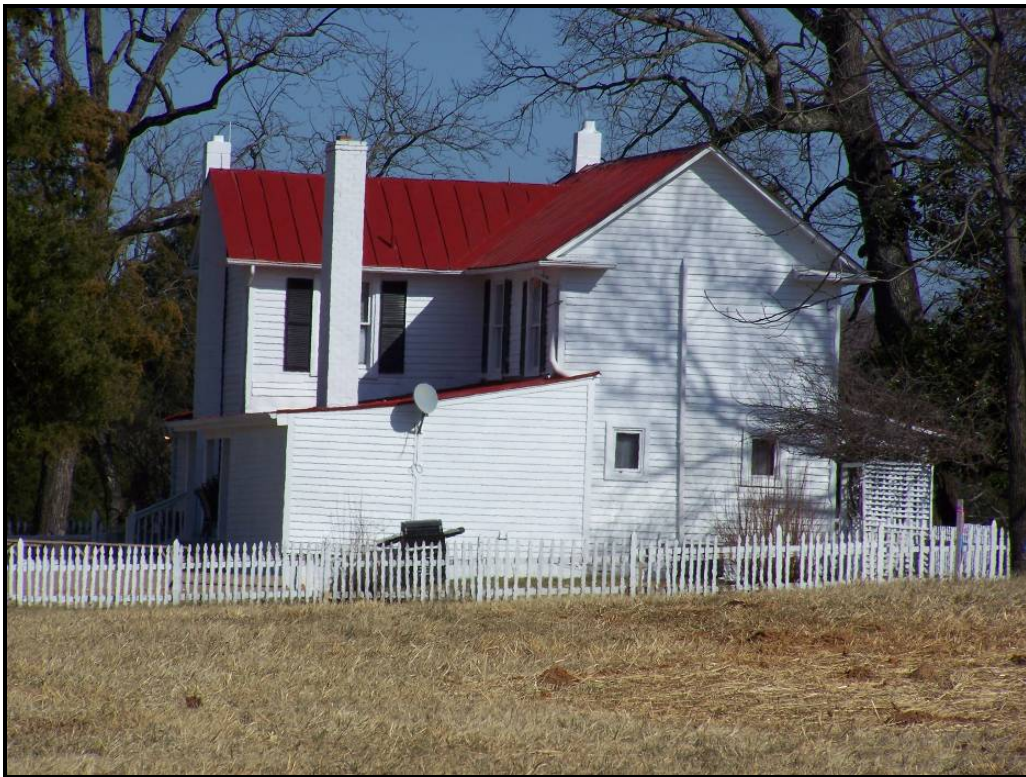
Potomac Run Farm, post 1870, is sited perpendicular to the road with restricted visibility due to distance from the road and topography. The property is heavily posted with “no trespassing” signs at the entrance to the driveway. Much of the landscape does not appear to have changed substantially since the previous survey with the exception of a newly constructed split rail fence adjacent to the road. Alteration to the dwelling since 1992 include the replacement of the original six-over-six wood double-hung sash windows with one-over-one vinyl sashes and the addition of vinyl siding, which has replaced the wood weatherboards (Figure 20). In addition the flue in the western end of the building has been removed above the roofline. Outbuildings noted during the previous survey – a barn and two sheds – have been demolished. A modern one-story barn has been constructed to the rear of the property and is only slightly visible.

**Figure 20. Potomac Run Farm (VDHR #089-0210), 561 Mount Olive Road, View Looking East.**

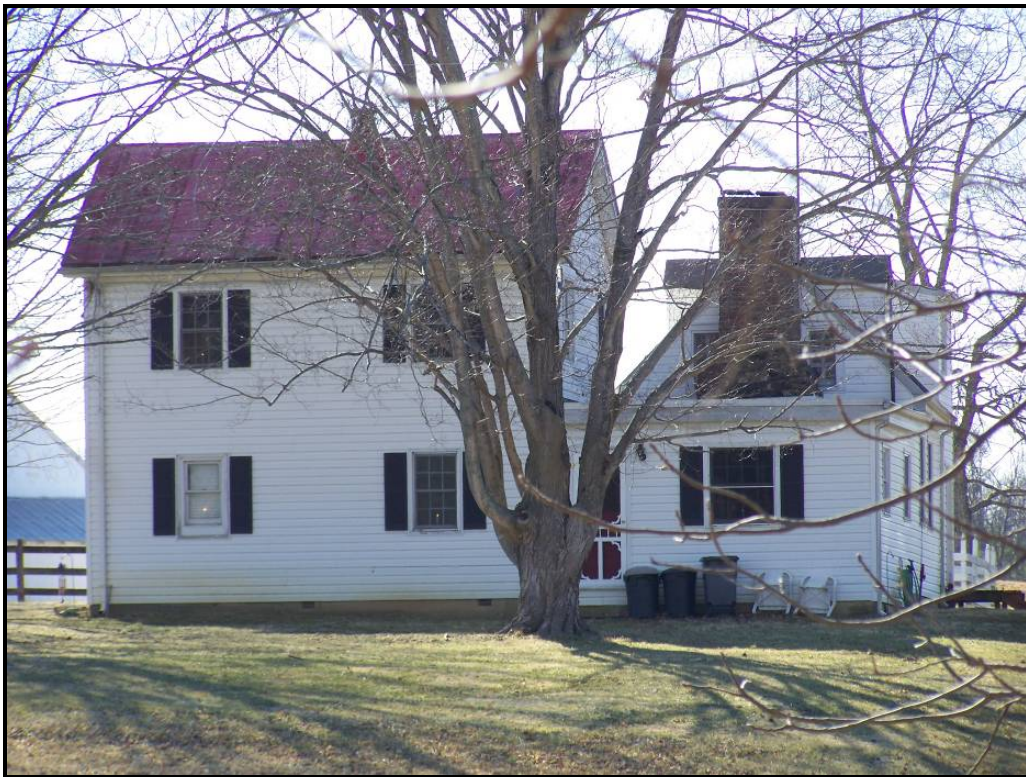
Locust Grove, located on Mount Olive Road, has had alterations to its setting, dwelling and outbuildings since 1992. Although retaining a substantial amount of acreage, the adjacent lot is in the process of being developed. Portions of the infrastructure have been constructed including a paved road and an entry gate. The road runs along the southern side of the property. The house itself retains the same or similar configuration; however, vinyl siding has replaced the asbestos siding, the concrete block foundation has been parged, and several one-over-one vinyl double-hung sash windows have replaced the original six-over-six sashes (Figure 21). Several of the outbuildings have been demolished and include a large frame barn, silo, two sheds and the stone chimney. Remaining secondary resources, which have changed little in the last two decades, include the granary, vehicle shed and non-contributing barn.

**Figure 21. Locust Grove (VDHR #089-0211), Mount Olive Road, View Looking West.**

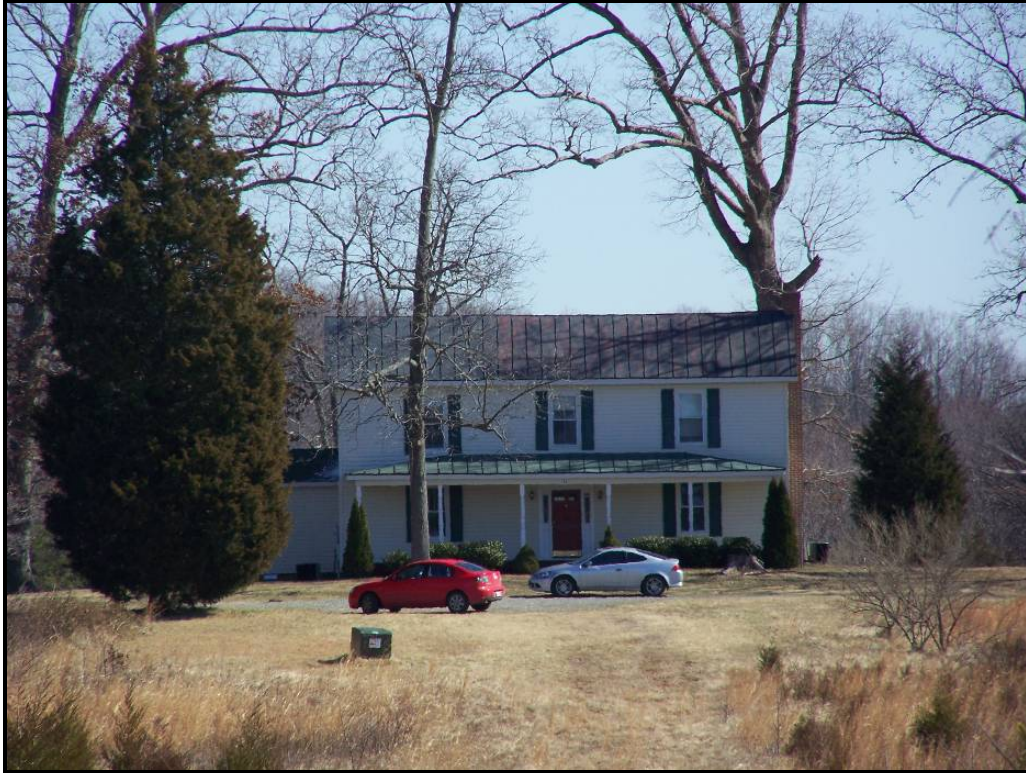
The farm, while still oriented towards Poplar Road is now part of a modern residential development with the houses within the development sited on large lots. The farm complex has lost a majority of its outbuildings since 1992 including a large bank barn, a smaller frame barn, corn crib, and shed. The garage and vehicle shed remain; however, the shed is deteriorated and collapsing. Minor alterations to the house include several one-over-one vinyl double-hung sash windows and the addition of a bay window on the first floor of the rear ell (Figure 22).

**Figure 22. Farm (VDHR #089-0217), 31 Orchard Lane, View Looking East.**

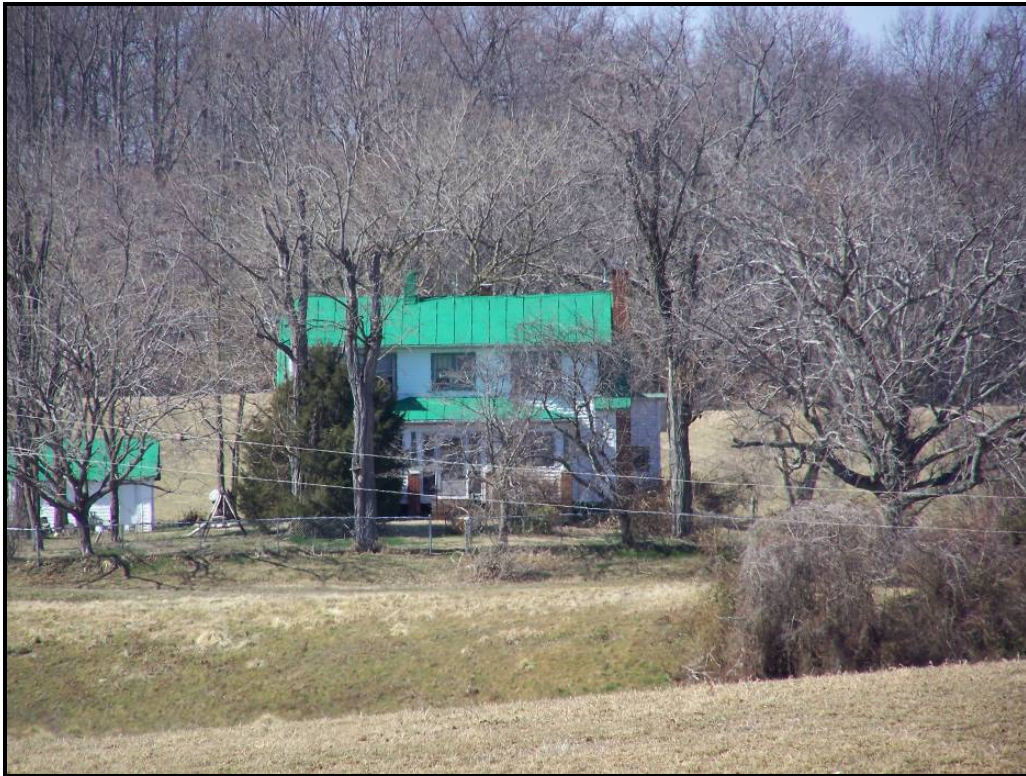
The original dwelling at Poplar Grove Farm was dismantled in the 1930s and the current house constructed shortly after (Figure 23). A number of the outbuildings present on the property post date the study date range; however, the cemetery, summer kitchen and stone spring house fall within the specified time period. The spring house was not visible during the current survey due to vegetation and access issues. During the previous survey the summer kitchen is noted as being in disrepair; however, since 1992 the building has been restored, though appears to retain a number of its original architectural features including the weatherboards.

**Figure 23. Poplar Grove (VDHR #089-0218), 1499 Poplar Road, View Looking Southwest.**

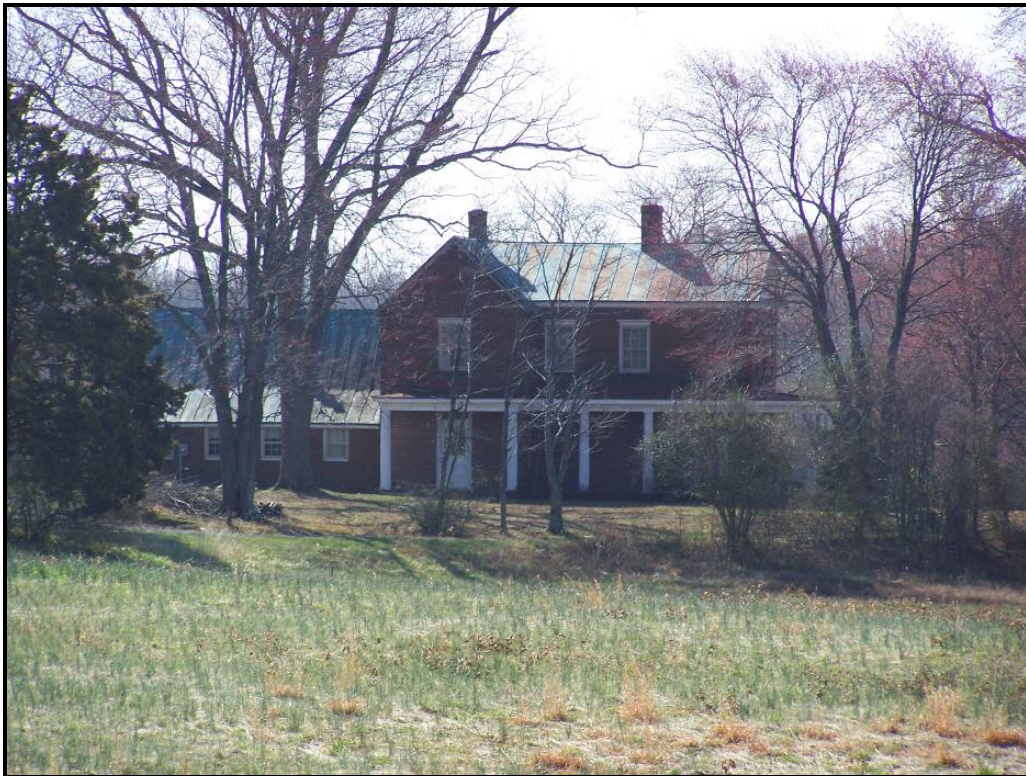
Abel Farm, as an agricultural complex, remains intact architecturally as well as in its setting. The buildings are set back from the road and accessed by a narrow gravel drive. Agricultural fields are located to the northwest and east of the complex. The house retains all the architectural features noted during the 1992 survey and many appear to be original to the dwelling or to early additions including the wrap-around porch and four-over-four, six-over-six and eight-over-eight wood double-hung sash windows (Figure 24). The surviving secondary resources listed on the previous survey include several barns and silos. The detached dairy and greenhouse have been demolished.

**Figure 24. Abel Farm (VDHR #089-0241), Truslow Road, View Looking South.**
