**A RECONNAISSANCE-LEVEL COUNTY-WIDE ARCHITECTURAL SURVEY  
OF POST-BELLUM FARMS (1865-1914)  
STAFFORD COUNTY, VIRGINIA**

**VDHR Project No. 2005-1066**

**May 10, 2011**

**CRI Project No. 1556**

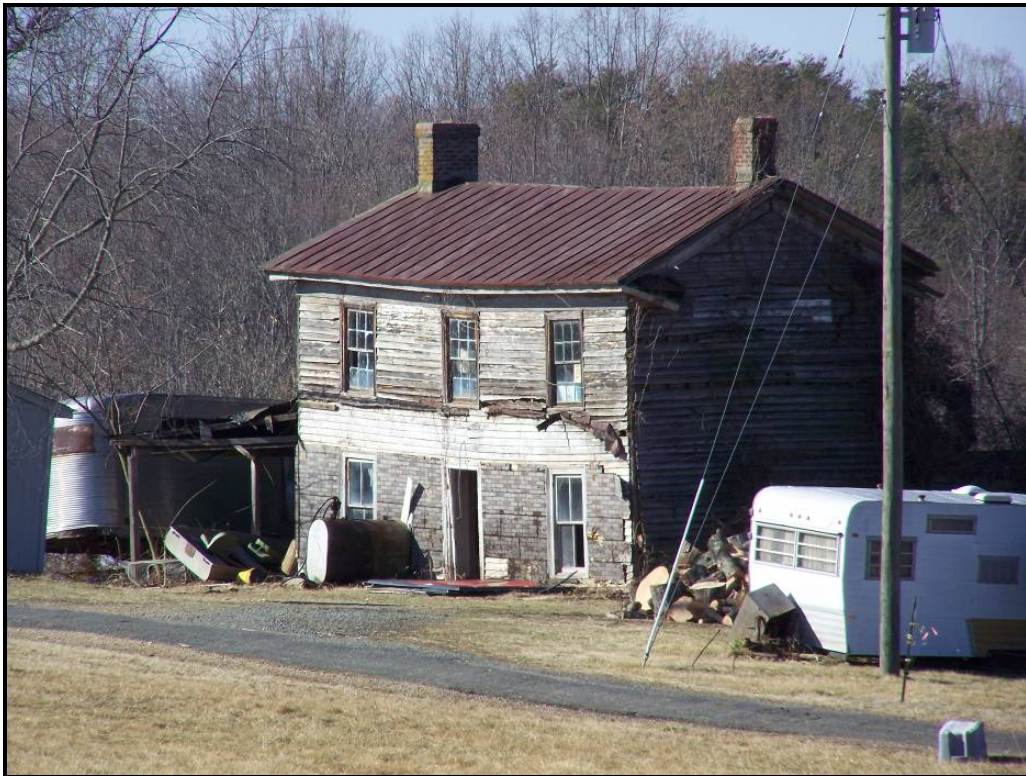
Rocky Pin, since the previous survey, has rapidly deteriorated and is vacant. The front five-bay porch has been removed and the rear ells have partially collapsed (Figure 25). A visible bow in the front plate indicates the main block of the building is also experiencing structural issues. Although in disrepair, the dwelling retains a number of original and earlier alterations including weatherboards, and two-over-two and six-over-six wood double-hung sash windows. Currently the outbuildings noted during the previous survey are extant and in similar condition as in 1992. A modern shed to the northeast of the house has been added to the assemblage of secondary resources.

**Figure 25. Rocky Pin (VDHR #089-0272), Sanford Drive, View Looking Southwest.**

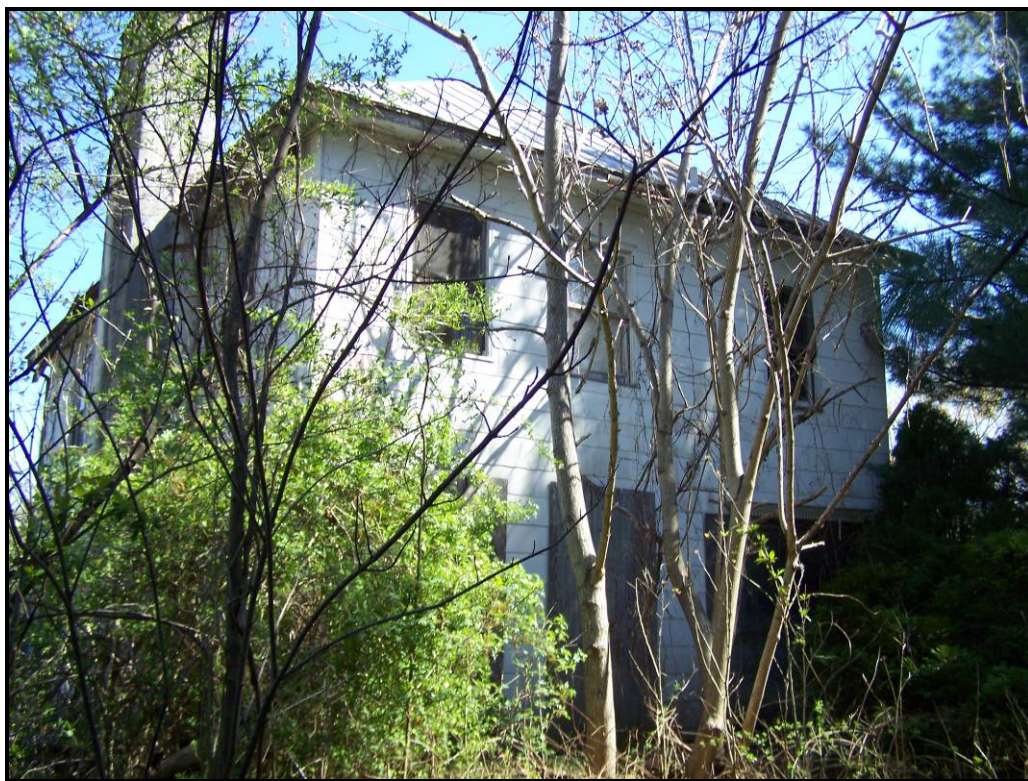
Oetiker House, located down a long, now grass covered drive lined with pine trees, is a two-story, side hall, three-bay dwelling. It is apparent from the landscape that the house was once surrounded by gardens and flowering trees; however, since the house has been vacated overgrowth has encroached and taken over the more formal landscaping. Since the house, c. 1910, fit the limited description noted in the 1992 survey, it was assumed that this property was one that was noted but not formerly surveyed. Though the house and secondary resources were subsequently surveyed in 1995, the property was resurveyed during the current effort as it met the criteria outlined in the MOA. The house, as noted in 1995, was in fair condition and remains so. The windows and doors on the first floor have been boarded-up; however, little, if any, architectural detailing appears to have changed (Figure 26). The outbuildings have deteriorated significantly within the last 15 years. The shed to the east of the house, as noted on the sketch map, has collapsed and the vehicle shed attached to the hay barn has experienced significant structural issues.

**Figure 26. Oetiker House (VDHR #089-0352), 366 Holly Corner Road, View Looking Northeast.**

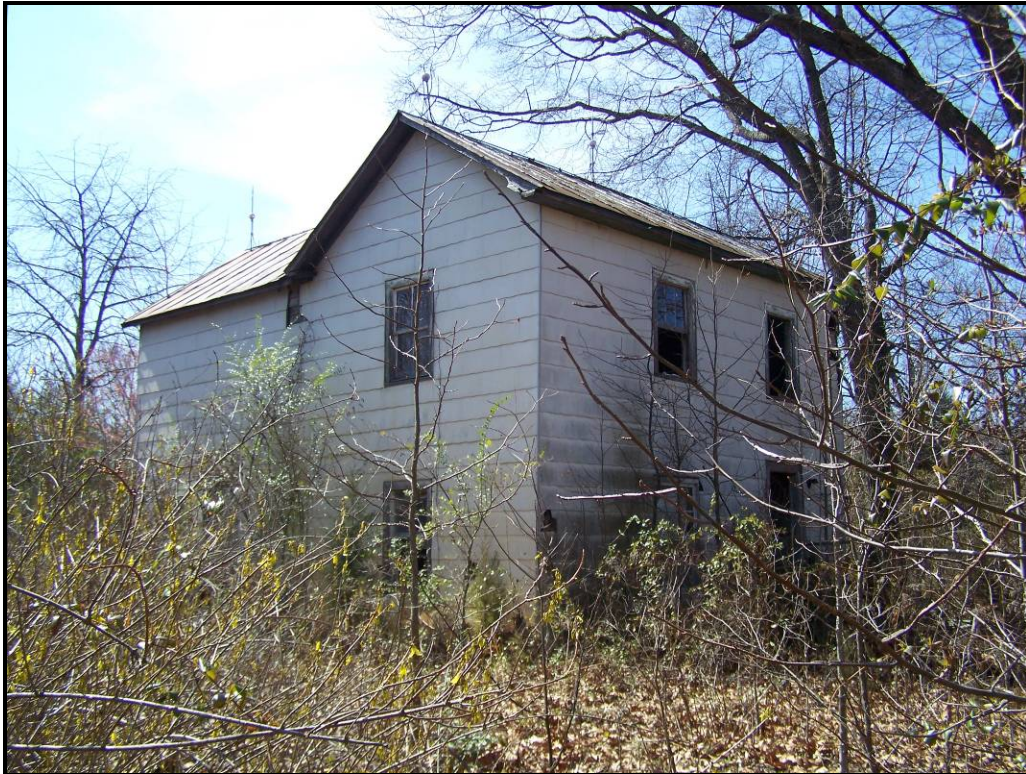
Located off of Skyline Drive along a farm road, which also accesses Deer Run Farm (VDHR #089-0189), is a two-story two-bay dwelling, c. 1900, with associated agricultural outbuildings (Figure 27). The dwelling is abandoned and the outbuildings under-utilized or are no longer used at all. The secondary resources include a barn, chicken house, stable and shed. The barn is the only outbuilding that appears to be used, perhaps by a renter, and functions as hay storage.

**Figure 27. Farm (VDHR #089-5390), Skyline Drive, View Looking Southwest.**

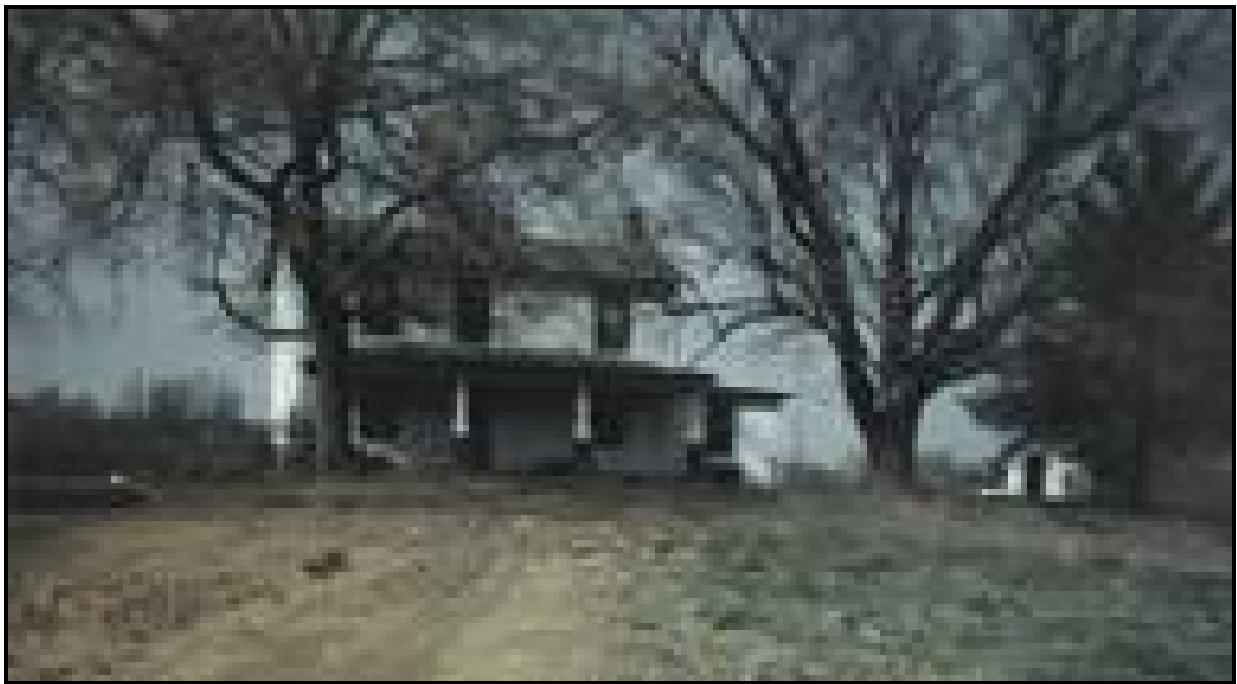
Rock Hill Plantation was originally a two-story, three-bay dwelling with a one-story, three-bay hipped-roof porch with square tapered wood columns on brick piers extended across the front façade (Figure 28). The photograph depicts a brick chimney, on the exterior or interior of the north gable end, as well as a one-story wing. Two large trees flanked the house in the front. The house, since 2004, has been extensively altered (Figure 29). The main building has had to additional bays constructed on the south end and the front porch has been replaced with a two-story, seven-bay porch with an identical porch constructed off the rear of the building. To access the second floor of the porch a door has replaced one of the upper floor windows. The one-story addition remains; however, it appears the roofline may have been altered.

**Figure 28. Photograph of Rock Hill Plantation (c. 2004) before Renovations, View Looking Northwest**  
(Source: [http://www.rockhillplantation.com/about\\_rockhill/index.asp](http://www.rockhillplantation.com/about_rockhill/index.asp)).

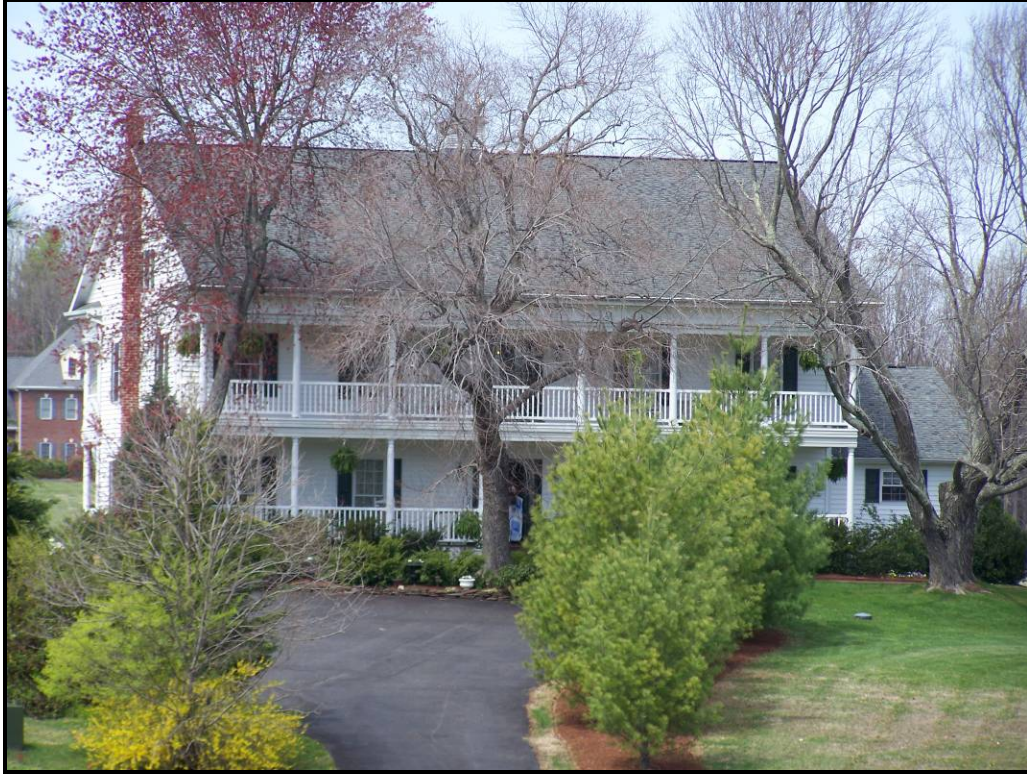
The shed visible in the photograph is still extant as are the trees (Figure 28). Also currently located on the property is a stable, which has been renovated and functions as a wedding reception hall, a modern stable or large rectangular shed, and a gazebo. The gazebo was added to the property during its transformation into a wedding venue.

**Figure 29. Rock Hill Plantation (VDHR #089-5391), 228 Rock Hill Church Road, View Looking Northwest.**

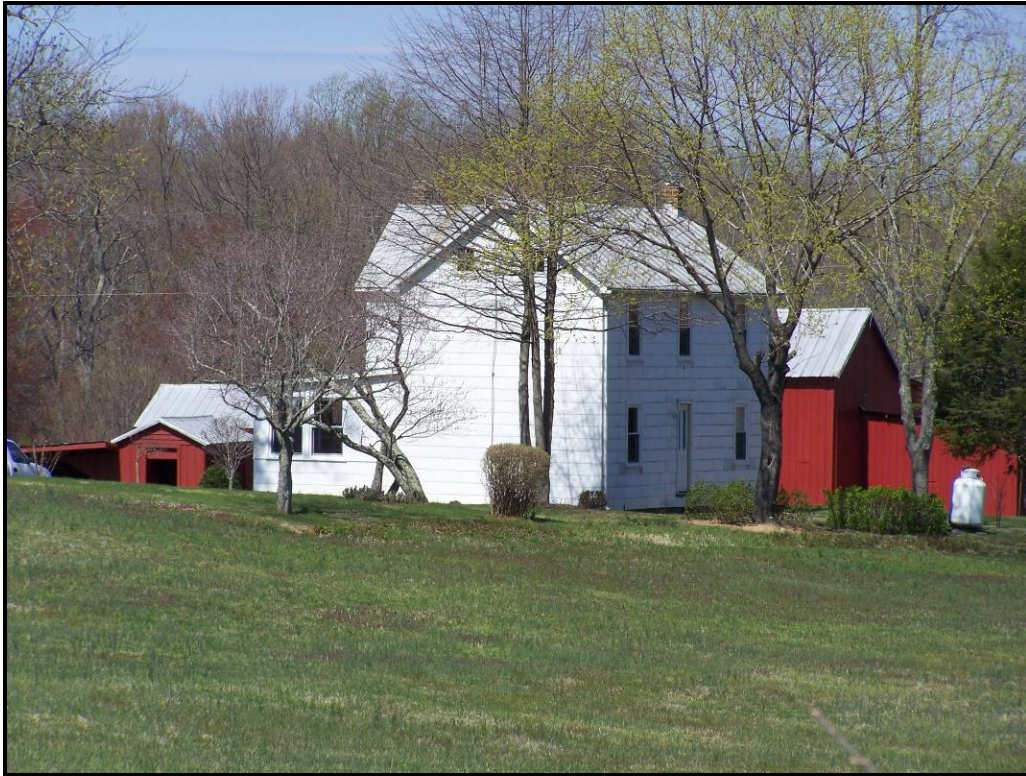
The farm at the end of Clark Patton Road includes a c. 1910 dwelling with four outbuildings dating from the early to mid-twentieth century (Figure 30). Since the farm fit the limited description and is the only farm on Clark Patton Road/Route 724, it was assumed that this property was one noted, but not formerly surveyed in 1992. The house is two stories with three-bays, a two-story ell and one-story shed-roofed addition. As was common in the mid-twentieth century the exterior of the house is sheathed in asbestos siding. The secondary resources, which include a chicken house, workshop, vehicle shed and barn, are a cohesive assemblage of wood-framed agriculture building representative of a small twentieth century farm.

**Figure 30. Farm (VHDR #089-5392), Clark Patton Road, View Looking West.**

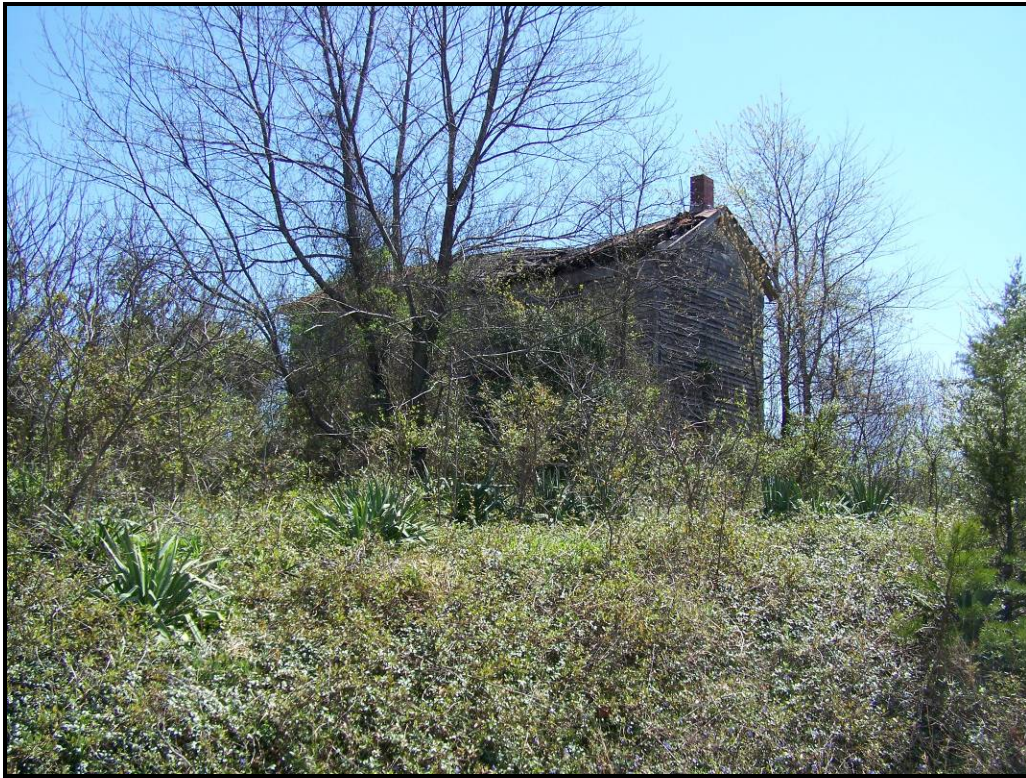
The farm, now vacant, sits on a rise on the west side of Mountain View Road. The dwelling is immediately surrounded by overgrowth with fallow agricultural fields to the west and north. The house, a post 1880 dwelling, is in a deteriorated condition. The two-story, three-bay dwelling with two-story ell is sheathed in weatherboards attached with cut nails (Figure 31). The porch, which extended across the front façade, has collapsed. Architectural features characteristic of its time period include interior end brick flues, wide eaves and two-over-two wood double-hung windows. The only visible secondary resource is a collapsed wood-framed barn.

**Figure 31. Farm (VDHR #089-5393), Mountain View Road, View Looking Southwest.**
