National Register of Historic Places Registration Form

Historic name: Reynolds Property

Other names/site number: Alphin Stone House; VDHR File No. 011-0138

City or town: Buchanan State: VA County: Botetourt

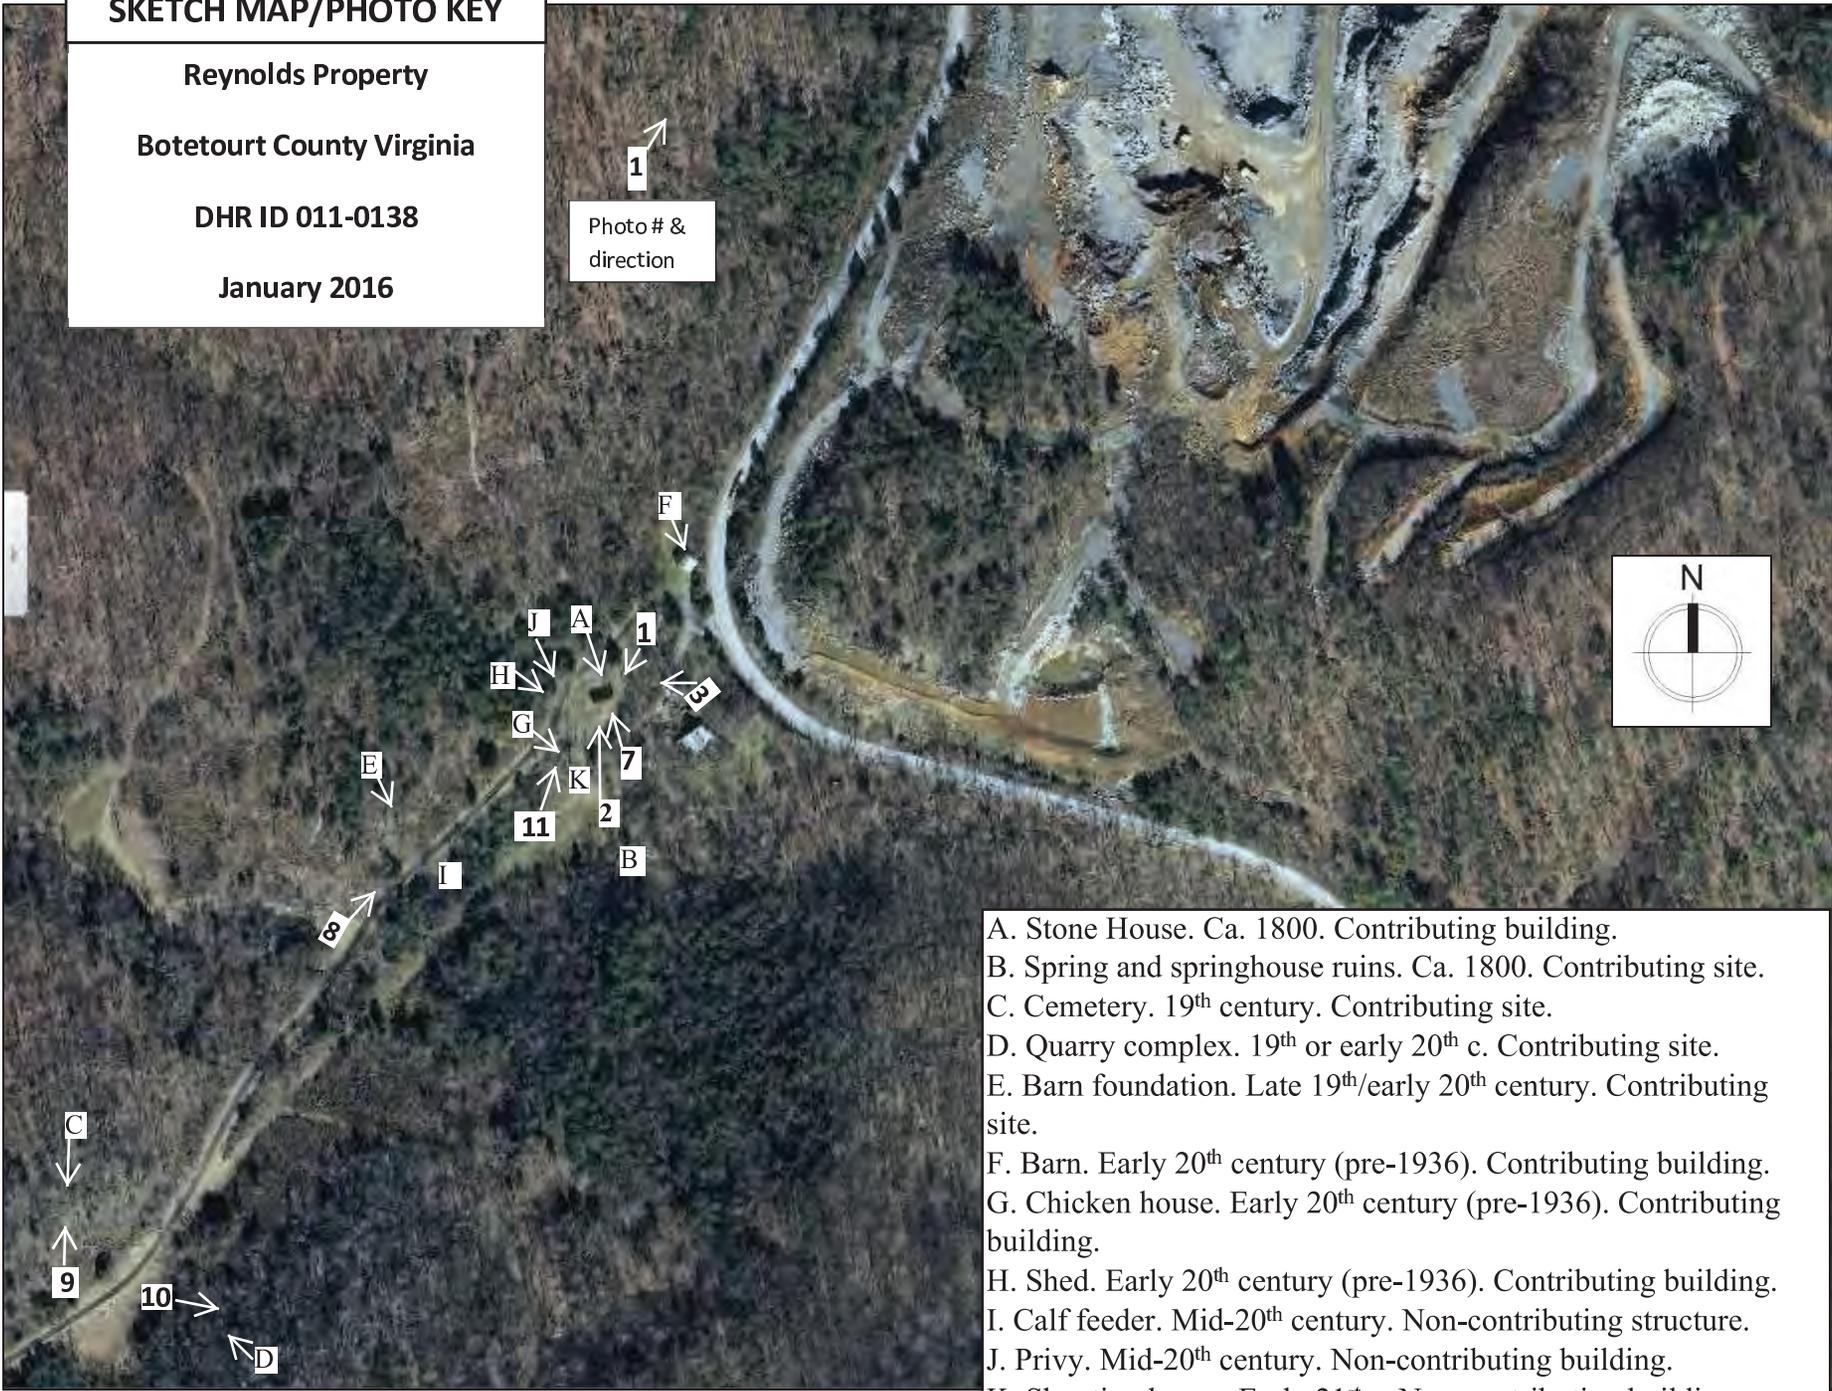
- A. Stone House. Ca. 1800. Contributing building.
- B. Spring and springhouse ruins. Ca. 1800. Contributing site.
- C. Cemetery. 19th century. Contributing site.
- D. Quarry complex. 19th or early 20th c. Contributing site.
- E. Barn foundation. Late 19th/early 20th century. Contributing site.
- F. Barn. Early 20th century (pre-1936). Contributing building.
- G. Chicken house. Early 20th century (pre-1936). Contributing building.
- H. Shed. Early 20th century (pre-1936). Contributing building.
- I. Calf feeder. Mid-20th century. Non-contributing structure.
- J. Privy. Mid-20th century. Non-contributing building.
- K. Shooting house. Early 21st c. Non-contributing building.
