National Register of Historic Places
Registration Form

historic name Mount Stirling

other names/site number VDHR File No. 18-15

Mount Stirling
Charles City County, Virginia

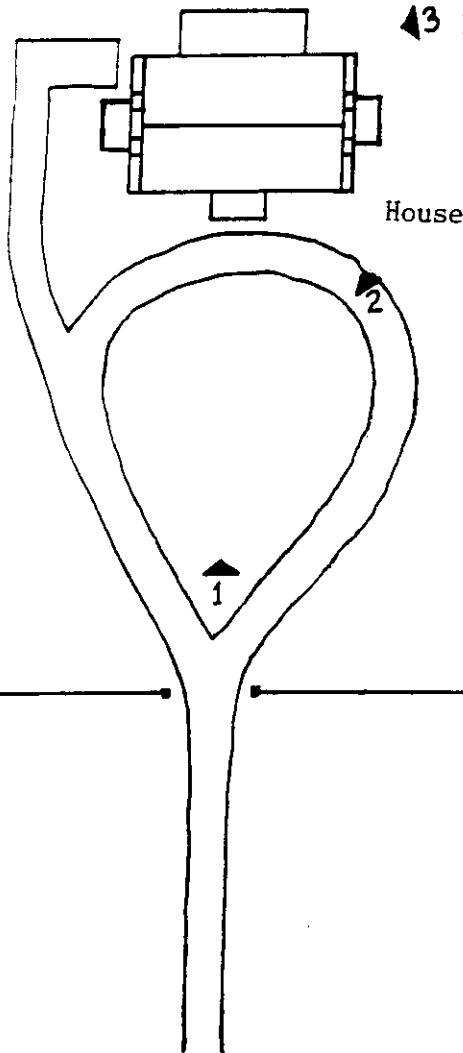
SITE PLAN not to scale

Garden
non-contributing

Ruins of Possible Slave House

Garage
non-contributing

3 Kitchen/Laundry

Pool
non-contributing

House

Poolhouse
non-contributing

wood plank fence

Photo Key 7

Mount Stirling is a Greek Revival plantation house situated on an expansive hill overlooking pastureland and forest that edge the Chickahominy River in Charles City County, Virginia. Monumental in its imposing scale and carefully crafted details, the red brick house is distinguished by a small-scale Greek Ionic portico and stepped gable parapets. The house is notable for its high degree of integrity, including the retention of architectural details and hardware. The 1851 date of construction for Mount Stirling marks it as one of the last great plantation residences to be built in the county before the Civil War; most structures in Charles City County comparable in size and quality to Mount Stirling were built a century before. The dependencies of an eighteenth-century plantation complex once surrounded the house, but the only remaining structure is an altered kitchen building. This simple frame structure gives evidence of the common materials and details of its vanished companion buildings and illustrates how the architectural formality of Mount Stirling was heightened by its contrast to the simple, small-scaled support structures. The grounds of Mount Stirling contain buildings and elements added by recent owners, including a pool with poolhouse, a small garage, and a formal boxwood garden.
