**NATIONAL REGISTER OF HISTORIC PLACES
REGISTRATION FORM**

historic name Four Locust Farm
other names/site number Pettus Dairy Farm, VDHR File Number 019-5206

**Four Locust Farm
Charlotte County, VA**

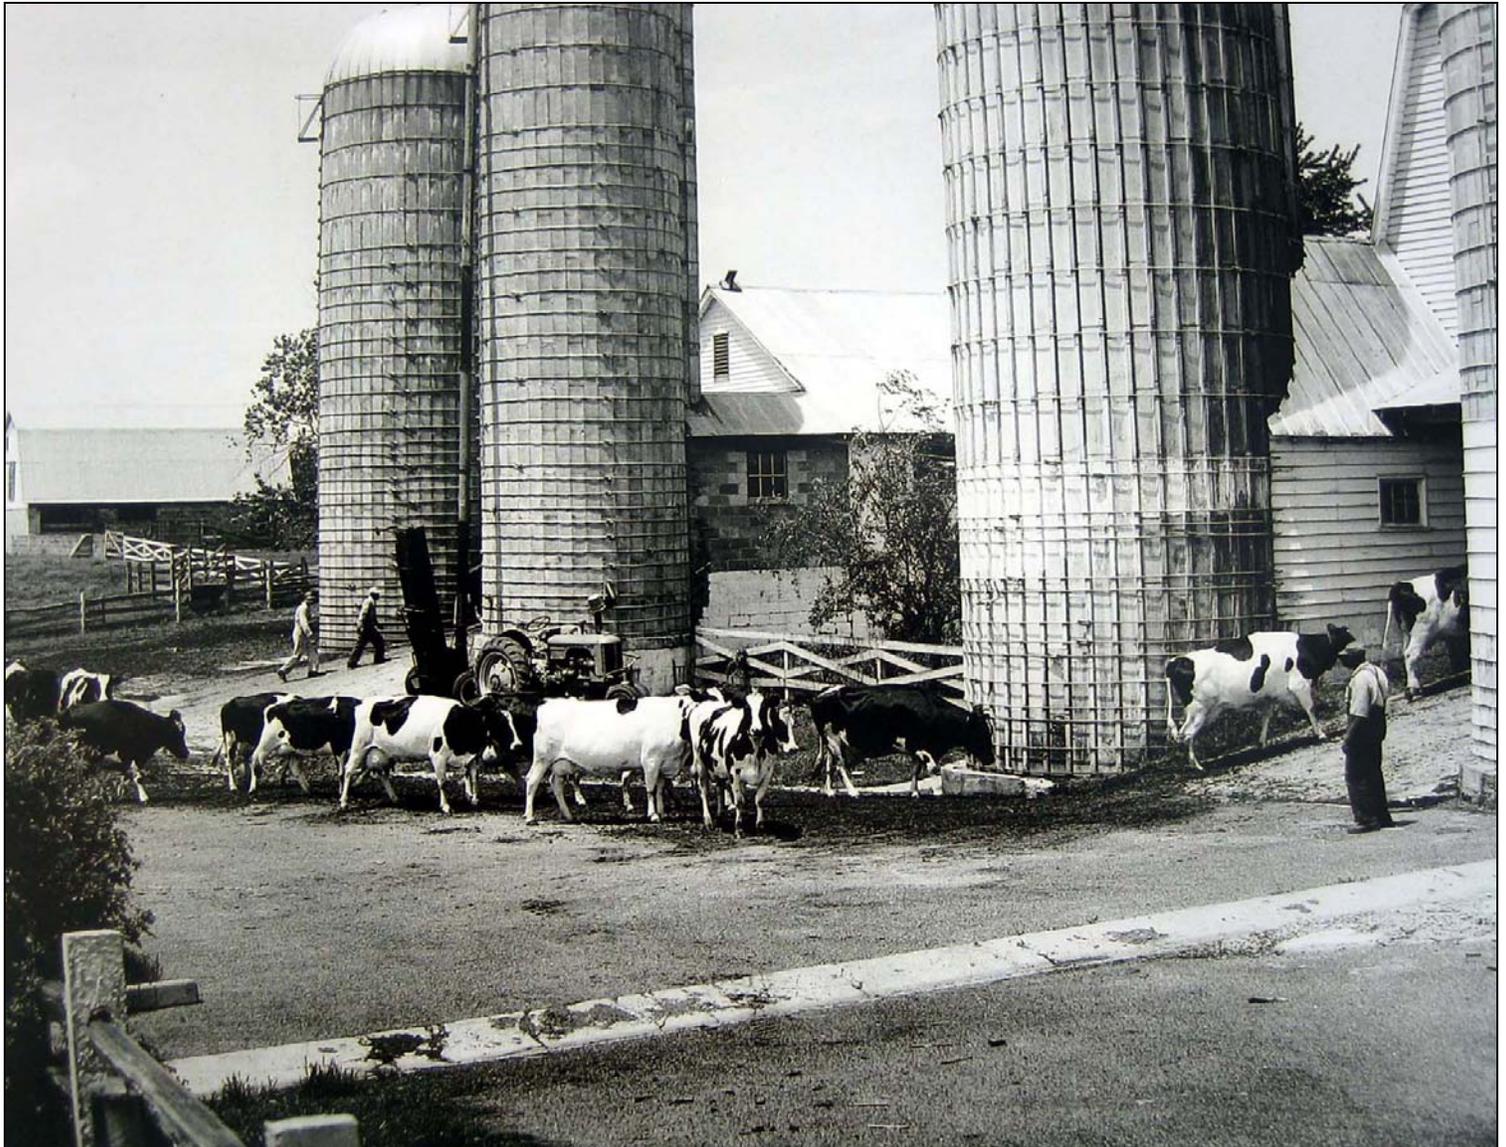
Figure 1. Farm laborers driving cattle into dairy barn no. 2 for milking. Ca. 1940. Photo courtesy Bernardine Pettus Tucker.

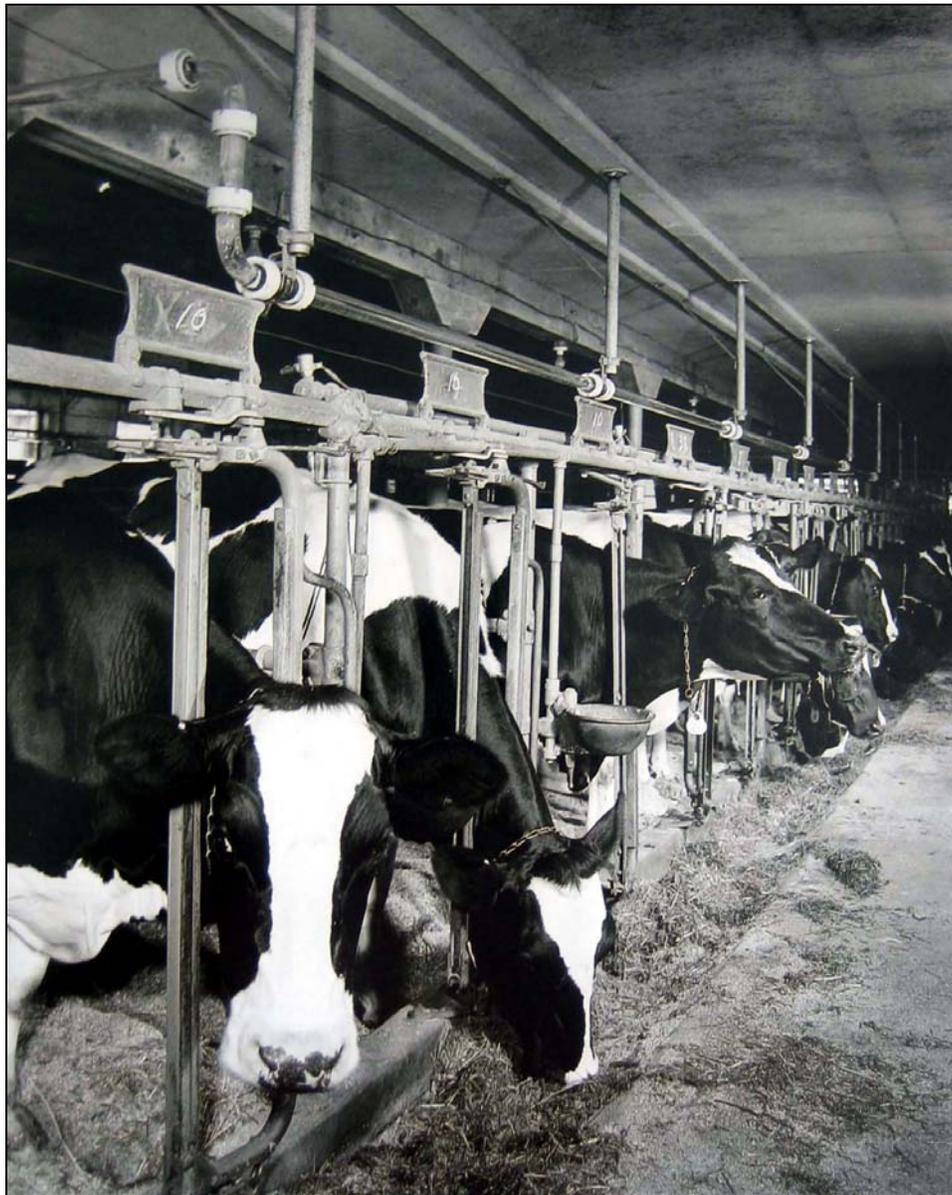
Figure 2. Pettus herd in milking stations. Note numbers written in chalk on small tags above each station, hay in manger. Compare to current photos 12 and 15. Circa 1940. Photo courtesy Bernardine Pettus Tucker.

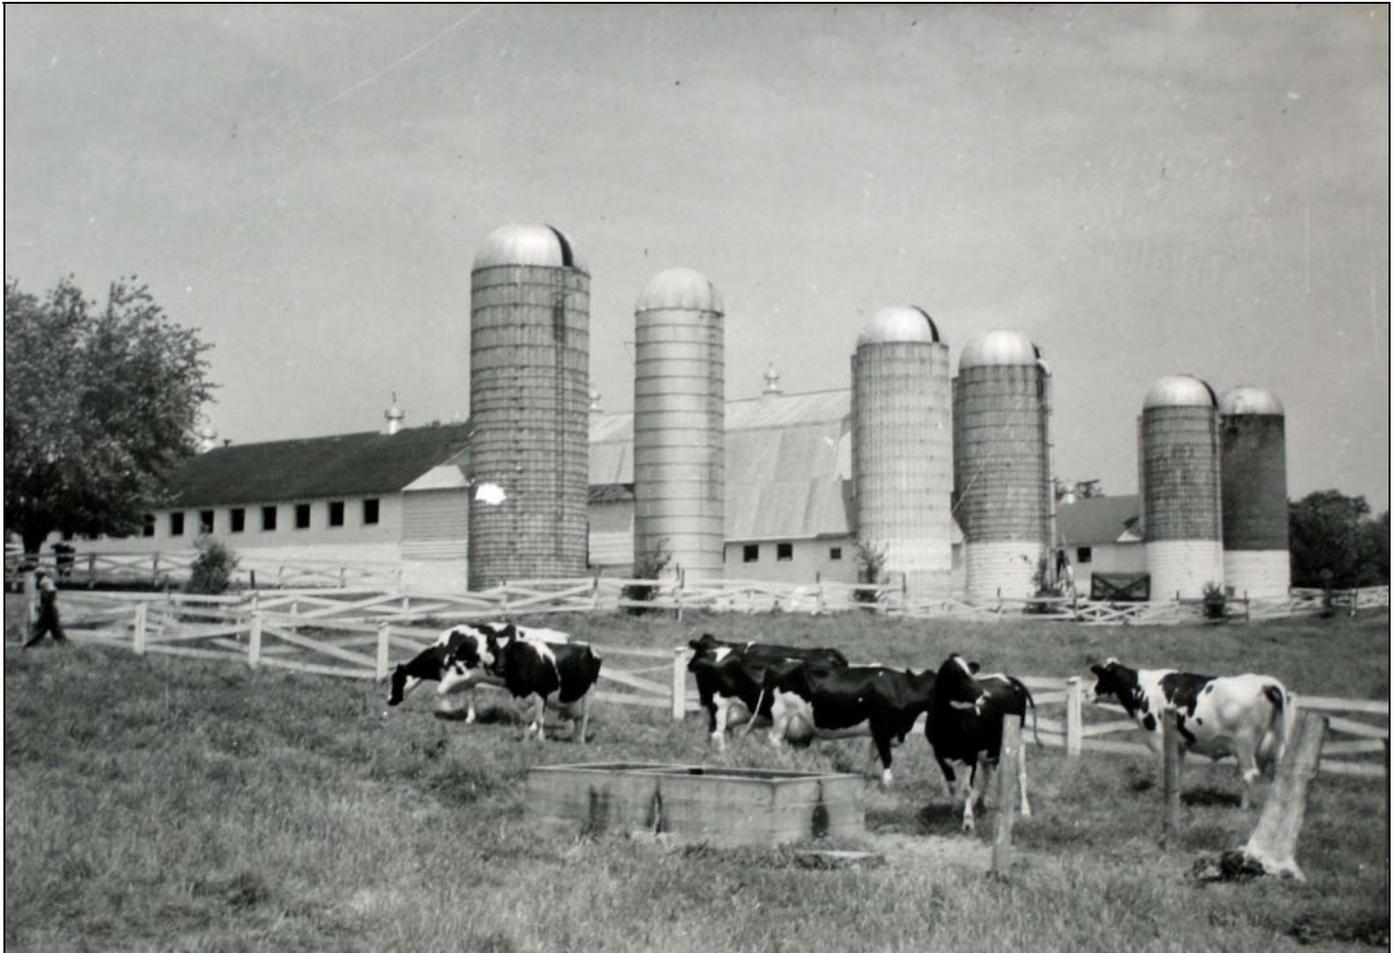
Figure 3. View looking east at Pettus dairy barns nos. 1 through 3 and silos nos. 1 through 7(right to left). Circa 1940.
Photo courtesy Bernardine Pettus Tucker.

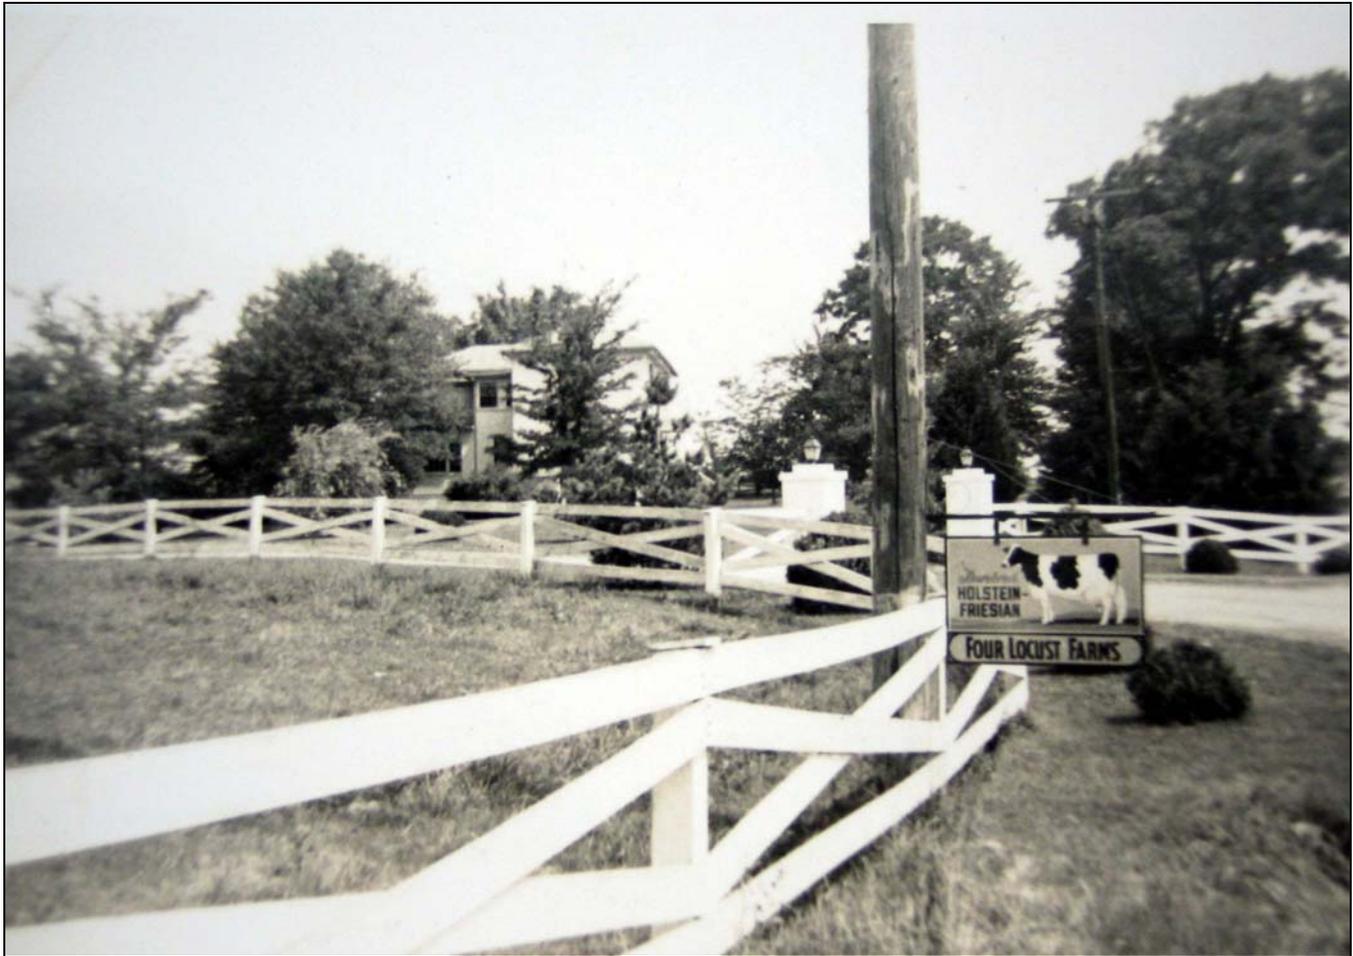
Figure 4. Entrance to Four Locust Farm, ca. 1950. Note wooden fence and brick piers. Photo courtesy Bernardine Pettus Tucker.

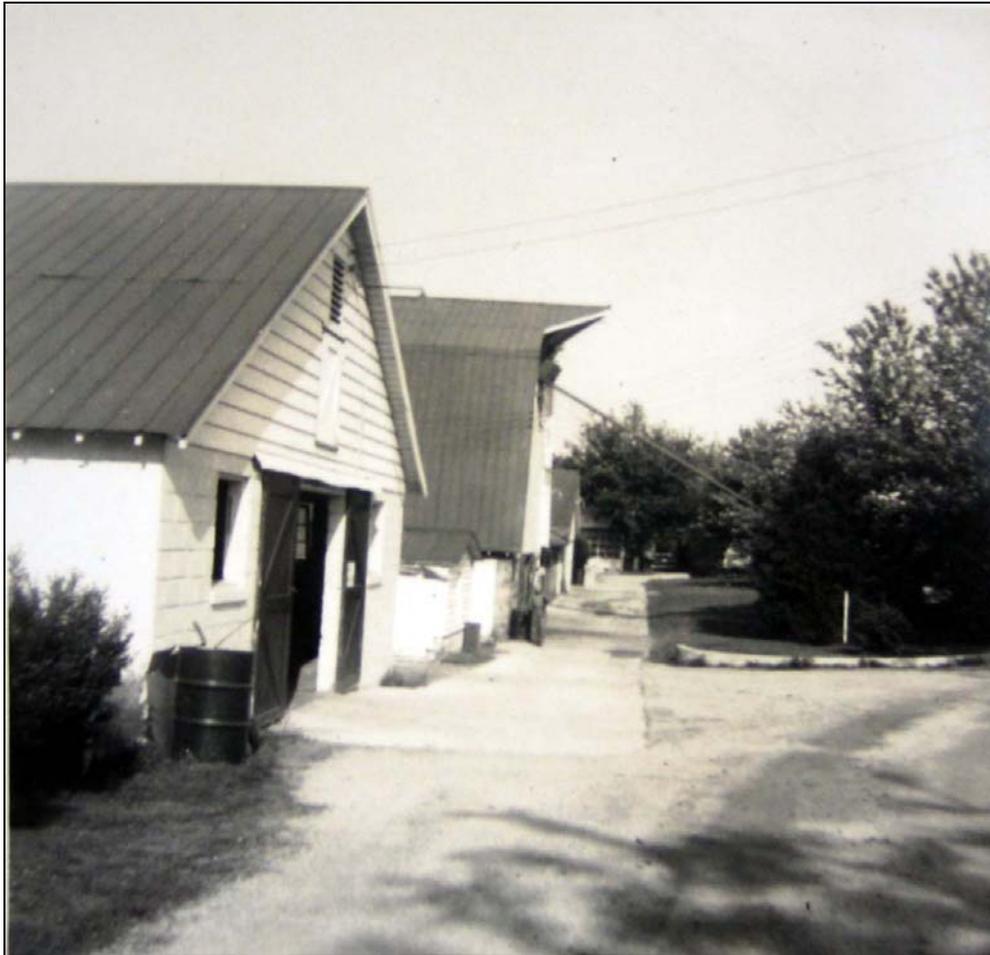
Figure 5. View looking west at dairy barns nos. 1 through 3 (left to right) along paved section of farm road. Note small frame building (no longer extant) between barns nos. 1 and 2. Compare to current photo no. 9. Photo courtesy Bernardine Pettus Tucker.

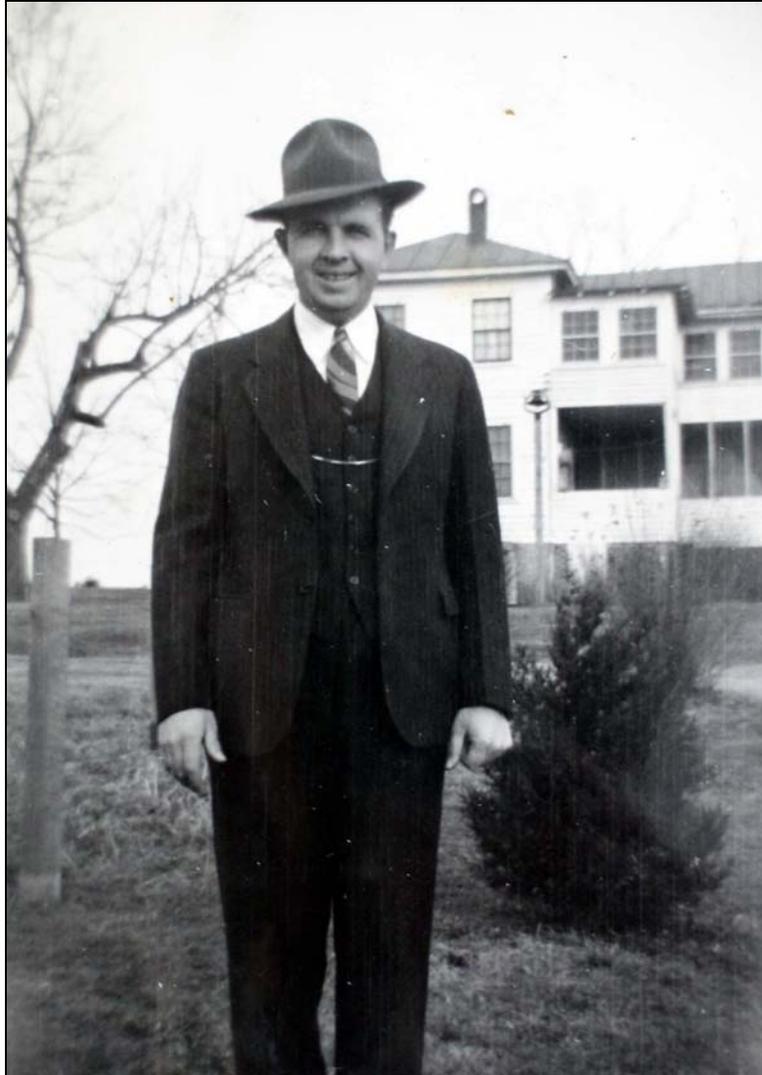
Figure 6. George O. Pettus Jr. behind main dwelling at farm. Ca. 1937. Note that first floor porch is open and that stairs lead up to second floor sleeping porch. Photo courtesy Bernardine Pettus Tucker.

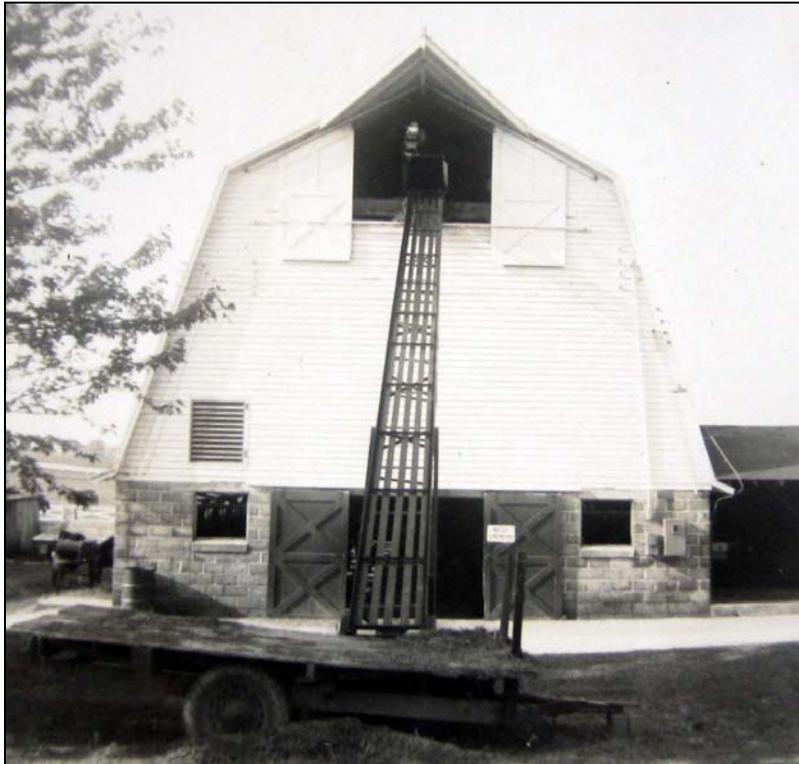
Figure 7. Barn no. 2 with hay elevator constructed by George O. Pettus Jr. set in front. Ca. 1930. Note milk house to right. Photo courtesy Bernardine Pettus Tucker.

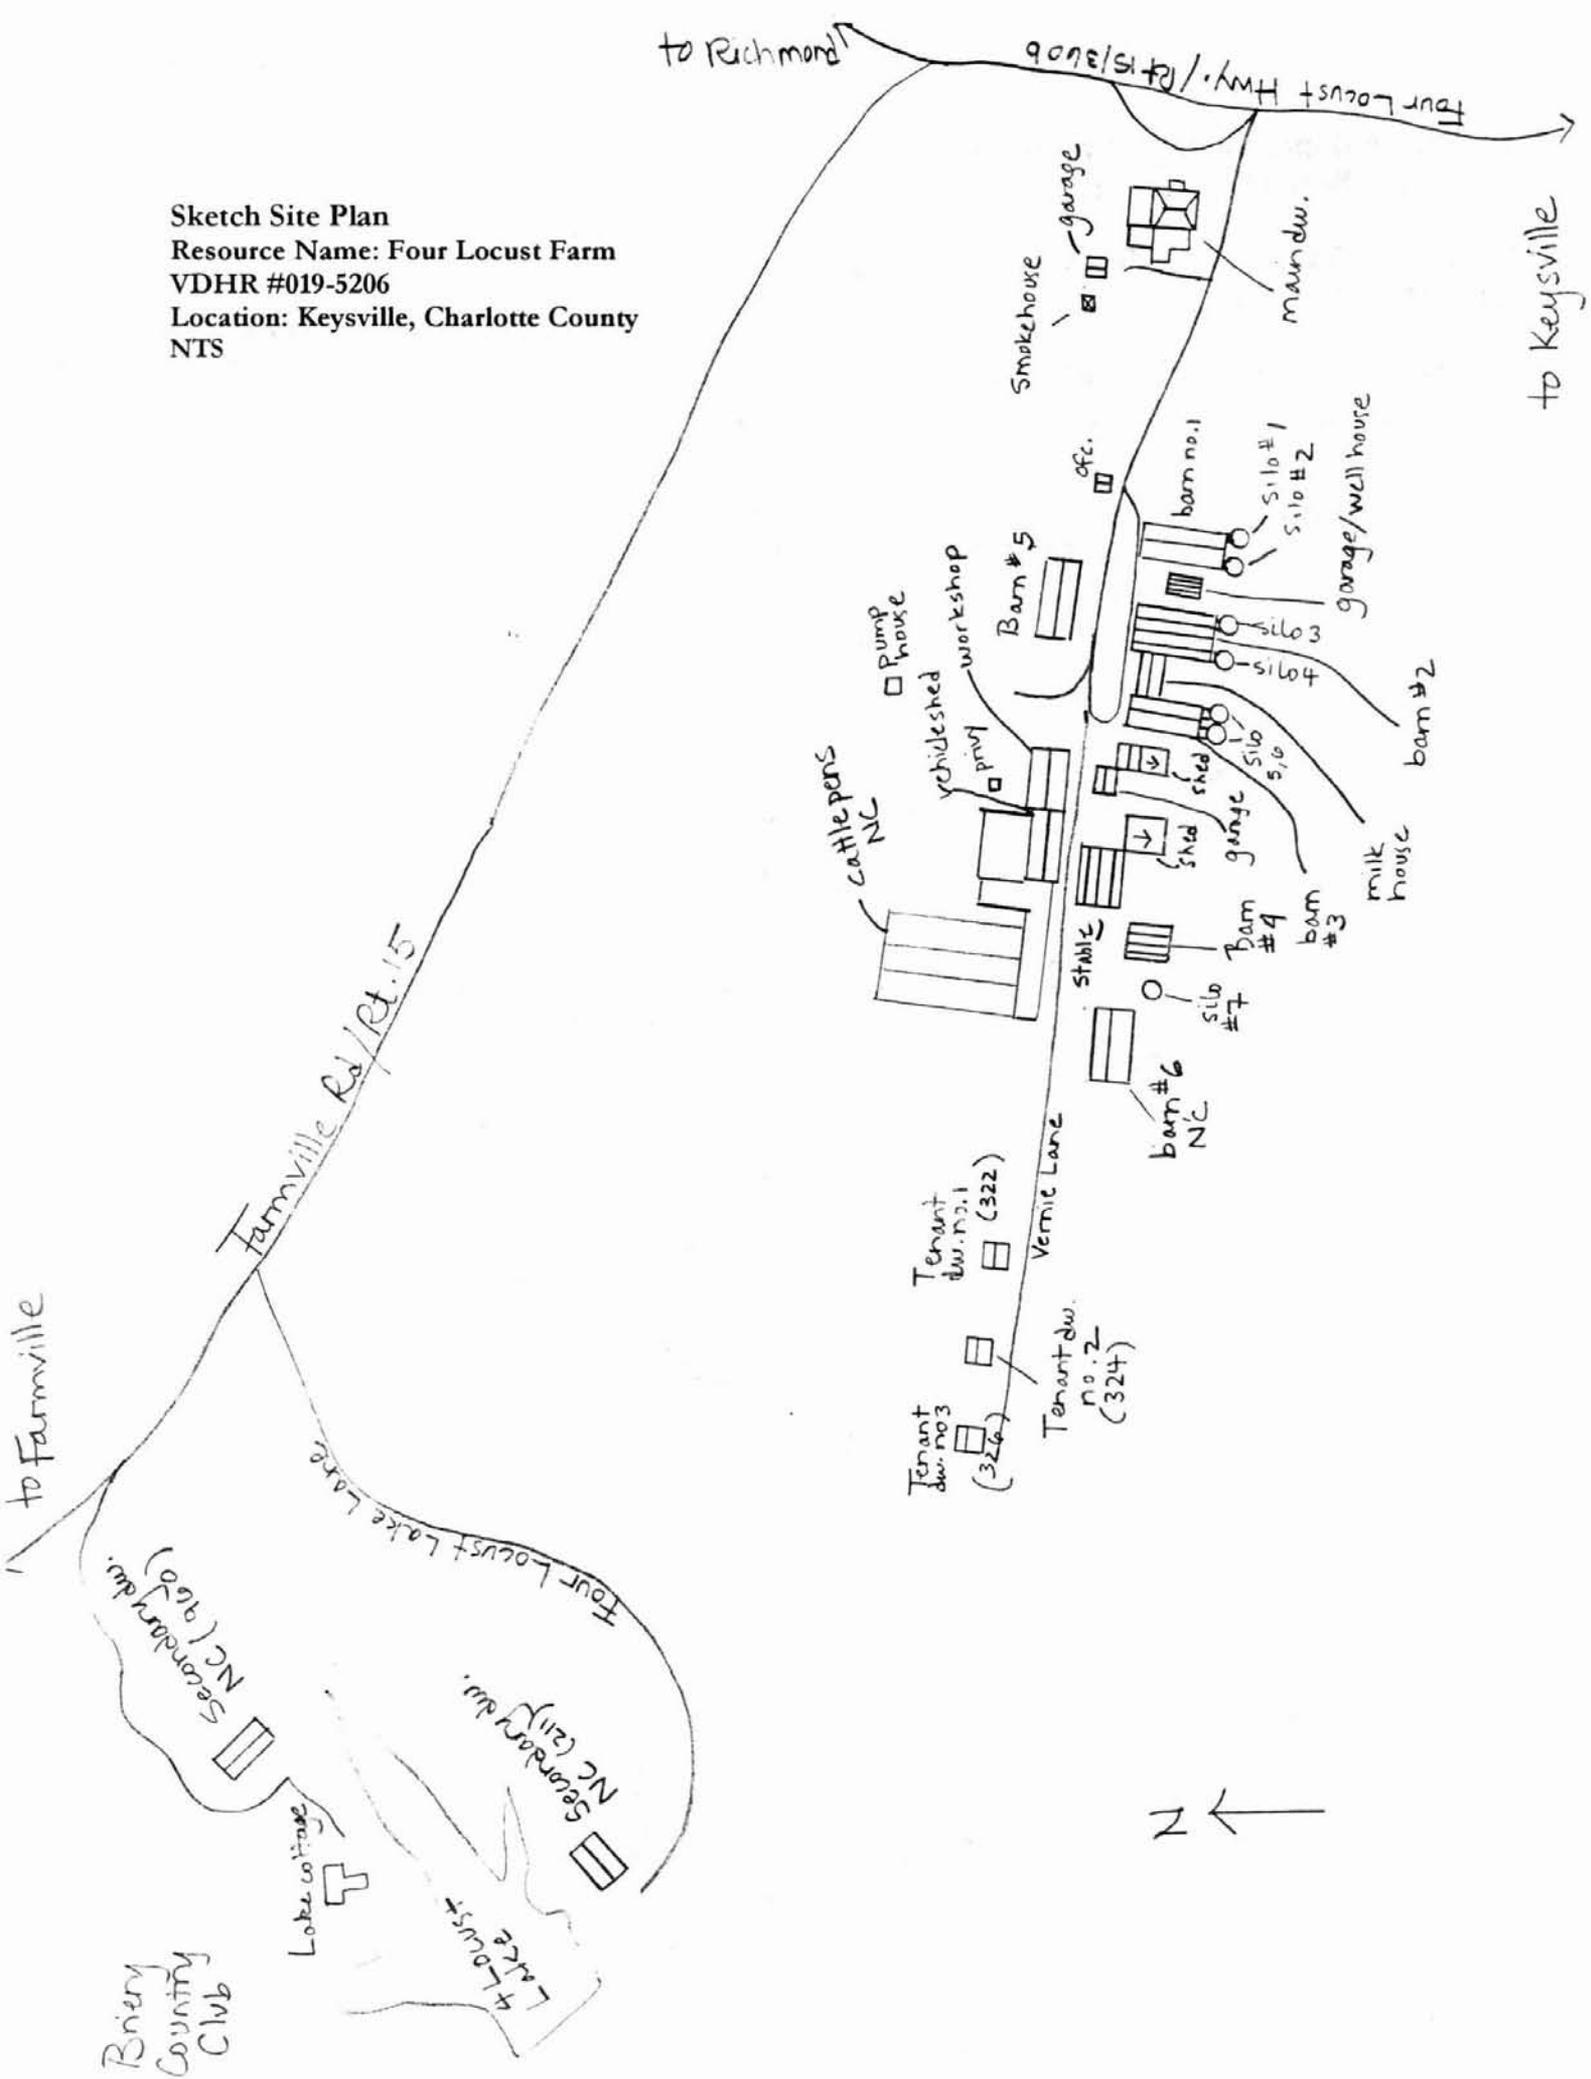
Sketch Site Plan
Resource Name: Four Locust Farm
VDHR #019-5206
Location: Keysville, Charlotte County
NTS
