National Register of Historic Places Registration Form

1. Name of Property Historic name: Brown/Koerner House	VLR: 6/16/2016 NRHP: 8/15/2016
Other names/site number: William C. Brown Far	m; Koerner, Susan House; Weadon Place;
<u>DHR No. 053-0342</u> Name of related multiple property listing: <u>N/A</u>	
(Enter "N/A" if property is not part of a multiple pr	roperty listing

2. Location Street & number: 38340 Winsome Trail Lane City or town: Purcellville State: VA C Not For Publication: N/A Vicinity: N/A	County: Loudoun
3. State/Federal Agency Certification	
As the designated authority under the National His	toric Preservation Act, as amended,
I hereby certify that this X nomination required the documentation standards for registering proper Places and meets the procedural and professional registering propersional registering propersion	ties in the National Register of Historic
In my opinion, the property _X_ meets doe I recommend that this property be considered signi level(s) of significance:nationalstatewideX Applicable National Register Criteria:ABX_CD	ficant at the following
Signature of certifying official/Title:	Date
Virginia Department of Historic Resources	<u> </u>
State or

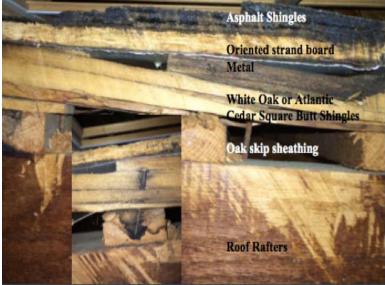
The attic is accessed by another boxed winder staircase located in the second-story hallway. The attic provides phenomenal visuals of the house's construction. With no ridge beam present there are common rafters resting on a false plate connected along the ridge with pegged mortise-andtenon joinery. Another feature found in the attic is a roof hatch with a circular iron pull. This hatch is now inaccessible and it is likely a later addition based on the wood variation that frames the opening. The ceiling joists are spaced at roughly 20 inches on center. The wood lath attached to the bottom of the joists is supported at mid-point by an intermediate ceiling joist made from rough-cut logs, and the attic floor is sheathed with tongue and groove boards. When the current owners began construction of the 1998 addition, an image of a cross section of the original roof assembly became apparent. The layers include roof rafters at the bottom level, followed by oak skip sheathing, white oak or Atlantic cedar square butt shingles, metal, oriented strand board, and asphalt shingles, as shown below.

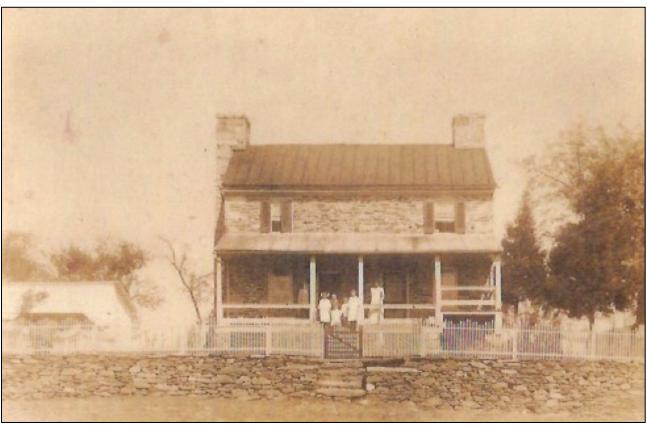
Figure 3. Ca. 1923 Image, Brown-Koerner House.

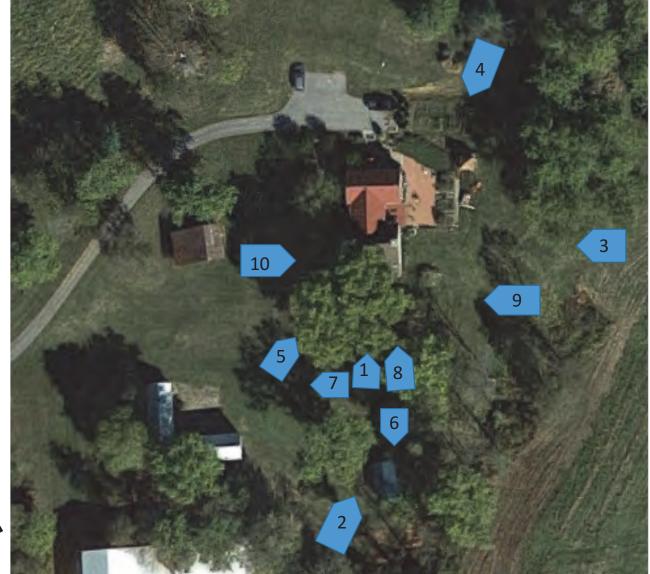
6 of 10: Spring House North Elevation, camera facing south

7 of 10: Milk House and Milk Parlor at left, Carriage House at right, camera facing west

9 of 10 Dwelling East Elevation, camera facing west

10 of 10 Dwelling West Elevation, camera facing east
