**NATIONAL REGISTER OF HISTORIC PLACES  
REGISTRATION FORM**

historic name Rock Hill Farm  
other names/site number VDHR File No. 053-1057

**Rock Hill Farm  
Loudoun County, Virginia**

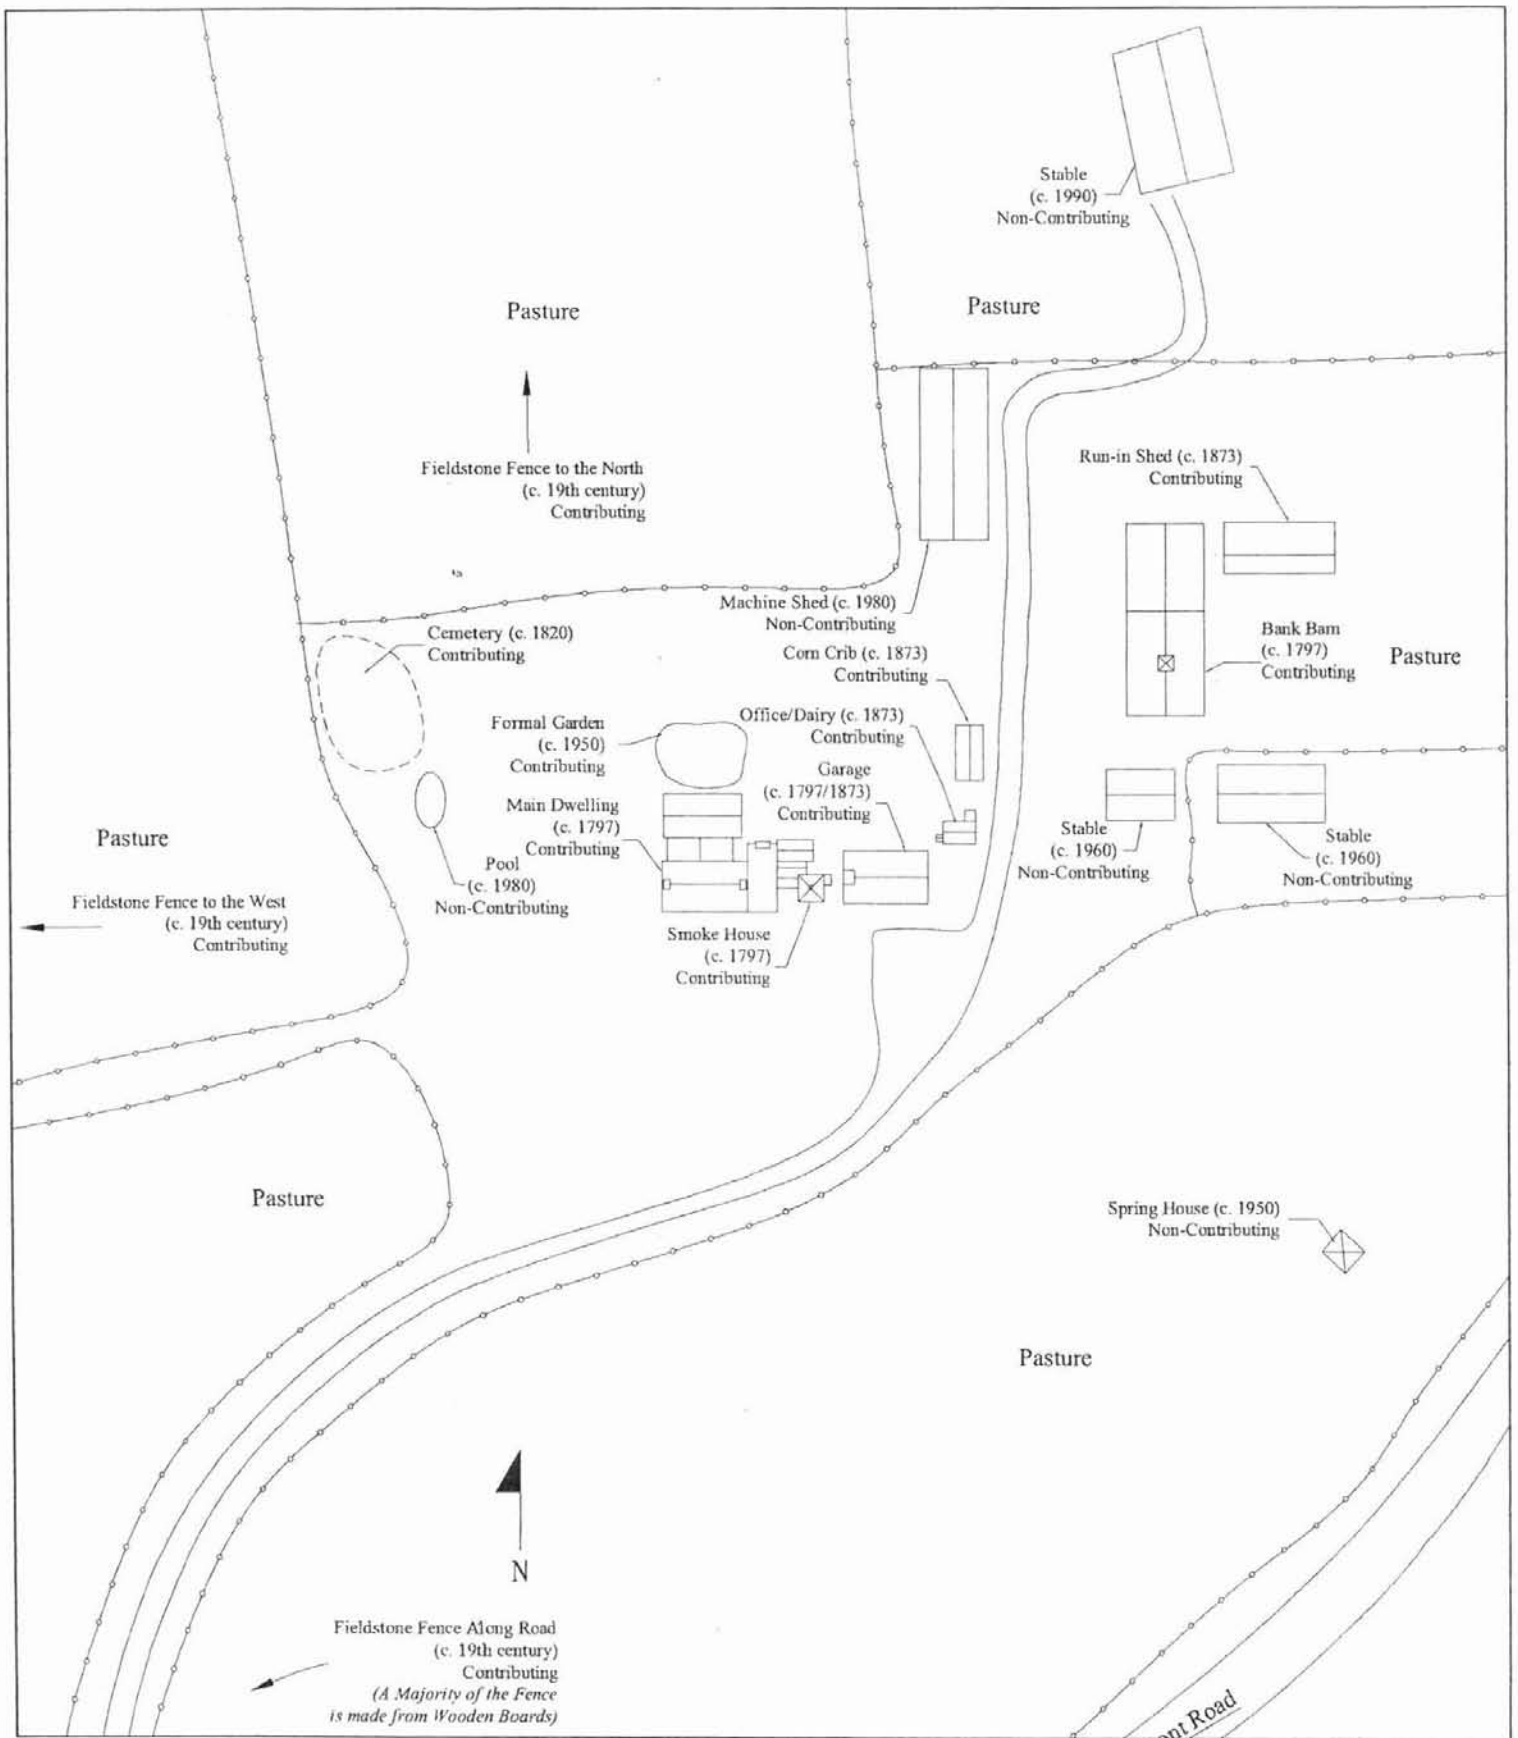
Figure 1. Plan of Rock Hill Farm (Loudoun County, Virginia) #053-1057  
 Drawn by Arcadia Preservation – 2/2009 – Not to scale
