National Register of Historic Places  
Registration Form

historic name Rockwood  
other names/site number VDHR file no. 077-0045

street & number 5189 Rockwood Drive N/A not for publication  
city or town Dublin X vicinity  
state Virginia code VA county Pulaski code 155 zip code 24084

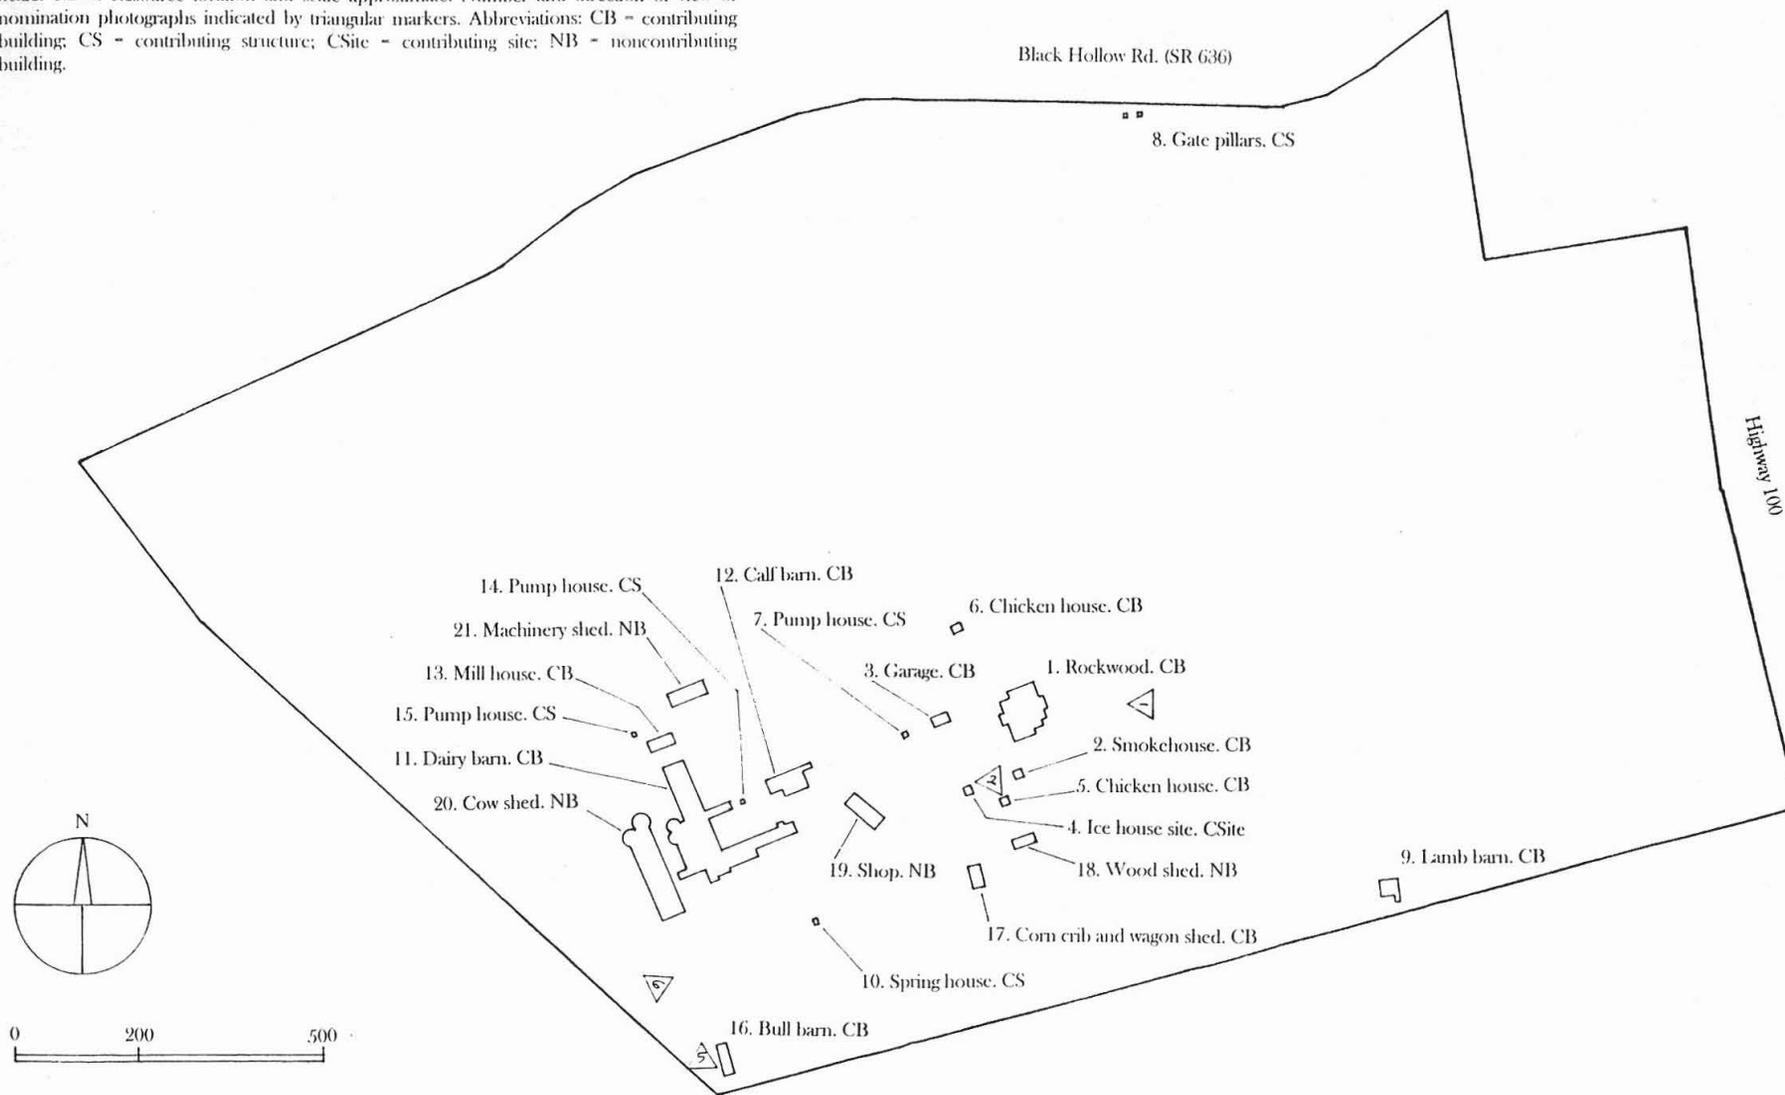
Scale: 1:200. Resource location and scale approximate. Number and direction of view of nomination photographs indicated by triangular markers. Abbreviations: CB = contributing building; CS = contributing structure; CSite = contributing site; NB = noncontributing building.

The buildings that comprise Rockwood's large farm are located mostly to the west of the house, as shown on the map that accompanies the nomination. Several resources are located apart from the others, and these are addressed first.
