National Register of Historic Places Registration Form

Historic name: Gilmer, Samuel House

Other names/site number: DHR # 083-0003

City or town: Lebanon State: Virginia County: Russell

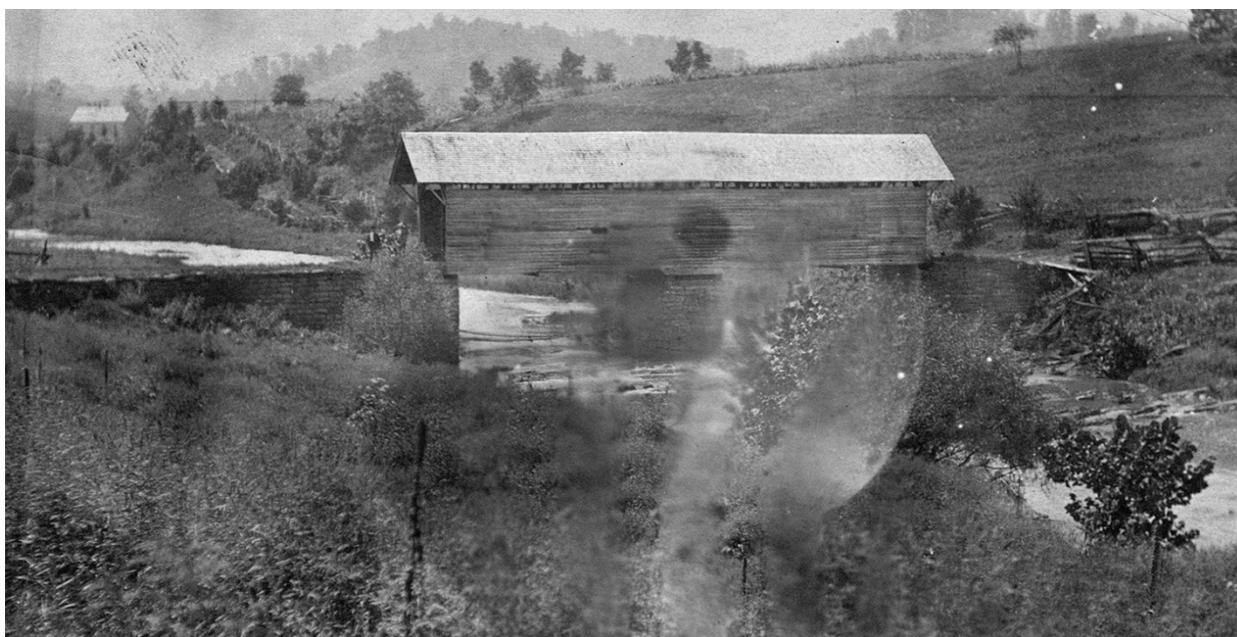
Figure 1. The covered bridge spanning Big Cedar Creek, facing south, circa 1900.

With increased settlement and commerce in the area came the need for roads. The construction date of the covered bridge spanning Big Cedar Creek is not known, but it was most probably part of the Cumberland Gap Turnpike. The Cumberland Gap Turnpike from Jeffersonville (present-day Tazewell) through Lebanon and on to the Cumberland Gap via Jonesville is denoted on an 1838 map by Claudius Crozet as "turnpike in progress."¹² On Crozet's map dated 1848, the section from Jeffersonville to Lebanon is denoted as completed.¹³ Oral family history notes the stone for the bridge, as well as that for the house foundation, was quarried from a site on the west side of Big Cedar Creek approximately 300 feet upstream from the covered bridge. The western abutments of the U.S. Route 19 bridges sit at the top of the old quarry, and the quarry itself has been filled with rip-rap stone.

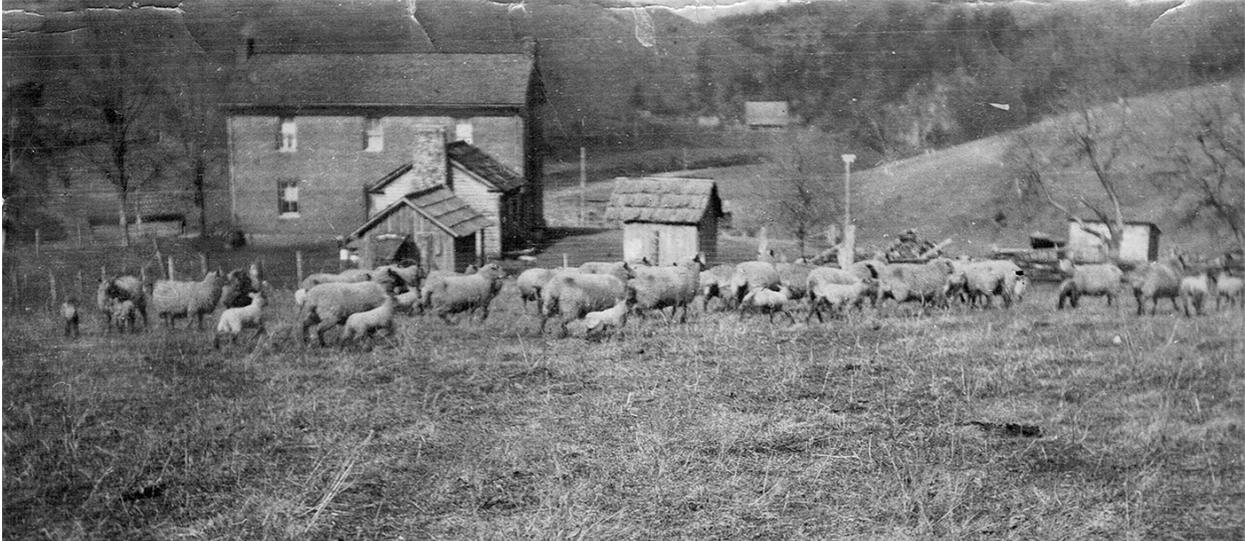
Figure 2. View of the house from the rear (southeast), circa 1900. The original kitchen is immediately to the rear of the house, with the cellar directly behind the kitchen.

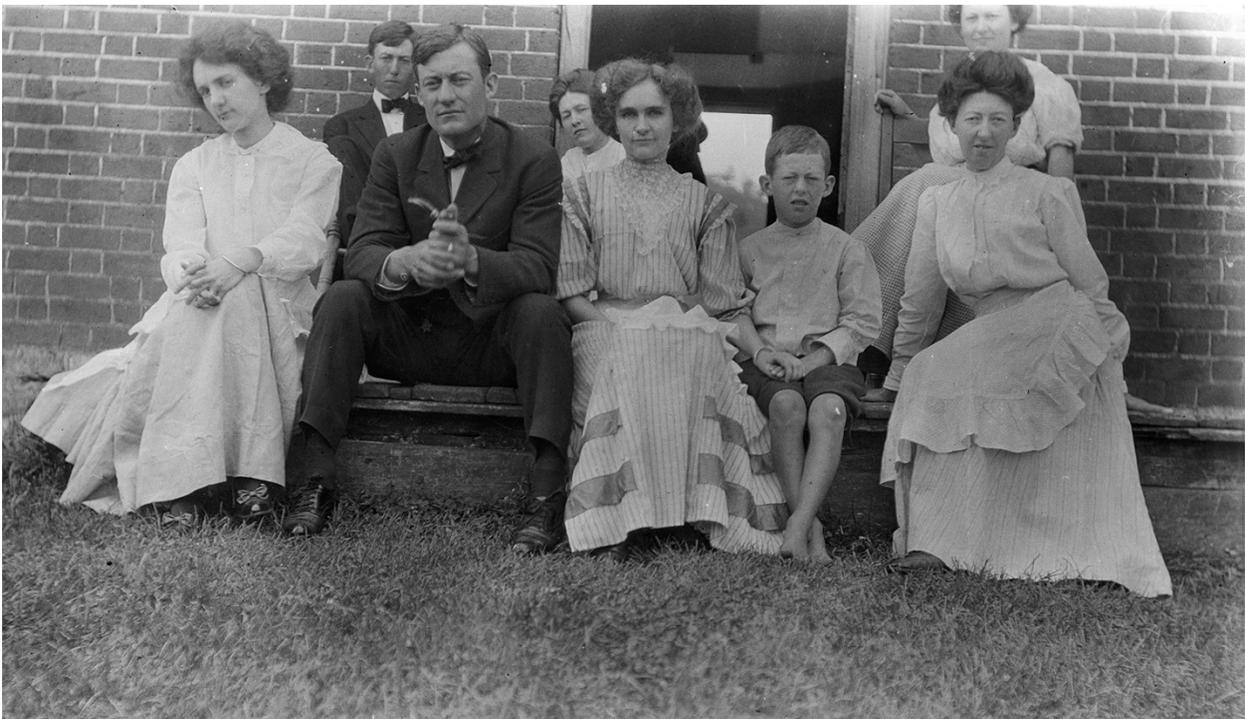
Figure 3. Several of E.T. Gilmer's children and others on the front landing, circa 1908.

Figure 3: Several of E.T. Gilmer's children and others on the front landing, circa 1908.

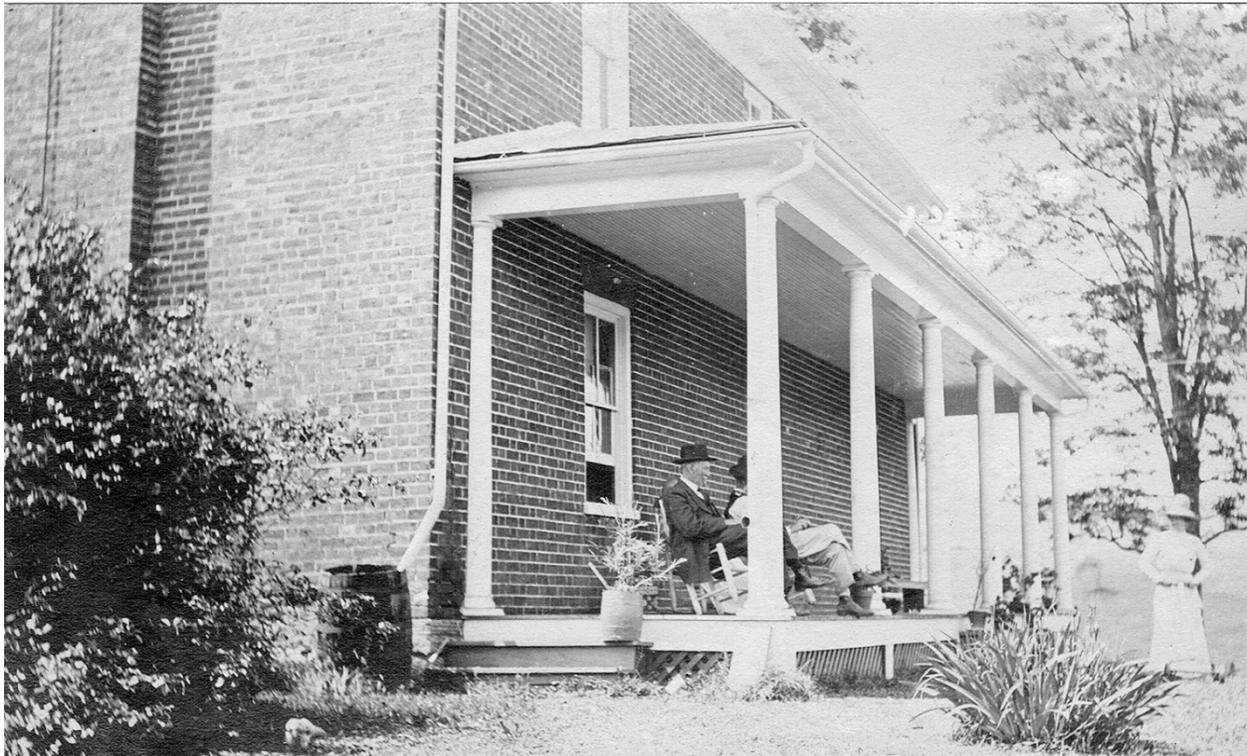
Figure 4. The wooden-columned front porch, circa 1910.

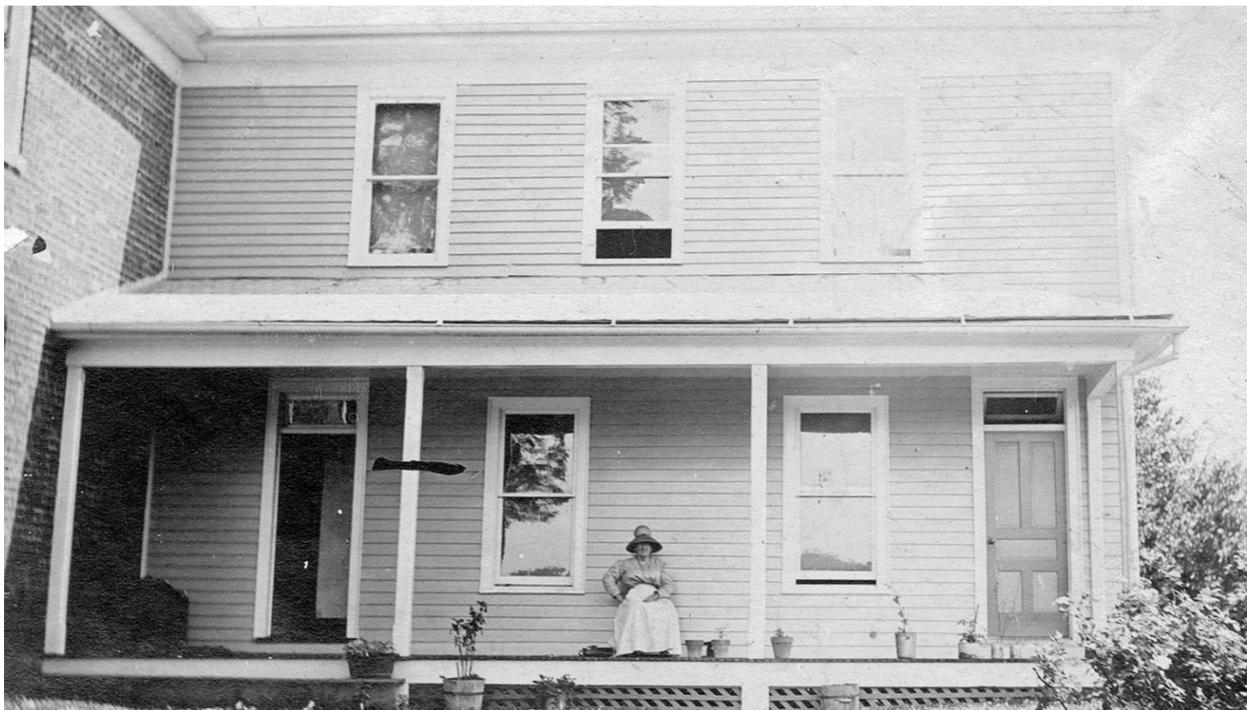
Figure 5. The rear frame annex, circa prior to 1925. Seated on the porch is E.T. Gilmer's wife, Ida Vermillion Gilmer (1858-1925).

Upon E.T. Gilmer's death the house was acquired by one of his sons, Marcellus Grundy Gilmer. In 1950 M.G. Gilmer dismantled the frame annex and constructed the current brick annex. During construction a collection of family papers was discovered consisting of 148 items from the years 1856–1865, which was largely incoming correspondence received and retained by M.G. Gilmer's grandfather, Cummings Gilmer (again, the brother of Samuel), and Cummings' daughter Martha. Also among the papers are letters and essays of Cummings' son John Edmonson Gilmer, written while he was a student at Emory & Henry College. The collection was deposited in the University of Virginia Library in October 1955.

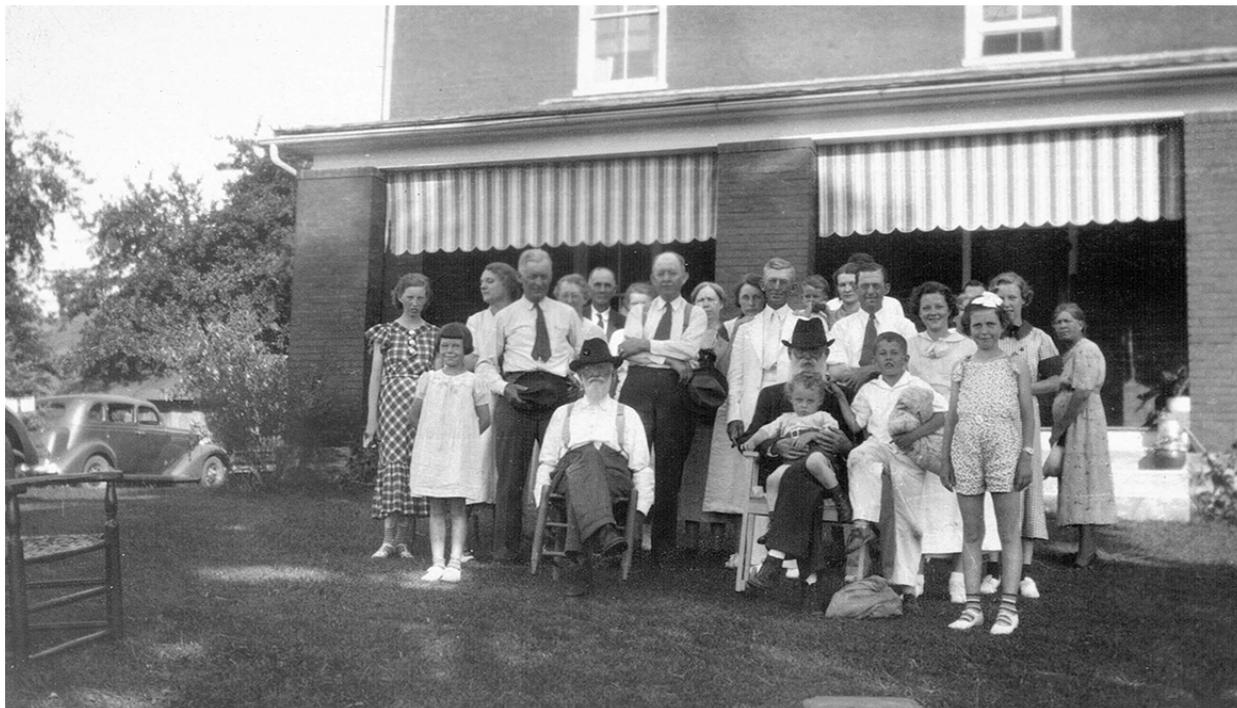
Figure 6. The brick-columned front porch, 1935. E.T. Gilmer is seated on the left.

In time, the building became the property of C.H. Gilmer's younger brother, Edward Theophilus Gilmer. E.T. Gilmer and his family moved into the building circa 1890, where he lived until his death in 1941. Family photographs from circa 1900 note the building did not have front or rear porches but small, uncovered wooden landings (see Figures 2 and 3). A covered wooden porch supported by wooden columns which spanned the façade was added circa 1910 (see Figure 4). Prior to 1925 the original detached kitchen was torn down and a two-story frame annex was added to the rear (southeast) of the building (see Figure 5). The circa 1910 porch was rebuilt with brick columns at some time prior to 1935, and the current portico was constructed in 1992 (see Figure 6).

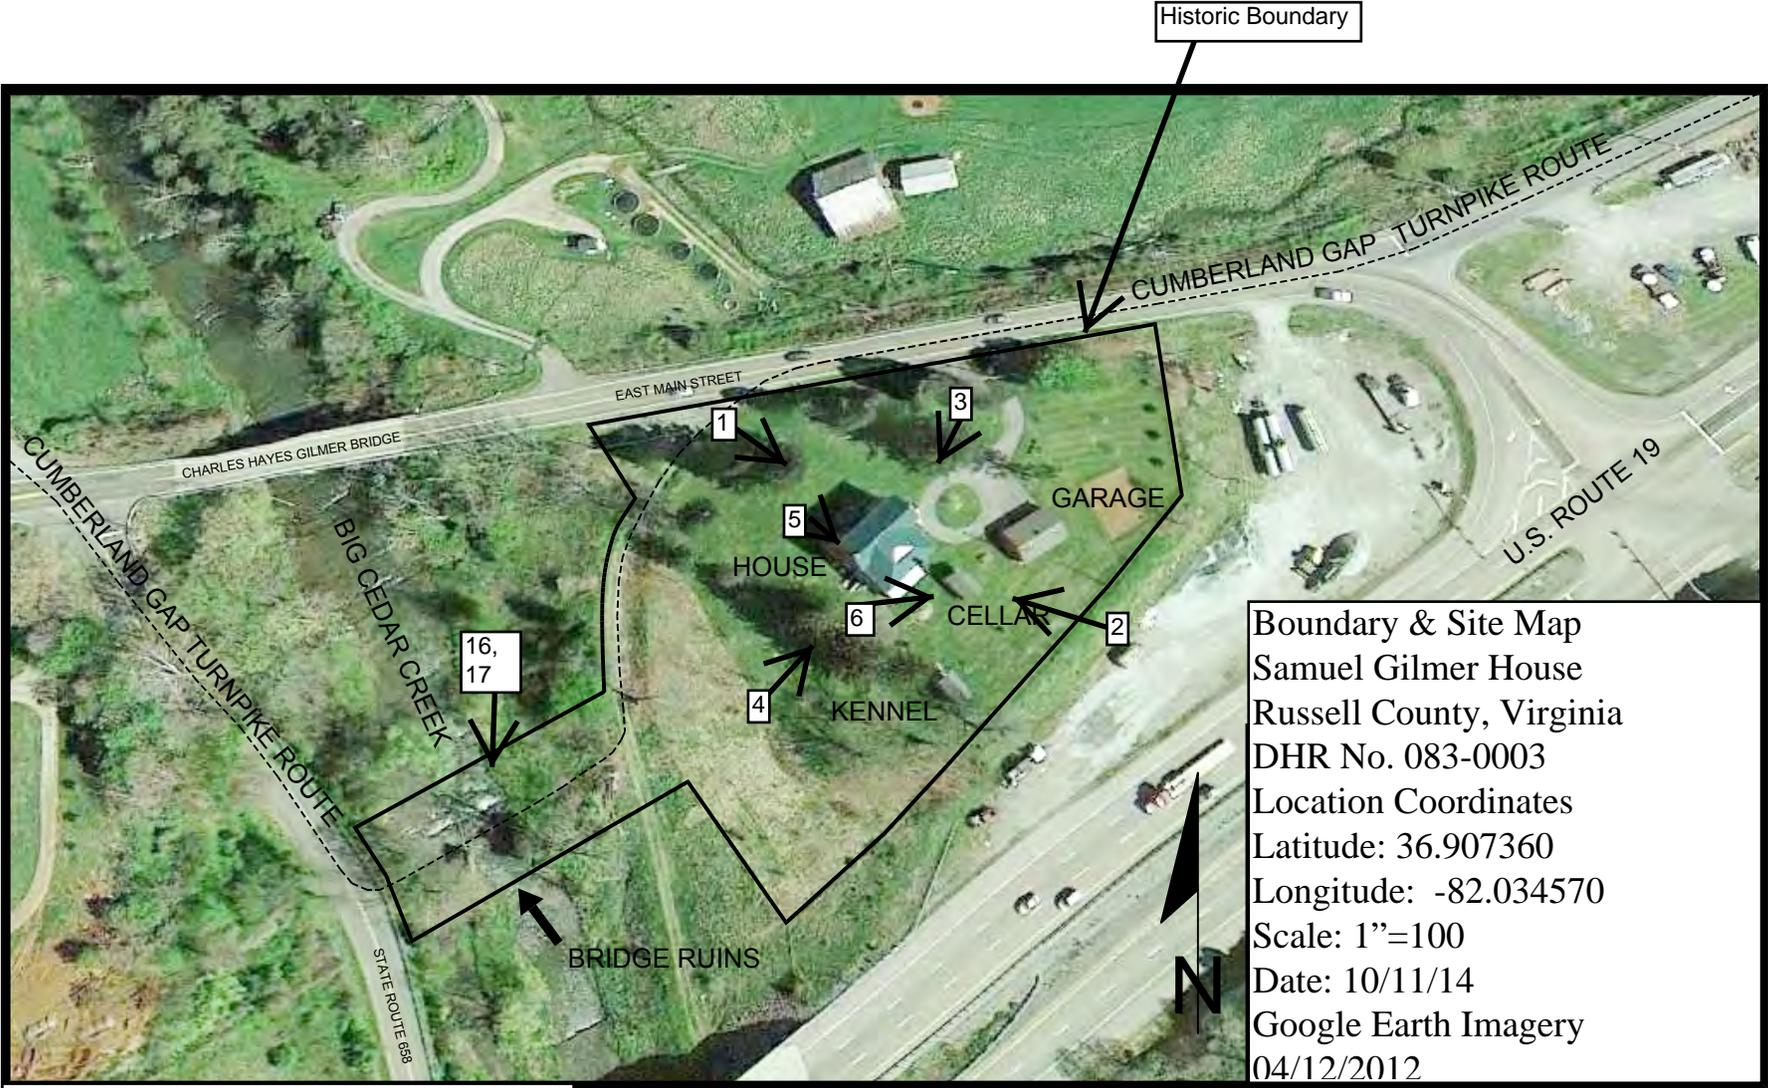
Boundary & Site Map
 Samuel Gilmer House
 Russell County, Virginia
 DHR No. 083-0003
 Location Coordinates
 Latitude: 36.907360
 Longitude: -82.034570
 Scale: 1"=100
 Date: 10/11/14
 Google Earth Imagery
 04/12/2012

- Contributing Resources:
 House (Building)
 Cellar (Building)
 Bridge Ruins (Structure)
 Non-Contributing Resources
 Garage (Building)
 Kennel (Building)

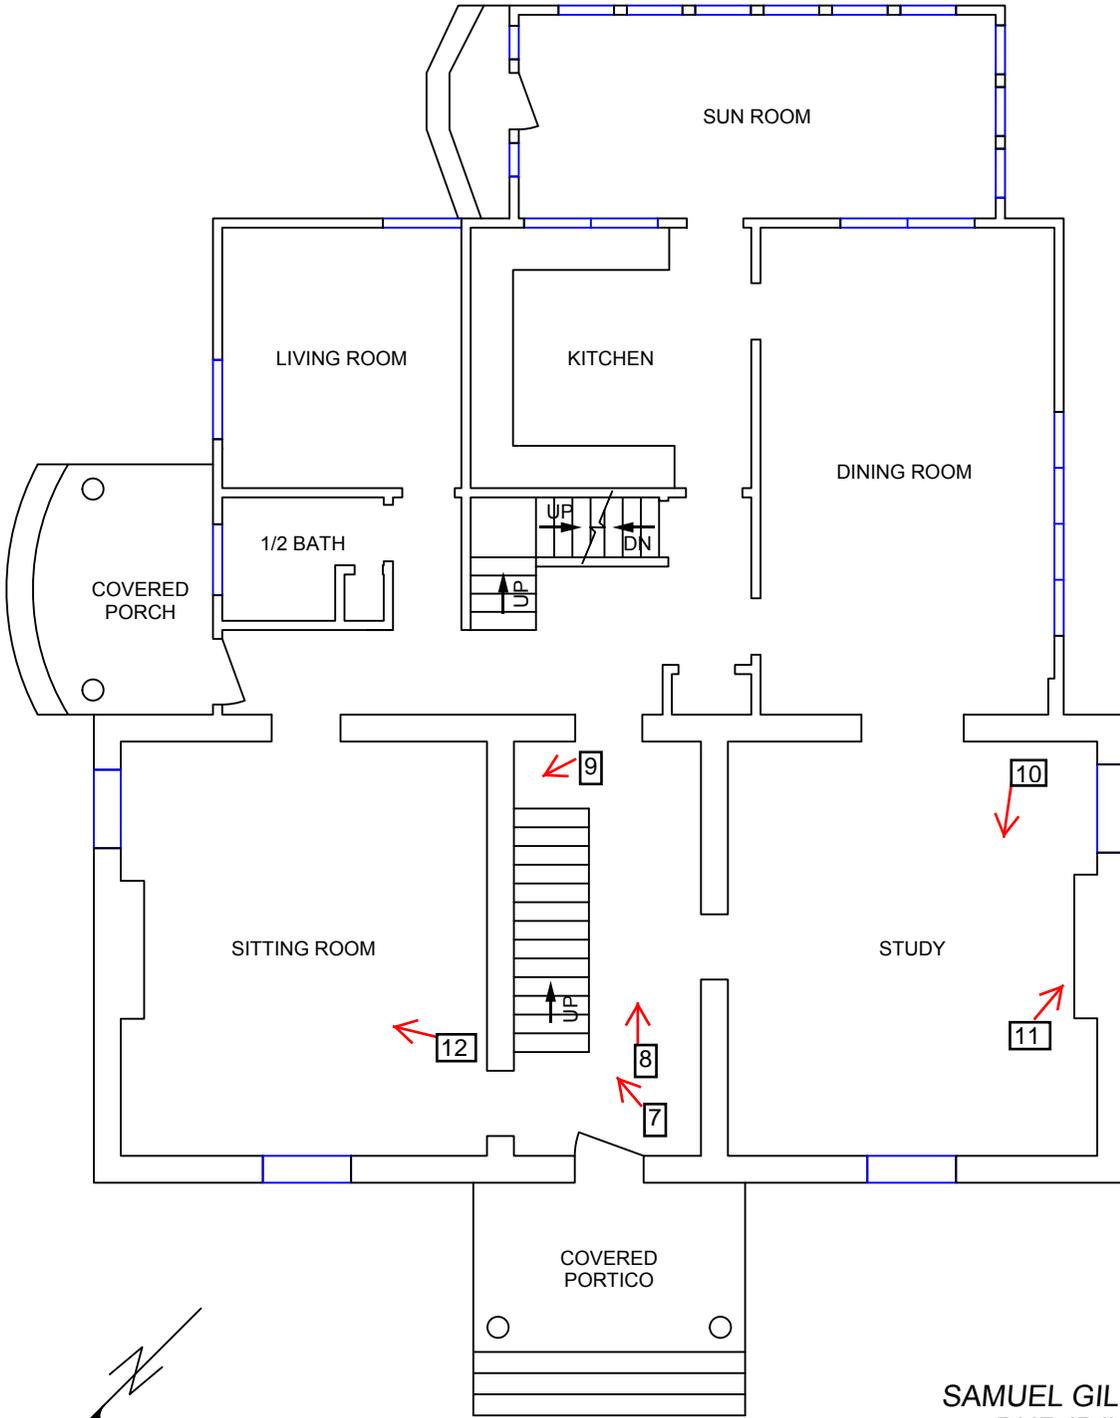
SAMUEL GILMER HOUSE
 DHR ID# 083-0003
 Russell County VA
 FIRST FLOOR PLAN
 September 2014
 NTS

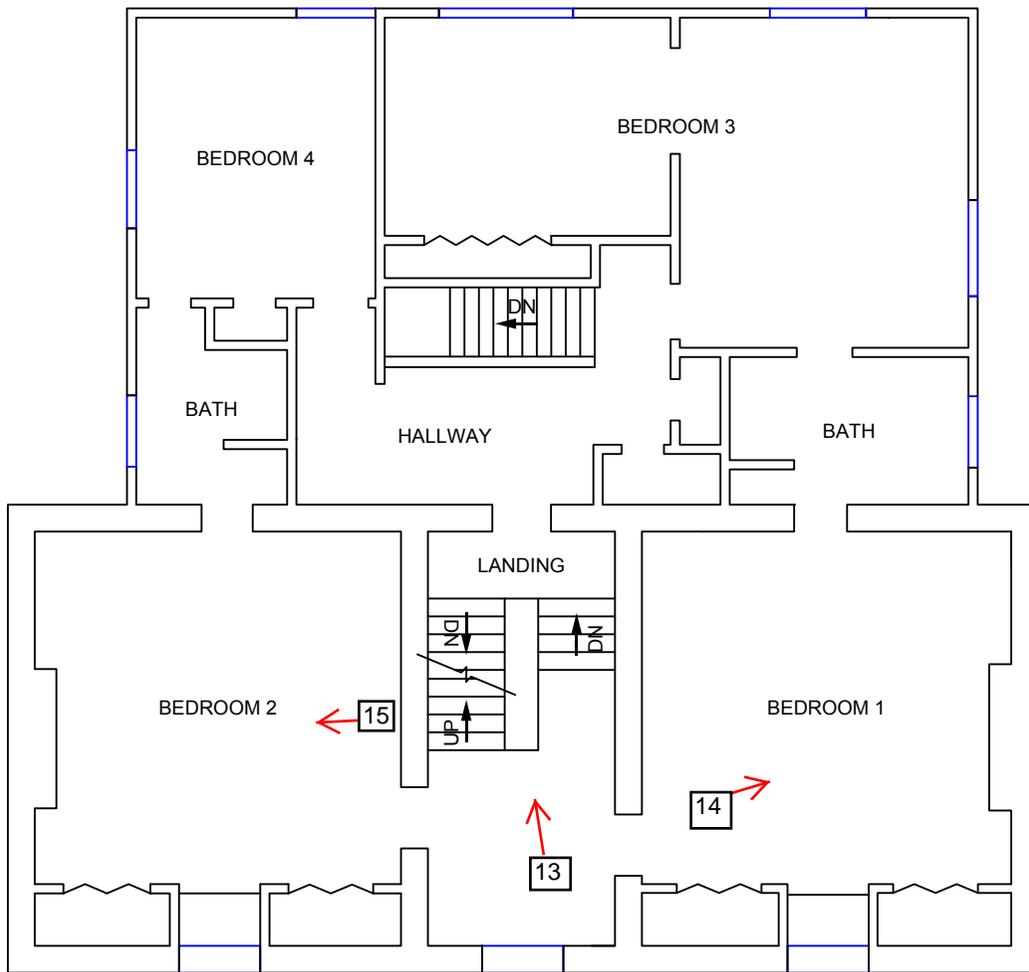
SAMUEL GILMER HOUSE
 DHR ID# 083-0003
 Russell County VA
 SECOND FLOOR PLAN
 September 2014
 NTS

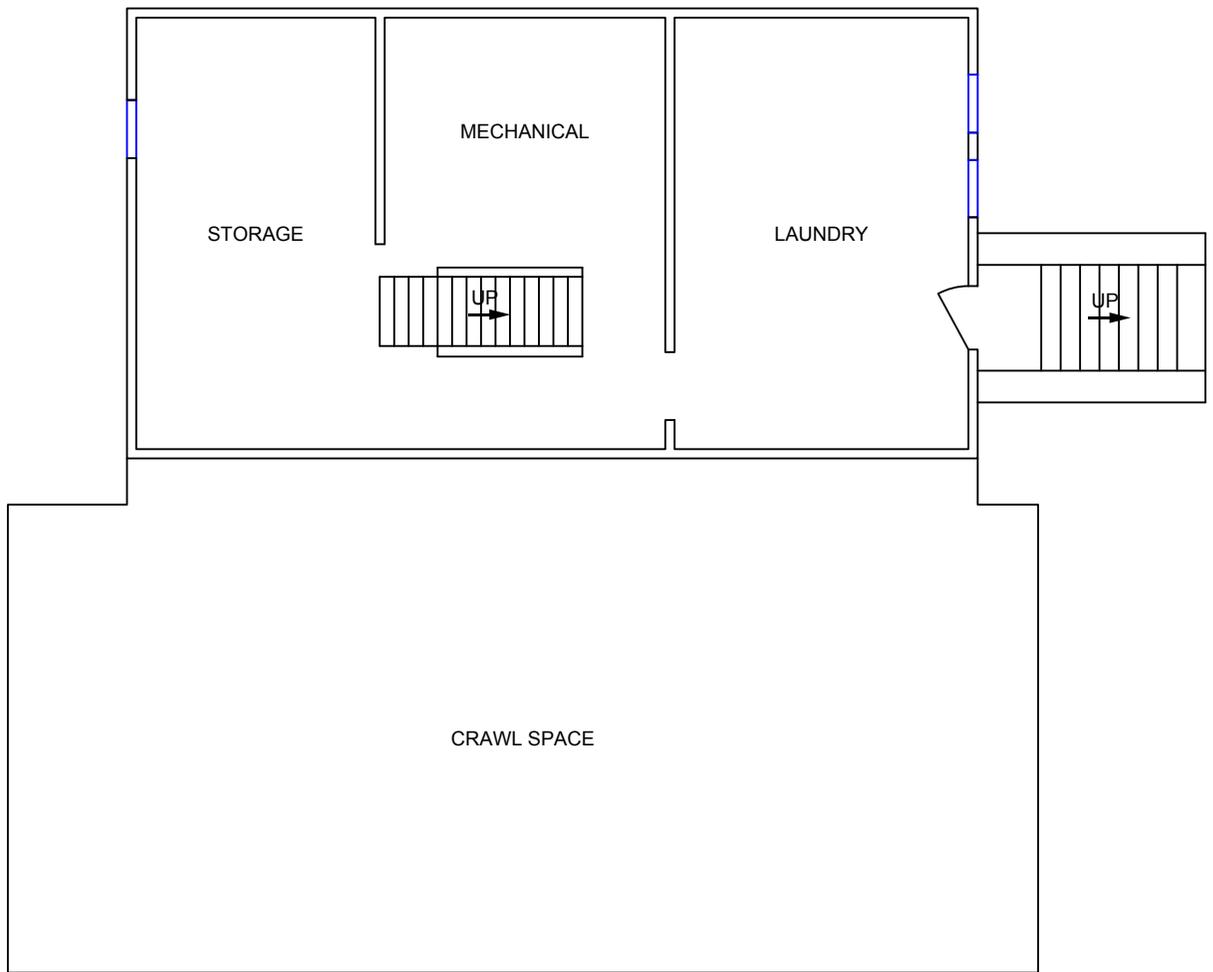
SAMUEL GILMER HOUSE
DHR ID# 083-0003
Russell County VA
BASEMENT FLOOR PLAN
September 2014
NTS
