National Register of Historic Places Registration Form

Historic name: Wilkins Farm
Other names/site number: VDHR File No. 085-0216
Name of related multiple property listing:
N/A
(Enter "N/A" if property is not part of a multiple property listing)

Street & number: 989 Swover Creek Road
City or town: Edinburg State: Virginia County: Shenandoah
Not For Publication: N/A Vicinity: X

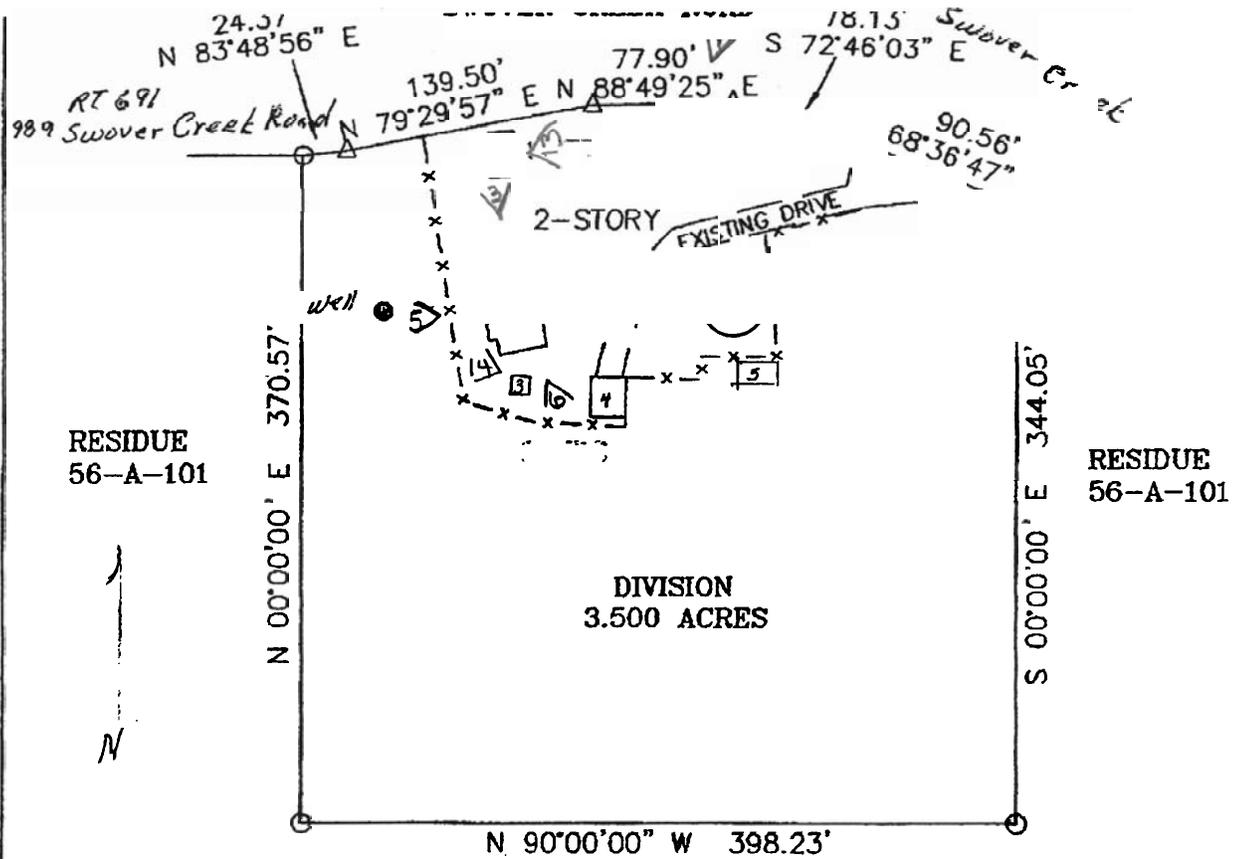
1. house c.1776-90 - C
 2. summer kit-wellhouse c.1790 - C
 3. log granary c.1790 - C
 4. garage c.1955 - NC
 5. run-in-shed c.2007 - NC
Jan. 16, 2013
 6. round pen 45'-2007 - NC
- 1/4" = 26.6' scale

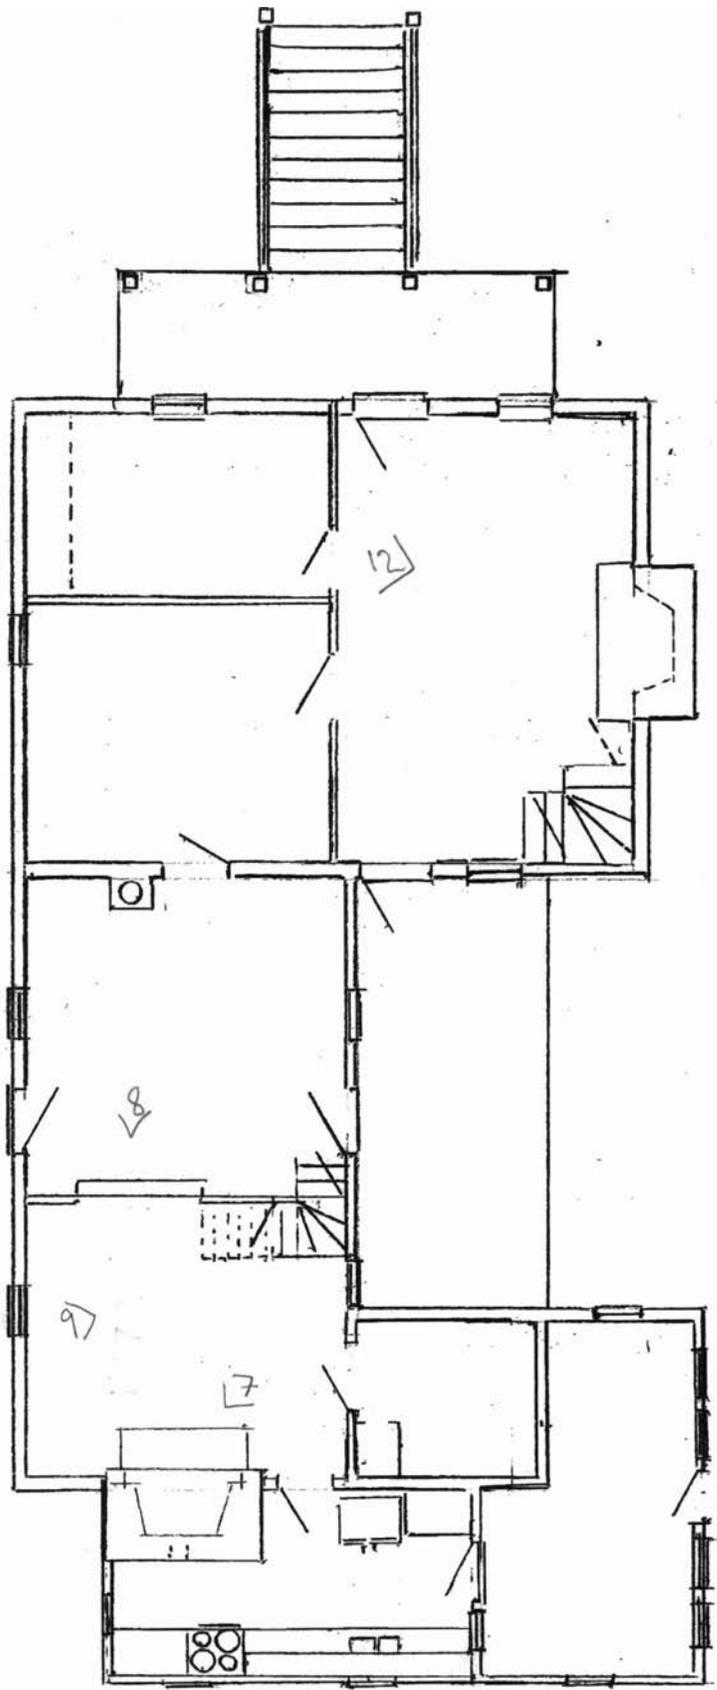
WILKINS FARM
SHENANDOAH COUNTY, VA
VDNR FILE NO. 085-0216
Dwelling - First Floor Plan
T Photo location

The main house on the first story consists of three rooms. The hall is 14 feet by 20 feet and is exactly one half the dwelling. The hall has two opposing six-panel entry doors with four-light transoms on the north and south, and two six-panel doors that lead to the other rooms on the west wall. All of the interior walls are plastered above a beaded six-inch baseboard. A continuous hand molded chair rail encircles each room and is an integral part of the window sills. The floors are constructed with random-width, tongue-and-groove yellow pine boards. The room on the front of the house is 8 feet by 14 feet, and the other in the southwest corner is 12 feet by 14 feet. The interior walls are non-load-bearing board walls which have been plastered. A board-and-batten-door with a Suffolk bean thumb latch opens to a boxed, winding staircase at the third riser. From the hall the stair rises over the fireplace on the east wall. The fireplace mantel is made of boards with a large 5/8-inch bead and features three recessed panels below the shelf. The plinth blocks appear to be an alteration to the surround. The fireplace opening is 49 inches by 38 inches and has an exposed face of cut limestone. The six-inch mantelshelf has a hand-molded bead edge.
