National Register of Historic Places Registration Form

1. Name of Property				
historic name Schoolfield Welfare Building				
other names/site number DHR ID # 108-5065-0083				
2. Location				
street & number 917 West Main Street	not for publication			
city or town Danville	vicinity			
state Virginia code VA county Danville	code 590

Schoolfield Welfare Building Danville, Va. (DHR ID# 108-5056-0083)

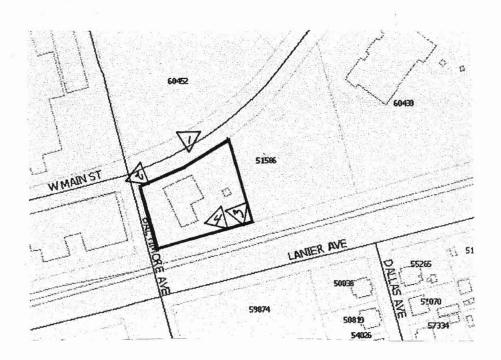
Exhibit 1: The nominated area is defined by the heavy line. Map scale: 1:200. Number and angle of view of nomination photos indicated by triangular markers.
