National Register of Historic Places
Registration Form

historic name Harper House
other names/site number VDHR File No. 007-0233

Harper House
Augusta County, Virginia

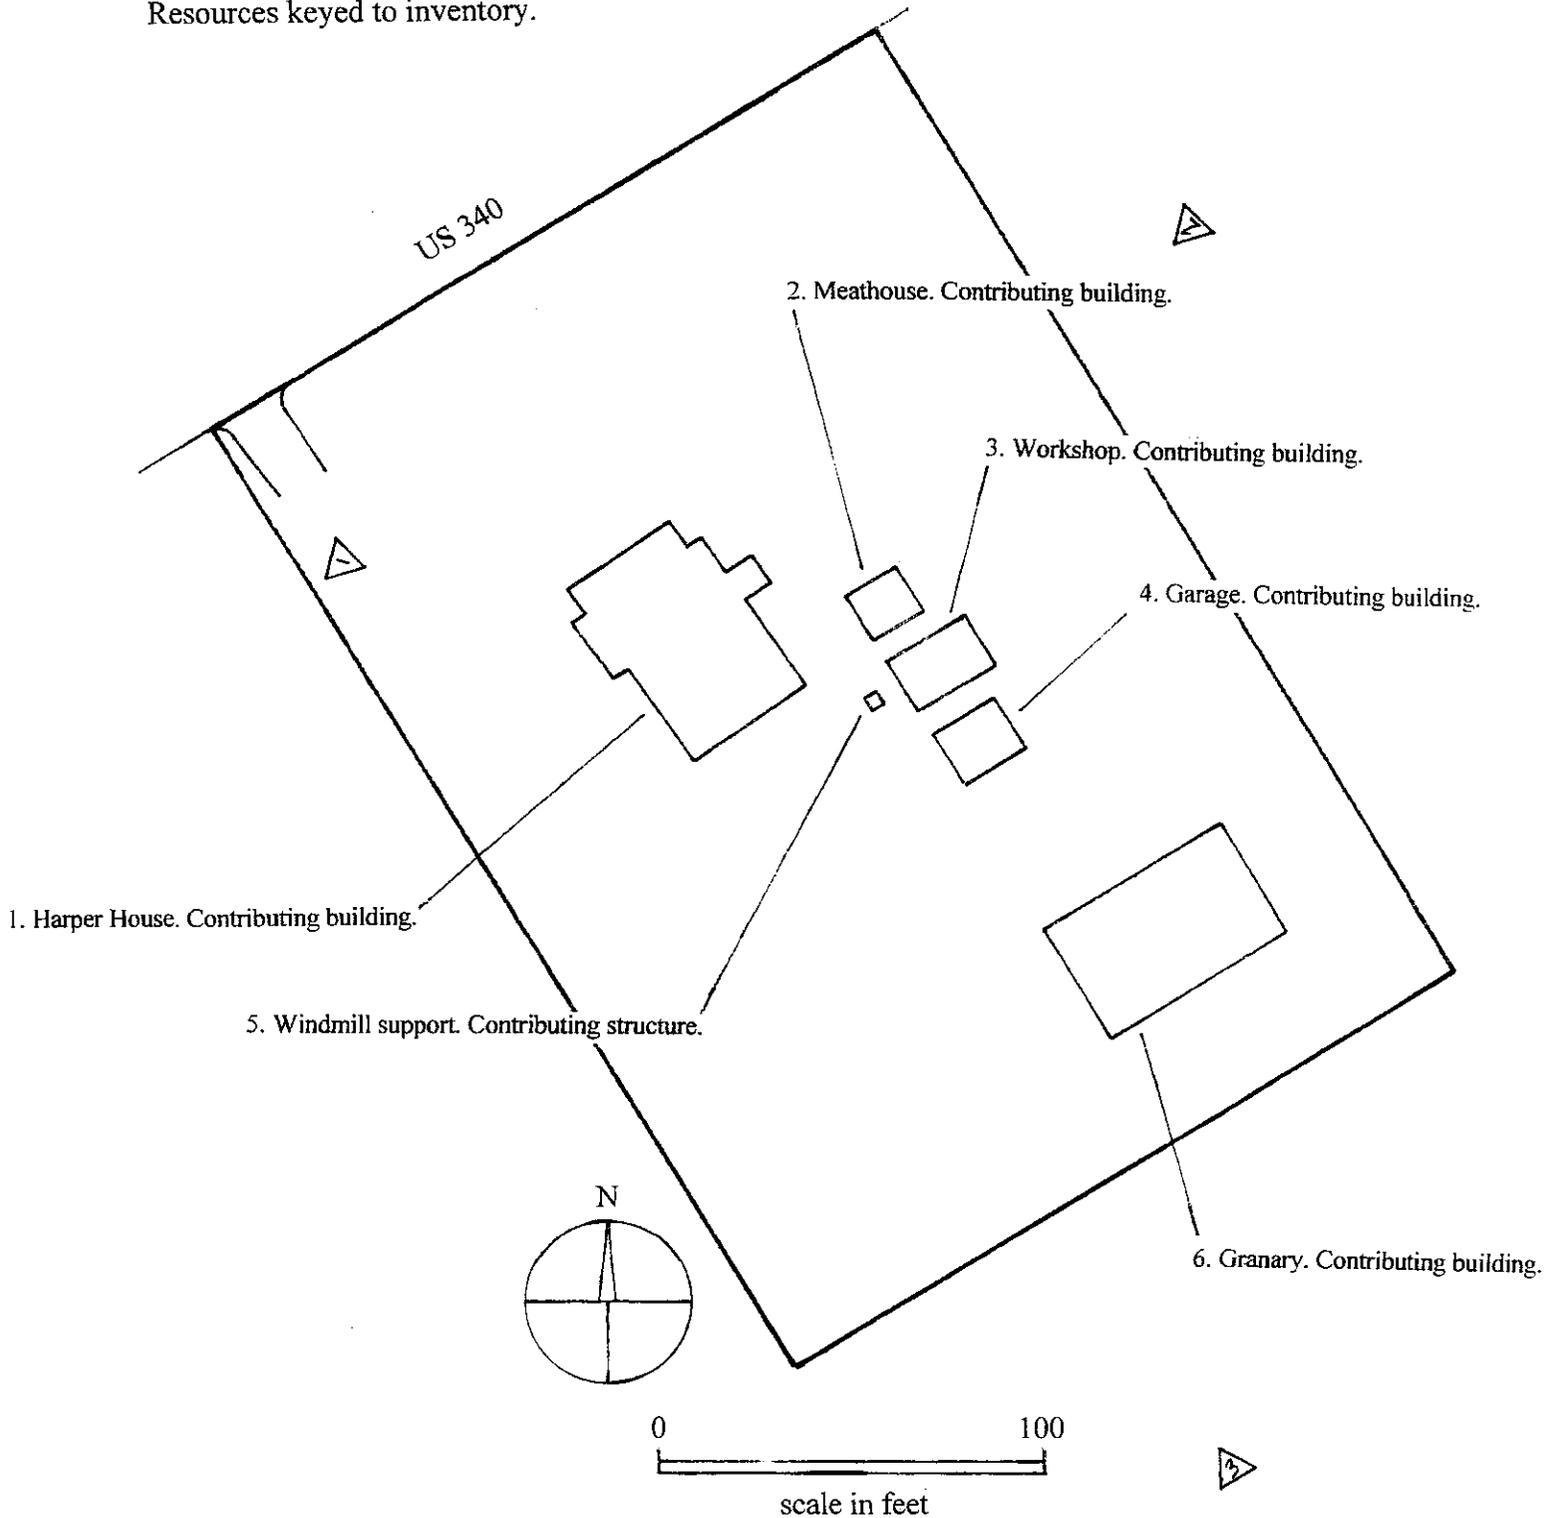
Harper House

Scale: 1 inch equals approximately 50 feet.

Nominated area indicated by heavy line.

Number and direction of view of photos indicated by triangular markers.

Resources keyed to inventory.

The boundaries of the nominated area are depicted on the approximately 1:50-scale map that accompanies the nomination.
