NATIONAL REGISTER OF HISTORIC PLACES
REGISTRATION FORM

historic name Glenview
other names/site number Chambliss House/DHR File #091-0028

**Glenview
Sussex County, Virginia**

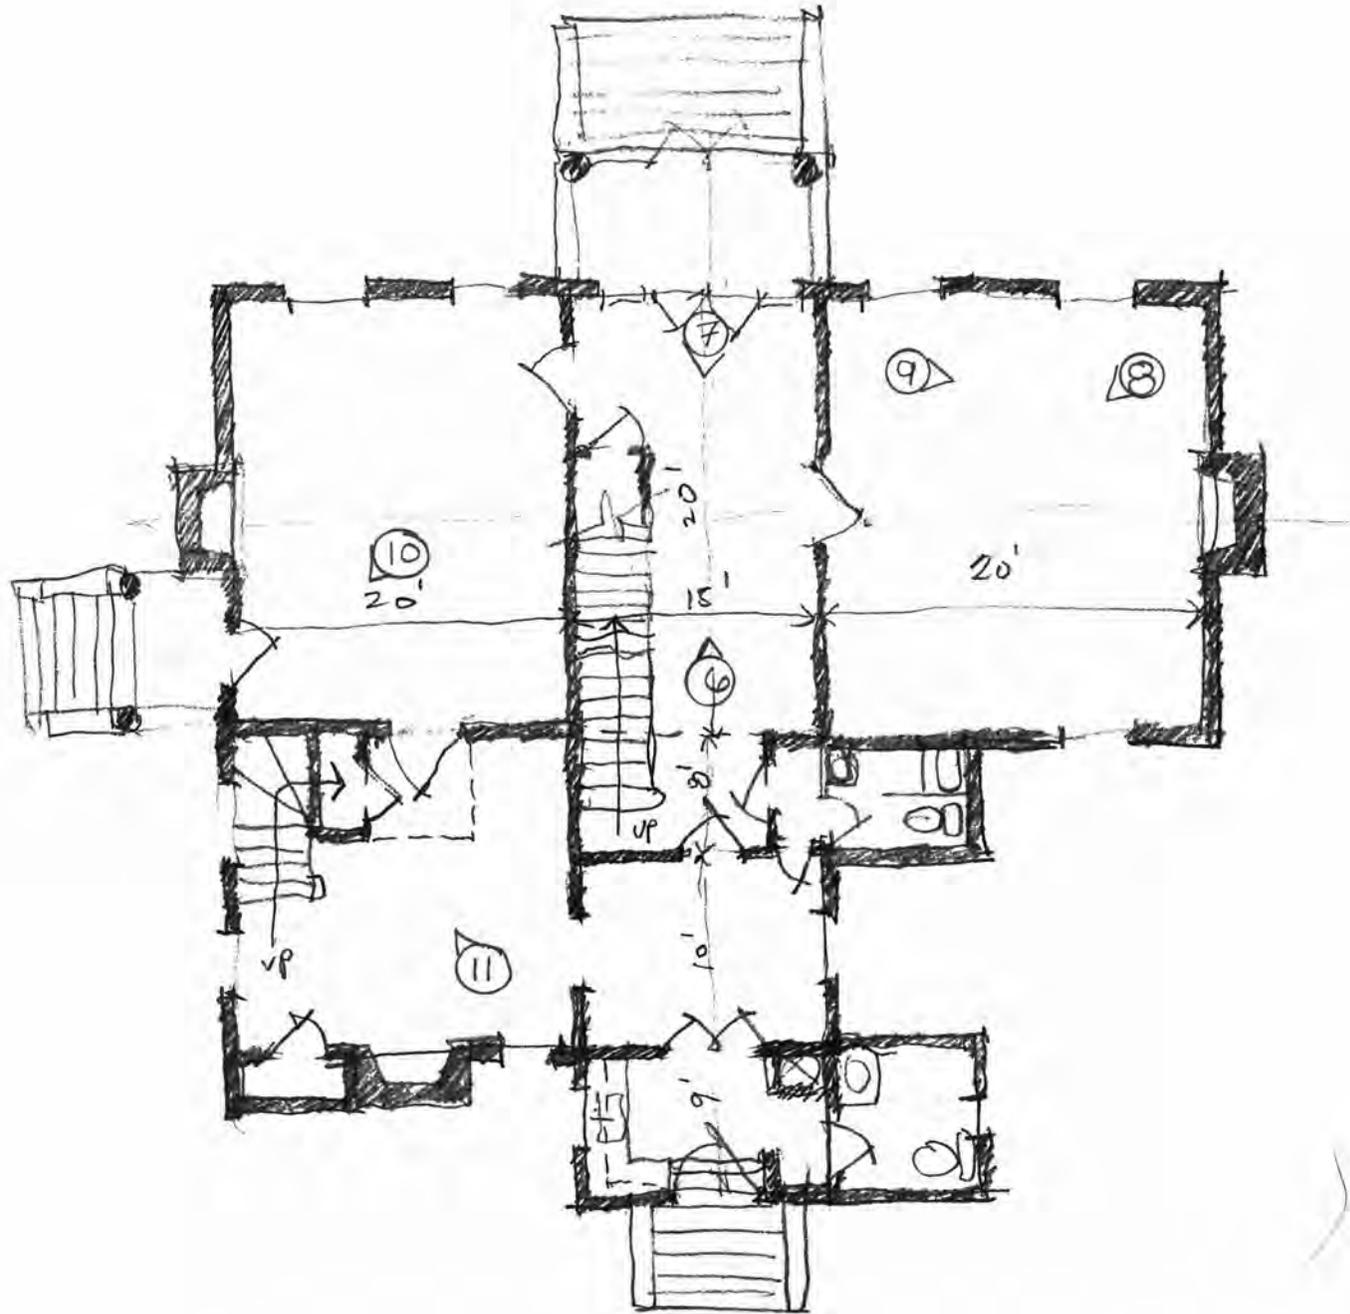
FIRST FLOOR PLAN

The house exhibits a center hall, single-pile plan with stairs located in the center hall. Large, 20-foot-wide rooms flank the hall on the north and the south. The eastern wall of the center hall appears to have been moved about six feet to the east. An overhead beam and a depression in the flooring probably indicate where the original wall stood. A door has been inserted into the eastern wall and accesses a short hallway and a rear porch (converted to a kitchen).

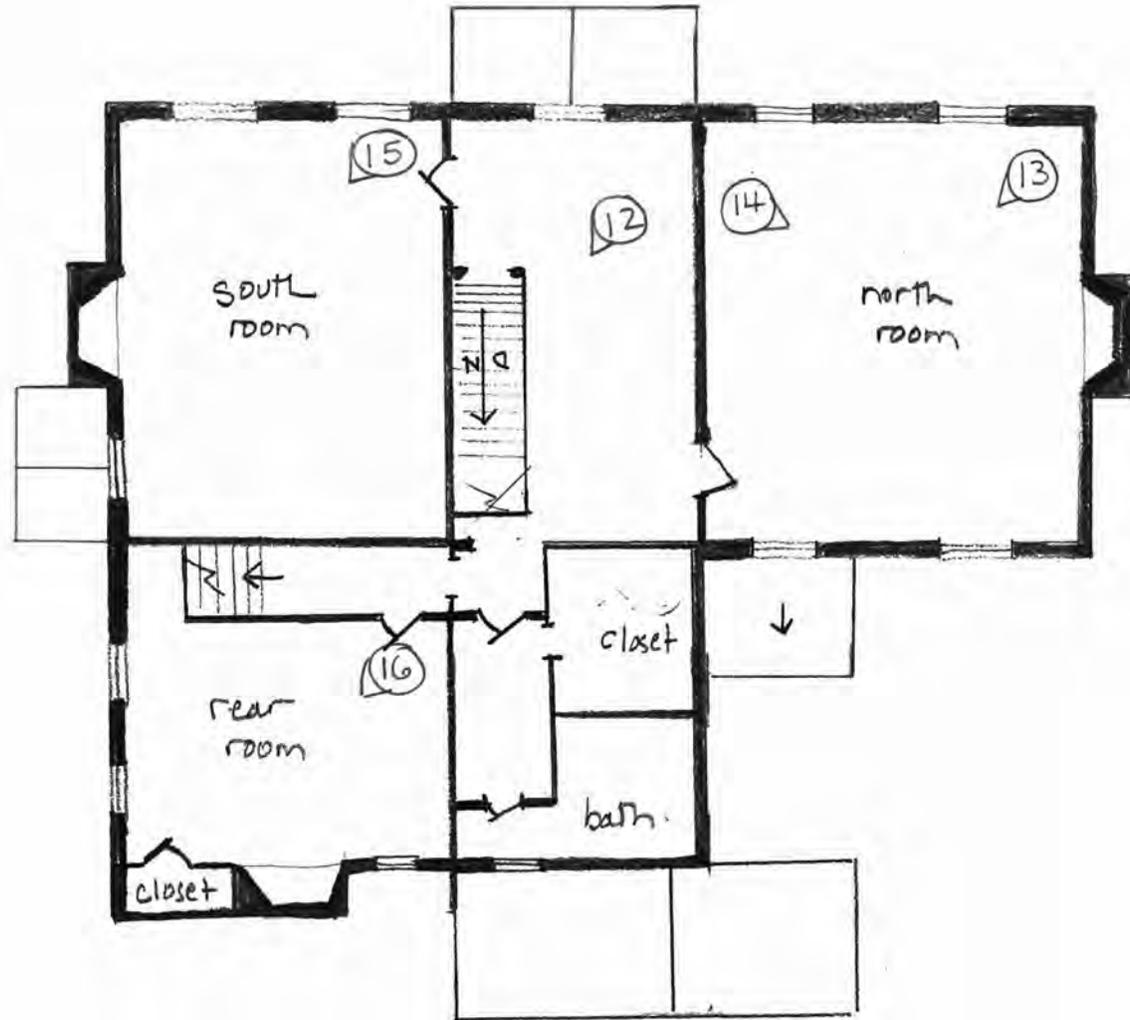
Second floor plan NTS

The stairs open onto the second floor center hall on the west side. Turned balusters are used as newel posts at the top of the stairs. The plaster walls of the center hall are detailed with a molded chair rail. A six-over-six window is centrally located along the west wall of the hall. Doorways lead to the north and south rooms and a cased opening on the east wall leads to the rear additions.
