Downtown Danville Historic District
2019 Update
Name of Property
City of Danville, VA
County and State
N/A
Name of multiple listing (if applicable)

**115-117 S. Union St. Register and Bee Building. 1899-1904. 108-0111-0066. CB.**

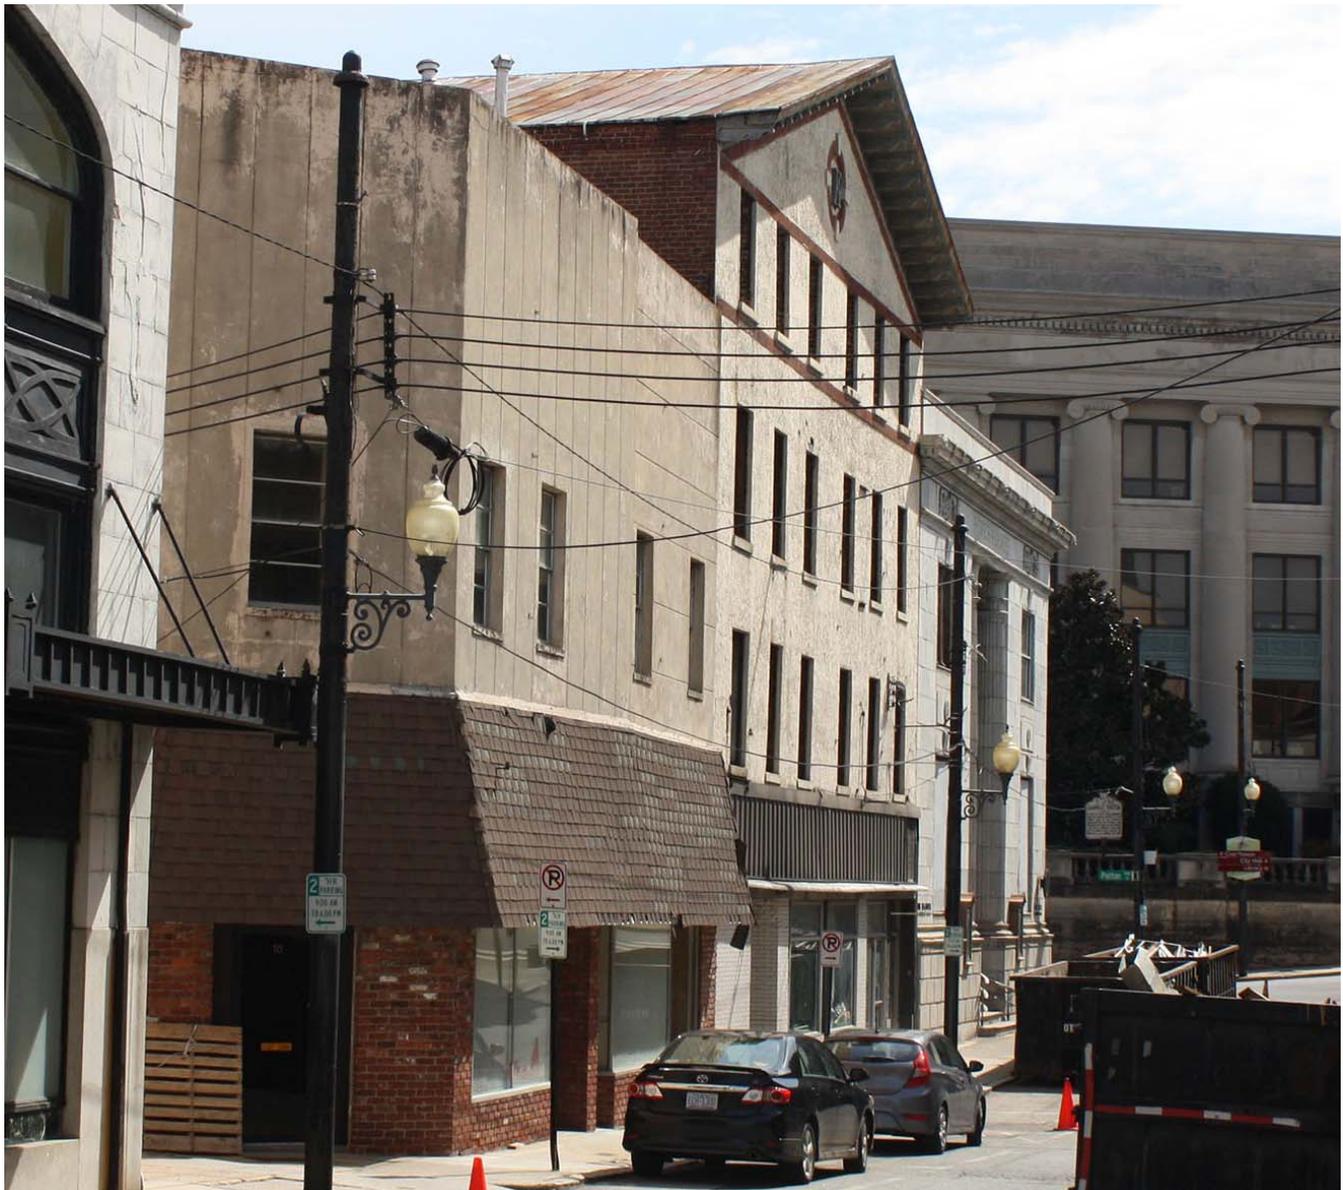
Photo 1: 115-117 S. Union Street, view SE (2019)

This two-story brick building is actually two buildings joined under a single concrete façade on the upper two stories. The façade has vertical and horizontal scorings and dates to 1940, when the Dan Theatre opened. The extant rectangular windows on the façade's second story do not appear in a photograph (see below) of the building taken immediately after it was converted to house the Dan Theatre. The windows have metal-framed sash with stacked horizontal lights, and are of a type that was commonly used during the 1940s-1960s. Spacing, size, and shape of the window openings, as well as their alignment with windows on the north elevation, suggest that the current openings are in the same places as the original windows. Patching of the concrete façade also suggest the windows were installed after the concrete cladding.

The marquee and theatre signage that once identified the building are no longer extant. The current storefront has brick veneer, large, single-light display windows flanking a recessed entry that is in the same location as the historic theatre entrance, a corner entry with a flush metal door, and a mansard-type roof with wood shingles. The design and materials suggest the storefront was in place by the early 1980s. Original stretcher-bond brickwork and segmental-head door and window openings (most bricked up) are apparent on the north side elevation; a later rear addition, noted in the 1993 nomination, remains extant.

The alterations to convert the two buildings at 115 and 117 S. Union Street occurred during the district’s period of significance. The scored concrete façade is intact and in relatively good condition overall. In addition to the concrete façade, the building also retains other historic features, including its flat roof, two-part commercial block form, and intact north elevation.

Since the 1940s, however, and likely as late as c. 1980, the building’s integrity has been diminished by loss of the marquee and theatre sign, installation of a new storefront that spans both buildings, and reopening of five windows on the second story. The second-story windows are a reversible alteration and are considered less detrimental to the building’s overall integrity of design, workmanship, and materials.

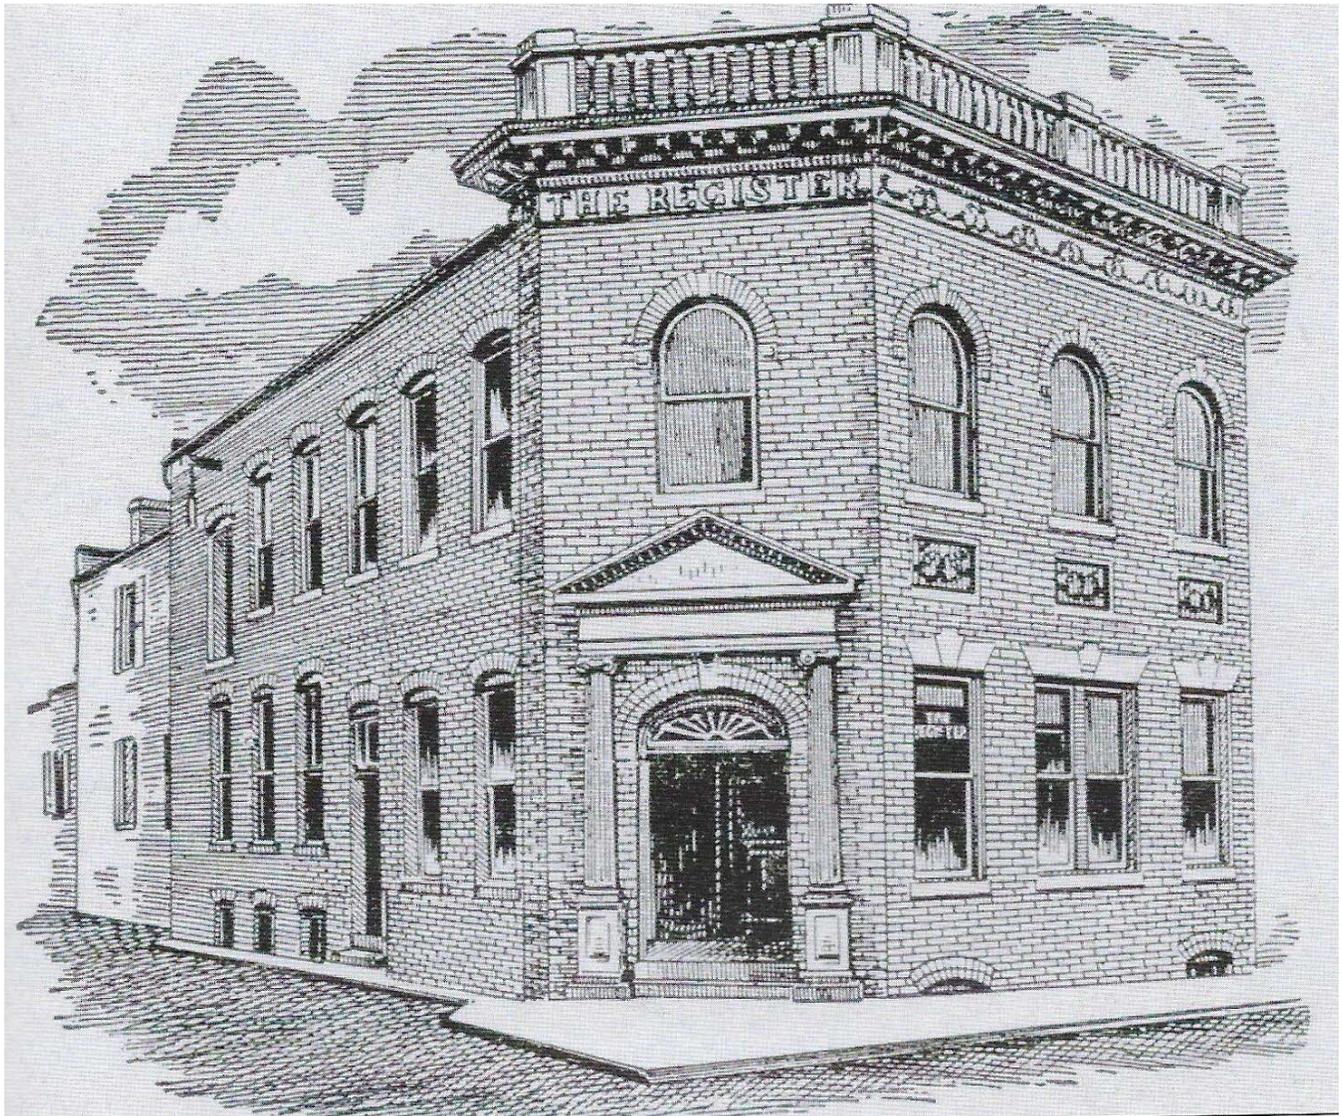
Photo 2: Historic Rendering, 115 S. Union Street, ca. 1903

The two altered buildings that came to comprise the Dan Theatre are of approximately the same age. The building at 115 South Union was constructed between 1899 and 1904 for the Register Publishing Company and was known as the Register and Bee Building. Danville's principal historic (and present) newspaper was published in the building. The printing press was located in the basement, offices occupied the ground floor, and the second floor was used for composing. Damage sustained from the Masonic Temple Fire of January 3, 1920, combined with a desire for more sumptuous quarters, prompted the newspaper's move down the street to the Rorer A. James Memorial Building (108-111-0070). The Register and Bee Building originally had a Neoclassical façade with a parapet balustrade and cornice, round- and jack-arched-head windows on the front, and a pedimented surround for the angled corner entry.

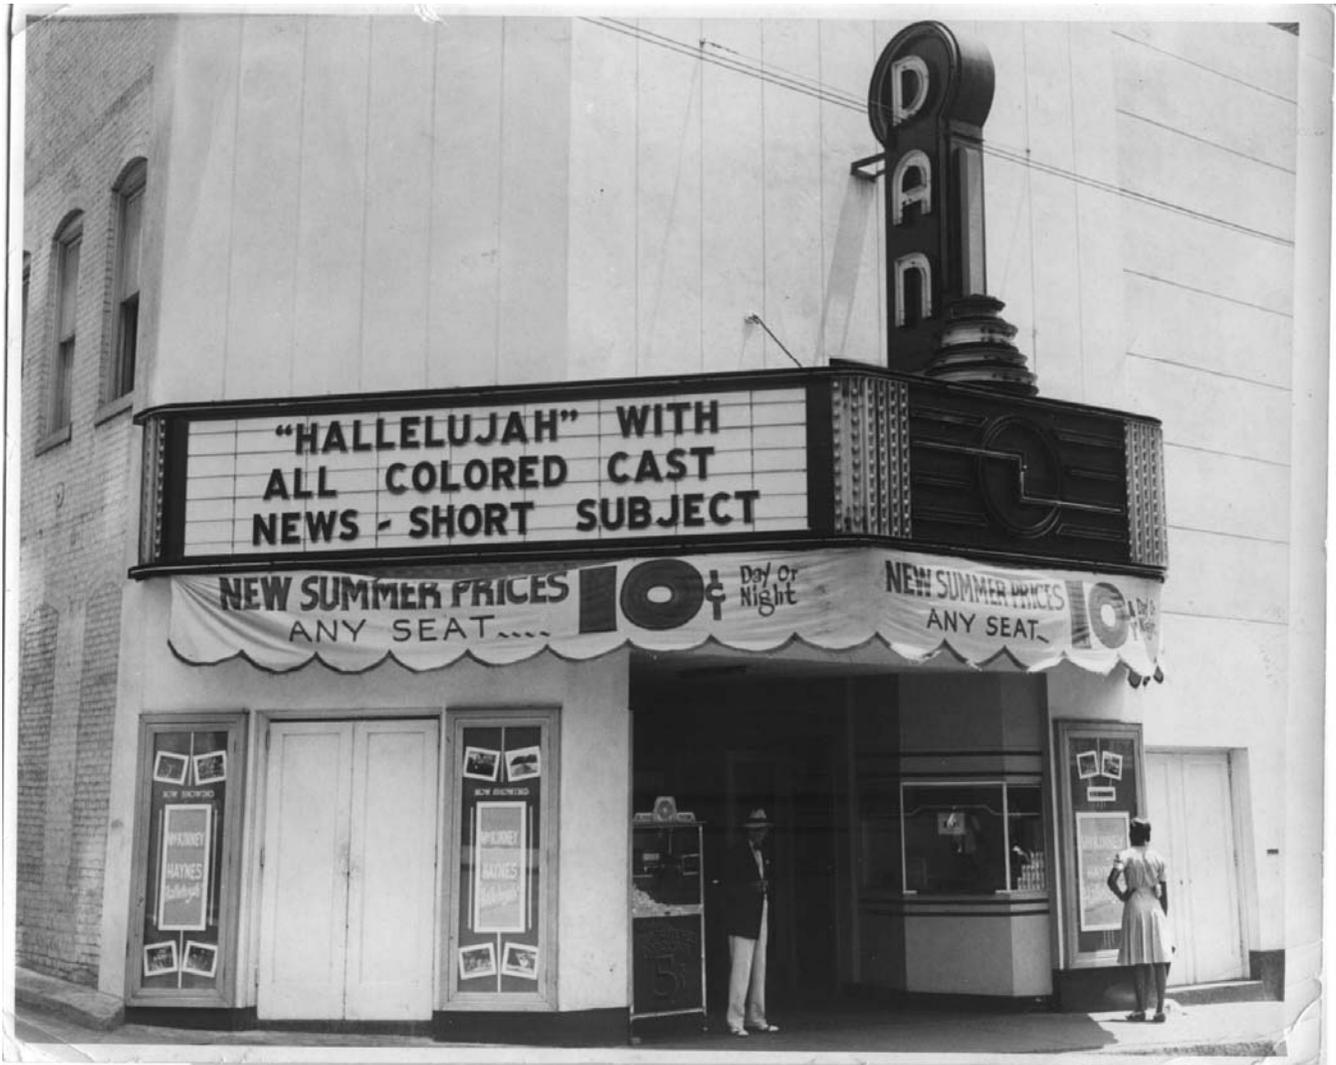
Photo 3: Historic Photograph, 115-117 S. Union Street, 1941

The availability of historic photographs, however, along with retention of the theatre entrance's general form with a centered entry and a separate entry on the canted corner, provide evidence that at least rough integrity of design has been retained, although the integrity of workmanship and materials on the façade's first story have been lost. The property also has integrity of association, as noted above, and of location and setting within a historic downtown commercial district. The property's integrity of feeling is partially intact as the commercial block on which the former theatre is located has seen few major architectural changes in recent decades and the property itself has remained in commercial use. Overall, therefore, the buildings at 115-117 S. Union Street retain sufficient integrity to be contributing to the historic district.
