National Register of Historic Places Registration Form

Historic name: Riverside

Other names/site number: DHR ID# 041-0089

City or town: Sutherland State: Virginia County: Halifax

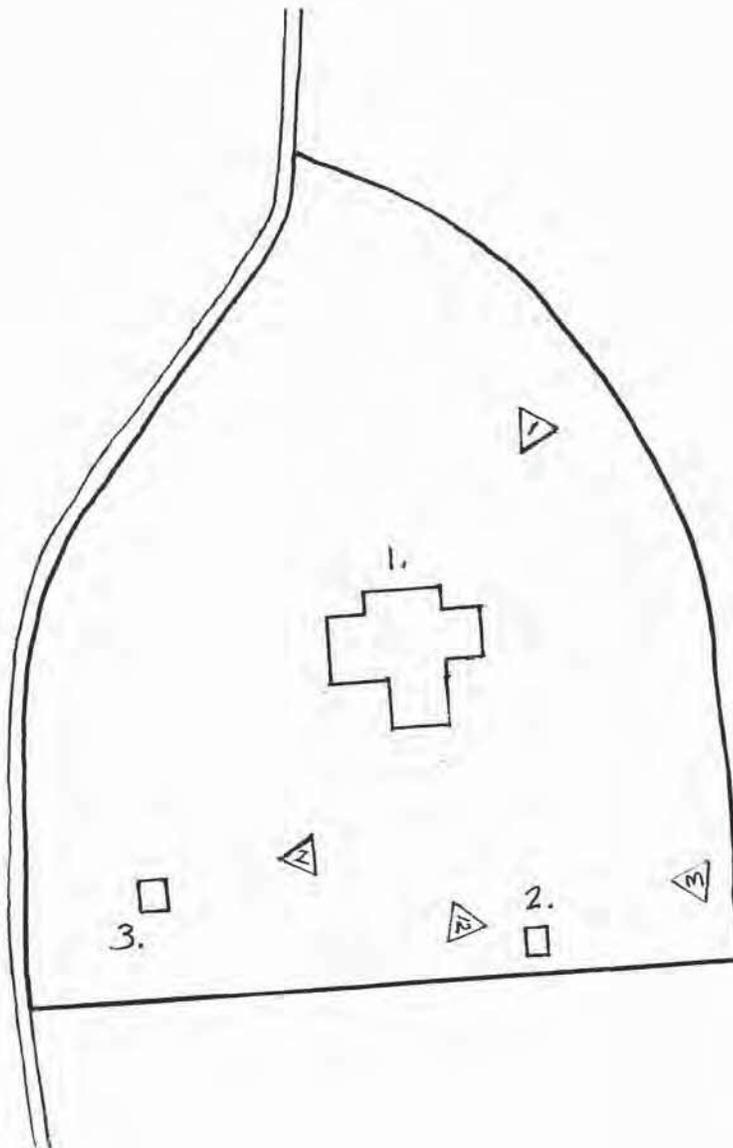
2013 Aerial Image

1. Riverside. Contributing building.
2. Smokehouse. Contributing building.
3. Wellhouse. Non-contributing structure.
