National Register of Historic Places Registration Form

Historic name: Slusser-Ryan Farm
 Other names/site number: Hickory Ridge Farm/DHR 060-0337
 Name of related multiple property listing:
N/A
 (Enter "N/A" if property is not part of a multiple property listing)

Street & number: 2028 Mt. Tabor Road
 City or town: Blacksburg State: VA County: Montgomery
 Not For Publication: Vicinity:

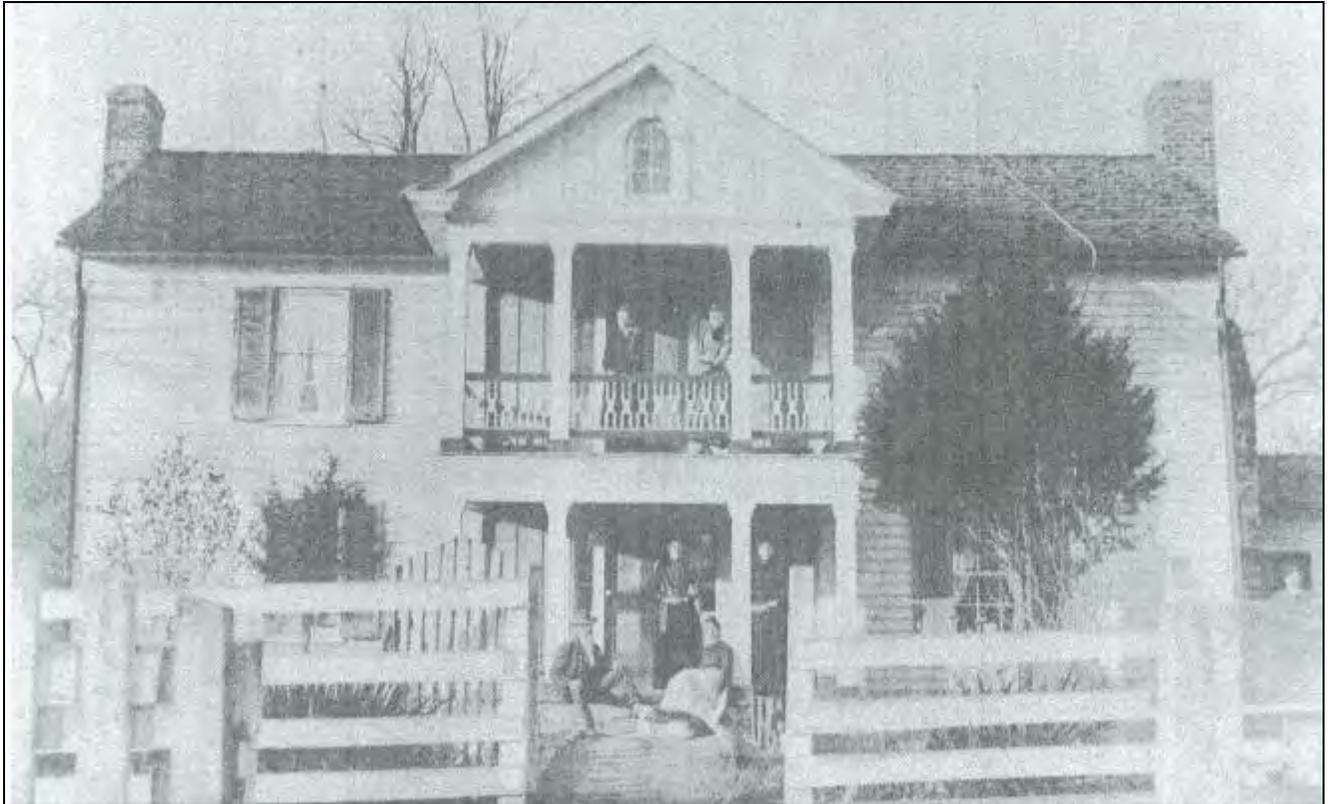
1. James P. Slusser House, ca. 1880. Source: Tom Slusser (Grandson of James P. Slusser) and Susan Bull Ryan, current property owner.

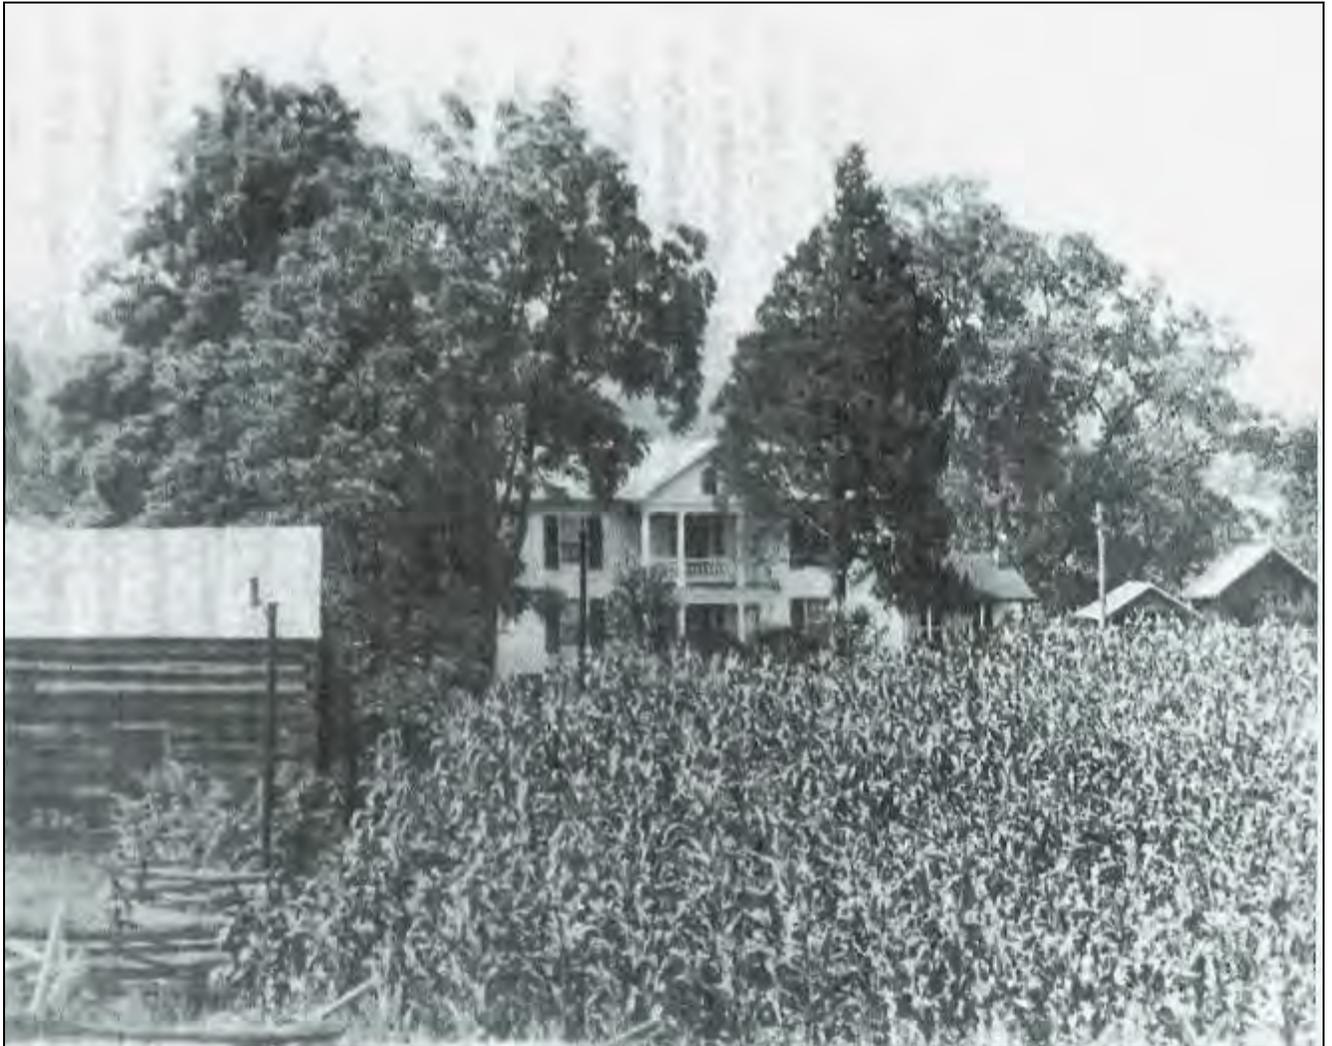
6. James P. Slusser/Byron G. Slusser House, ca. 1940. Note log building to left and pump house and meat house to right. Source: Tom Slusser (son of Byron G. Slusser) and Susan Bull Ryan, current property owner.

The one-and-a-half-story building (ca. 1870) located in front of the house and near the driveway stands on a limestone and concrete foundation, is of hewn log construction with V notches, and is covered by a metal-clad gable roof. An entrance door is located on the west end of the building and six-over-six wooden sash windows are present on the south and east sides. The gable ends are clad with board-and-batten siding and hold small six-over-six windows. The single pen interior holds a wooden ladder to the loft in the southeast corner. No chimney or fireplace is present and the foundation appears to be uninterrupted. The building was known to have been used as a dwelling during the early twentieth century, but originally may have been a domestic or agricultural outbuilding. Although family oral tradition states that the building was a slave quarter, its location at the front of the house, as well as the lack of a fireplace or chimney and

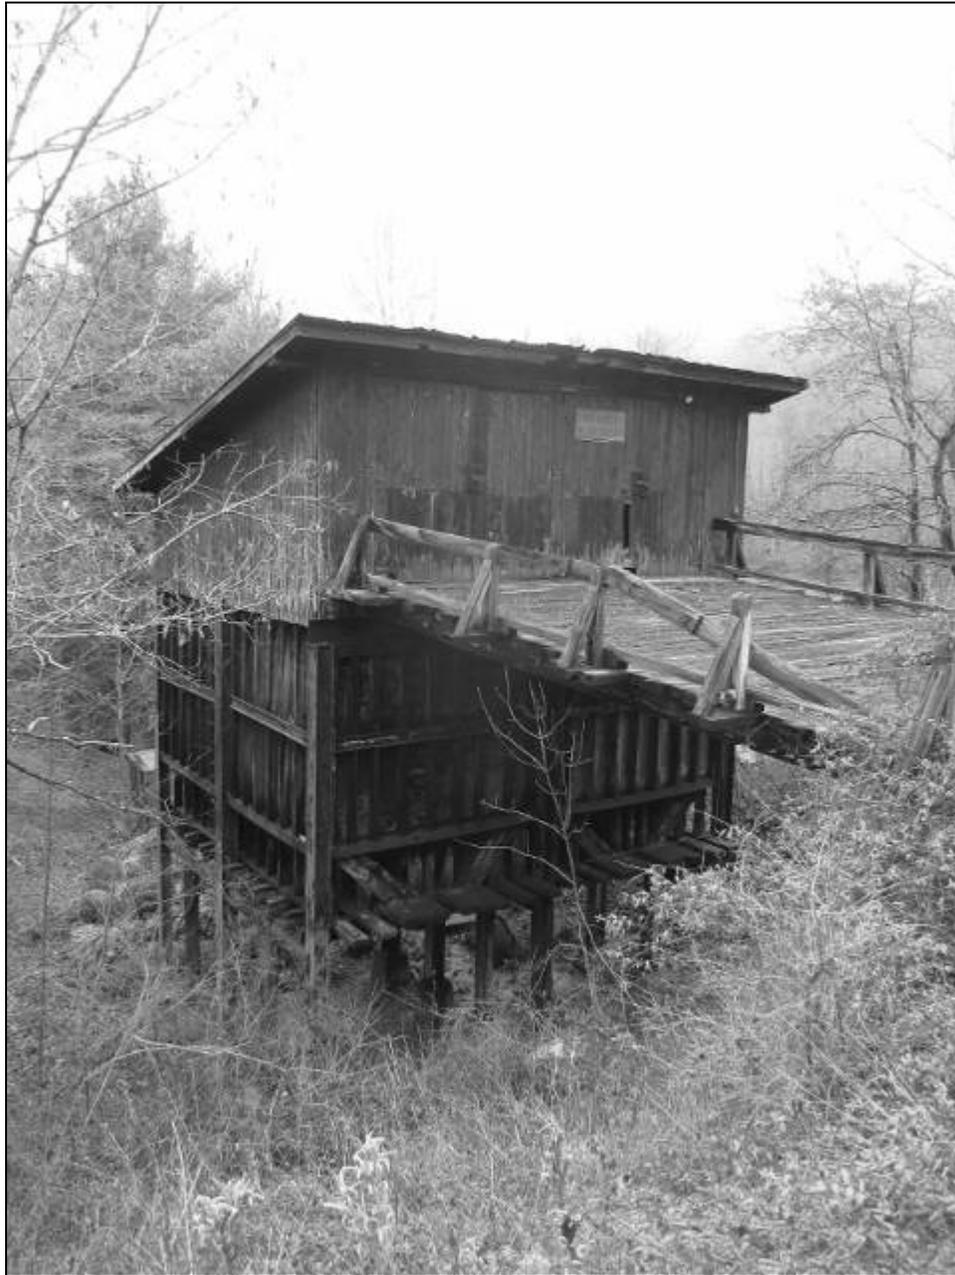
8. Slusser Coal Mine Tippel at intersection of Route 460 and Coal Bank Hollow Road.
Photo by Debra A. McClane, 2017.

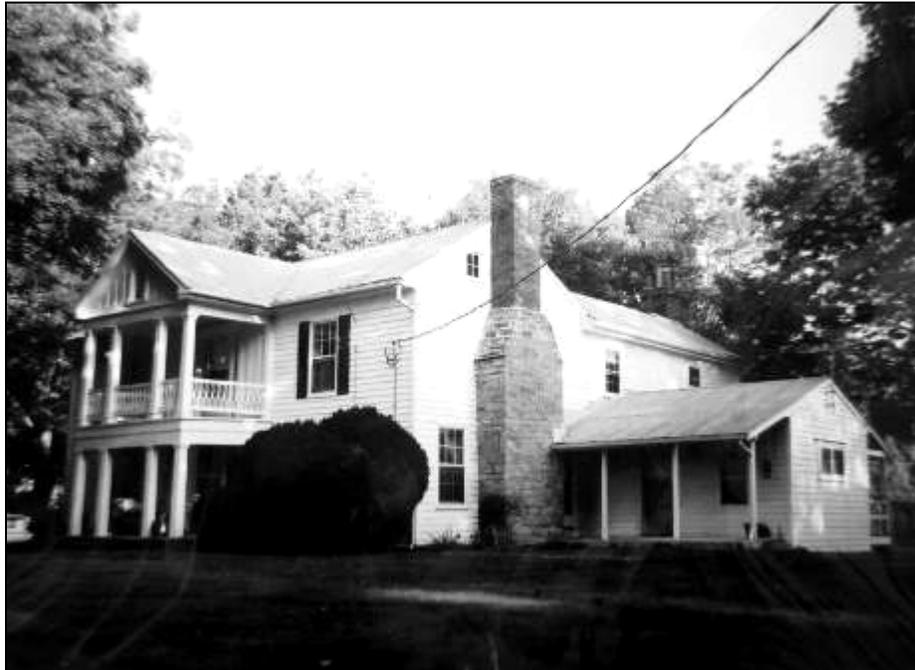
9. Slusser-Ryan House Showing Old Kitchen Wing, prior to 2011. Source: Susan Bull Ryan.

A one-story, two-bay frame kitchen wing was added to the east end of the house probably at the turn of the twentieth-century. Porches were present on the front and back of the wing, which was covered by a side-facing gable roof. In 2011, this wing was removed and replaced with a larger kitchen wing with additional living space to the north and below grade. The wide stone fireplace on the east side of the new wing was constructed in part using stone from the original kitchen foundation. The fireplace surround in the upper room was constructed exclusively from the original stone, and the fireplace below was constructed using limestone primarily collected on the farm.² A pyramidal-roofed screened-in porch was added to the northwest corner of the new wing to take advantage of the extensive views of the farm and mountains.

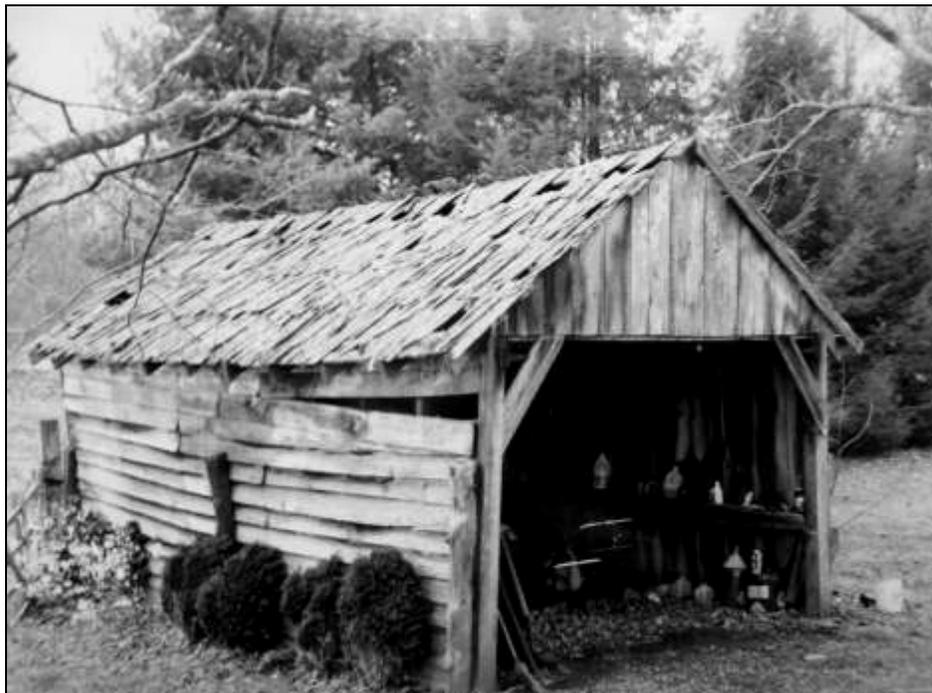
10. Early Twentieth-Century Garage Formerly Located In West Side Yard. Source: Susan Bull Ryan.

Three known resources that were on the farm but are no longer extant include a twentieth-century frame garage, formerly located west of the house. The site is denoted by a stand of boxwoods that formerly encircled the building. When the garage was removed, the driveway also was rerouted from the west side of the log building to the south side and extended to the east side of the dwelling. A detached kitchen is also said to have been located in the house yard, but exactly where it stood is not known. The current owner also stated that a tenant house was built in the early twentieth century and formerly stood on the hill behind the house.

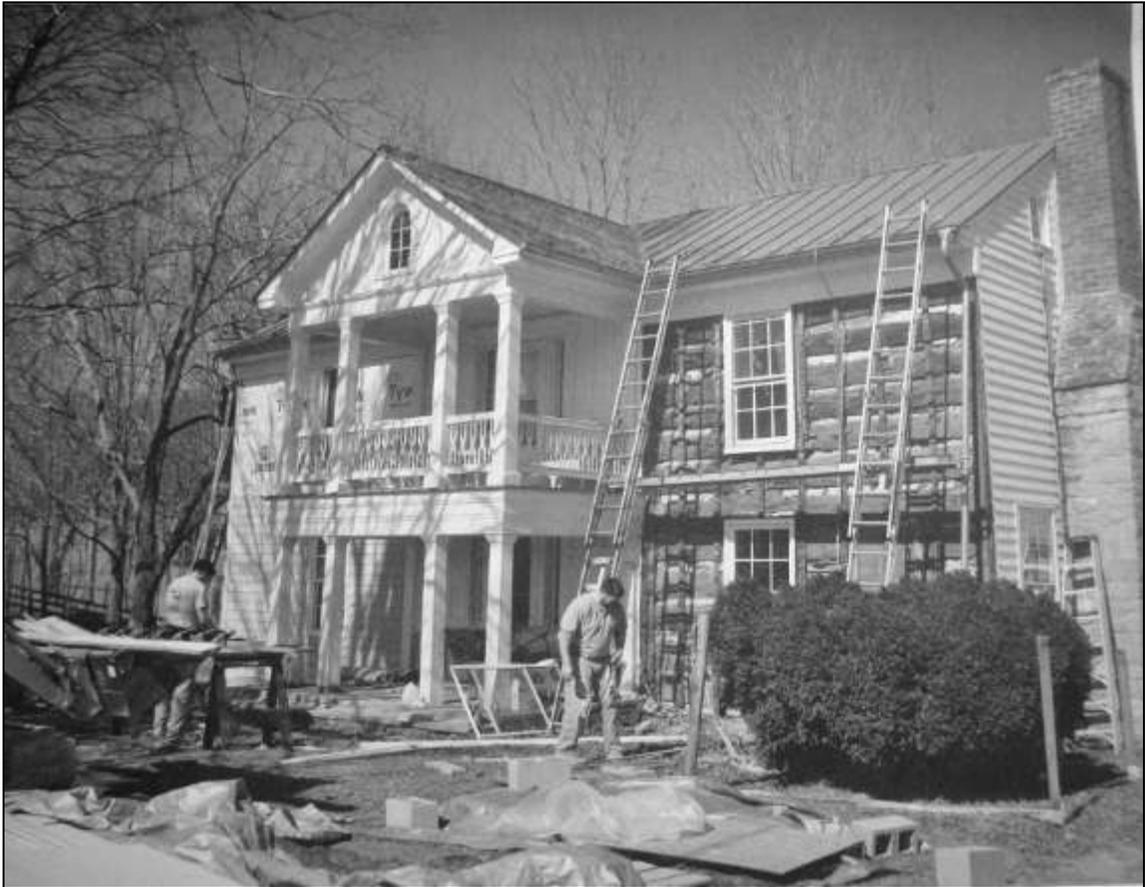
11. Slusser-Ryan House during Renovation Showing Log Construction of East Wing, Prior to 2011.
Source: Susan Bull Ryan.

In Montgomery County, log construction continued to be popular into the mid- and late-nineteenth century, due in part to the building traditions brought by the German immigrants who settled there.¹¹ The use of hewn logs secured with notched corners with the spaces between the logs filled with wood or stone chinking and daubed proved to be a more permanent . The Slusser house reflects a high level of workmanship in its log construction with its tight fitted notched corners and logs hewn both on the interior and exterior. Over the years, the daubing appears to have been replaced and resurfaced in areas, but the overall profile of the walls is intact. The Slusser house also reflects the historical practice of expanding the floor plan of the original house rather than replacing the original structure. Although log houses of the period were often one-and-a-half-story hall-parlor houses, the Slusser house appears to have been a two-story, single-pen house. The log construction is visible on the interior, but investigation of the exterior was limited to a single photograph taken during early twenty-first century renovations.

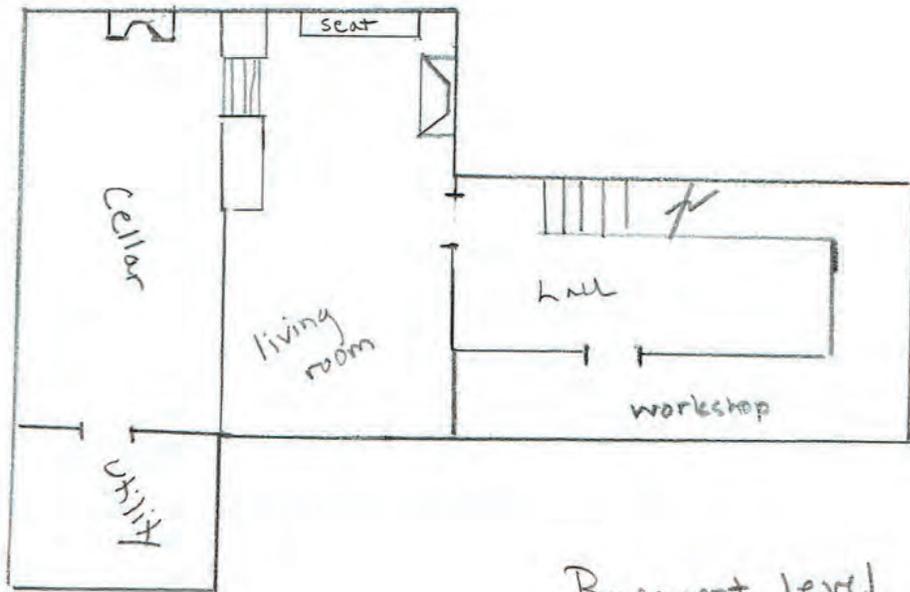
Sketch Floor Plan

Basement level
