**NATIONAL REGISTER OF HISTORIC PLACES  
REGISTRATION FORM**

historic name Sunnyside

**Sunnyside  
Lexington, VA**

**7. Summary Description:**

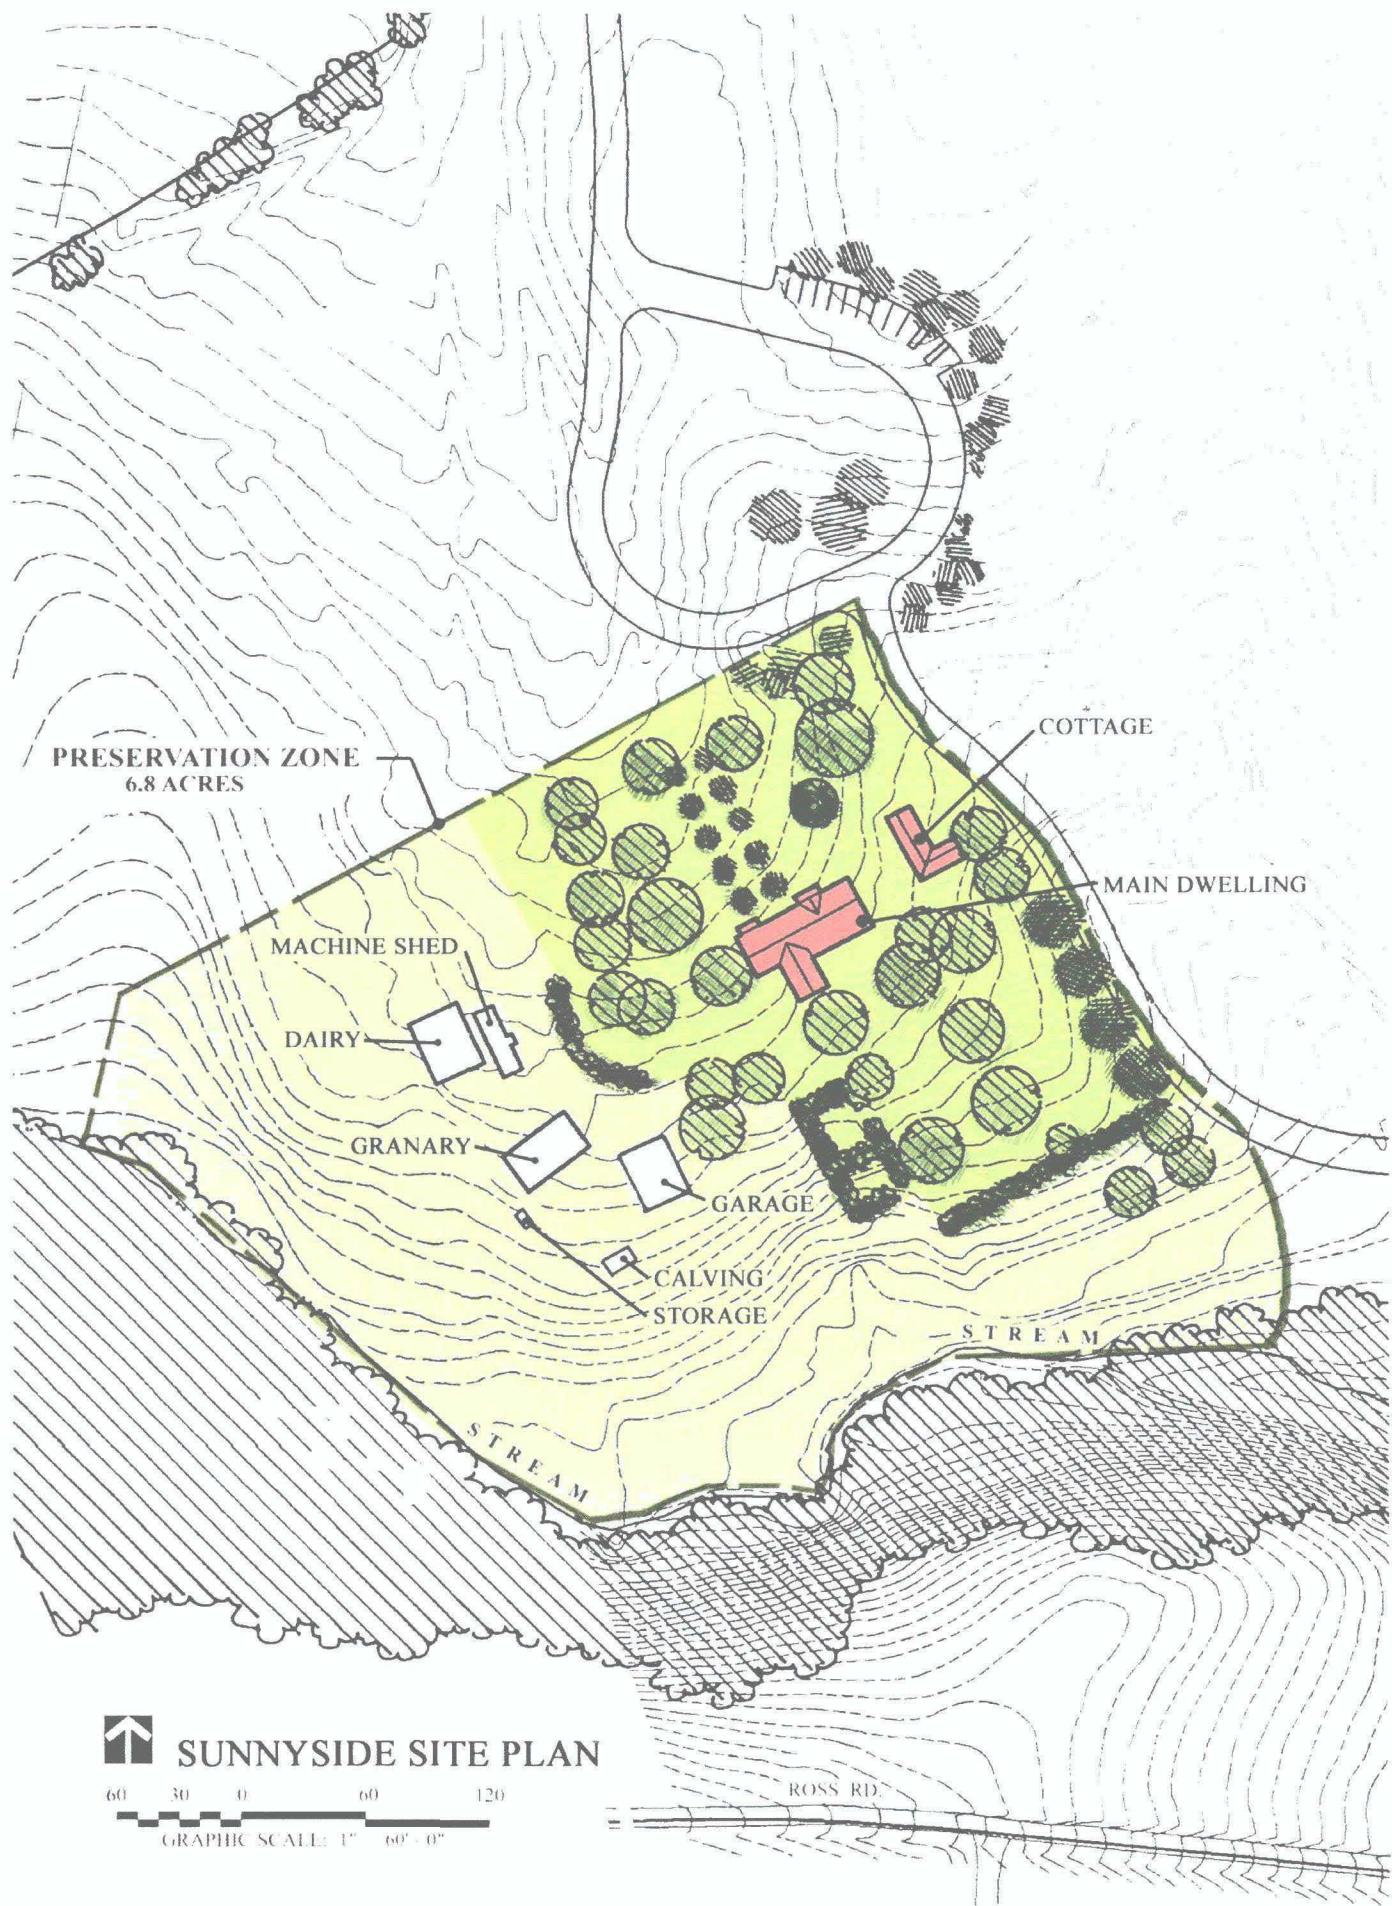
- GREEK REVIVAL REMODELING
- CA. 1791 FED. ORIGINAL
- CA. 1800 - 1805 ADDITION
- CA. 1840'S
- CA. 1860'S
- CA. 1880 - 1890 (1) VICTORIAN REMODELING & BAYS
- CA. 1880 - 1890 (2) REMODEL
- CA. 1940'S

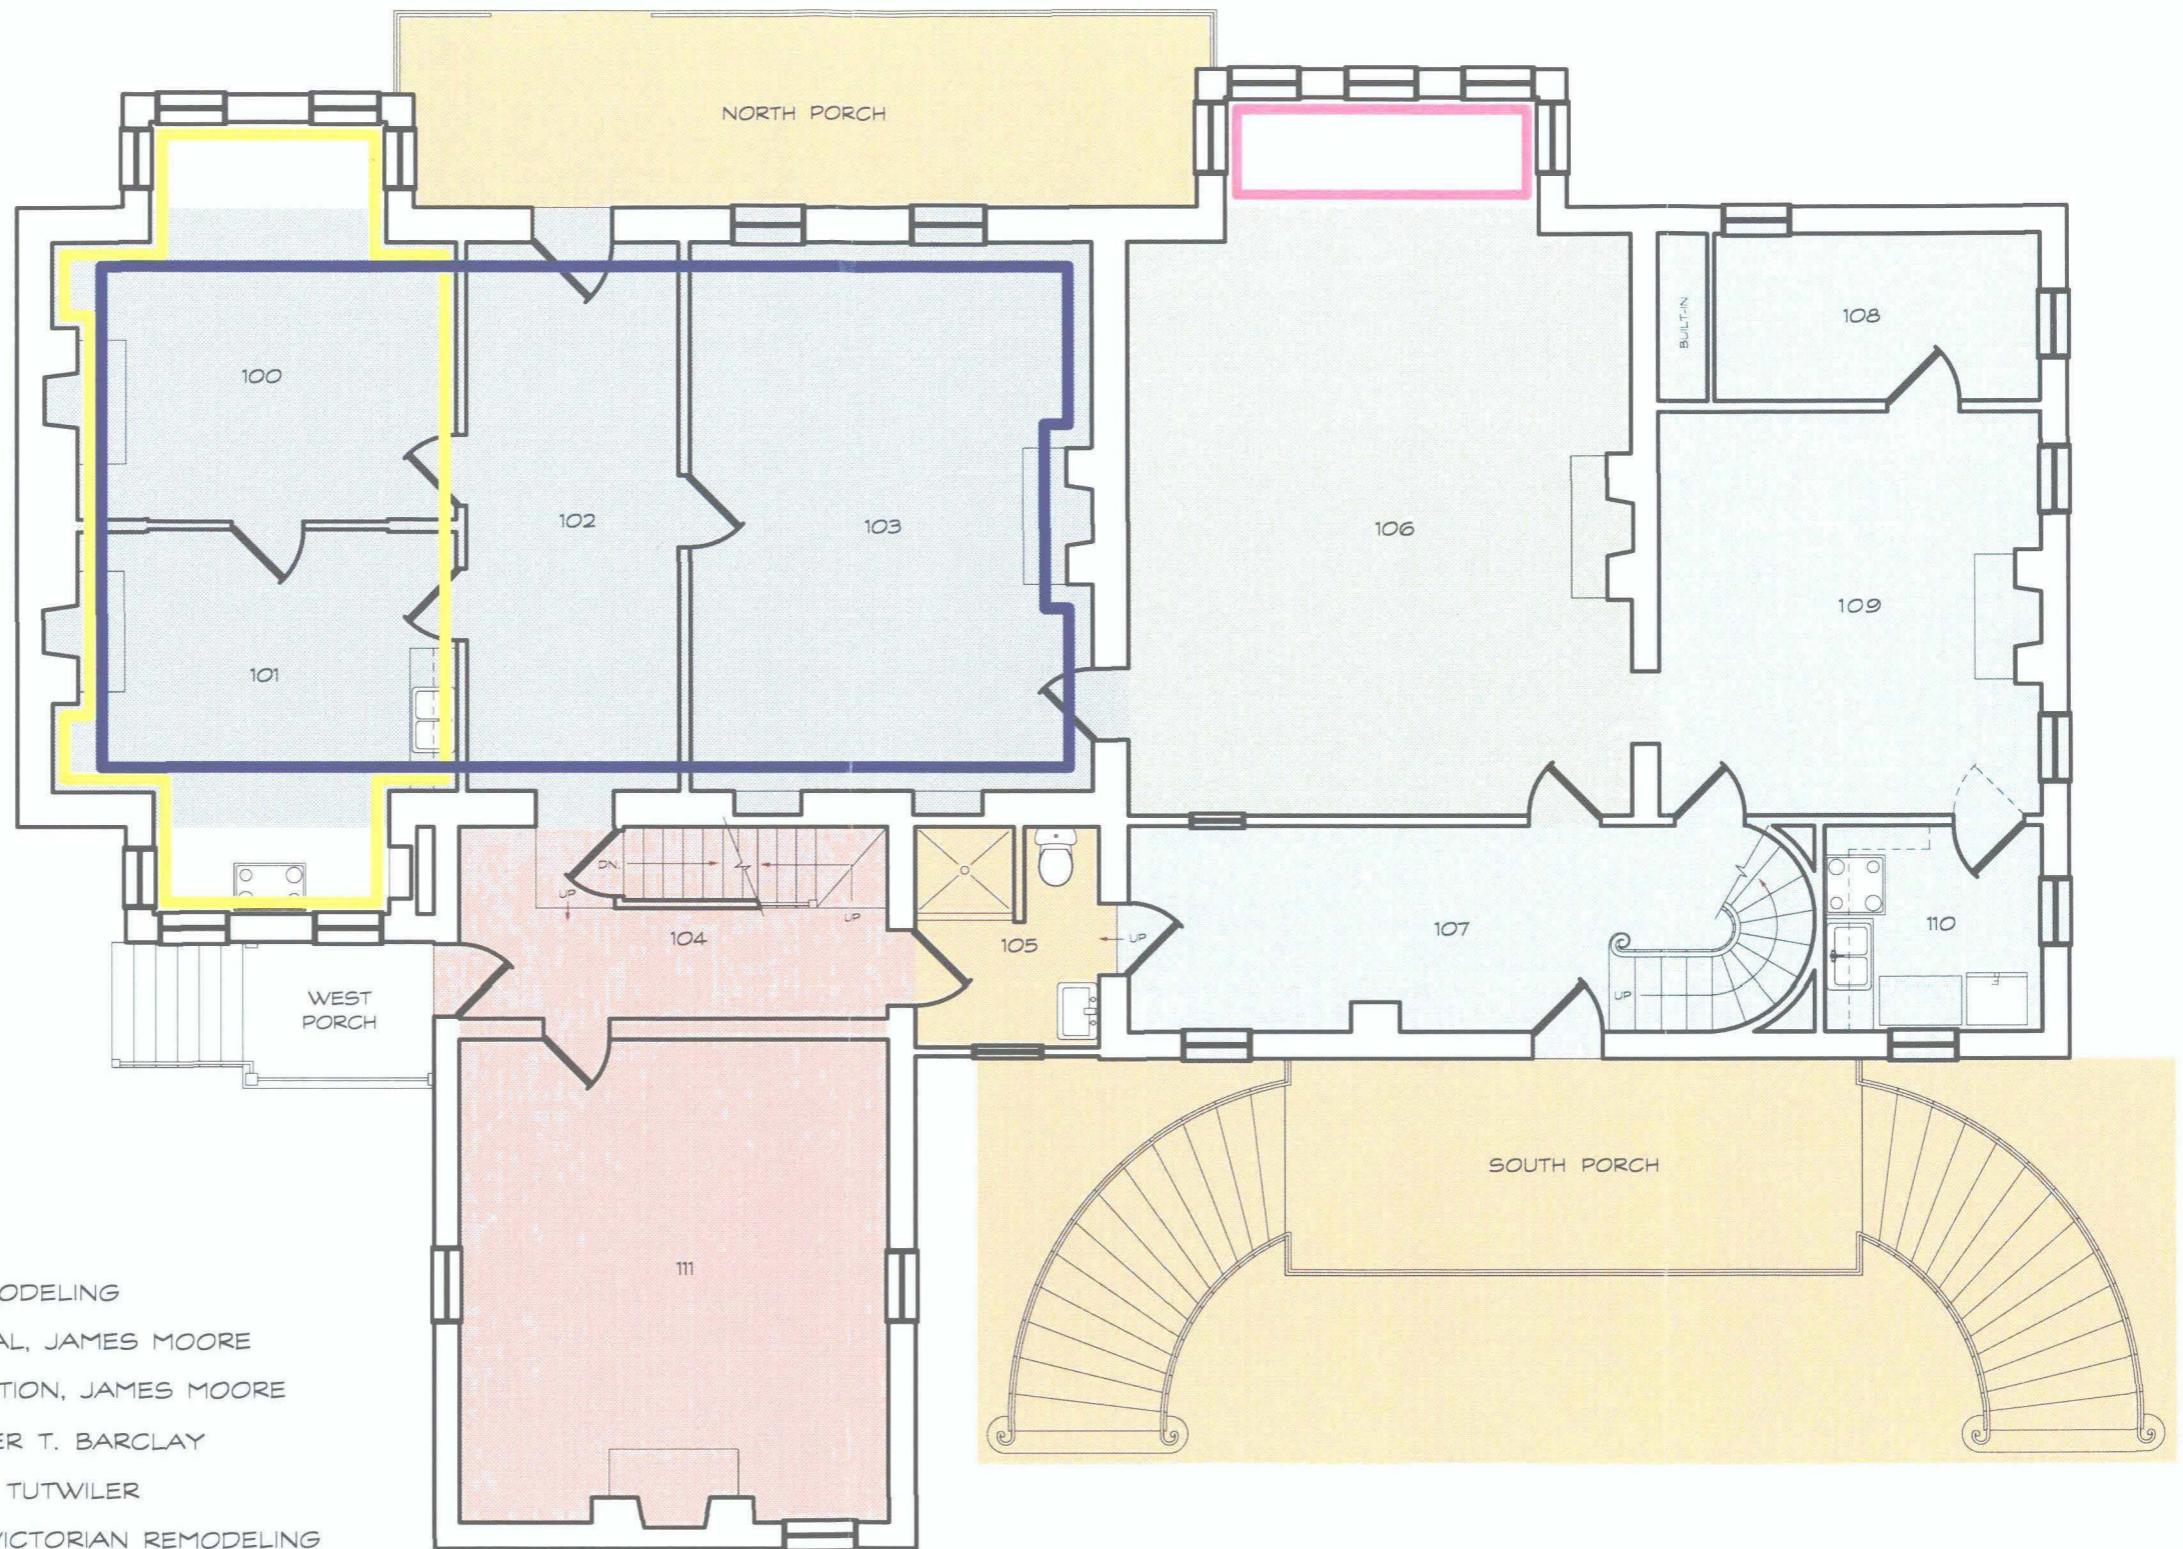
CONSTRUCTION SEQUENCE (MAIN LEVEL)

- GREEK REVIVAL REMODELING
- CA. 1791 FED. ORIGINAL, JAMES MOORE
- CA. 1800 - 1805 ADDITION, JAMES MOORE
- CA. 1840'S, ALEXANDER T. BARCLAY
- CA. 1860'S, CAPT. ELI TUTWILER
- CA. 1880 - 1890 (1) VICTORIAN REMODELING & BAYS, COL. JOHN ROSS
- CA. 1880 - 1890 (2) REMODEL, COL. JOHN ROSS
- CA. 1940'S, COL. JAMES ANDERSON
