National Register of Historic Places Registration Form

Historic name: Lynnhaven House (Additional Documentation and Boundary Decrease)

Other names/site number: Wishart-Boush House; James Wishart House; DHR #134-0037

Street & number: 4405 Wishart Road

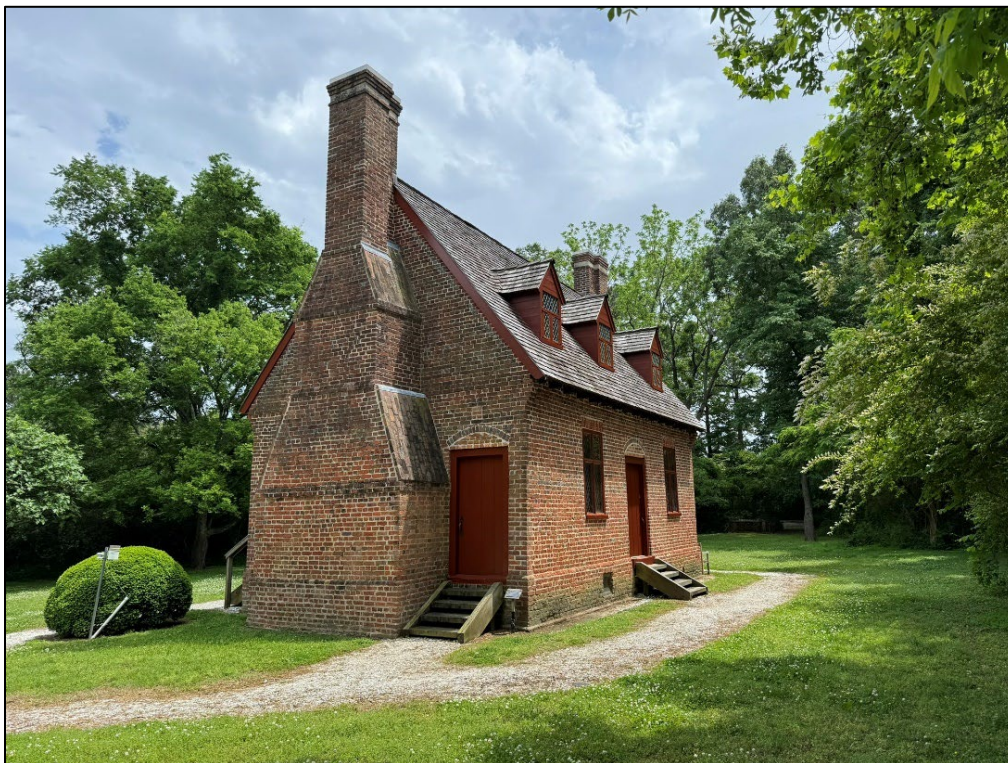
Lynnhaven House, NW oblique, May 2024. Cemetery is located in the woods at the rear of this photo.

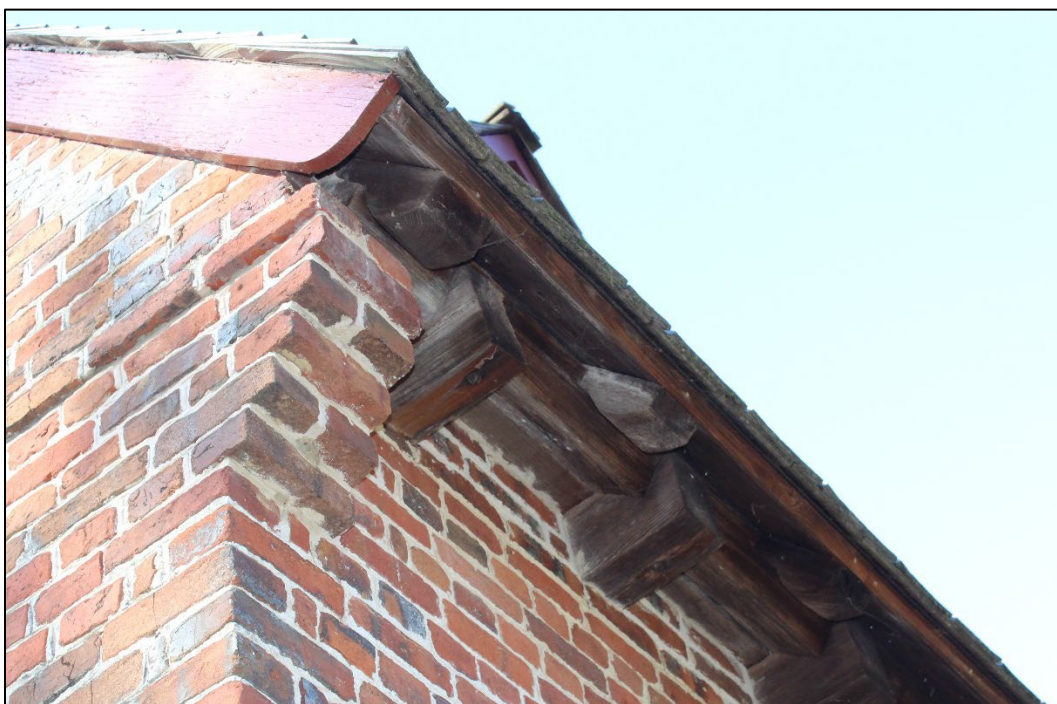
Cornice detail, SE corner, December 2023

The eaves also expose the tilted false plate roof construction. Unlike many refined Georgian houses, the cornice at the Lynnhaven House is open, or unboxed, exposing the curved ends of the rafters and the tilted false plate that they are notched over. The false plate is capped at the ends by large brick corbels that extend seamlessly from the brick walls.

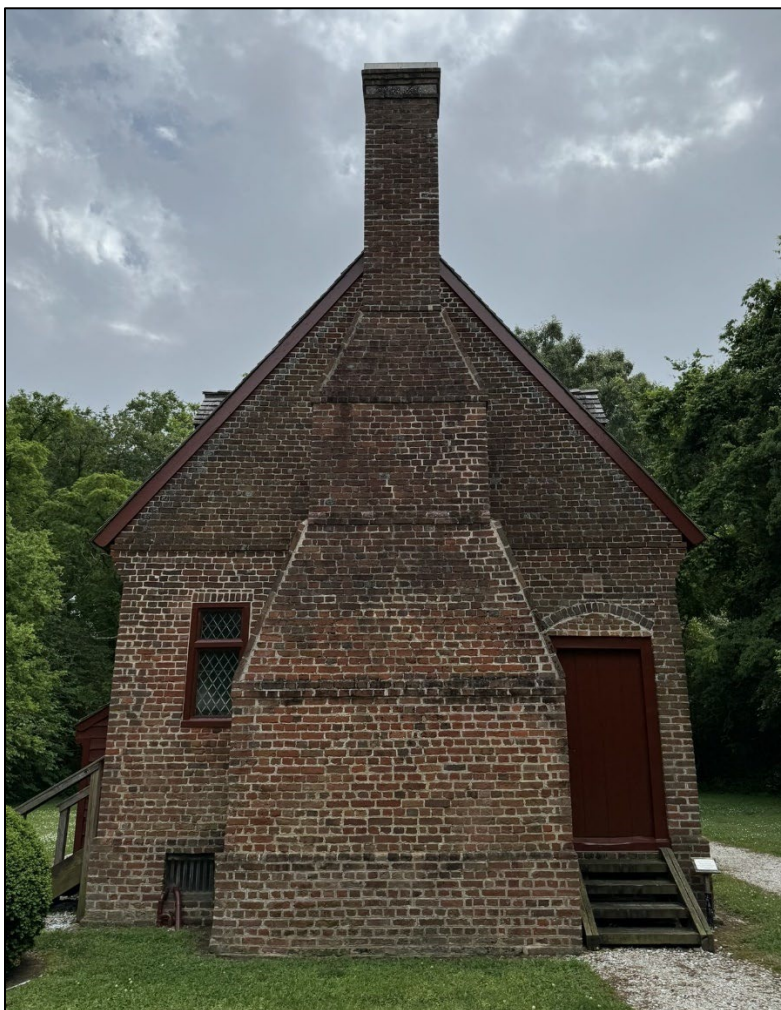
North side elevation, May 2024. Original window opening on the first story and original cellar window opening to the left of the chimney. Original doorway to the right of the chimney. Note glazed headers following the rake of the roof.

The north side elevation of the house is dominated by the massive exterior brick chimney which is centered on the wall and has two sets of weatherings. The wall is laid in English bond with closers at the corners and a stringcourse at the eaves. A band of glazed headers runs along the rake of the roof in the gable. The chimney is laid in English bond from the plinth up to the top of the second set of weatherings, where it switches to stretcher bond for the stack. There are stringcourses at the top and bottom of each set of weatherings. The tiled weatherings are largely rebuilt but old bricks were used and the detailing—bricks set flat in a vertical running bond—matches that seen in photographs from the 1920s and 1930s. The T-shaped stack is bonded into the wall, rather than being set apart, and terminates in subtle corbelling at the top. There is also a two-course section of plaster necking near the top of the chimney; the plaster was replaced by APVA but the detail appears in early photographs.

To the right (west) of the chimney is a door that appears to be an original opening. Physical evidence in the masonry, and in the lintel visible from the interior, suggest that this opening is original to the house, though this conclusion has been much debated over the years. The opening is capped with a segmental

brick arch and this, along with the door frame, sill, and leaf which matches the front door, dates to the APVA restoration. The 1934 HABS drawings of this side of the house show a jack arch with alternating glazed headers above this door. Like the front door, this one is accessed via a simple ladder-style set of wooden steps.

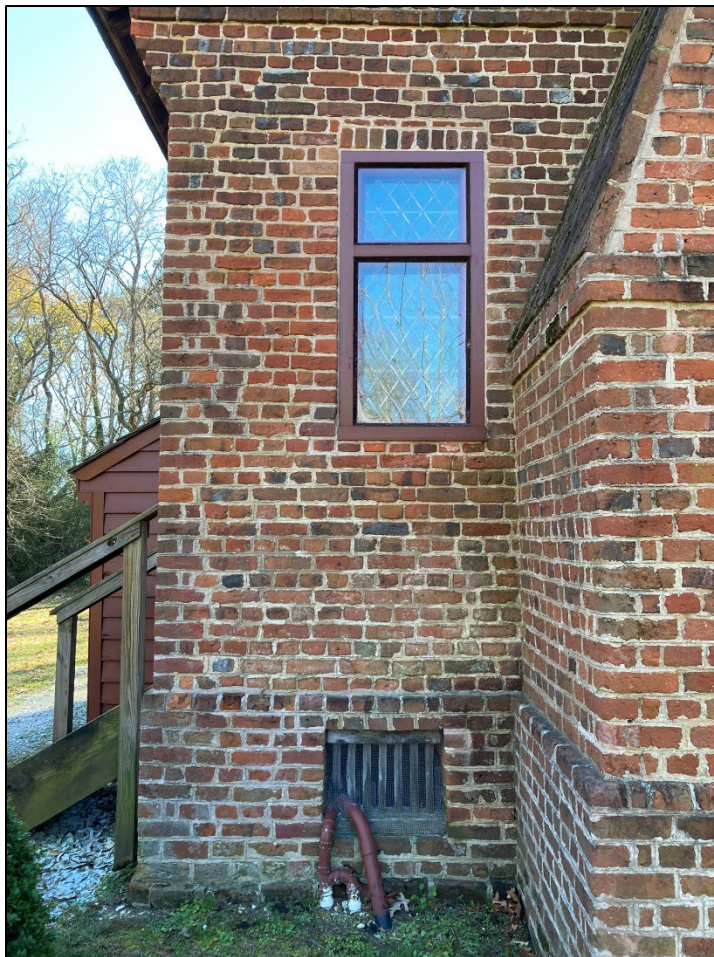
North side elevation, original sized window openings

To the left (east) of the chimney on the first story is an original window opening. The window itself matches the others in the house—a single casement with leaded, diamond-shaped panes—and dates to the APVA restoration. But unlike the other window openings, this one was not enlarged during the early 19th century and is close to its original size. It is capped with a rudimentary jack arch that was rebuilt by APVA; the HABS drawings show it with a jack arch with alternating glazed headers. There is also an original window opening in the cellar to the left of the chimney. Like the one found on the front elevation, this small window opening has a wooden sill and header and seven diamond-set vertical wooden bars. The surrounding masonry suggests that this is an original opening.

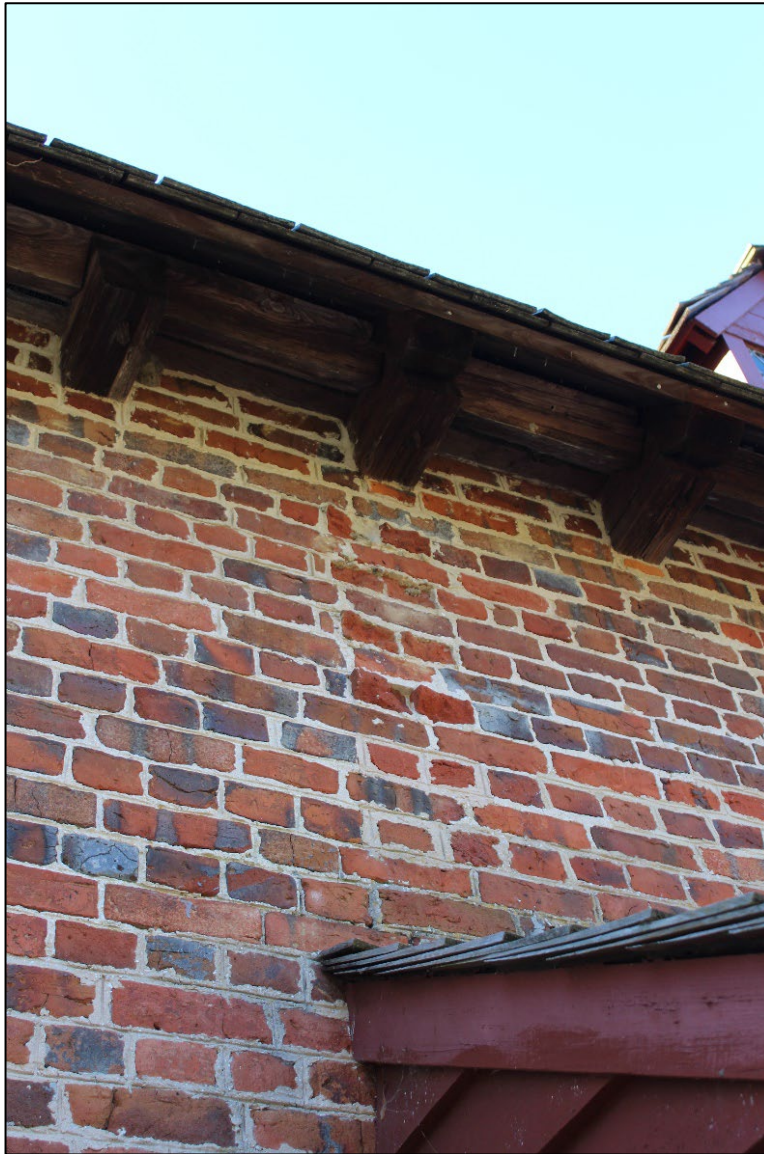
Evidence of missing rear wing. Note broken bricks in the middle of the photo. December 2023.

plinth topped by a plain, stepped water table. Like the front, it features brick corbeling at the corners of the eaves and exposed framing—joists, tilted false plate, and rafters with decorative ends—at the cornice. The most significant feature of the rear wall of the house is the surviving evidence of a now-missing rear wing. Extending up vertically from the south end of the shed-roofed bulkhead all the way to the eaves is a section of brick racking two bricks wide that shows where the now-missing wing was originally bonded into the rear wall. The north wall of the wing was located just inside the brick corbelling at the corner, and patching is evident here, though reconstruction during the APVA restoration has obscured it somewhat. HABS documented original surviving plaster on this portion of the wall between these vertical markers in the 1930s (see photo below), though only small traces remain today. Willie Graham noted that the mortar joints on the rear wall of the house are different on the northern half and the southern half. On the northern half, where the brickwork would have been covered with plaster as an interior wall, original surviving mortar joints show evidence of a simple, freehand, weathered joint, while on the southern half of the wall, which has always been exposed, surviving original mortar joints are struck (grapevine). Graham also documented a large hand-forged, wrought-iron spike in-situ in the attic above the collar beams that he believes marks where the roof of the one-story wing tied in with the roof of the main block. It is unknown when this original wing was destroyed. In the mid-20th century, another rear wing was added and appears in photographs, though it is unclear if it occupied the same footprint as the earlier wing. This later wing was removed shortly after APVA acquired the property. Archaeology has been done in the area to try to determine the original size of the wing, but it has so far been thwarted by heavy disturbance resulting from the APVA restoration and earlier use of the property.

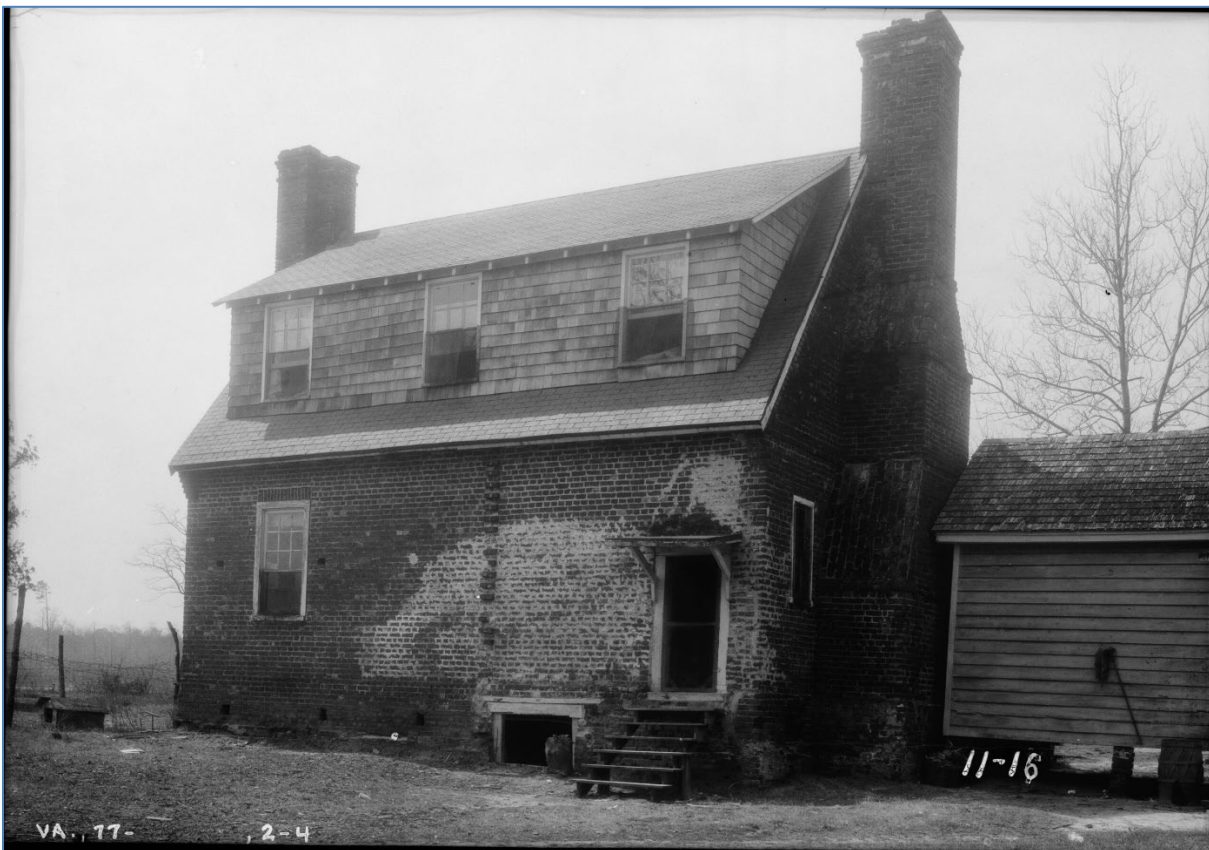
Rear elevation of Lynnhaven House, ca. 1936, showing the same brick racking illustrated by the photo above, along with surviving plaster on the rear wall. Image courtesy of HABS/Library of Congress.

The door opening that would have connected this original wing to the main house (the doorway shown in the image above and below) is now an exterior door located close to the north corner of the house. The masonry around this opening was extensively reworked during the APVA restoration, but the door frame appears to date to the early 19th century. The board and batten door leaf was designed by APVA to match the other exterior doors that they installed in the 1970s. The opening is now capped by a segmental brick arch that was constructed by APVA; the HABS drawings show a simple wood lintel over the door. Today, the door is accessed by a simple set of wooden ladder-style stairs, matching those found on the front and side of the house.

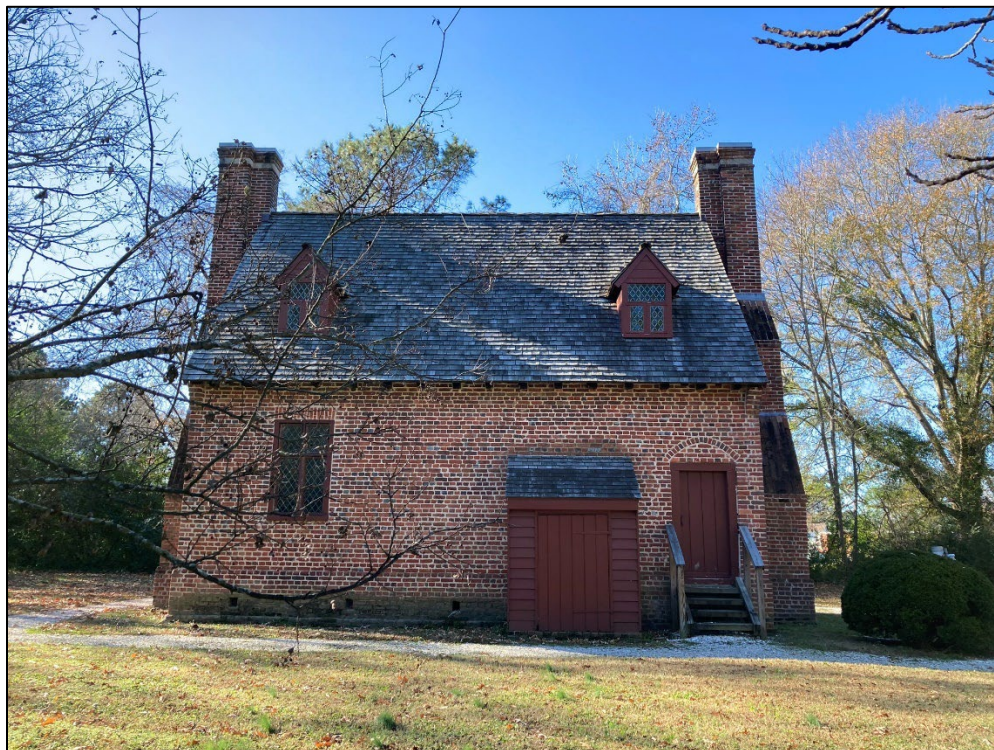
Rear elevation, December 2023.

Just to the left (south) of the first story door, is the shed-roofed frame bulkhead that shelters the original cellar door. The frame enclosure has weatherboard siding and a wood shingled shed roof and a wide board and batten door and is entirely modern, though it was intended to look older. Its construction by APVA was for the purely utilitarian purpose of providing shelter and protection to the cellar door; they knew that the enclosure did not have any historical precedent. The cellar doorway below is an original opening, though the surrounding brickwork was reworked by APVA. It is unclear at this time how access to the cellar worked originally. It would have been beneath the original wing, so perhaps an interior stair from the rear room led down to the cellar.

There are two dormers on the rear slope of the roof. Like those on the front, these are gabled dormers with weatherboard siding on the cheeks and in the gable and the windows are the casement design dating to the 1970s restoration. These dormers are also reconstructions; when APVA acquired the property long shed dormers covered the front and rear slopes of the roof. APVA supposedly used physical evidence to reconstruct the dormers, but the Historic Structures Report by Graham and others suggests that the reconstructed dormers are improperly sized. Graham noticed that historic photographs (undated, but pre-1933) illustrate that the dormers on the rear slope of the roof were taller than those found on the front slope of the roof, with a shallower roof pitch. These differences suggest that the dormers were built at different times, which makes sense considering that the north dormer on the rear slope of the roof could

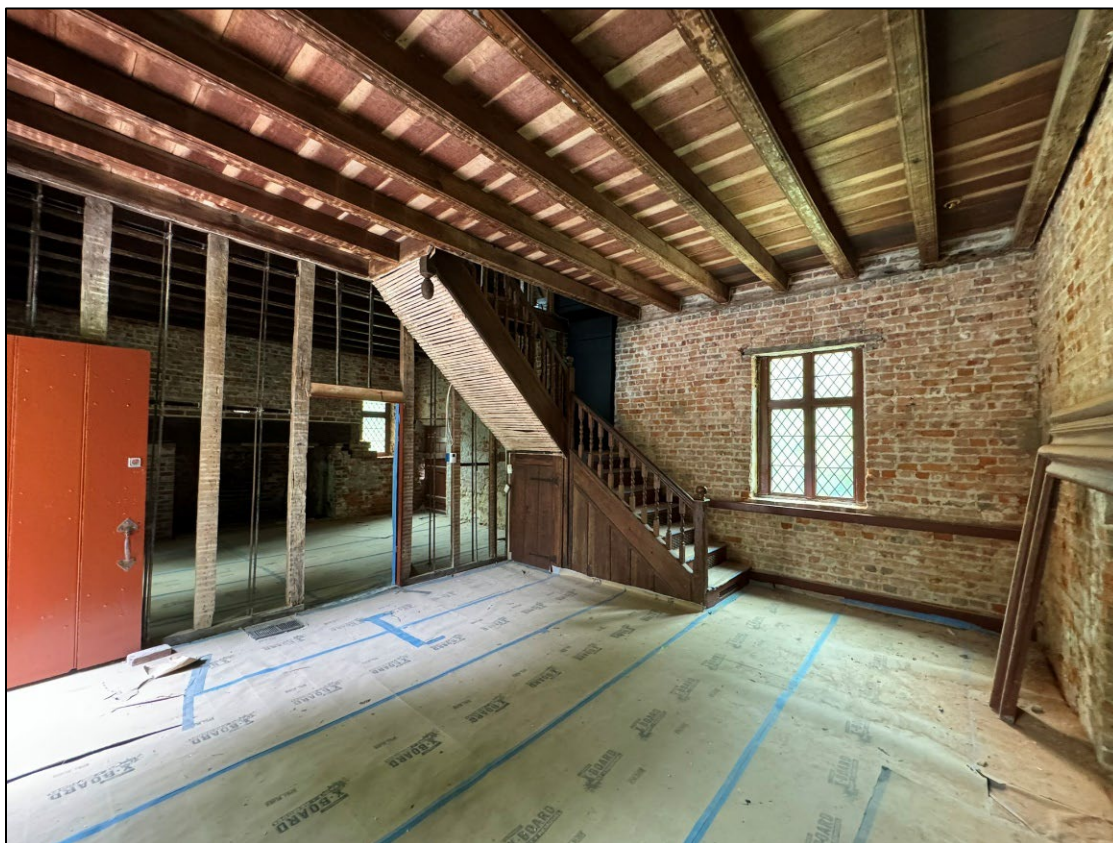
Hall. Front entrance is the open door leaf seen on the left. May 2024.

The front door opens into the hall, the larger of the two first floor rooms. The hall has wide, random width floorboards (covered; replaced by APVA) and currently has exposed brick on the south, east, and west walls and a wooden stud wall partitioning it from the parlor/dining room. There is a simple beaded baseboard on the east and west walls of the room and part of the south wall; this dates to the APVA restoration and architectural historians have found no evidence for a baseboard before ca. 1820. There is also a simple chair rail with a bead on both the top and bottom edges on the east and west walls and part of the south wall. Like the baseboards, it dates to the APVA restoration and there is no evidence for a chair rail prior to 1820. At the time of the 2018 HSR, there was a fragment of 19th century chair rail to the left of the fireplace that Graham thought could have possibly been the only surviving evidence of an early 19th century renovation of the house, though it was unclear where in the house it had been located prior to the APVA restoration. That piece of chair rail is no longer in place on the wall, but it is currently stored inside the hall firebox with other trim pieces and it is labeled. There is currently no door or window trim around any of the openings; it is believed that most of the door and window trim that was removed in the last several years dated to the 1970s APVA restoration.

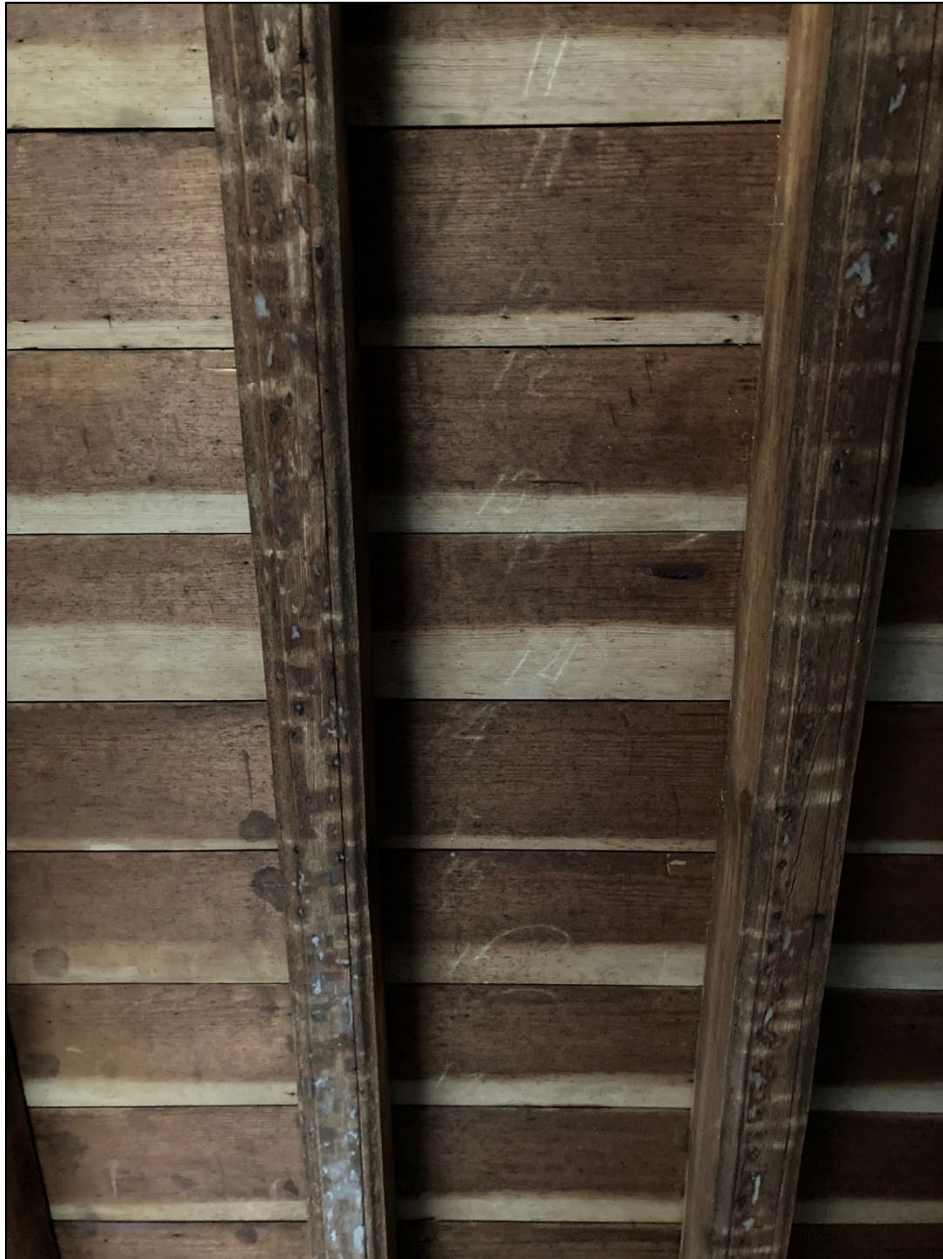
Hall, ceiling detail, exposed joists and numbered floorboards. December 2023.

Regardless, the most important and character-defining elements of the hall do remain in remarkably original condition—the ceiling, the stair, and the fireplace. An 18th century mantel, believed to be the one originally located in the parlor/dining room, is also currently leaning up against the fireplace in the hall. The ceiling of the hall is characterized by exposed framing that was meant to be seen. Hand-planed joists span the room and are molded on their bottom corners with ogee detailing that extends the full depth of the room. The bottom of the floorboards above, which were meant to be exposed, are also hand-planed and are not gauged or undercut, meaning the carpenter hand finished each board to fit exactly before setting it in place. In doing so, he numbered the bottoms of the boards with chalk with Arabic numerals (and not the more common Roman numerals) so that matching edges had the same number. These chalk marks are still visible in one location 300 years later. There is also the faint ghost of an inscribed date – “August th5 1754” (or 1734?) – on the side of one of the joists near the stair. The significance of this date is unknown.

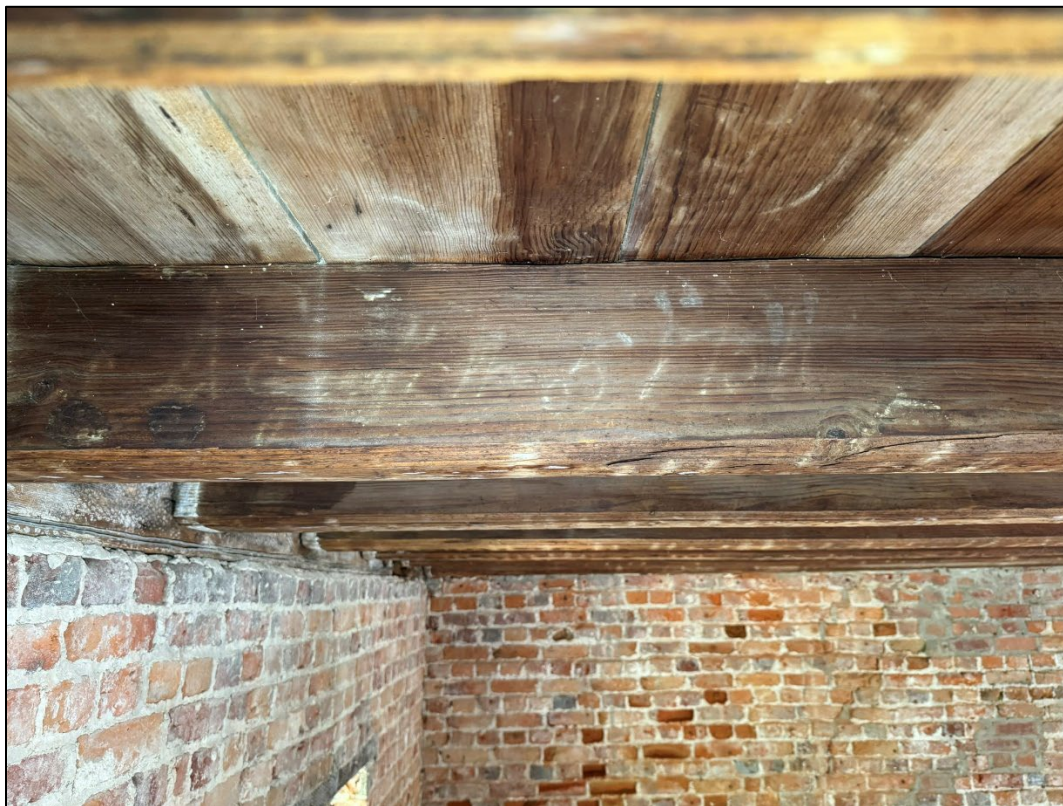
Hall, ceiling detail, "August 1754" [or 1734?].

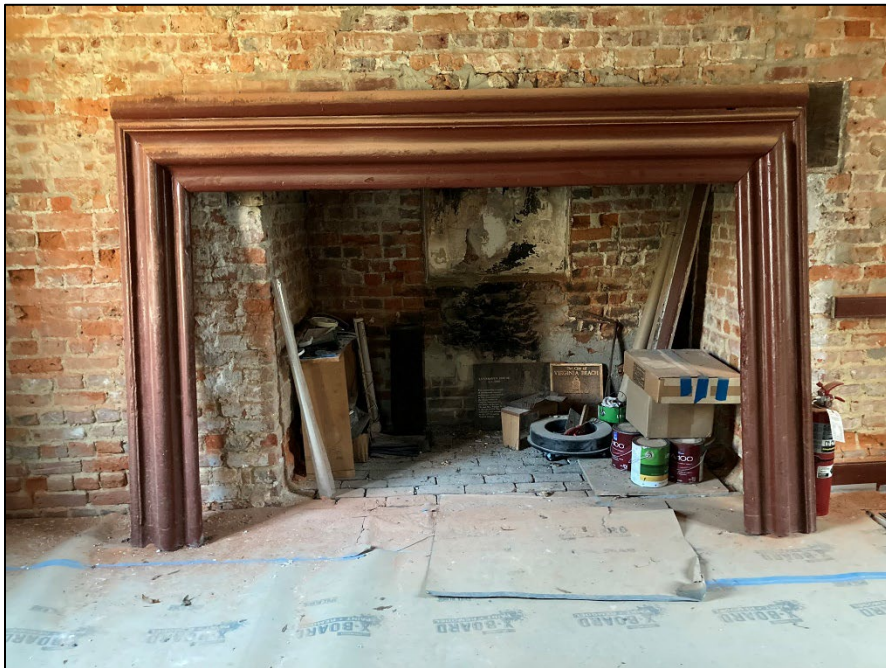
Hall, fireplace, December 2023.

The fireplace in the hall is original and was an important element of the 18th century space for its promise of hospitality, an increasingly important concept in the early 18th century. Although the original mantel has been missing for nearly 100 years (the 1934 HABS drawings note a “new” mantel in this space), the lintel is the original massive hewn beam, chamfered on the backside to facilitate smoke uptake, and the firebox has been restored to its original size: 6’11” wide by 3’6” deep by 4’7 ½” tall. It is slightly smaller than the firebox in the parlor, which is surprising, and supports the theories about shifting room use in the early 18th century. Current thinking suggests that the mantel currently leaning up against the hall fireplace was actually originally located in the parlor (Narvaez and Stoll, 60). Photos suggest that it was in the parlor when APVA acquired the house and the HABS drawings document it in that room as well. The mantel is an early 18th century design with mitered sidepieces molded with a complex bolection profile, while the horizontal member has a pulvinated molding.

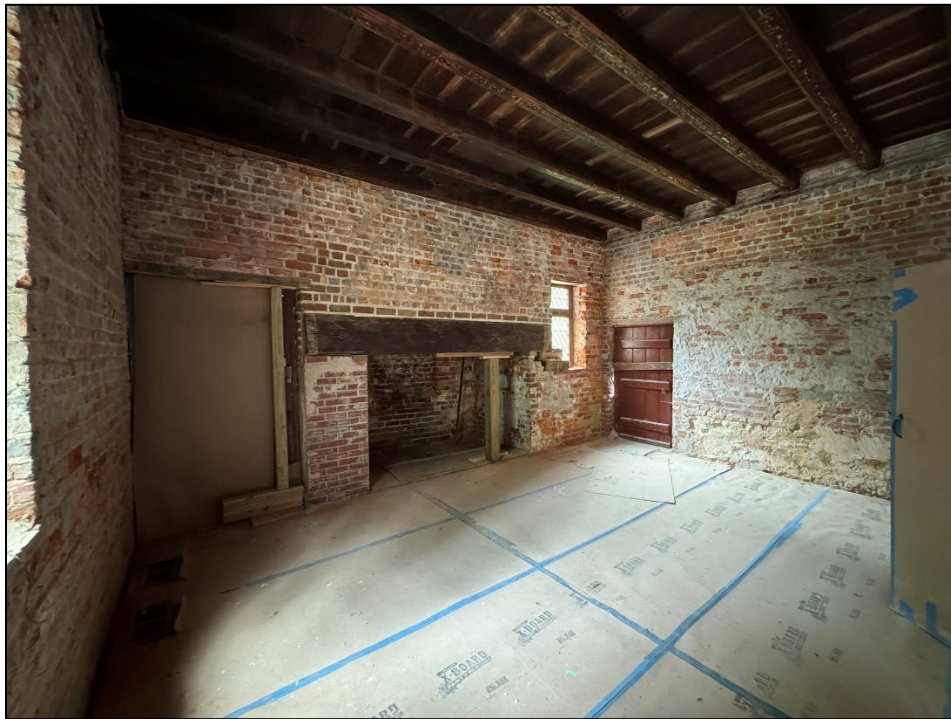
Parlor/dining room, May 2024. The doorway that originally led outside, to the north yard, is on the left beside the fireplace, while the doorway that originally connected to the rear chamber is in the center of the photo.

The parlor/dining room is a slightly smaller room than the hall with two exterior doors, one on the rear (east) elevation and one on the north end beside the fireplace. The rear door opening, which is original with a hewn lintel set in the surrounding brickwork, would have initially been an interior door that opened into the rear chamber in the now-missing rear wing. The north door opening, also original with a hewn lintel set in bed molding, was an original exterior door, suggesting that the service yard, and possibly a detached kitchen, was located to the north of the main house.

Like the hall, the ceiling in this room features exposed, molded ceiling joists. There is no evidence that the room originally had chair rail or baseboards and there are none present today. There is no window or door trim in this room either. Also like the hall, the removal of the 1970s plaster has revealed the brickwork on the north, east, and west walls. All are laid in English bond on the inside and the rear (east) wall has remnants of original plaster.

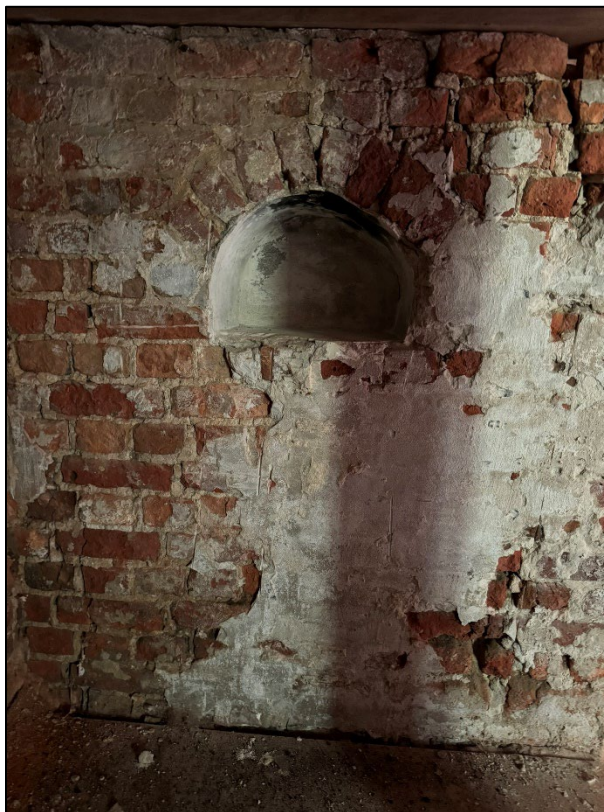
Parlor/dining room fireplace, warming niche on the east wall of the firebox. May 2024.

The fireplace in the parlor/dining room was originally larger than the one found in the hall, though it had been reduced in size by the time APVA acquired the property. The masonry of this fireplace required more reconstruction than the one in the hall, but it has been restored to close to its original size. During the removal of filler bricks, APVA discovered warming niches on both side walls of the firebox; the one on the west wall had to be completely reconstructed but the one on the east wall appears to be original. The large hewn lintel over the fireplace had to be replaced in recent years due to severe termite damage, but the front face of the original beam was removed and affixed to the new structural beam so that the appearance is unchanged.

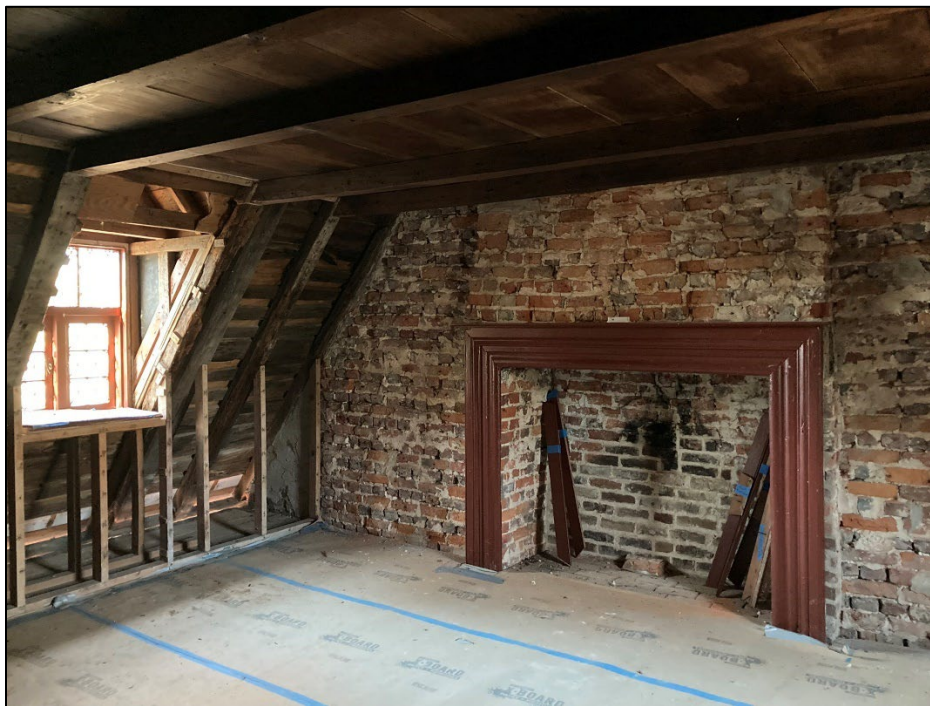
Second floor, parlor chamber. May 2024.

Each room has an original fireplace and mantel, though the fireboxes are slightly different sizes. The firebox in the hall chamber is the smaller of the two (which aligns with the hall firebox being smaller than the parlor/dining room one); it is 3' 8 1/2" wide by 3' 7 1/4" tall and 1' 2" deep and is flush with the interior of the gable, rather than projecting into the room. The original mantel consists of three molded boards with a large bolection profile near the inside edge and a backband with a beaded edge and a quirked cyma. The parlor/dining room chamber has a mantel with identical moldings, but it is slightly larger to fit the larger firebox, which measures 5' wide by 3' 10 1/2" tall by 1' 9" deep. This firebox also projects into the room slightly, about 4 1/2". Like the first floor, there is no trim on the second floor—no chair rail or baseboards, no window or door trim—and evidence suggests that the space did not originally have chair rails or baseboards (Narvaez and Stoll, 78). Like the second-floor partition walls, the two doors into each chamber date to the APVA restoration. Both are board-and-batten doors, similar to the style used elsewhere in the house, hung on reproduction hinges on plain, unbeaded door jambs.

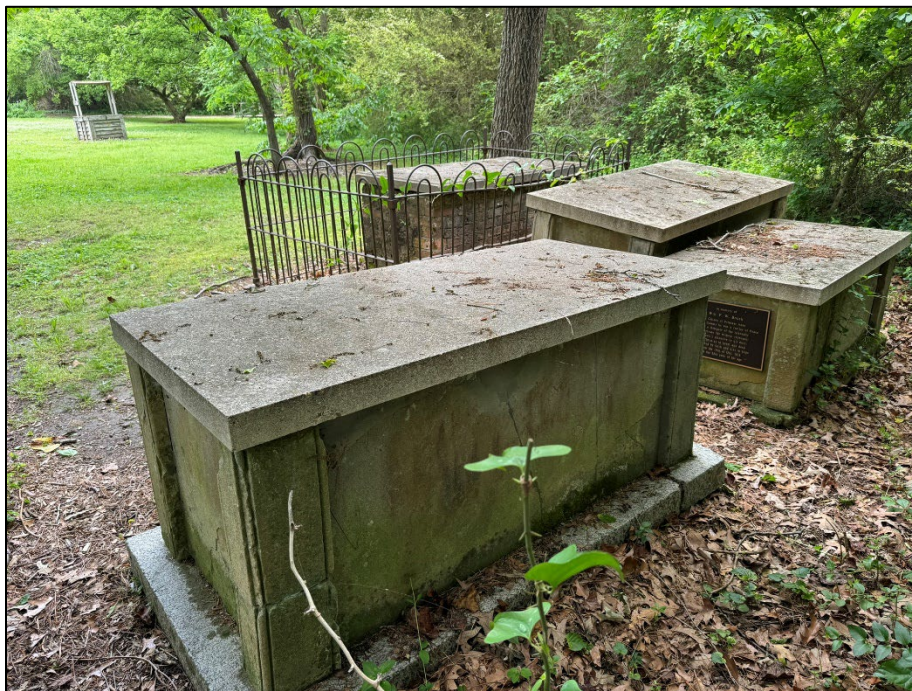
Cemetery, looking northeast. Lynnhaven House is just out of frame to the left. May 2024.

The cemetery is located to the south of the house, at the edge of the treeline that separates the house from the newer retention pond on an adjacent parcel. There is no wall, fence, or any other type of enclosure around the cemetery; instead, it consists of four marked graves located very close together in a cluster, all oriented east-west. The overgrown vegetation in the surrounding trees is threatening, but the City keeps the cemetery mowed. There are four box tombs, three have sandstone walls and one is brick construction. All have replacement cast stone slabs taking the place of the very deteriorated original ledger stones, except for the brick tomb belonging to Eliza Walke which retains its original ledger stone. Interred here are William Boush (1759-1834), Mary Boush, his wife (1764-1822), William F.M. Boush, their son, (1793(?)–1818), and Eliza J.S. Walke (1802(?)–1884), daughter of William and Mary Boush.

When APVA acquired the property in the early 1970s, the cemetery was in an advanced state of disrepair. Repeated acts of vandalism had broken all of the tombs and scattered the pieces around the property; the cemetery was badly overgrown. In 1975, APVA restored the cemetery and repaired and reconstructed the tombs. The original ledger stones may have been reinstalled at that point and removed later, but they were certainly replaced for their own protection in 1991 with the existing cast stone slabs. At that time, brass plaques with transcriptions of the inscriptions from the original stones were installed on the sides of the box tombs. The original ledger stones are in fragmentary condition and are stored in a City-owned offsite secure storage facility. The only brick tomb, belonging to Eliza J.S. Walke, is surrounded by a wrought iron fence. It is a bow and hairpin style fence with two rails and corner posts set on granite blocks. The fence looks today much as it did in photographs from 1975 and is the most original feature in the cemetery. In addition to the four marked graves, archaeology in 1983 discovered four additional burials in subterranean brick vaults and another possible burial not enclosed in a brick vault, all located to the north of the marked graves, closer to the main house. That same investigation located a section of brick wall to the south of the marked graves but did not chase the wall to see where it led. The area covered by known burials, including the marked graves and those located during the 1980s archaeological dig, measures approximately 60 feet north-south by 35 feet east-west. In 2013, the Chicora Foundation prepared a Preservation Assessment of the cemetery for the City and noted a brick pile approximately three feet east of Eliza Walke's grave that they believed marked the remnants of another burial. This pile was only about a foot high in 2013 and is not easily visible today. No additional archaeology has been done since 1983 in the area of the cemetery, nor has ground penetrating radar been used to try to determine the boundaries. It must be assumed that the archaeological potential of this portion of the property is high, as is the likelihood of finding additional graves.

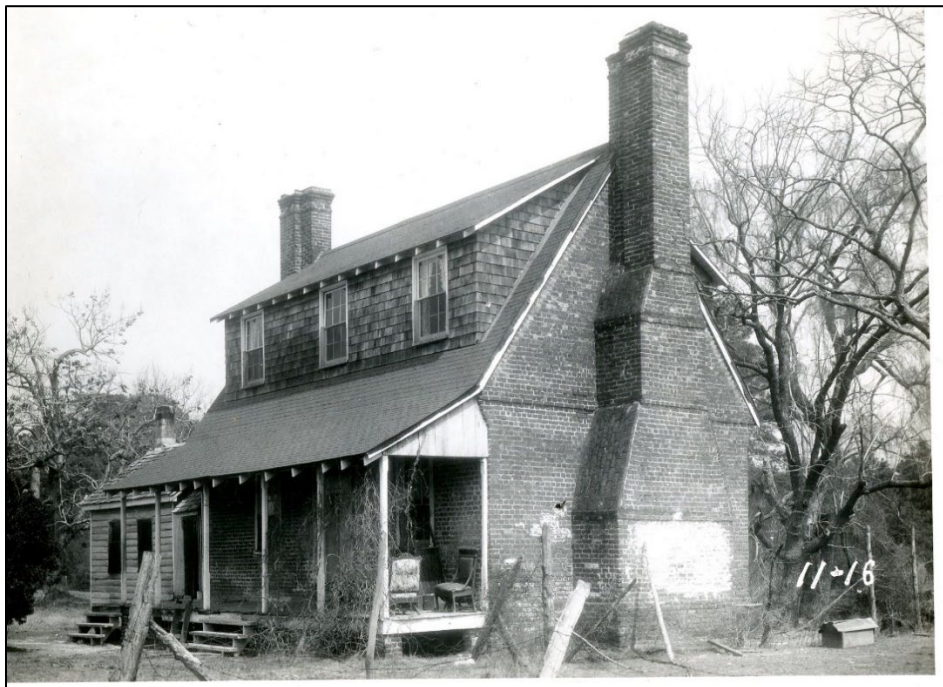
Architectural research team examining Lynnhaven House, Virginia Beach, Virginia, in 1933. Note the barn on the far left of the image. Image courtesy of Visual Resources, John D. Rockefeller Jr. Library, The Colonial Williamsburg Foundation.

Architectural research team examining Lynnhaven House, Virginia Beach, Virginia, in 1933. Image number AUN 182. Visual Resources, John D. Rockefeller Jr. Library, The Colonial Williamsburg Foundation.

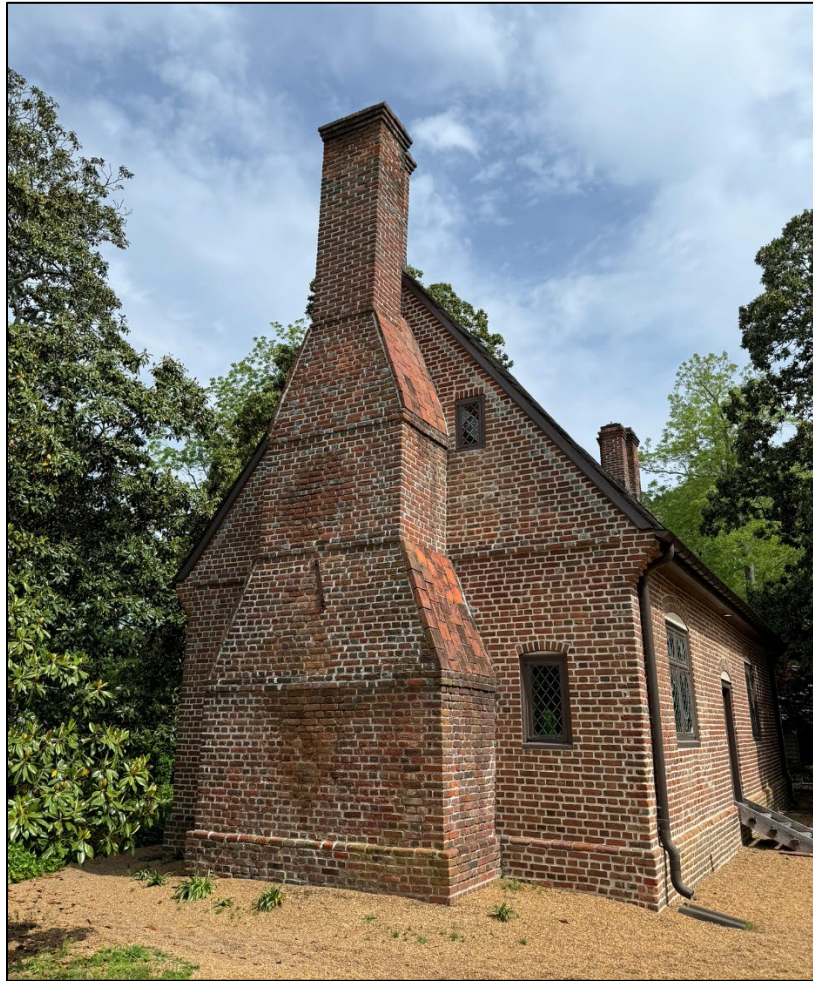
Thoroughgood House, Virginia Beach, Virginia, May 2024. Compare the chimney, the brick corbels at the corners, and the glazed headers following the rake with Lynnhaven.

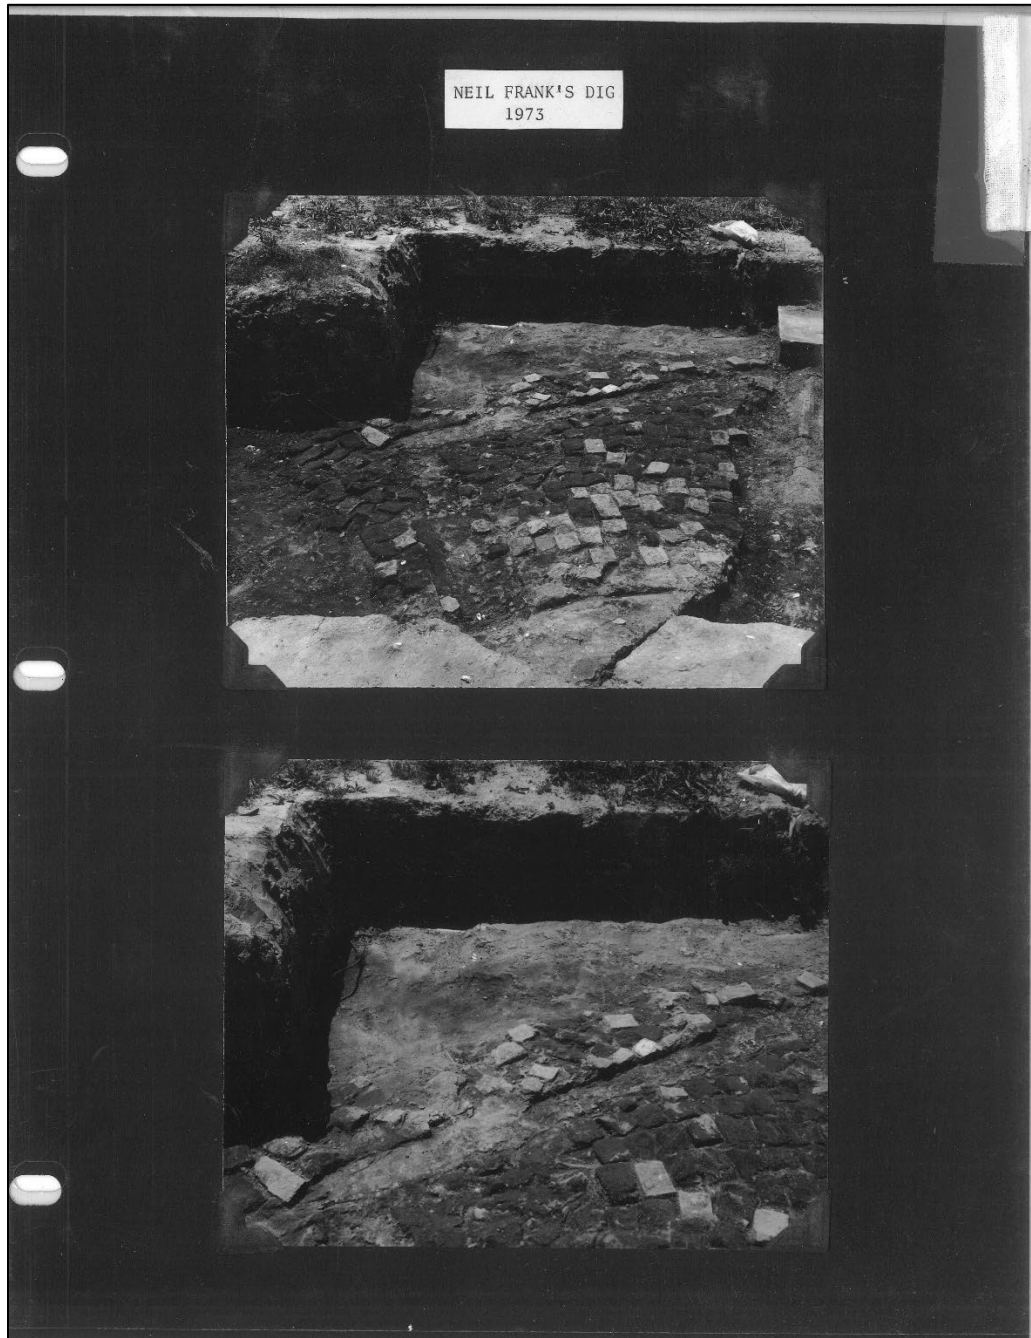
Images of Neil Frank's archaeological investigations from 1973. There is very little information about this dig beyond a few intriguing images and a map showing the locations of test units. Image courtesy of the Virginia Beach History Museums.
