CHARLOTTESVILLE DOWNTOWN MALL FINAL SURVEY REPORT

200 Block West Main St. to 600 Block East Main St.
Charlottesville, Virginia

May 4, 2022

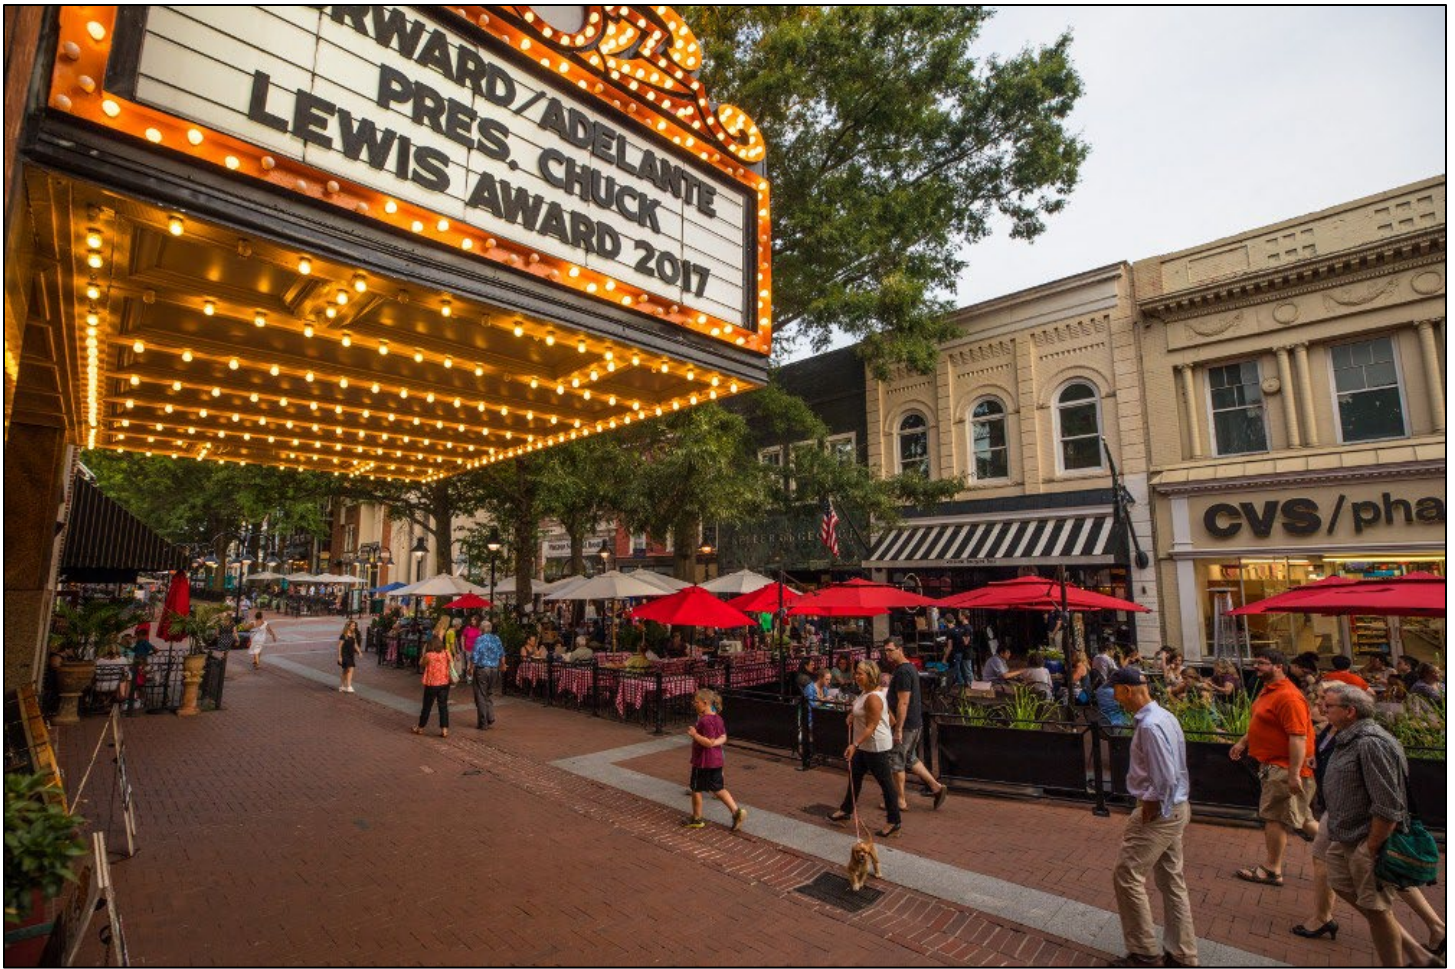
In addition to its business community adapting commercially to the opportunities the Charlottesville Downtown Mall offered, city officials also continued to make improvements and adjust their approach. When development of the Vinegar Hill urban renewal area failed to attract the multi-use environment that LHA had envisioned (including hotel accommodations), the city provided financing for the construction of a large luxury hotel and parking deck on the site, which opened in 1985. Also not immediately successful, the hotel was initially managed as a Radisson Hotel, but later sold and run as an Omni Hotel. (*More than a Mall* 2010:44) West Main Street in the area of the hotel was pedestrianized at the time, although not in the manner the Halprin team had planned, which included water features, outdoor seating, and shade trees. The 1985 work and the extension of the Mall to the east in 1994 to accommodate the outdoor amphitheater did respect the original paving, use of willow oaks, and street furniture. The two vehicular crossings on Main Street, at West 2nd Street (1996) and East 4th Street (2006), ultimately resulted in removal of LHA-designed features from those intersections, including the cruciform paving element at their centers, and the addition of crossing signage, textured paving, and other changes. Over time, vehicular traffic has damaged the paving, especially the contrasting granite elements, and the added safety features disrupt and obscure the

Figure 8. Private dining areas serving Mall restaurants now occupy planned public space in the center of the pedestrianized Main Street. (Visit Charlottesville website, <https://www.visitcharlottesville.org/directory/charlottesville-historic-downtown-mall>)

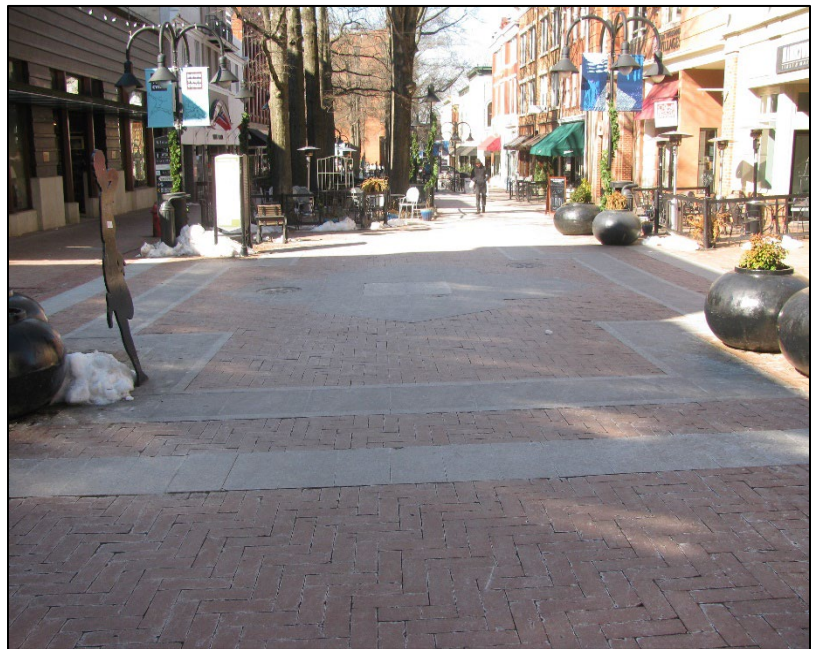
Figure 9. Intersection paving, looking west. (Robinson & Associates, 2022)

rectangle surrounds this frame. At each intersection, brick laid in a herringbone pattern fills the space between the pointed cruciform element and its cruciform frame and between the latter and its rectangular frame. Other light gray granite borders, of varying lengths and with brick infill, delineate the ground plane of the bosques of trees and open space along the Mall. These features follow the original LHA design, but were installed in 2009, replacing the concrete installed originally as a cost-cutting measure. The two exceptions to this approach are the vehicular crossings at West 2nd Street and East 4th Street, where the original cruciform elements were removed in 2009 in favor of a light gray granite rectangle around a plain brick field.

Condition: Overall, the condition of the Downtown Mall appears fair to good, with features in certain locations showing greater effects than others. The paving at the intersections where automobiles cross the Mall shows damage caused by the weight of the vehicles. Cracked granite and irregular repairs of asphalt and concrete are evident. Mortar in the original brickwork, especially in the drainage bands, also shows deterioration. A recent assessment of the health of the Mall’s trees determined that, as an urban forest, the willow oaks are in a state of decline, and the maple trees at Central Place have been replaced at least once. Some of the willow oak trees, which were 6-inch caliper when specified in 1976, have reached calipers of up to 30 inches and heights of over 60 feet. Several are upwards of fifty years old. The addition of dining enclosures, sandwich board

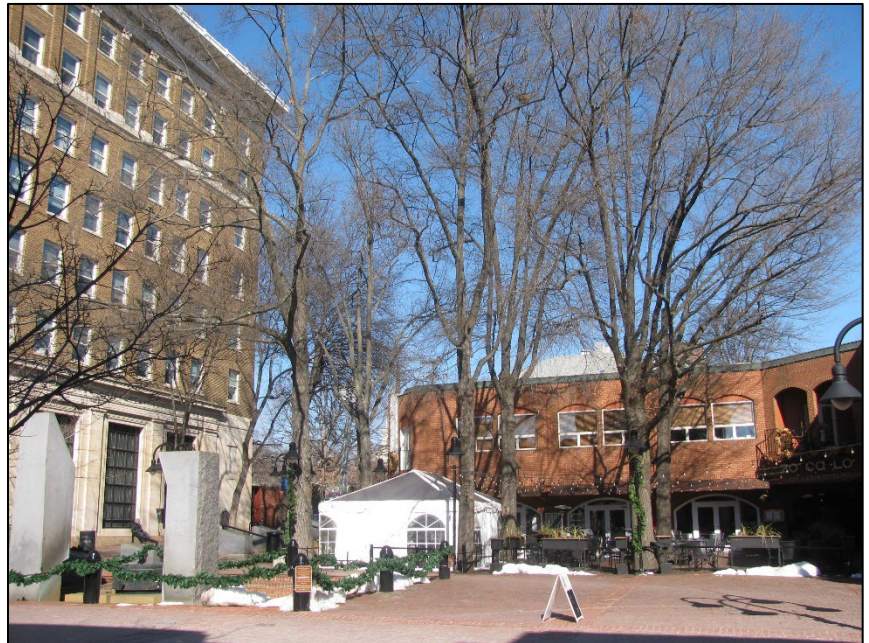
Figure 10. Willow Oak tree bosque at Central Place, looking north. (Robinson & Associates, 2022)

The bosques of trees vary in length, containing either three, five, or seven specimens of willow oaks. Some of the trees are fifty or more years old. Whereas the Mall's brick paving initially surfaced the ground plane immediately around the trees, square metal grates (DHR ID#104-5994-0004) have served that purpose since 2009. The trees provide shade in the summertime and create distinct spaces, bordered by gray granite, within the Mall's length. Like other features of the LHA design, the bosques are located along the Mall's center line, but weighted to one side or the other to encourage lateral movement. Associated with the trees are what the LHA drawings called "tree lights" (DHR ID#104-5994-0011). Altered since their original installation but remaining in the LHA-planned locations, the single-pole fixtures now employ flared, cone-shaped shades, aiming light downward instead of both up and down, as the original fixtures did. Many of the bosque areas are now given over to outdoor dining areas for nearby restaurants; the spaces were intended by LHA as the locations for movable benches where pedestrians could rest, eat, or interact. All of the original LHA-designed benches have been removed.

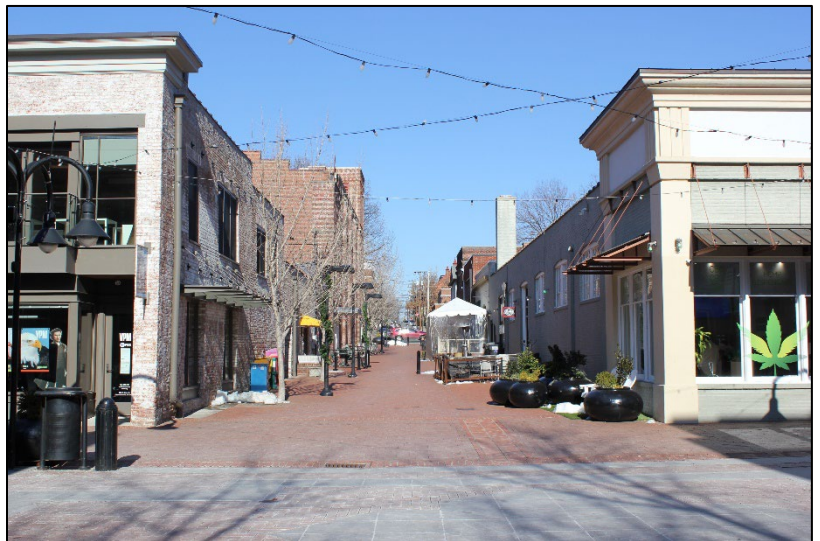
Figure 11. Pedestrianized 3rd Street NE, looking north. (Robinson & Associates, 2022)

area between Water Street and Preston Avenue, west of the 1980 expansion, was originally landscaped in association with the construction of a Radisson Hotel in 1985 (now the Omni Hotel). The design did include brick paving in a herringbone pattern, concrete cruciform paving elements, and willow oak trees, but the water features and plantings LHA envisioned were never built. Additional changes were made in this area when the Center of Developing Entrepreneurs (C.O.D.E) was constructed in 2021. This stretch of the Mall now includes sand-set brick in a herringbone pattern, concrete cruciform elements, a row of LHA planters near Water Street, altered LHA-style “spider” light fixtures, willow oak trees on the north side of Main Street, and two raised planting beds with concrete walls, containing rows of young willow oaks.

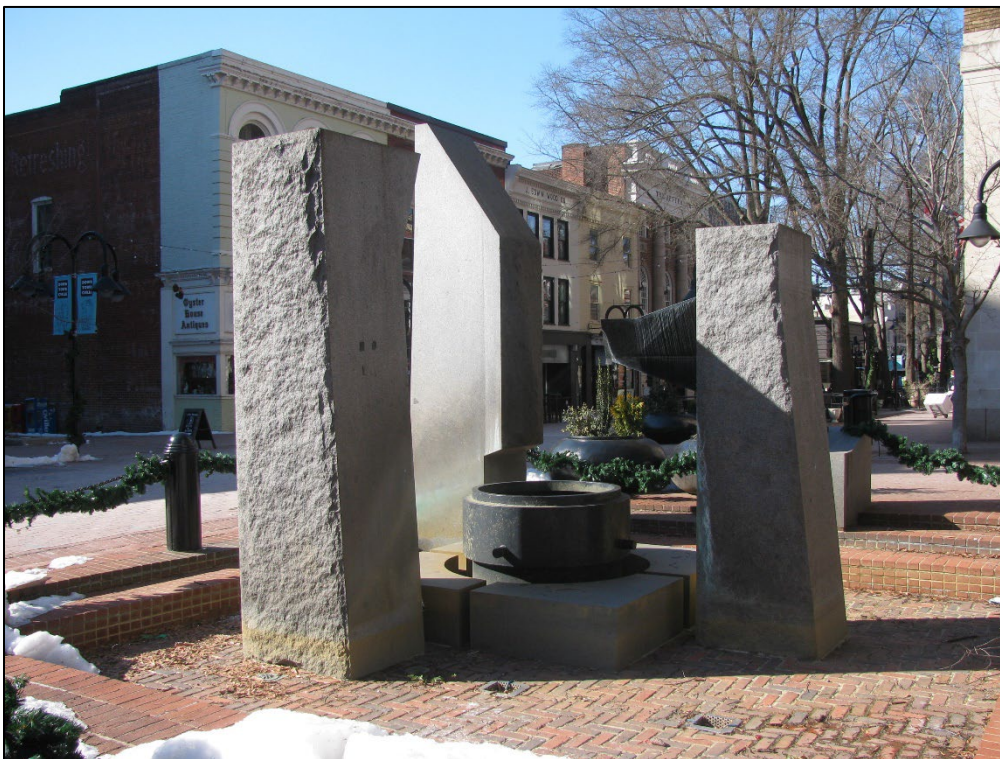
release water into the pool. The pool itself measures 19 feet on each side and has a herringbone-patterned brick floor. The bricks had paved Main Street sidewalks and were reused in the fountain, per LHA plans. Three brick steps accommodate the change in elevation from the pool floor to plaza level. The step bricks are original 11 ¼ by 3 ¼-inch bricks with mortared joints. The mortar is now light colored rather than the original gray. The vertical granite elements are 10, 12, and 15 feet tall, with the shortest being the location of the water spout. Their faces vary in width between 2 feet,

Figure 12. Central Place Fountain at the intersection of East Main Street and 2nd Street, looking southwest. (Robinson & Associates, 2022)

Condition: The fountain itself was not functioning at the time of the survey; therefore, the condition of the fountain works could not be assessed. No condition issues were apparent in the physical features of the fountain during the visual survey other than discoloration at the bases of the vertical granite elements and the wire-cut blocks surrounding the basin, all of which would sit in the fountain pool when it was in operation.

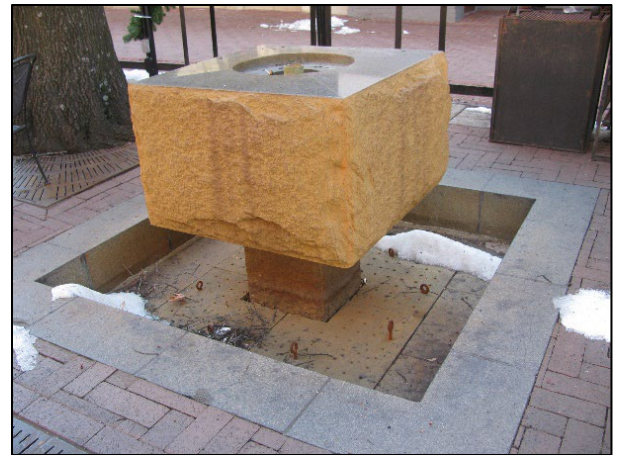
Figure 13. Square fountain in the 400 block of East Main Street. looking northwest. (Robinson & Associates. 2022)

Today, a metal floor is located level with the top of the lowest step, meaning that the pool is only 1 foot deep and the original brick floor can no longer be seen. Lamps in each face of the lower granite square are also hidden by the metal plate. Access to the below-grade fountain works is provided by removable granite pavers in the bands that outline the tree bosques.

Condition: None of the fountains were in operation at the time of the survey; thus, the condition of the works could not be assessed. The granite square of the pools, granite bases, and tops of all three fountains appeared to be in good condition, with some discoloration of the rough sides of the fountain tops and bases.

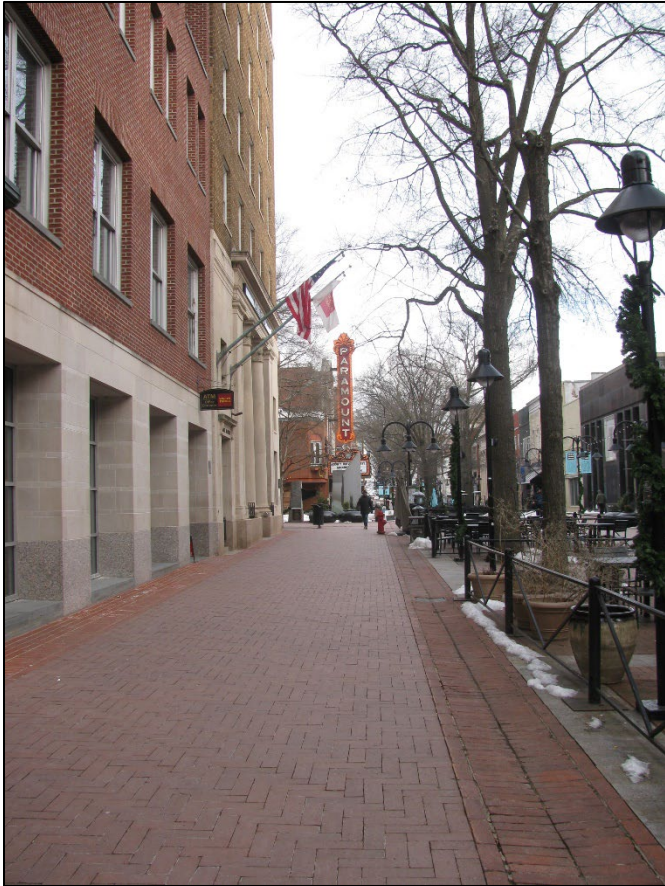
Drainage System (104-5994-0003)

Figure 14. The LHA drainage runnels run east to west where the Main Street gutters and curbs had been located. Looking east. (Robinson & Associates, 2022)

In its original design for the Downtown Mall, Lawrence Halprin & Associates developed a drainage system that maintained the original brick ground, using slight grade changes and a specially designed feature to drain rain water from the Mall. Collaborators on utilities, mechanical, and electrical elements of the Mall design were Hazen/Sawyer of New York City and Beamer/Wilkinson Associates of Oakland, California. Based on a drainage detail observed in the brick sidewalks along Court Square, the design included a concave runnel composed of two parallel rows of soldier course bricks (11 ¼ by 3 ¼) set in gray mortar, creating a drainage band 2 feet wide. As built, two of these drainage bands ran parallel to each other in an east-west direction for the length of the mall. They were located where the gutters along the Main Street sidewalks had stood, which also paralleled the granite rectangles that divided up the Mall's space. The drainage bands drew water away from both the former sidewalk areas and the former roadbed of Main Street, yet did not interrupt the continuous surface paving of the Mall or disrupt the pedestrian experience.

Condition: The original drainage bands in the original design remain in place. Visual inspection of the runnels indicates that most of the soldier course bricks and drop inlet grates appear to be in good condition. Some of the mortar joints, especially at the bottom of the runnels, however, have deteriorated.

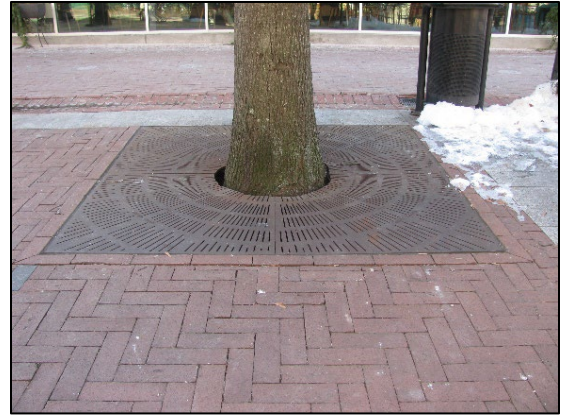
Figure 15. Tree grates were installed in the original portions of the Mall in 2009. Looking south. (Robinson & Associates, 2022)

In the 2009 renovation of the Downtown Mall, after another master plan by MMM Design Group, the tree boxes that LHA had designed were removed. Openings around the willow oaks on Main Street and the red maples near Central Place were enlarged into squares approximately 8 feet on each side. A frame consisting of a single row of bricks bordered the outer edge of the square and was not integrated into the herringbone pattern of the Mall paving. The space between each brick frame and the tree trunk was covered by a set of four slotted, metal plates resting on steel beams. As the trees grow larger, the plates can be removed, the openings enlarged, and the plates put back into place. The tree grates appear to be in good condition, although a 2015 assessment of the Mall's trees identified potential threats of the grates to tree health.

Condition: The tree grates appear to be in good condition. The below-grade supporting structures for the grates could not be inspected during the survey.

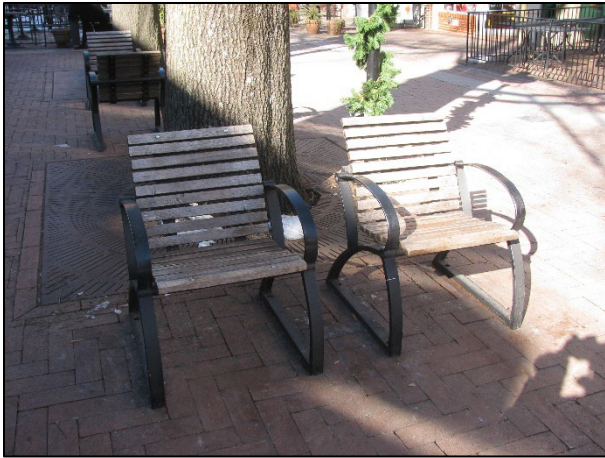
Figure 16. The current chairs were installed as part of the 2009 rehabilitation of the Mall. Looking west. (Robinson & Associates, 2022)

Condition: The extant chairs appear to be in generally good shape. The original, likely polyurethane finish of the wood slats, however, has worn away on many of them.

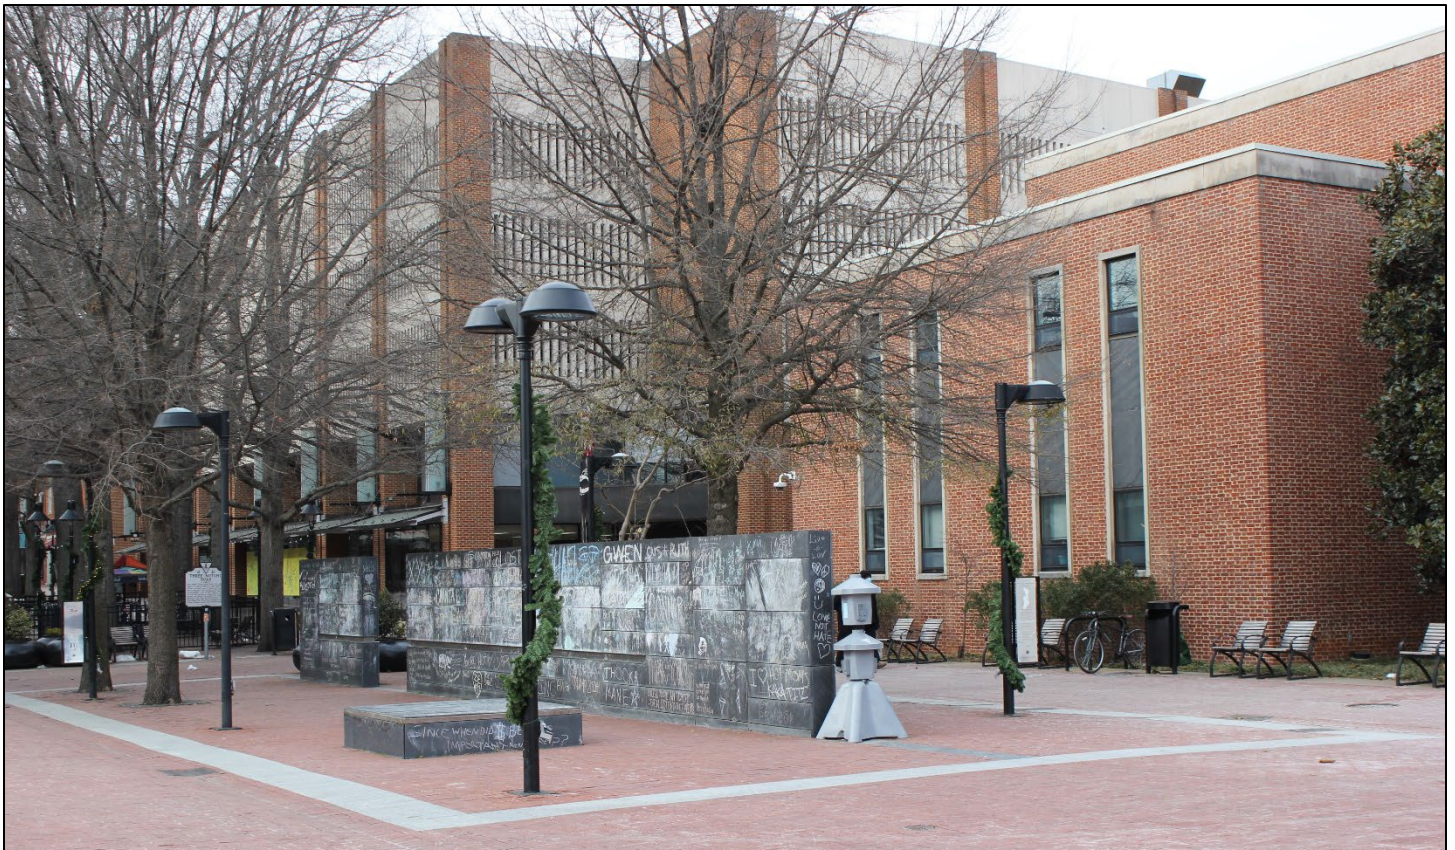
Figure 17. The Community Chalkboard was dedicated as a monument to the First Amendment in 2006. Looking northwest. (Robinson & Associates, 2022)

Condition: Roughly eight of the chalkboard's stones are chipped or show evidence of spalling, and a few no longer appear flush with the concrete backing. Despite this, the artwork is less than twenty years old and is in good condition. There are two signs associated with the artwork that are in poor condition and show evidence of vandalism.

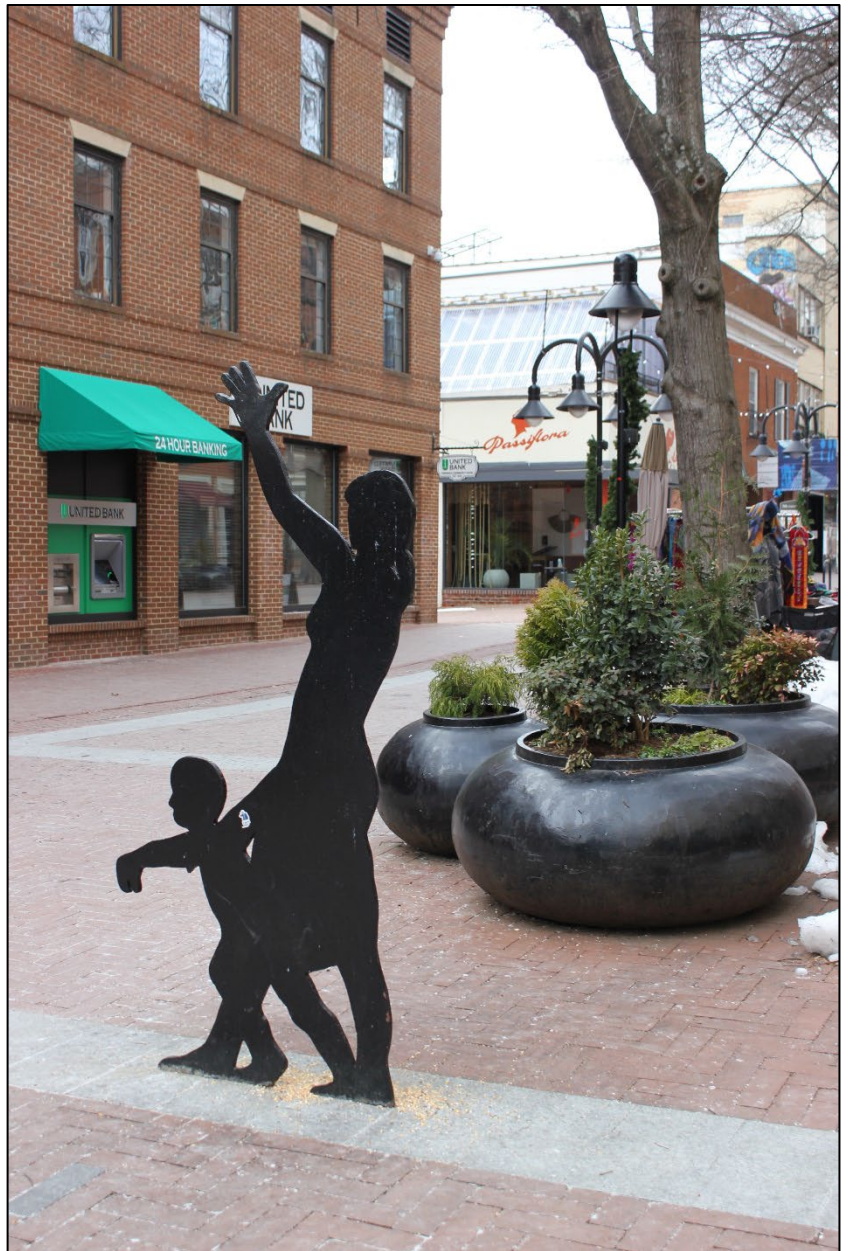
Figure 18. One of James Hagan's silhouettes, looking southwest. (Robinson & Associates, 2022)

Condition: While the sculptures are generally in good condition, there is evidence of minor vandalism, including graffiti and the application of adhesive stickers.

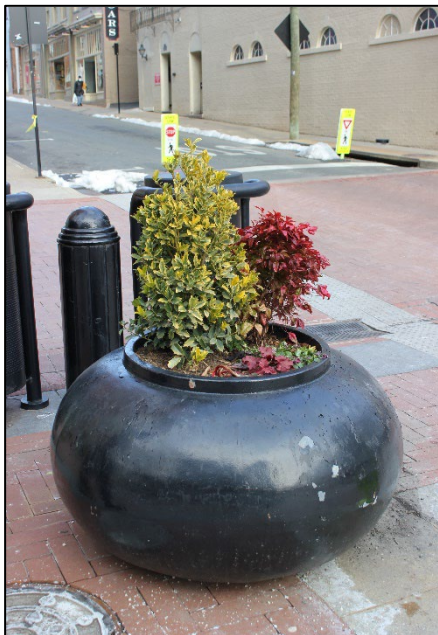
Figure 21. Historic planter at East 4th Street, looking northeast. (Robinson & Associates, 2022)

Condition: The seven planters arranged in a row at the edge of the Water Street plaza and the three planters along the Water Street sidewalk are in fair condition. These have an uneven finish where the paint is flaking off or has been rubbed or scratched off, and several have small patches of rust. The planters placed on Main Street at its intersections with the side streets are generally in better condition, although some of these also have small patches of rust where the painted finish has been chipped off or is flaking away. Generally, these small areas of deterioration tend to occur at the widest point of the planters. The planters do not appear to be impacted by graffiti or other types of vandalism.

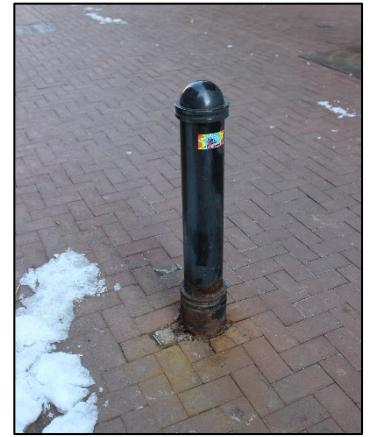
Condition: The nonhistoric bollards vary in condition from good to poor. Those in poor condition typically exhibit one or more of the following conditions – worn, peeling, or flaking paint, rust, small dents, and minor vandalism.

Figure 20. Nonhistoric bollard 2nd Street SE, looking northeast. (Robinson & Associates, 2022)

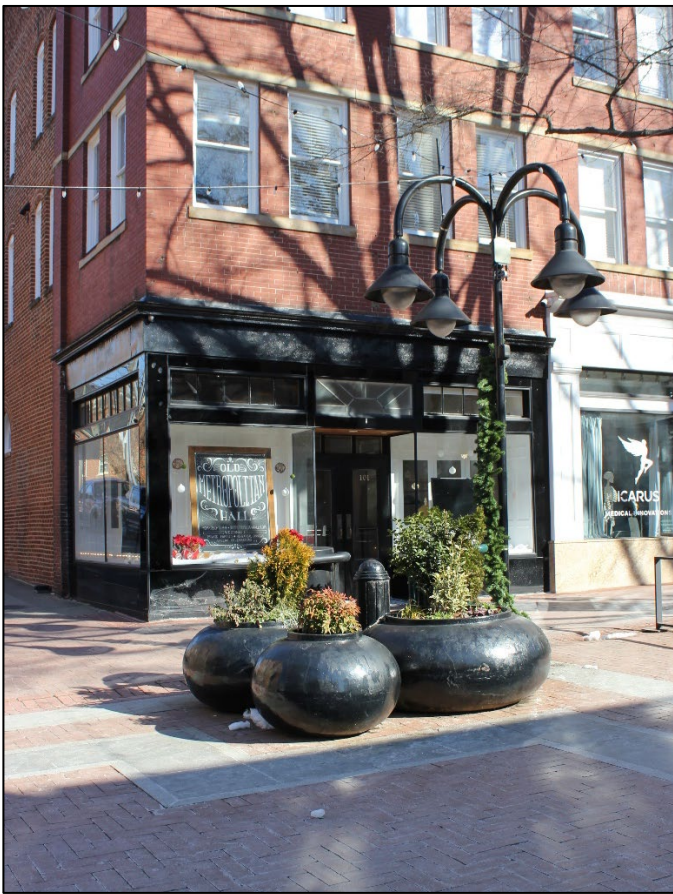
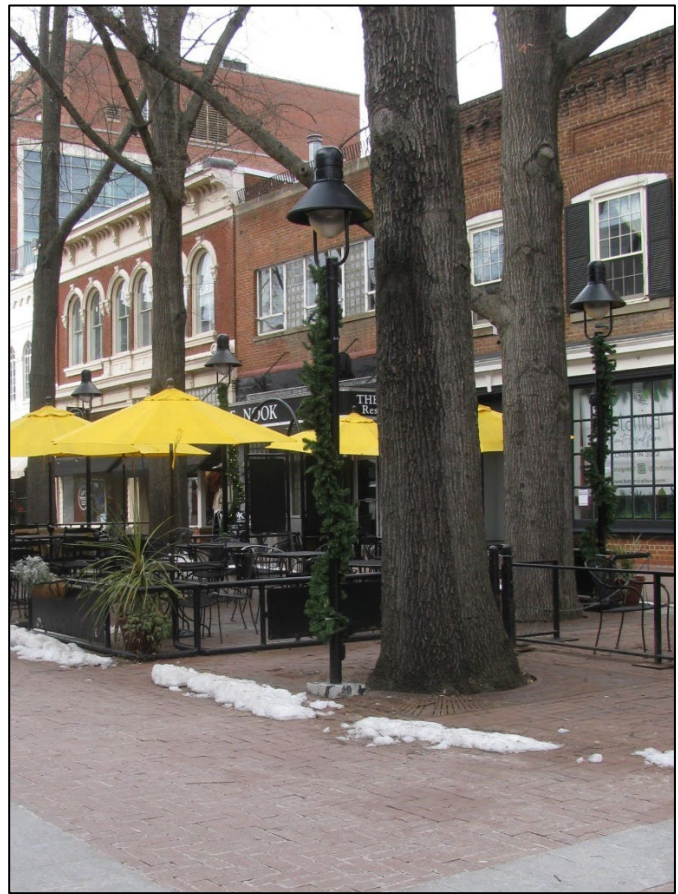
Historic Streetlights (104-5994-0011)

Figures 22 and 23. Historic pedestrian light (left), looking northeast, and historic tree light, looking northwest. (Robinson & Associates, 2022)

Lawrence Halprin & Associates designed two types of streetlights for the Downtown Mall, designated as “pedestrian lights” and “tree lights.” The pedestrian lights were located at intersections and along the sections of Main Street, while the tree lights were located within the bosques of willow oaks. When the pedestrian mall expanded in 1980 and later in 1985 and 1994, new streetlights replicated the design of the originals. The pedestrian lights, which are sometimes referred to as “spider” lights, consist of a single pole shaft supporting four curved arms each with a single fixture. As originally designed, the pole shaft was a 3-inch, schedule 80 steel pipe, which had a 3 ½-inch outside diameter, anchored to a concealed base. The cast-iron base covers sat flush with the level of the brick paving. The enameled steel fixtures had a tapered drum shape

Condition: While the pedestrian lights between Old Preston Avenue and Water Street have base covers that are severely rusted, the streetlights are generally in good condition. There is evidence of minor vandalism where adhesive stickers have been applied to the pole shafts.

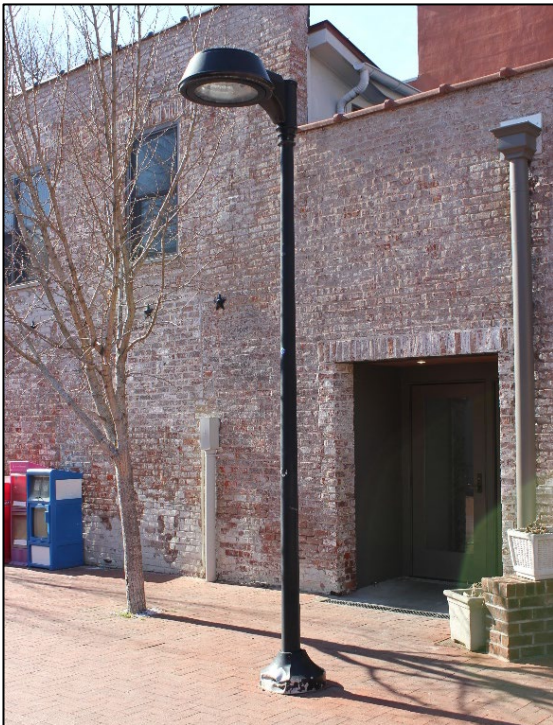
Nonhistoric Streetlights (104-5994-0012)

Figure 22. Nonhistoric streetlight on East 3rd Street, looking northeast. (Robinson & Associates, 2022)

Condition: The nonhistoric streetlights are in good condition.

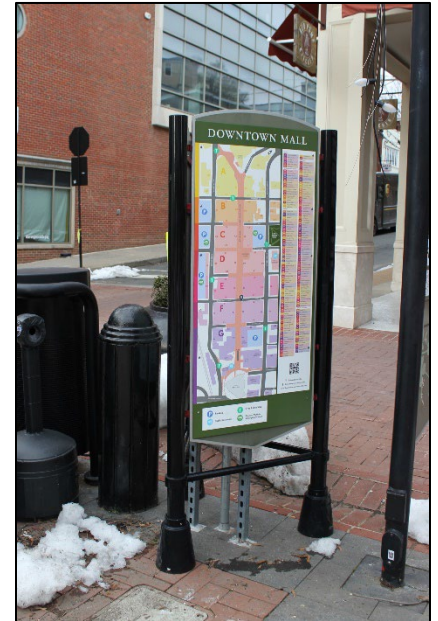
There is currently one type of permanent, freestanding wayfinding signage on the Downtown Mall. Probably installed in 2009, the signs are three-sided and consist of thin panels set between steel poles that measure roughly 6 feet high. The panels have a green finish that matches the permanent banner-type signage that is affixed to some of the streetlights on the Mall. Each sign has three panels – one displaying a map illustrating the Mall, one with a map of the greater downtown area, and one with a list of nearby destinations, such as municipal buildings, museums, and theaters. The signs are typically located at intersections near other small-scale elements, such as bollards or trash receptacles. Freestanding wayfinding signage that is not original to the Lawrence Halprin & Associates design of the Downtown Mall is located at the intersections of Main Street with West 2nd Street, East 2nd Street, East 3rd Street, East 4th Street, East 5th Street, and East 6th Street. This signage postdates the periods of significance for the Downtown Mall and should not be considered character-defining elements of the landscape.

Condition: The wayfinding signage was installed in 2009 and is in good condition.

Figure 23. Signage located Main and East 4th streets. Looking northwest. (Robinson & Associates, 2022)

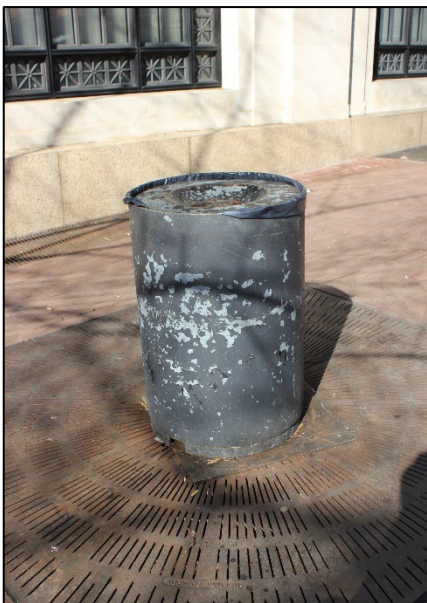
Historic Trash Receptacle (104-5994-0014)

Figure 24. Historic trash receptacle at Central Place, looking northwest. (Robinson & Associates, 2022)

The trash receptacles specified by Lawrence Halprin & Associates for the Downtown Mall were sturdy, cylindrical, steel vessels with interior fiberglass trash baskets and galvanized steel covers. Each measured 2 feet, 4 inches tall and 21 inches in diameter. The trash receptacles were finished with a matte black paint. Similar to the planters and chairs, the original locations of the trash cans are not shown on the LHA plans; rather, locations were decided in the field by the landscape architects. With one exception, all of the original LHA-designed trash receptacles were replaced with Petoskey brand, ergonomic cans as part of the 2009 rehabilitation of the Mall. The remaining LHA-designed trash can is located on East 2nd Street. It remains an important vestige of the LHA design for the Downtown Mall. Without the presence of other examples of this feature, however, it is difficult to describe it as a character-defining element of the landscape.

Condition: The extant original trash can is in poor condition with flaking and peeling paint, scratches, and spots of rust on the lid.
