PRELIMINARY INFORMATION FORM (PIF) for INDIVIDUAL PROPERTIES

DHR No. (to be completed by DHR staff) 012-5471

Property name: Blick Plantation

Property address: 686 Wilson Creek Lane

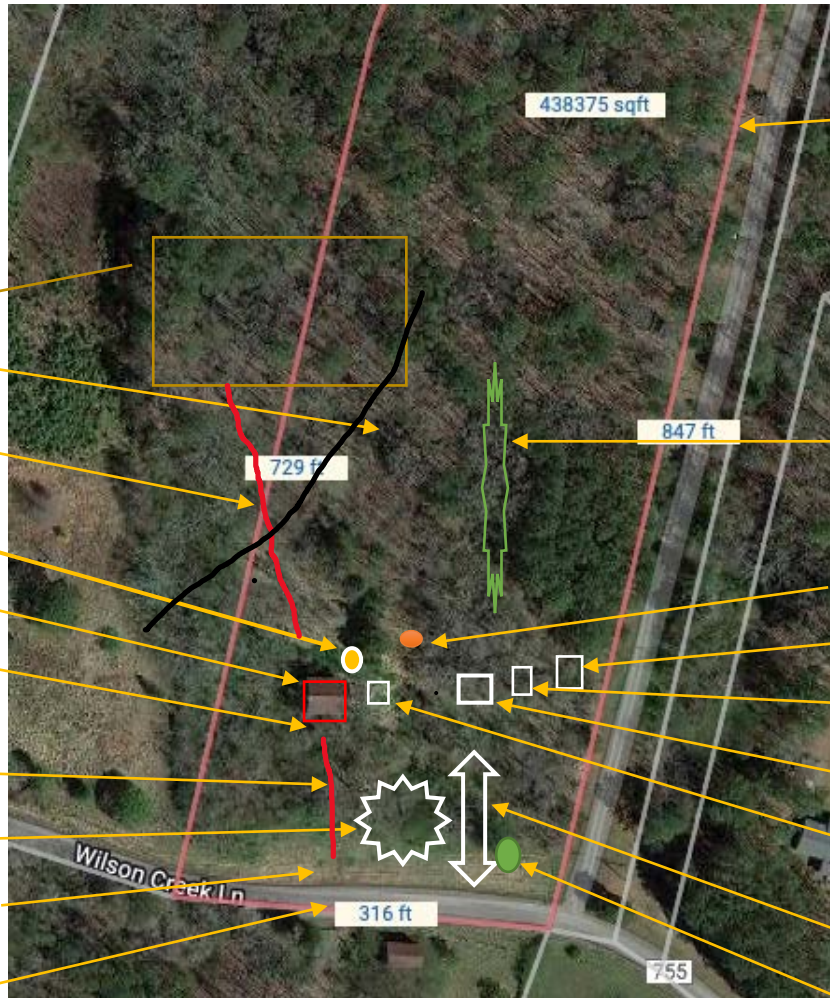
Sketch Map

SKETCH MAP

Family Cemetery

Wet Weather Run-Off stream

Hand-Dug Well

Main House

Collapsed Front Porch 10'x30'

Sycamore Tree

-Trash Pits

-Concrete Well

-Collapsed

Corn Crib

-Carriage Barn

-Summer

Kitchen-collapsed

-Small pond
