## PRELIMINARY INFORMATION FORM (PIF) for INDIVIDUAL PROPERTIES

Property name: Allen Taylor Crockett House

Property address: 3426 Cove Rd.

- Allen Taylor Crockett property
- Established 1848
- Wythe County, VA

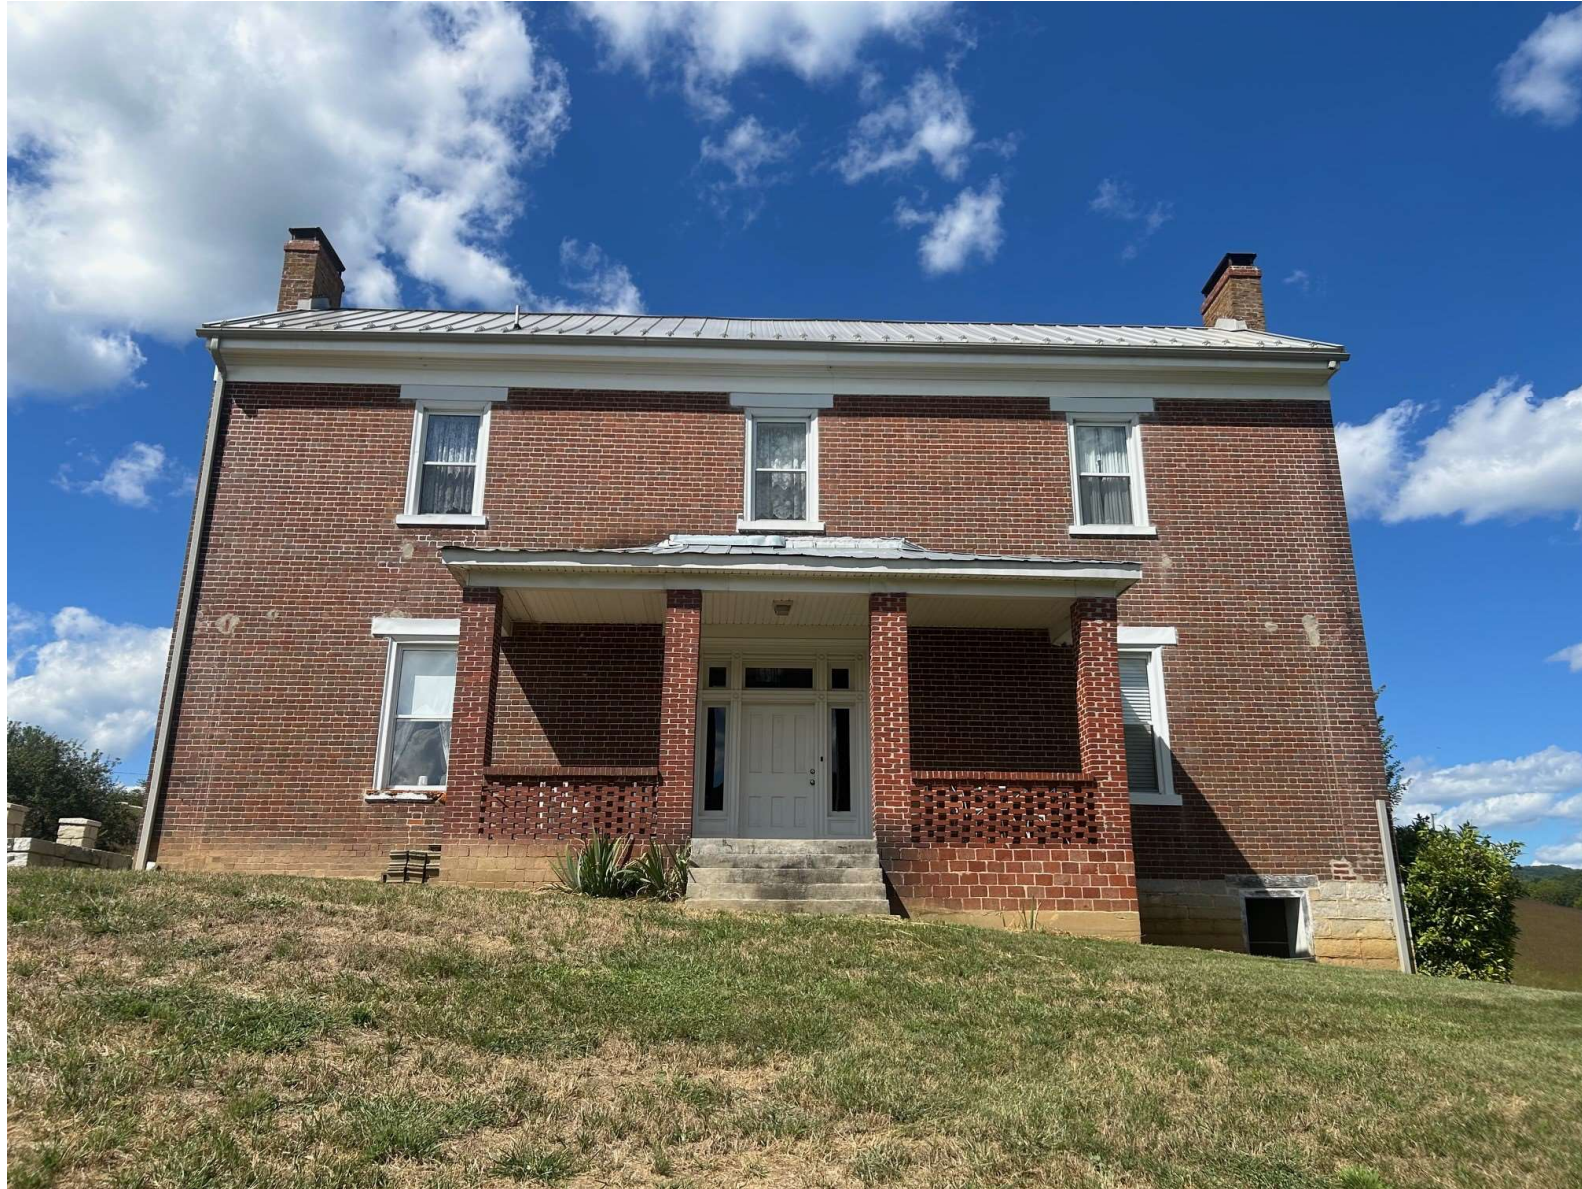
## **EARLIEST KNOWN PHOTO**

- This is the earliest known photo of the Allen Crockett home. Based on the structures surrounding the home it is believed that this photo was taken in the late 1800's

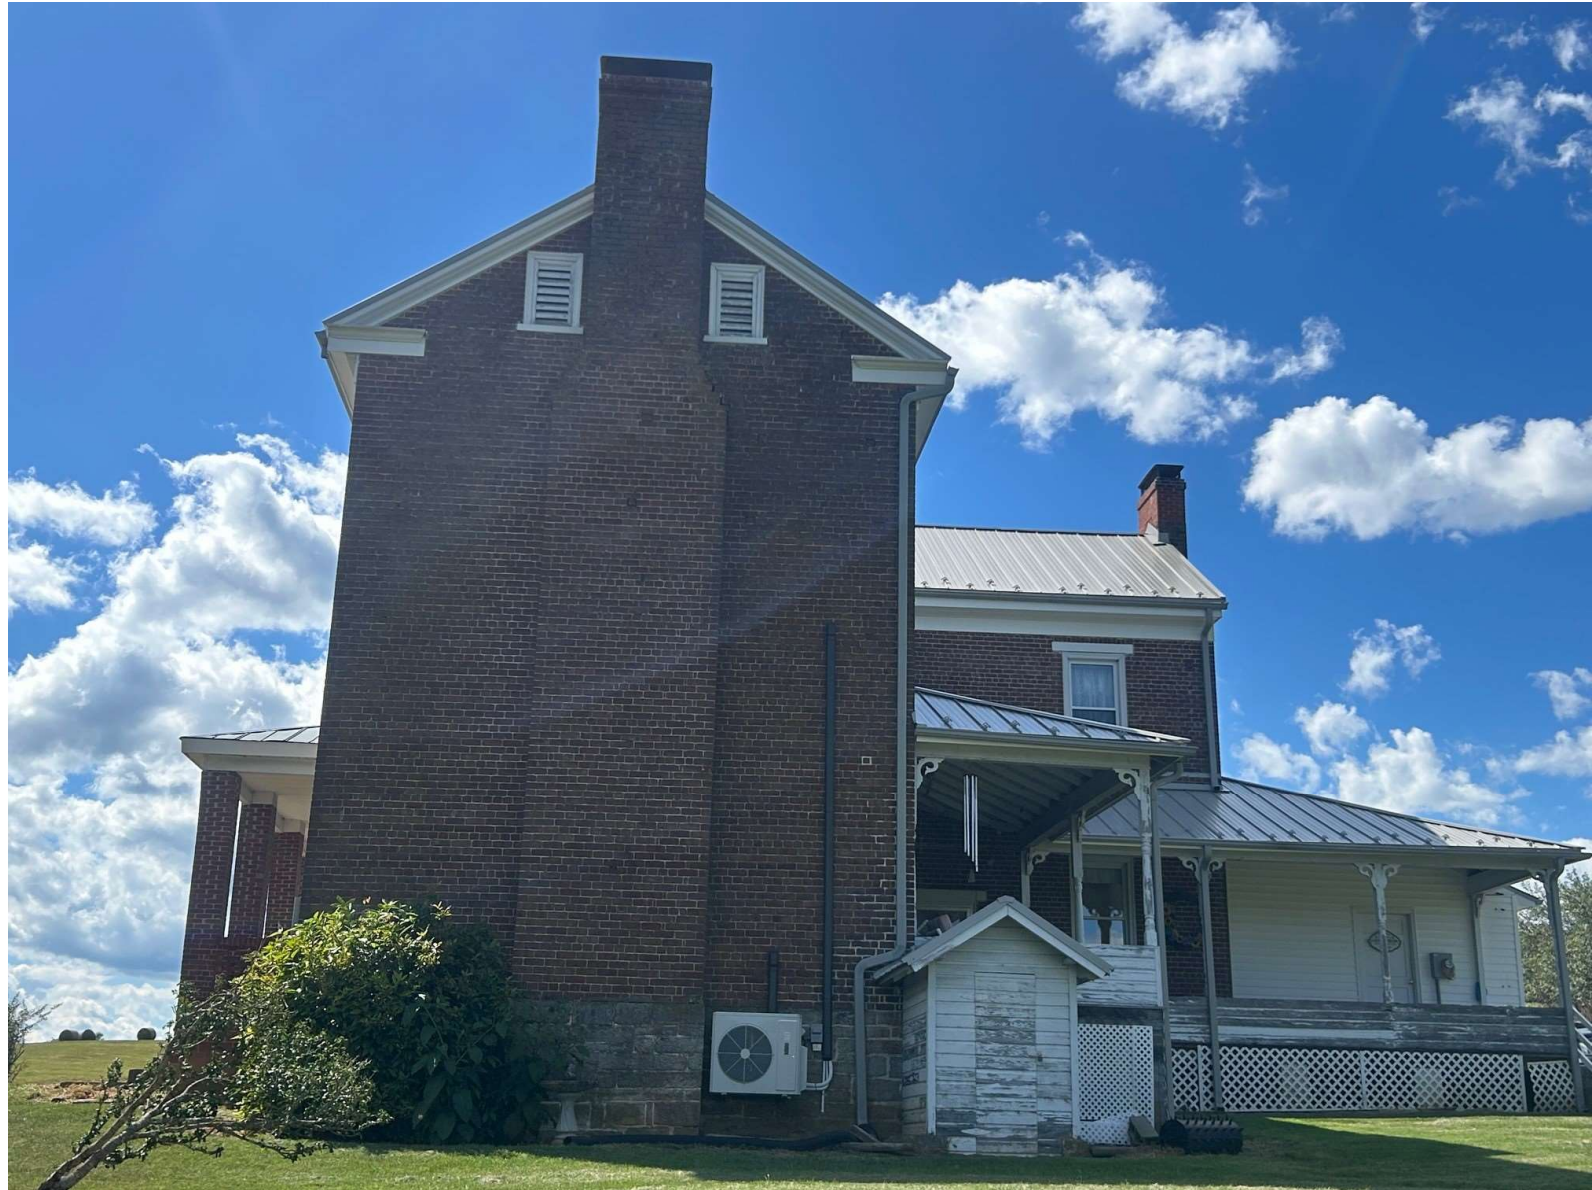
## NORTH VIEW

- Original:
  - This view faced the Civil War battle
- Modifications:
  - Original end-to-end porch destroyed in a storm in the 1950s and replaced with smaller porch
  - Owner intends to replicate original porch

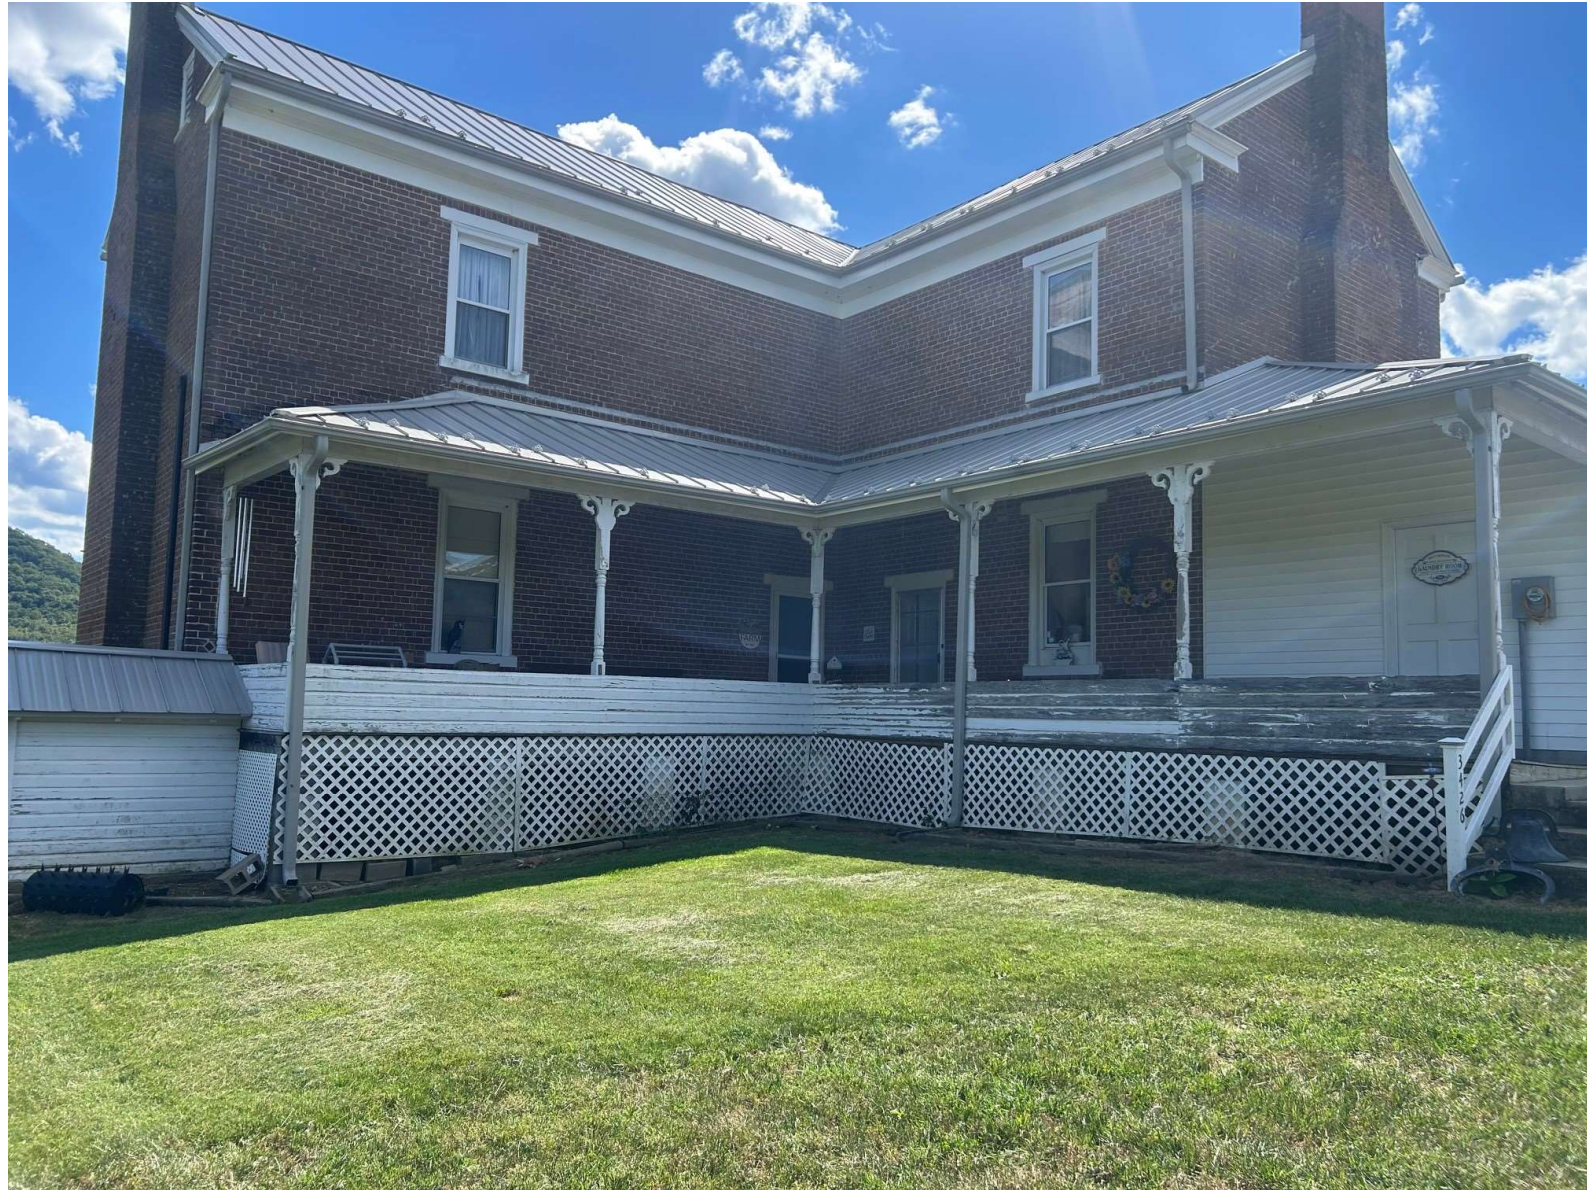
## EAST VIEW

- Original:
  - This view faces Crockett's Cove
- Modifications:
  - Minimalist HVAC system installed

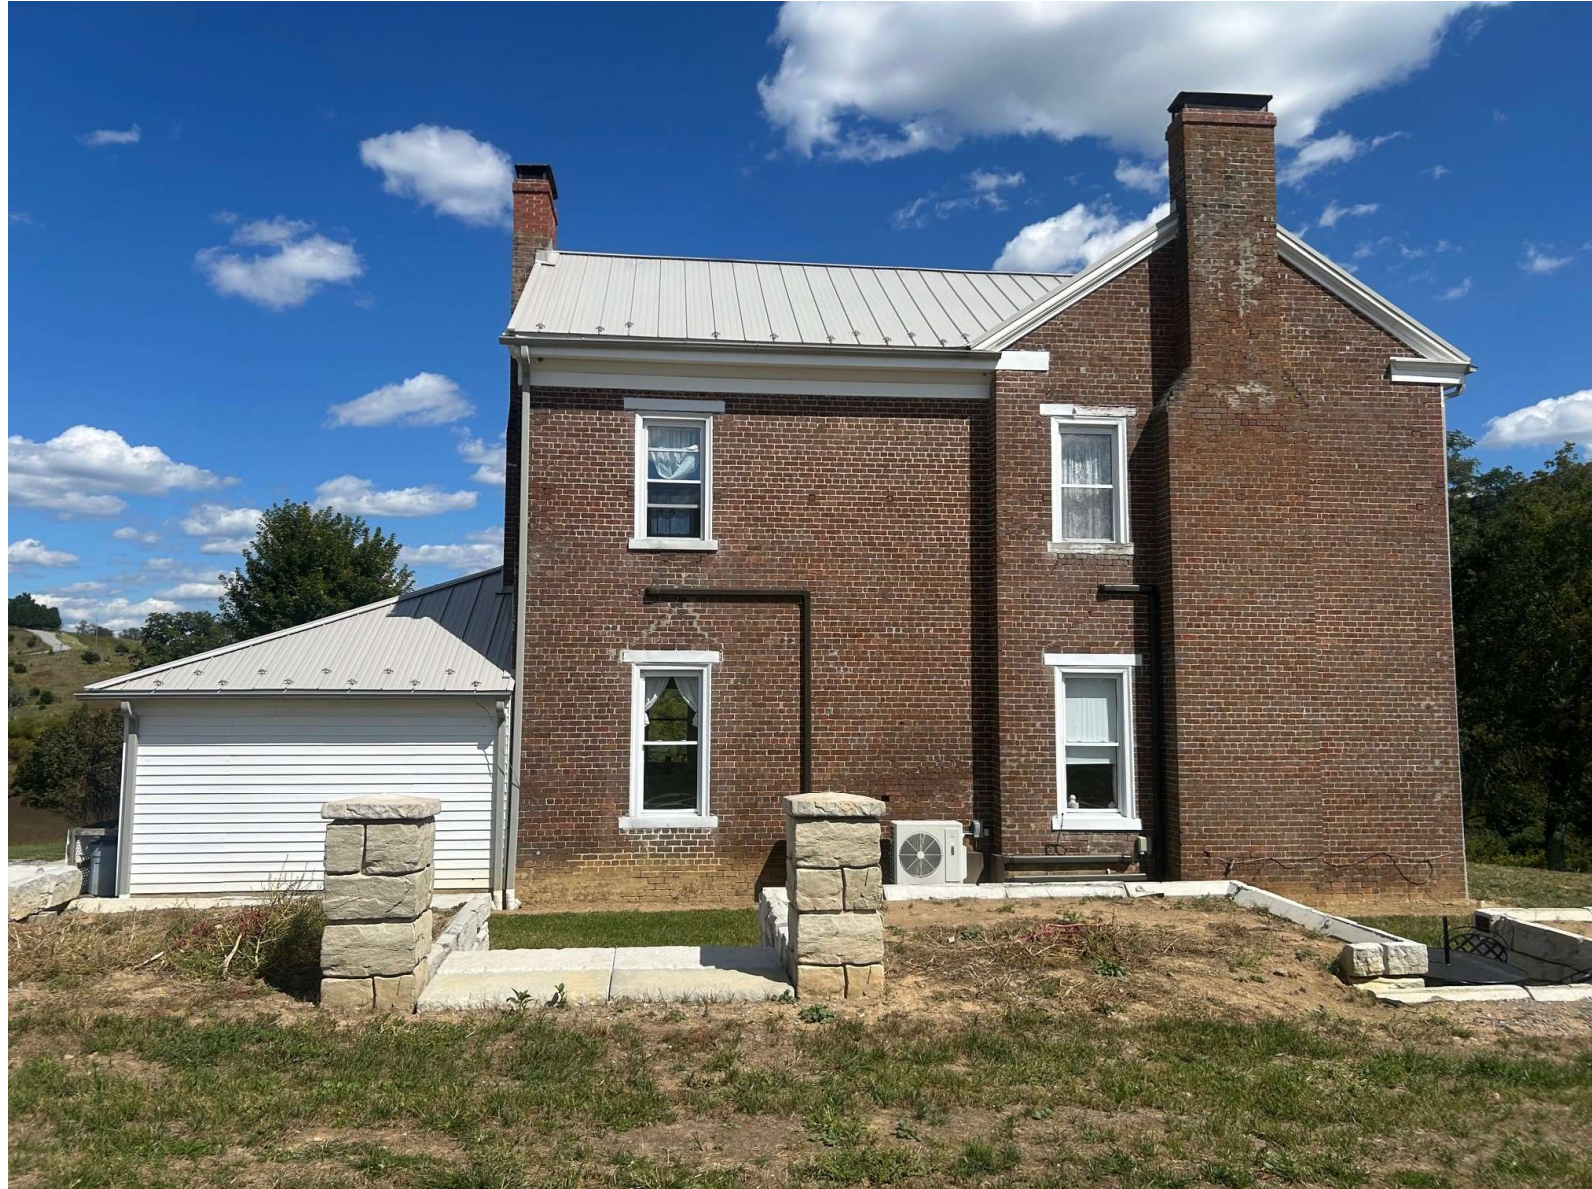
## SOUTH VIEW

- Original:
  - This view faces Little Walker Mountain
- Modifications:
  - Original stairs down to the kitchen were removed after slave era
  - Owner intends to replicate stairs and renovate basement area

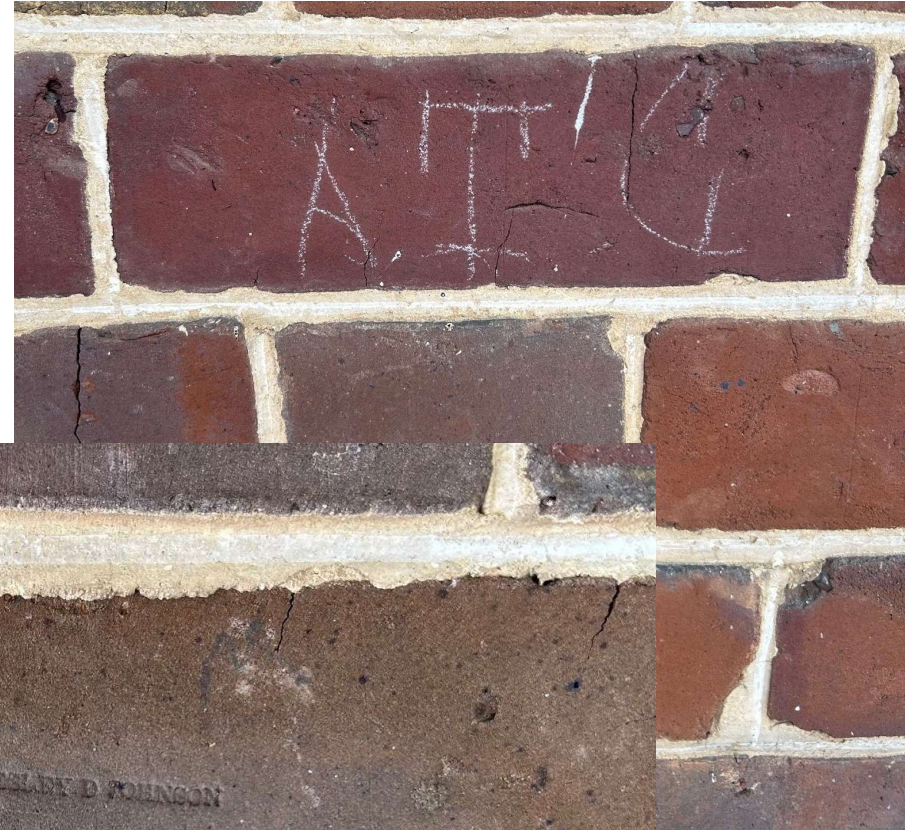
## WEST VIEW

- Original:
  - This view faced the Civil War battle
- Modifications:
  - Installed retaining wall due to soil erosion since construction
  - Owner intends to re-point much of the brick on this side of home due to extensive weathering

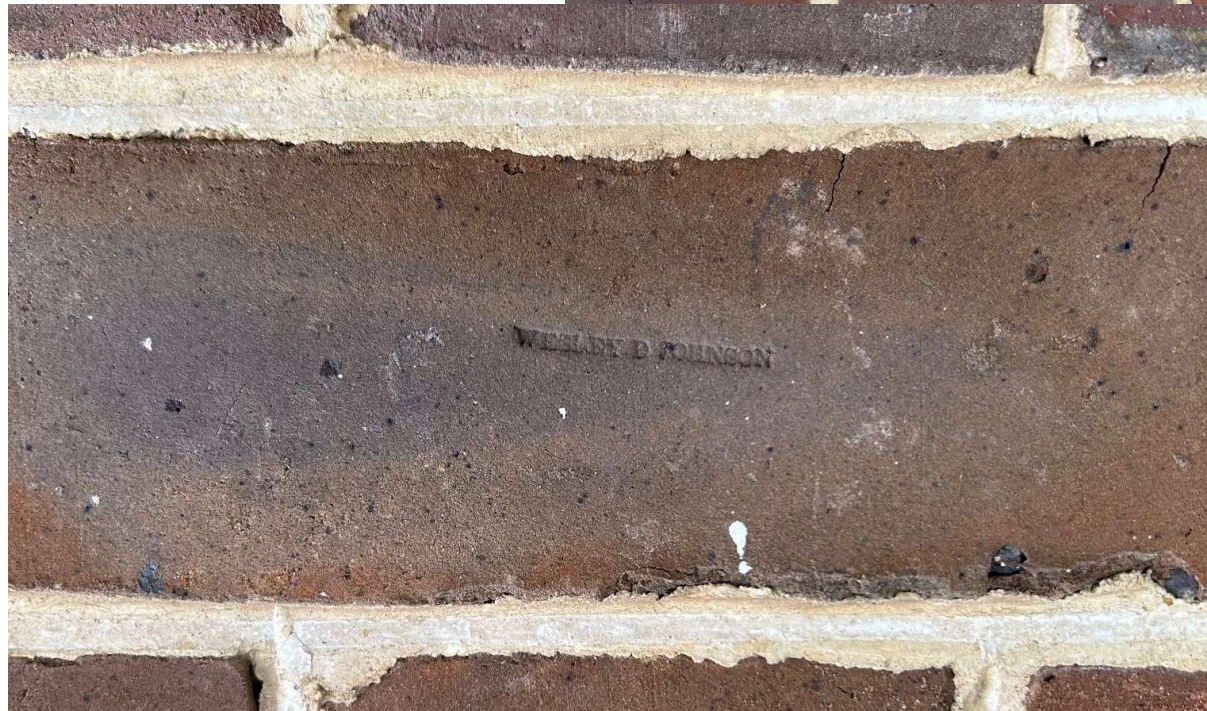
# BRICKS

- Owner: Allen Taylor  
Crockett lime  
“signature” brick at  
front door entrance
- Builder: Wesley D.  
Johnson brick placed  
at front door entrance
- Example of lime  
penciling still  
viewable on covered  
areas
- Modifications:
  - Owner intends to  
re-point  
damaged bricks

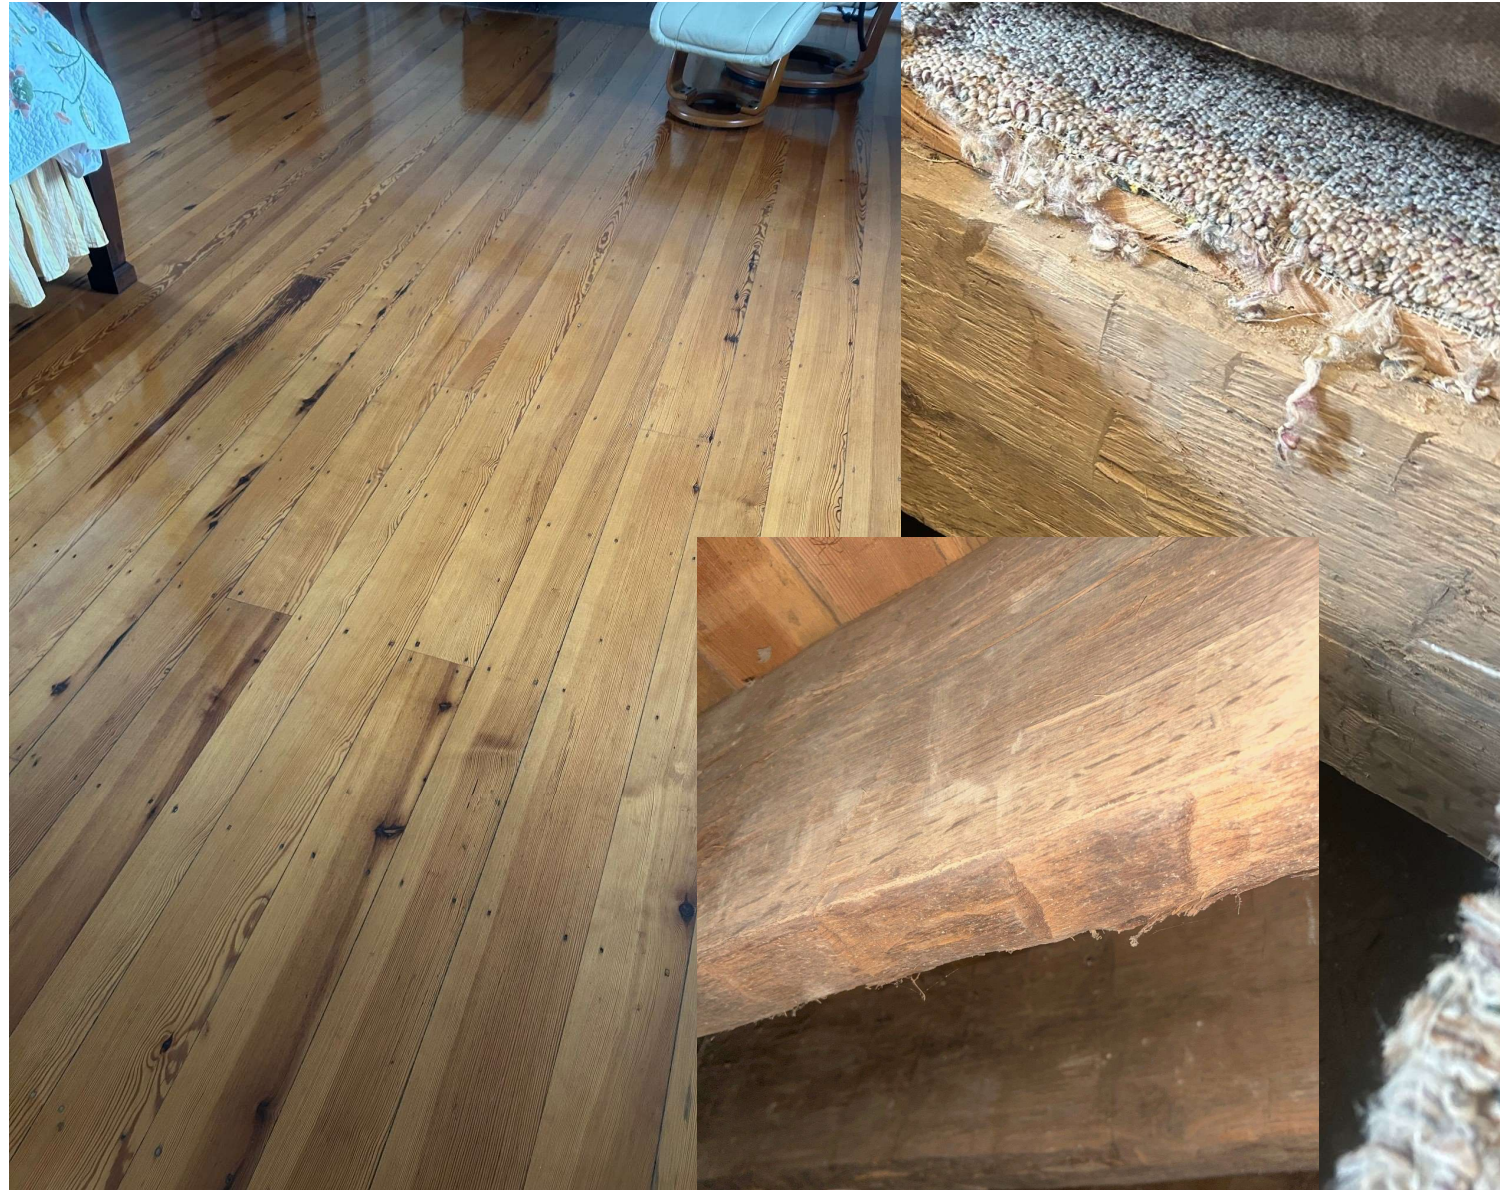
# ATTIC

- Hand-hewn rafter poles and rafter slats
- Hand-hewn American Chestnut ceiling joists
- 4" x 8" x 20' joists
- Top side of plaster ceiling
- All ceiling joists, rafter poles and slats are original and have not been modified since installation in 1848
- Modifications:
  - Insulation added in 2023

*The attic was built using stripped poles and erected in pairs over the joists. The 3"x10"x22' beams in the attic have faint Roman numeral etchings which suggest the house was carefully designed and constructed. It is not known whether the original roof was constructed with wooden shingles or slate, but at one time there was slate on some or all of the house as 1' x 2' slate shingles have been found on the property. The foundation is comprised of hand-hewn limestone with interiors blocks measuring 13" wide and exterior blocks measuring 16" wide, both with varying lengths of 24" to 48".*

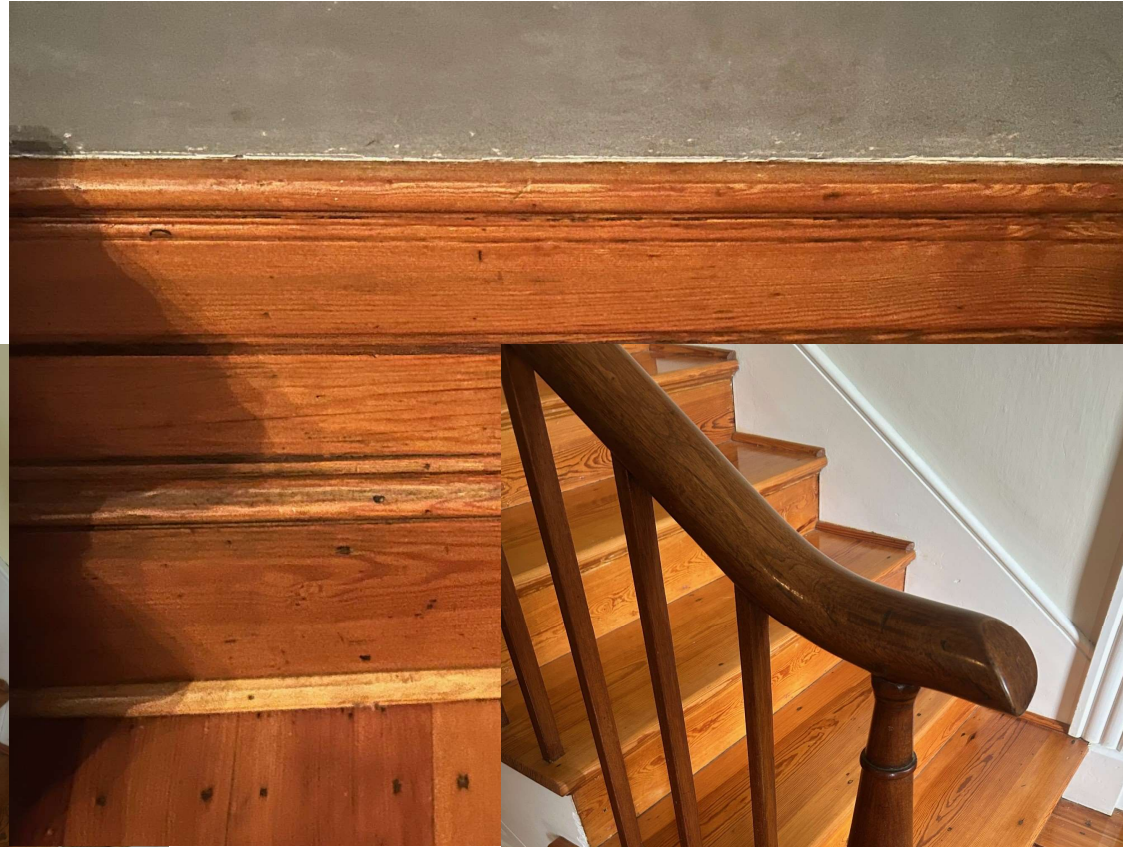
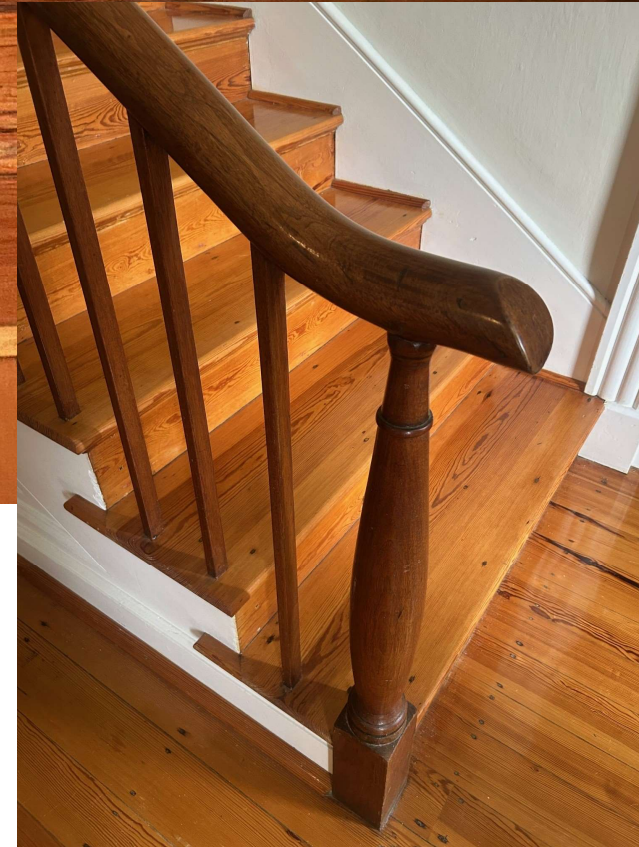
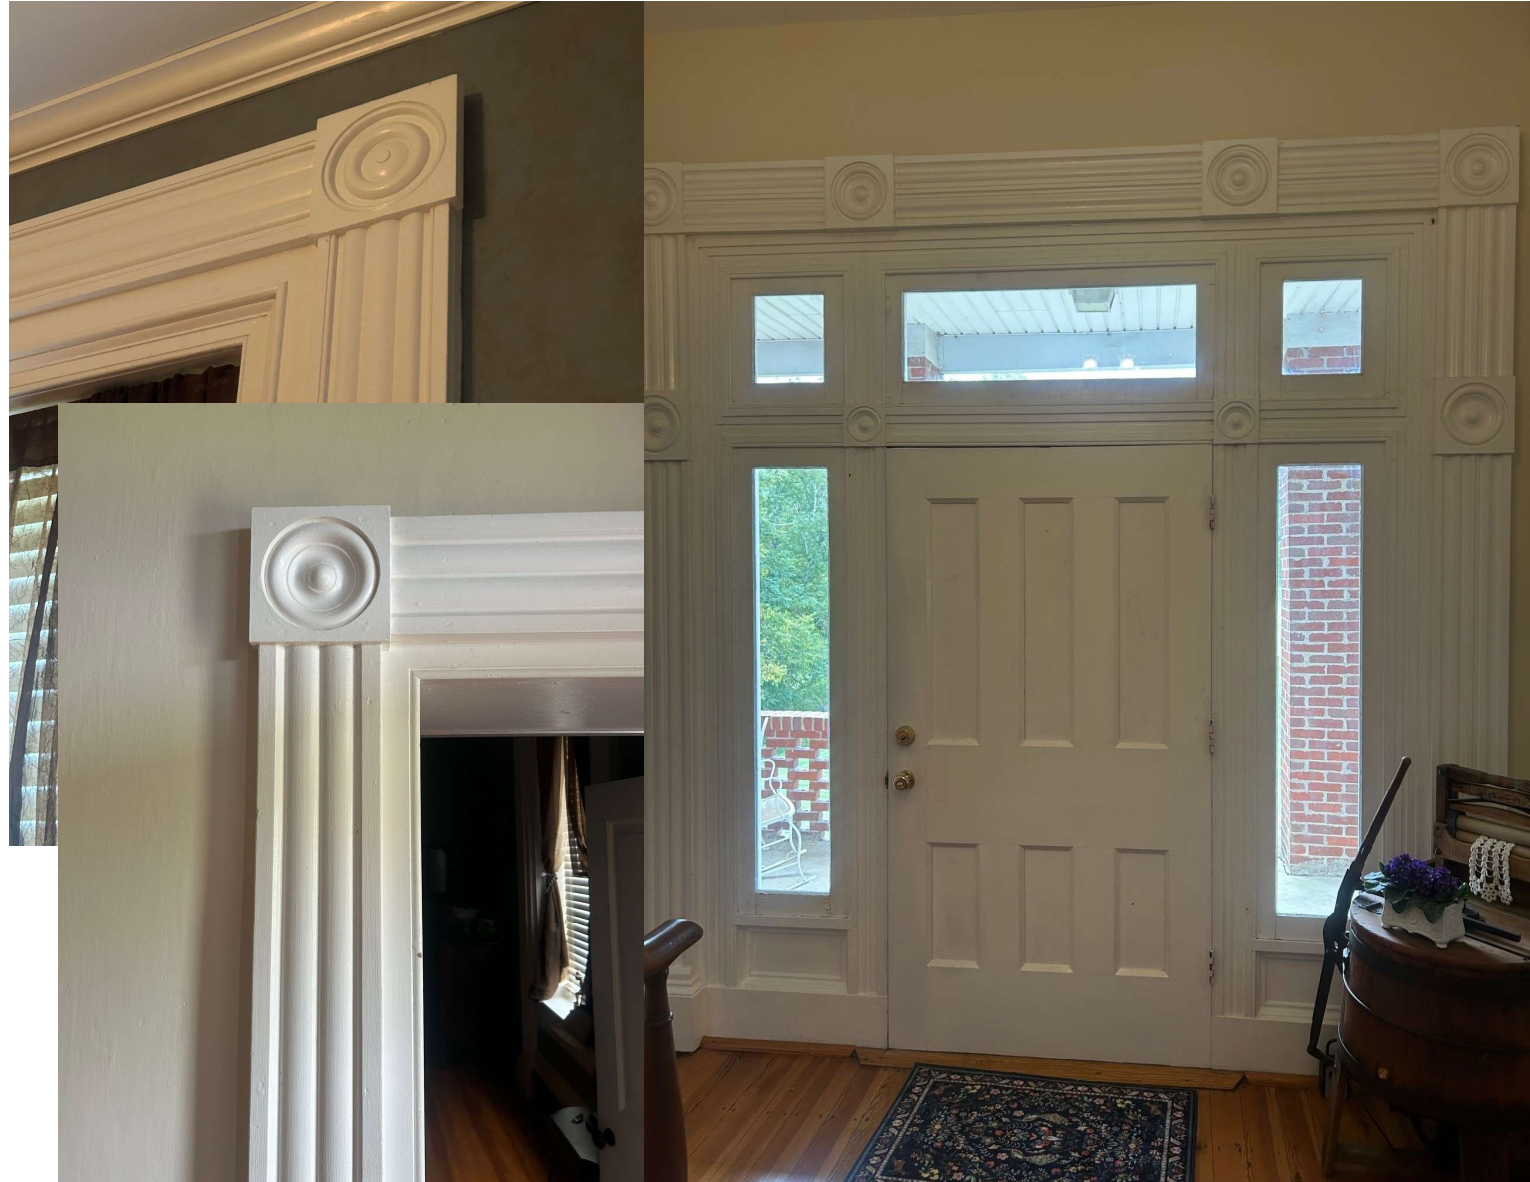
# TRIMWORK

- Original:
  - All trimwork is original

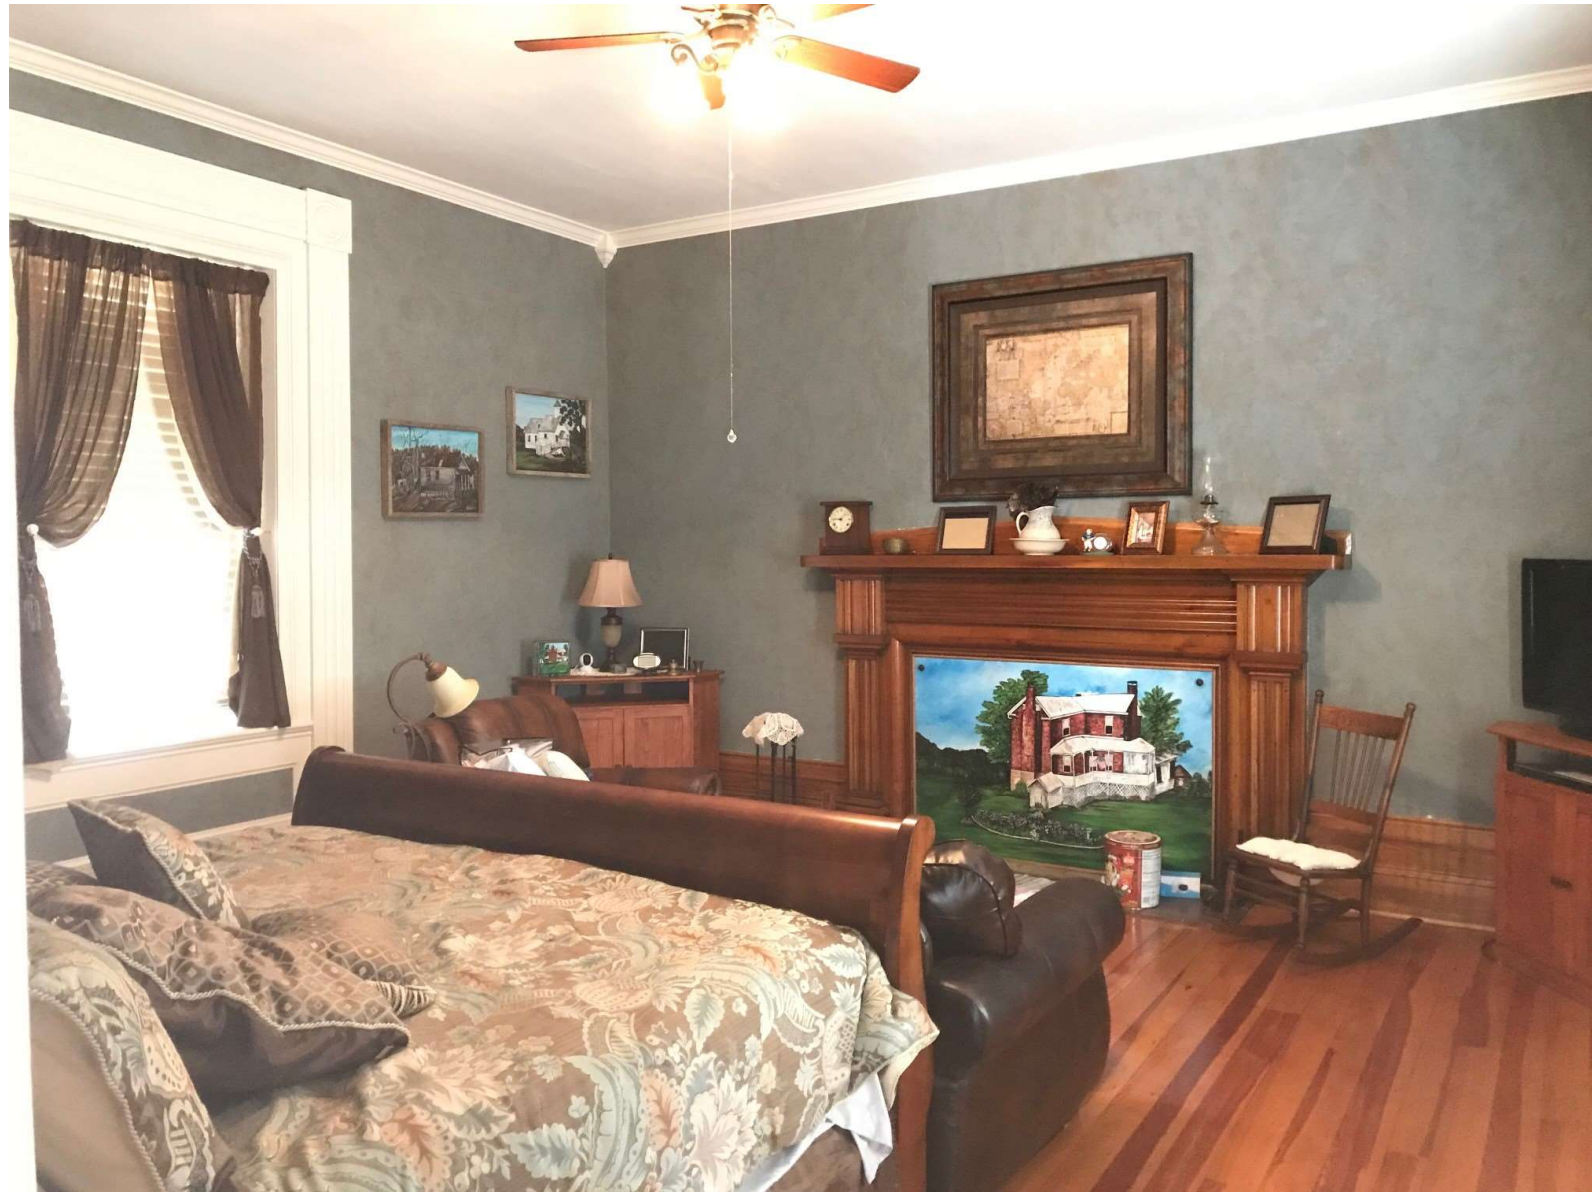
# CASEMENTS

- Original:
  - All door casings and window casings are original
  - Rosettes were included in all door and window casings

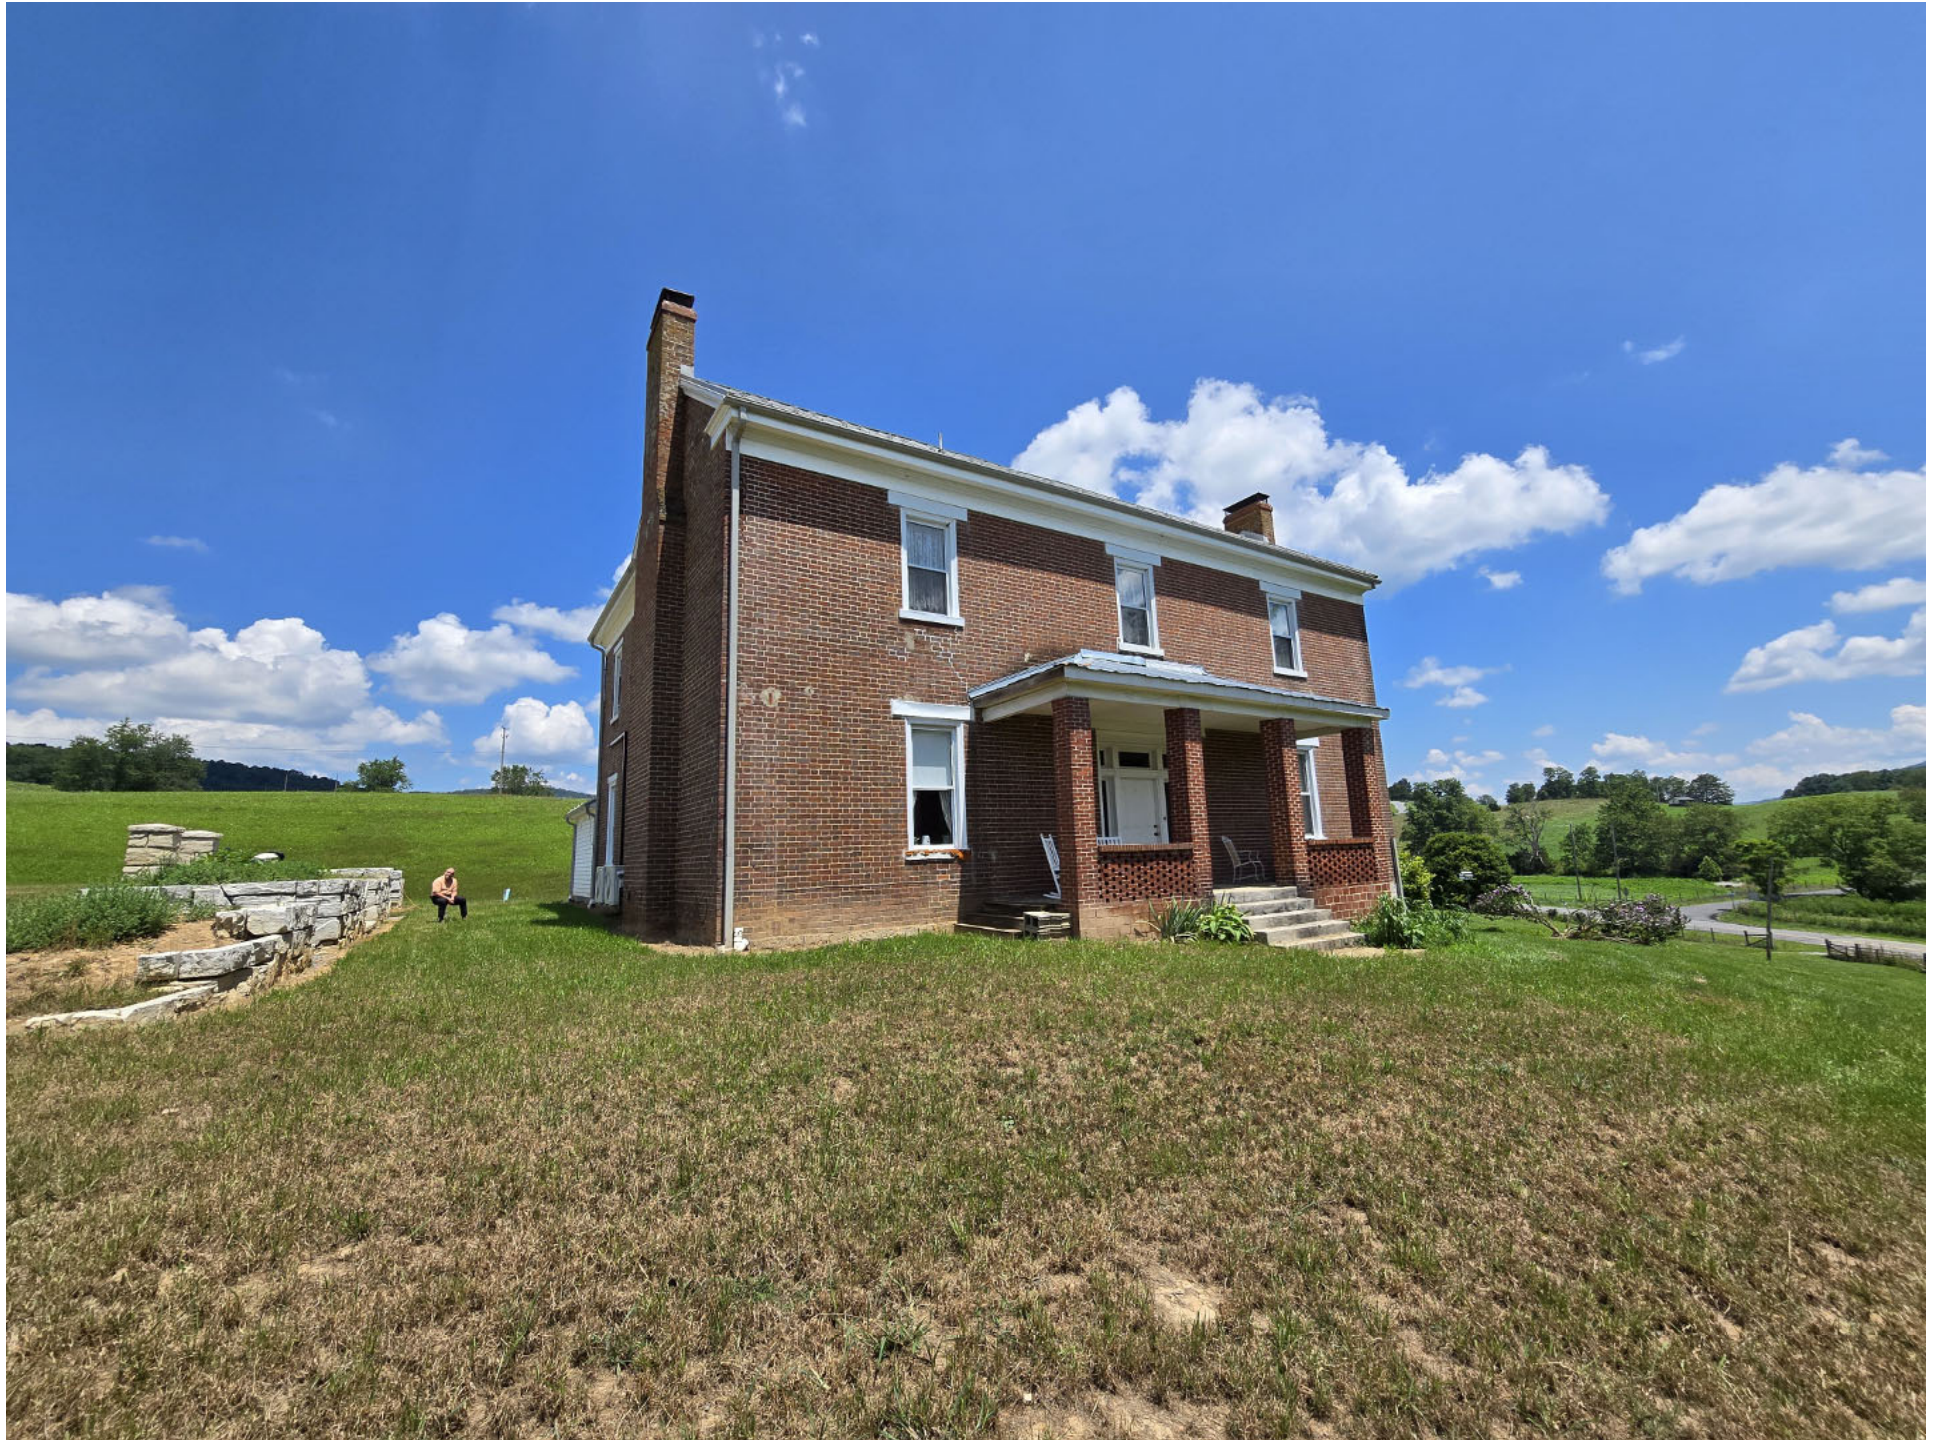
# KITCHEN

- Original:
  - Fireplace mantle
  - Window casings
  - Doors
  - Plaster walls
  - Floor trim/molding
- Modifications:
  - Electricity and plumbin in 1930's
  - HVAC
  - Sheetrock ceiling
  - Replaced rotted floor
