PRELIMINARY INFORMATION FORM (PIF) for INDIVIDUAL PROPERTIES

Property name: Montcalm Farm

Property address: 16473 Hillsboro Rd.

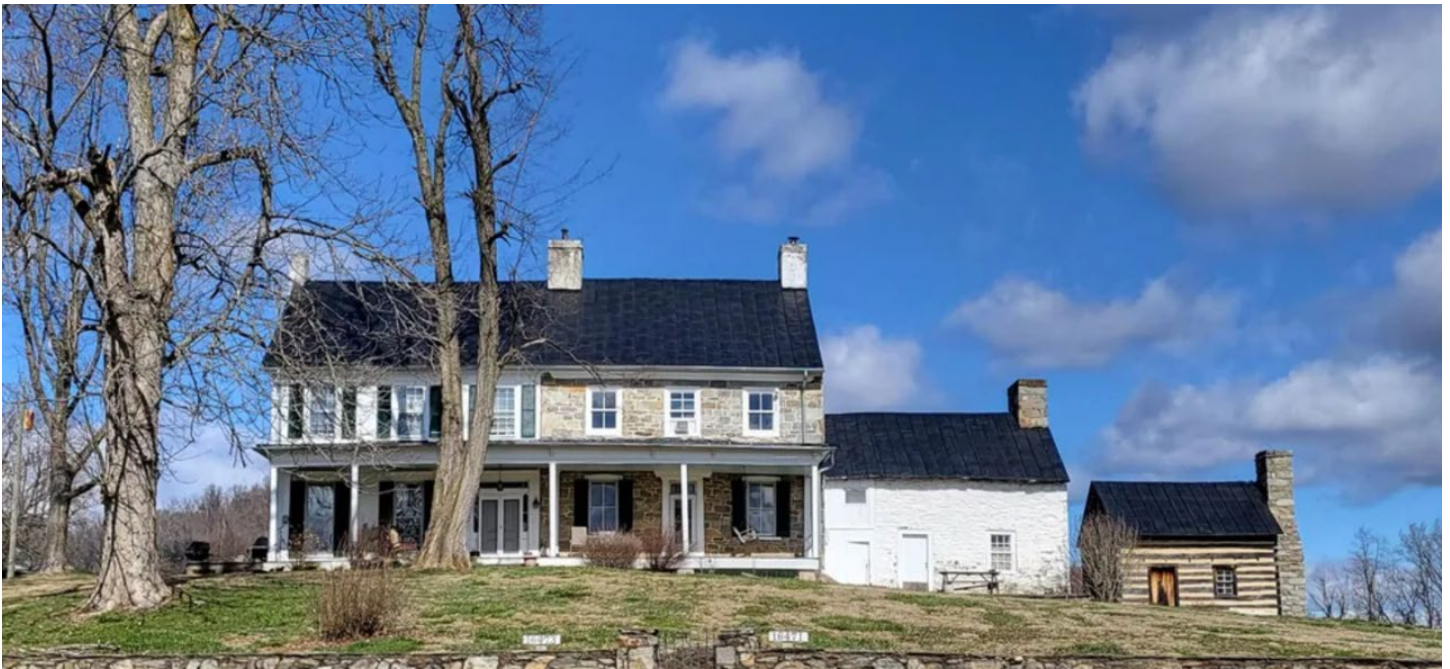
Montcalm Farm's historic domestic and agricultural buildings are clustered near the center of the farmstead. The primary residence is a multi-part "telescoping" house composed of several connected structures constructed in successive periods between the late eighteenth and mid-nineteenth centuries.

EXHIBIT 2: SOUTH (FRONT) FACADES OF TELESCOPING HOUSE COMPLEX

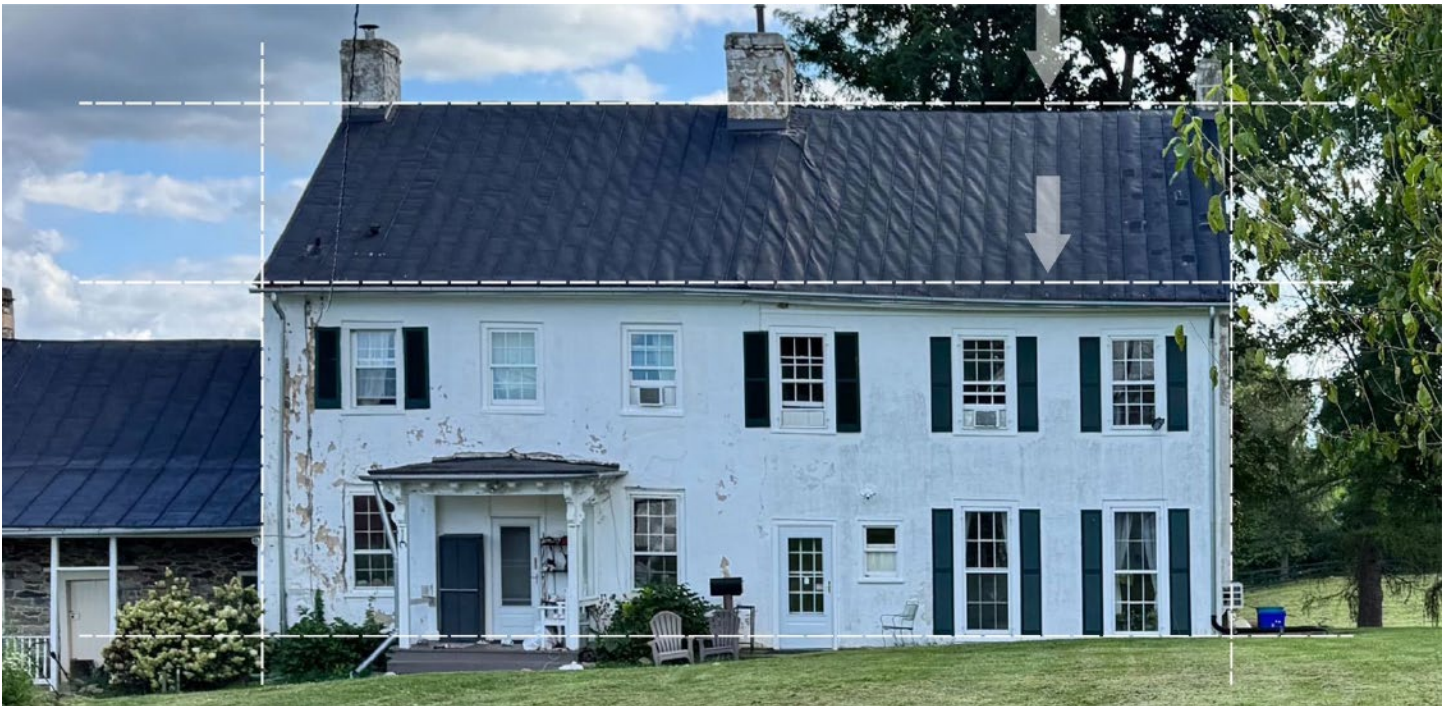
EXHIBIT 3: NORTH (REAR) FACADES OF MAIN HOUSE AND BALLROOM

- C. MAIN HOUSE (coursed fieldstone). Condition: Good. Minor deviation in floor elevations. See 2024 structural engineer's report.
- D. BALLROOM ADDITION (wood-framed). Condition: Differential settlement of foundation will require house lifting and foundation repair.

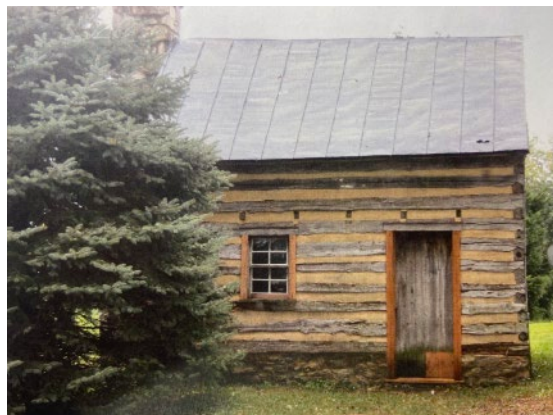
EXHIBIT 4: LOG CABIN NORTH

- A. LOG CABIN: Condition: Restored circa 1985 (Recognized by the Loudoun Preservation Society)
- B. STONE KITCHEN (uncoursed rubble fieldstone masonry). Condition: Stone is structurally sound but flooring and plaster ceiling are failing.

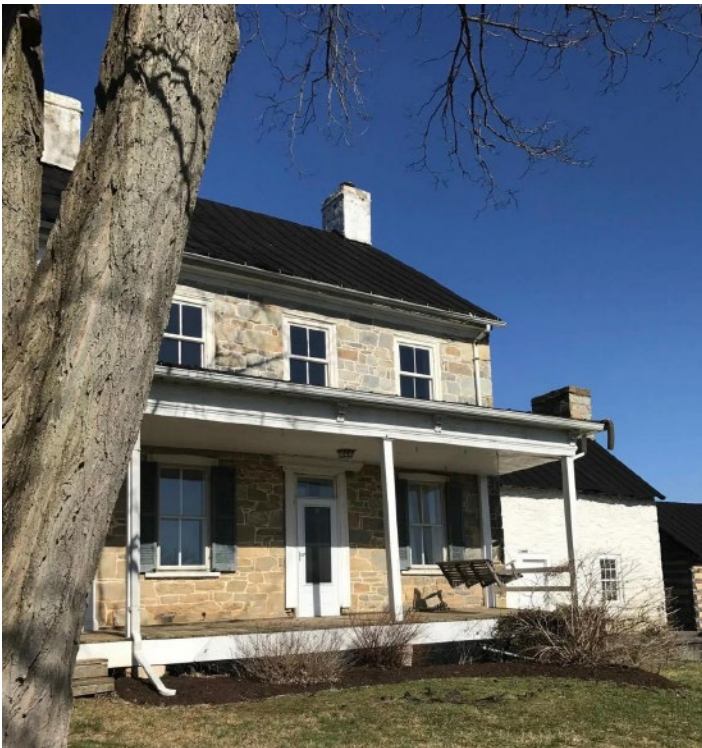
EXHIBIT 6: MAIN HOUSE SOUTH DETAIL

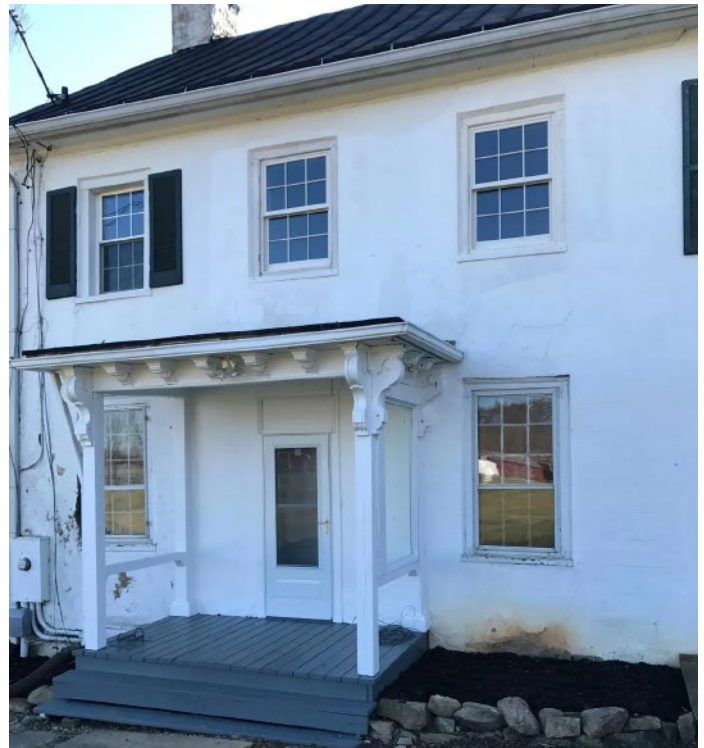
EXHIBIT 7: MAIN HOUSE NORTH DETAIL

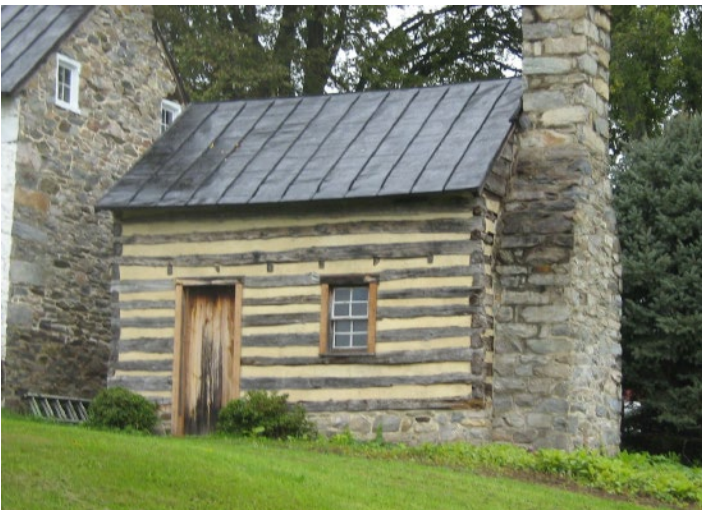
The earliest section is a Log Cabin (Building A), believed to date to the mid-eighteenth century based upon its appearance on a 1758 Plat in Loudoun's Deed Book A, Page 232, 1758. The Log Cabin is constructed of hewn log walls with traditional corner notching and resting on a stone foundation, with a footprint approximately 14'-6" x 17'-2". Original 18th Century nails can be seen in the overhead beams. This structure originally functioned as a standalone dwelling and later served secondary domestic uses. It was restored in 1982 by craftsman Michael Picchione of Maple Crest Co. and won recognition by the Loudoun Preservation Society.

EXHIBIT 8: LOG CABIN SOUTH FACADE

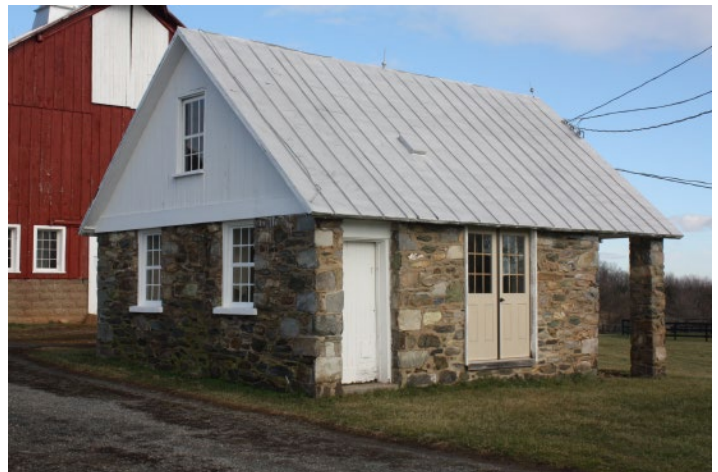
EXHIBIT 9: MILK HOUSE LOOKING N-E

- J. MILK BOTTLING HOUSE (coursed fieldstone). Condition: Good.
- K. DAIRY BARN (timber-framed). Condition: Good.
- L. CALF BARN (CMU, gambrel roof). Condition: Good.

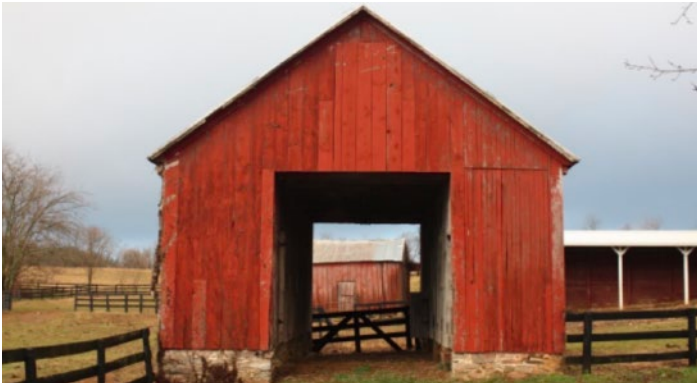
EXHIBIT 11: BANK BARN LOOKING N-W

- F. RUN-IN SHED #1 (wood-framed). Condition: Good. Constructed in the early 1990s.
- G. BANK BARN (timber-framed). Condition: Good.
- H. CORN CRIB (timber-framed). Condition: Good.

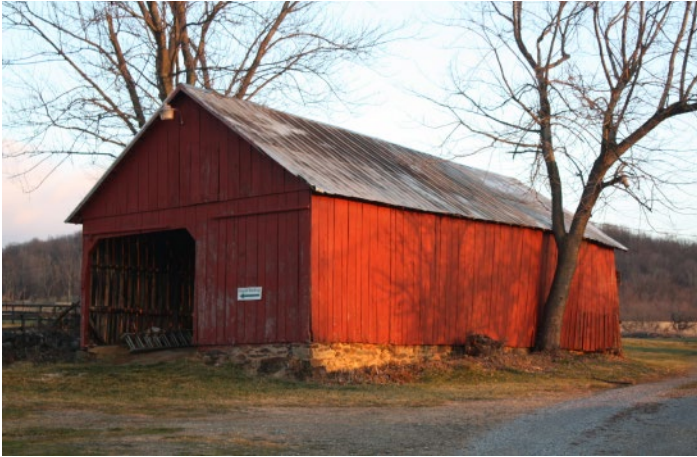
EXHIBIT 13: PIG STY EAST FACADE

- E. PIG STY (log-cabin style structure, clad with vertical wood planks): Condition: Situated in a flood plain and in need of lifting and a proper foundation. Standing seam metal roof will need to be repaired/replaced.

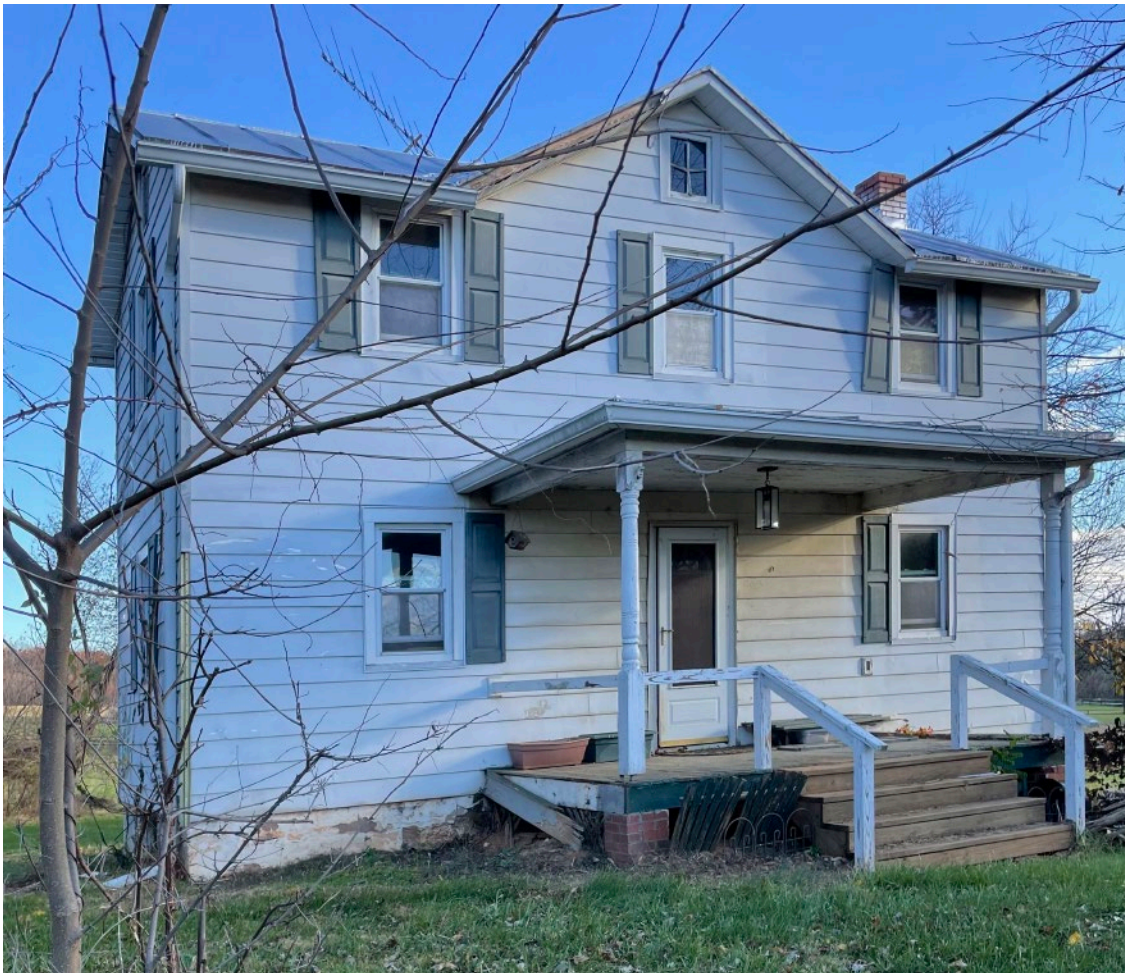
- M. RUN-IN SHED #2 (wood-framed). Condition: Good
- N. TENANT HOUSE (wood-framed). Condition: Fair. In need of proper water-resistant barrier and replacement of siding (presently aluminum). Roof in need of replacement.

EXHIBIT 15B: TENANT HOUSE (PRESENT DAY)

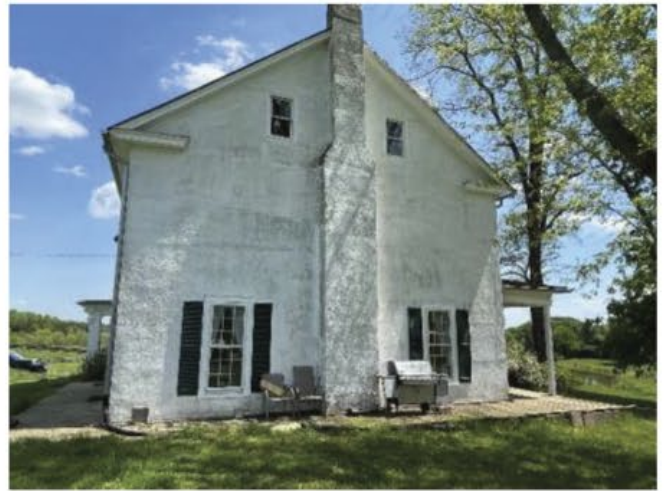
A wood-frame addition known as the "Ballroom" (Building D) was added circa 1865, extending the dwelling and completing the telescoping form. This addition is of stucco over wood-frame construction and reflects post-Civil War domestic expansion. Together, Buildings A through D form a single, integrated residence exceeding 5,000 square feet, unified by functional circulation and long-term domestic use. Despite incremental additions, the overall form, materials, and workmanship retain a high degree of historic integrity. The complex is representative of what Gerald Foster calls a "Telescope House" on Page 88 of his [American Houses: A Field Guide to the Architecture of the Home](#).

EXHIBIT 46: BALLROOM WEST FACADE

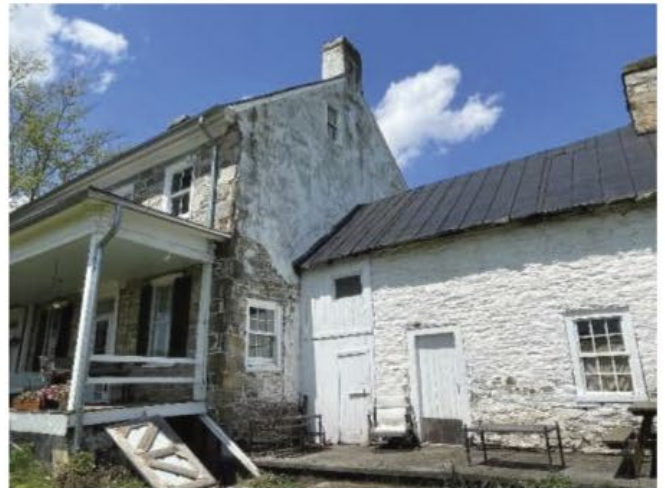
To the west of the Log Cabin is the 1 1/2 story Stone Kitchen (Building B), constructed of locally quarried fieldstone with lime mortar, followed by the principal two-story, stone Main House (Building C), which dates from 1822 (note: an 1822 "Coronet Head" One Cent coin was discovered during a window restoration project in 2016). The Main House is built of coursed rubble stone, set on a stone foundation, and exhibits restrained vernacular Mid-Atlantic Georgian proportions. Exterior features include a gable roof, symmetrically arranged fenestration, and simple stone lintels and sills. Interior finishes historically included plaster walls, wood floors, and modest trim reflective of rural Loudoun County construction of the period.

EXHIBIT 48: STONE KITCHEN SOUTH

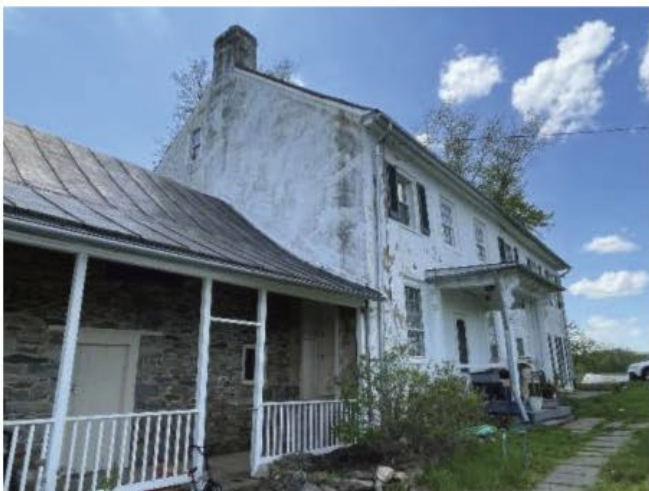
EXHIBIT 49: STONE KITCHEN NORTH
