Cedar Lane
Name of Property
New Kent County, Virginia
County and State
100000985
NR Reference Number

## Introduction

Cedar Lane, located at 9040 New Kent Highway in New Kent County, Virginia, was listed in the Virginia Landmarks Register in 2016 and the National Register of Historic Places in 2017. The property includes one resource, the manor house, which is situated on a low knoll about  $\frac{1}{4}$ -mile north of the highway. Since the property's listing, repairs and rehabilitation work at Cedar Lane have revealed new information about the construction of the primary dwelling. This additional documentation, prepared by architectural historian and State Review Board member Dr. Carl Lounsbury after a site visit to the property, updates and clarifies the construction and evolution of Cedar Lane from the second quarter of the 19<sup>th</sup> century through the early 20<sup>th</sup> century. Alterations made in the early twentieth century, including a small addition, are largely in keeping with the alterations discussed in the original nomination, but are explained further below. The most recent alterations occurred in 2017-2018 to accommodate renewed residential use.

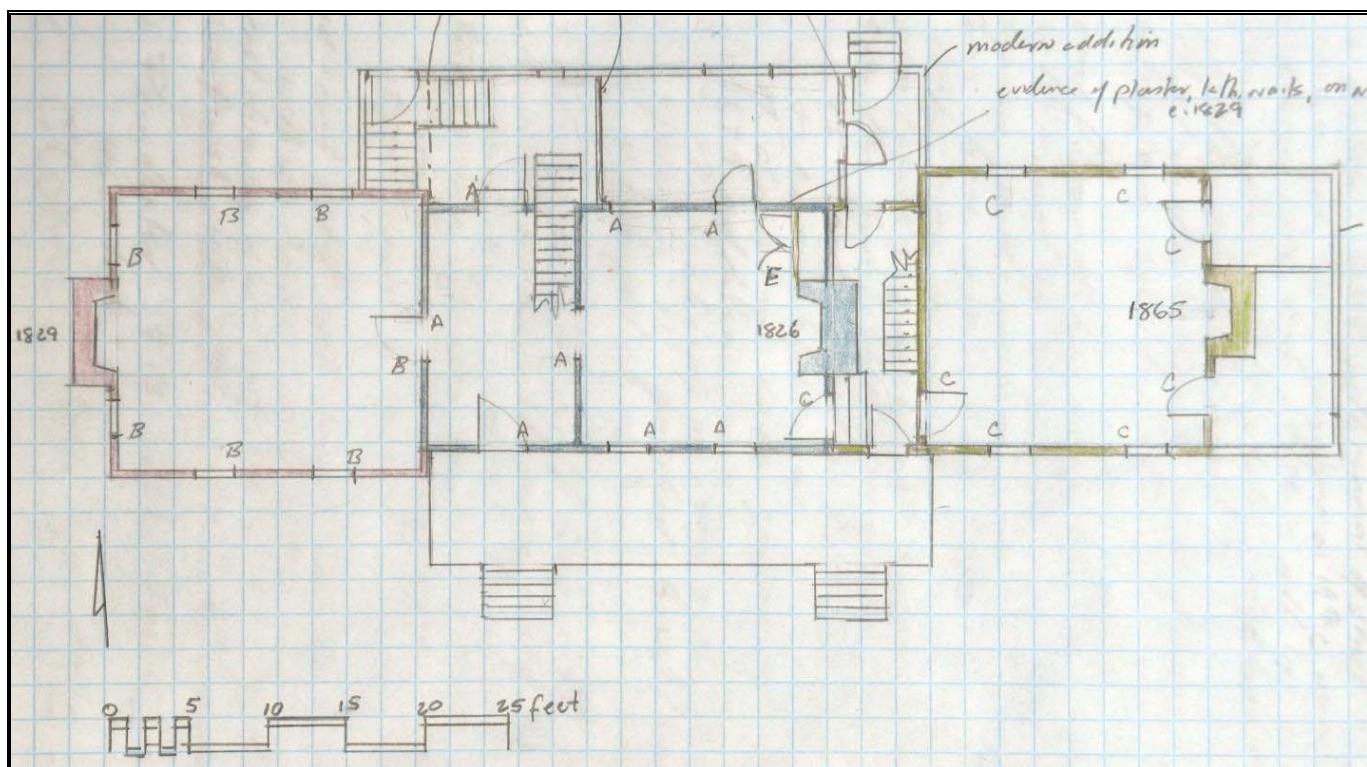
**Figure 1. Floor Plan with Construction Dates. Prepared in 2017 by Carl Lounsbury.**

Cedar Lane's irregular massing, stretching nearly 80 feet in length, reflects a series of additions and alterations made to the original central section of the house during the 19<sup>th</sup> and early 20<sup>th</sup> centuries (Figure 1). Built in 1826 as a modest 26- by 16-foot, one-story, side-passage house rising from a raised cellar foundation, the dwelling nearly doubled in size three years later with the addition of a 1½-story wing to the west and an 8-foot-deep, enclosed shed addition on the north (rear) side. At the end of the Civil War, the house was substantially altered when an 18-foot-square outbuilding was moved to the east side of the house and connected via 5-foot, 6-inch-wide entrance bay added to the east (side) end of the original 1826 block. At the same time, the original block was raised to two full stories. In the late 19<sup>th</sup> or early 20<sup>th</sup> century, a 6-foot, 6-inch by 18-foot enclosed shed was added to the east wing's east

The trim around the original door and window openings consists of a single architrave with a quirked ovolo back band with an astragal with a half-inch bead at the jamb (See architrave Type A at left in Figure 2 and on plan in Figure 1). The raised-panel doors are hung with butt hinges, but the one opening between the passage and original room has evidence of being hung earlier with HL side hinges.

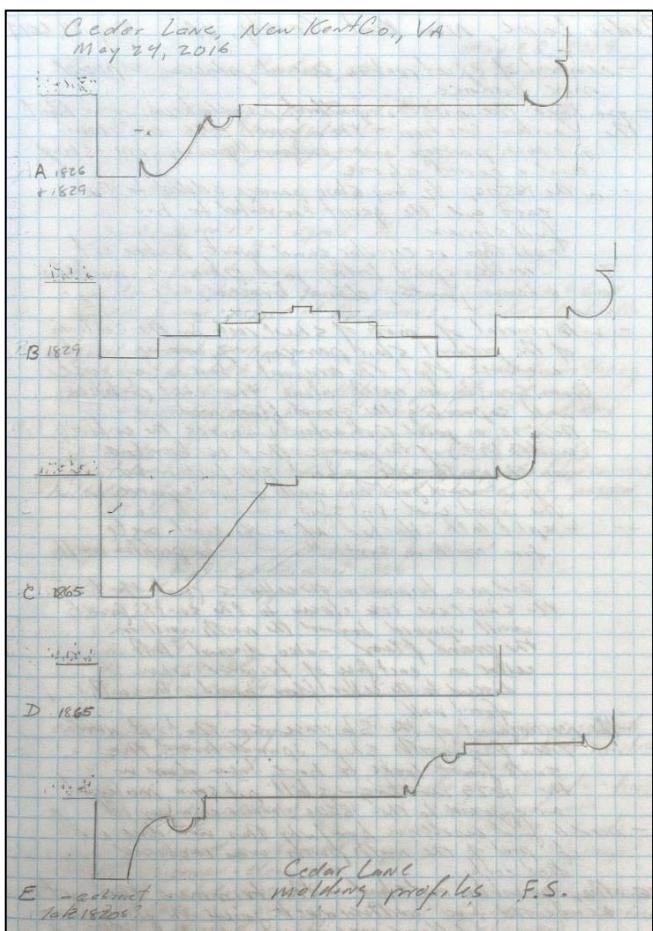
Figure 2. Architrave Profiles A, B, C, D, and E.

Prepared in 2017 by Carl Lounsbury.

Architrave Type B, Figure 2). The chimneypiece is similar in form to the one in the 1826 room

With the new west ground-floor room serving as the principal entertaining room or parlor, the old 1826 ground-floor room to the east of the passage was converted into a dining room with the addition of a built-in buffet or china closet in the northeast corner between the chimney breast and the north wall of the room. For the buffet moldings, see Type E (Figure 2).

All the trim in this second-floor bedchamber was modest, consisting of Type D unmolded architraves around the doors and windows (Figure 2). The doors are raised four-panel doors with iron rim locks that have porcelain knobs (Figure 8). Some of the doors are secured by two-knuckle raising hinges, which are often employed when the floor is carpeted. On the south side of the old chimney is a small storage closet built over the south end of the stair passage. The floorboards in the room are laid on top of the old 1826 garret floor.

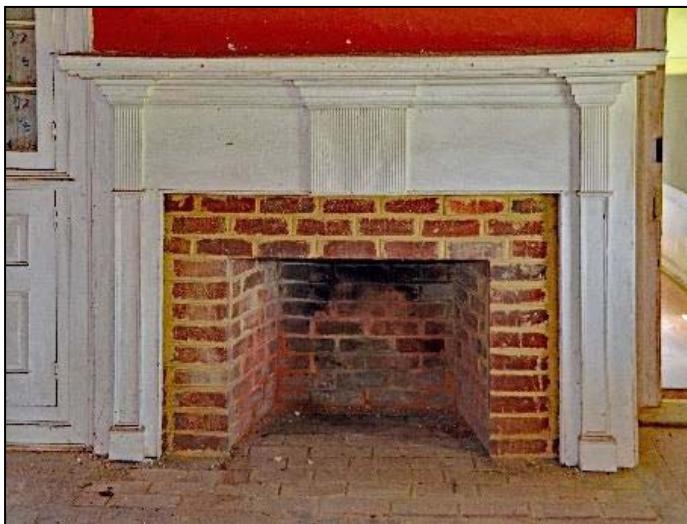
**Figure 3. Chimneypiece with Neoclassical Detailing, 1815-1835.**

The main floor consisted of a single 15-foot, 3-inch square room heated at the east gable end by a partially projecting chimney stack. The original secret or blind nailed Southern yellow pine floorboards survive and run the full length of the room from east to west. The chimneypiece is characteristic of the 1815-1835 period of Neoclassical detailing with flat pilasters, a three-part frieze with reeding, and a molded shelf with quirk moldings (Figure 3). The firebox itself was rebuilt in the late 20<sup>th</sup> century. The room was lit by two windows with single architraves on the south façade and two on the north wall. The easternmost window was originally directly

(Figure 3) across the passage with a three-part frieze resting on recessed pilasters and a shelf supported by a band of quirked Greek moldings.

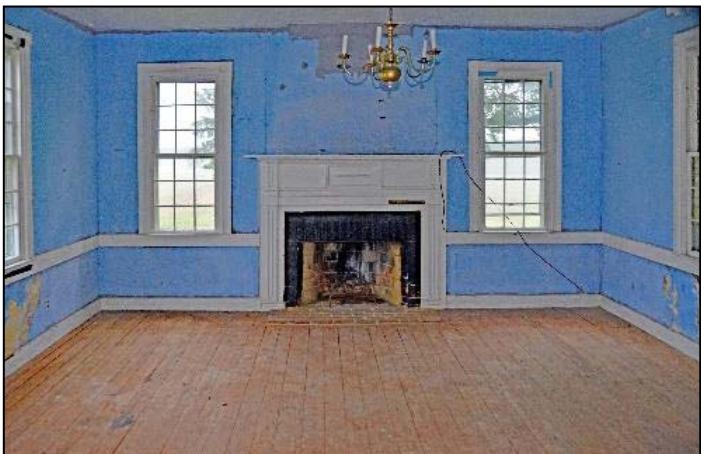
**Figure 4. First Floor, 1829 Wing.**

With a raised cellar to match the original, the new wing was 20-feet long and 2 feet deeper (18 feet, 4 inches) than the original section. Like the original house, the wing was insulated with brick nogging. The ground-floor room was well lit with a pair of windows on the north and south sides as well as a window on each side of the chimney. This was the largest room in the house and became the principal entertaining space, evident in the elaborate symmetrical Greek Revival moldings with corner blocks around the entrance door and the six windows (see

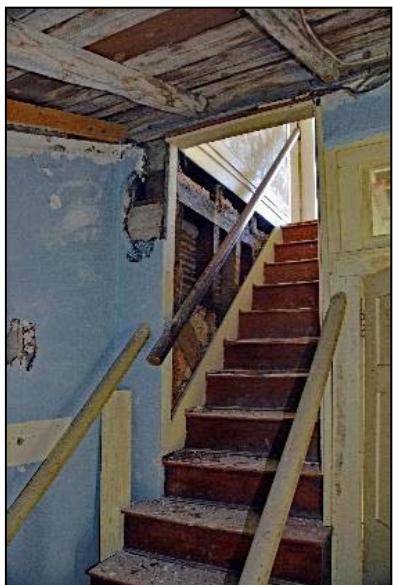
**Figure 5. Staircase Rising from Shed Room to Garrett.**

The addition of the west wing precipitated alterations to the original house. Foremost was the reconfiguration of the staircase in the passage. Whatever the arrangement of the original porch on the back of the house (there was also one on the front as well to provide access to the front door), it was expanded and enclosed to incorporate a large 8-foot deep room that ran the full length of the original house. (Several framing members that supported the flooring of the shed space survive). The old stair carriage was reused and reworked to form a straight run that rose in the shed room toward the front of the house in a north to south direction (Figure 5). The staircase landed in the original garret passage along the east partition wall. The original staircase to the cellar that had been in the northeast corner of the ground-floor passage was removed and the opening was floored over. These new floorboards have a deeper undercutting on their underside than the original ones that survived in the passage and the ground-floor room to the east. With the removal of

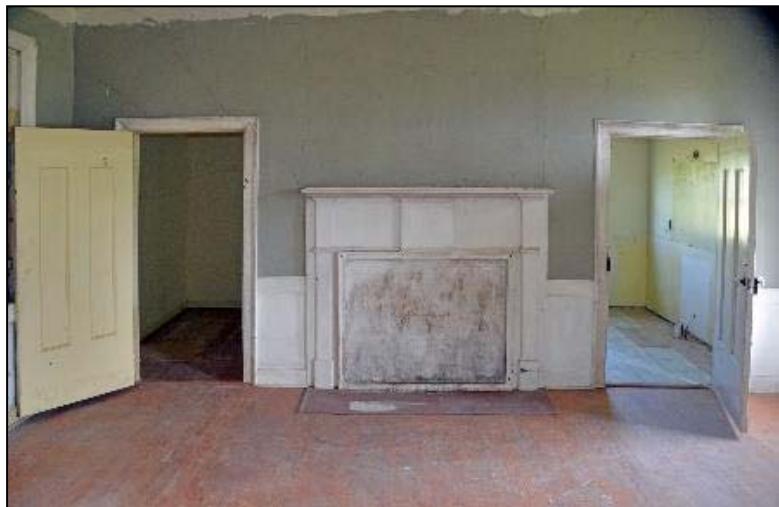
**Figure 6. First-Floor Room in East Addition.**

Just opposite these steps, a door led into a large room with a gable end chimney (1:5 to 1:7 bonding) (Figure 6). The door into the room was a two-panel Greek Revival variety and the door surround and the single architrave trim around the four windows (two on the front and two on the back wall) consisted of a backband with a quirked flat Greek ovoli (see Type C, Figure 2). This room may have served as a parlor or chamber for one set of extended family members or an individual who occupied the eastern part of the house. The room was heated by a fireplace at the east end. The mantel with its three-part unmolded frieze is a simpler version of those installed in earlier parts of the house. The east wing attic with its hewn and pit sawn common rafter roof framing is unfinished and inaccessible except through a small opening high in the east wall of the stair passage.

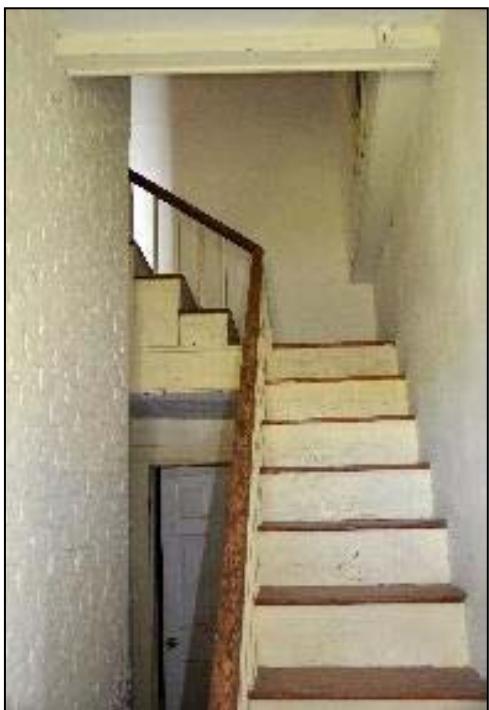
before it turns west at the second-floor level and rises a few additional steps to a doorway cut through the old wall just north of the chimney (Figure 7). This door opens into a bedchamber in the reconstructed second floor of the 1826 section. The area below the staircase was not enclosed at the time and there was no back door at the north end of the passage.

**Figure 7. Staircase in the 1865 East Addition.**

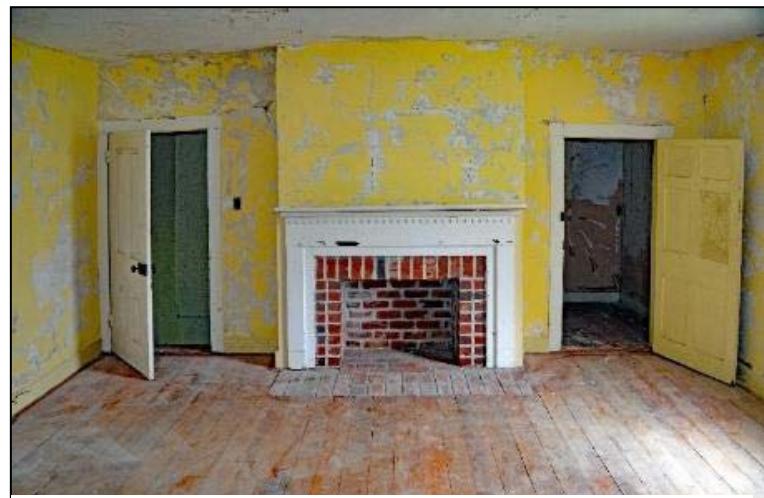
**Figure 8. Second-Floor Bedchamber in 1865 Addition.**
