NATIONAL HISTORIC LANDMARK NOMINATION

HUMPBACK BRIDGE

Historic Name: Humpback Bridge

Street & Number: Spanning Dunlap Creek at bypassed section of former James River & Kanawha Turnpike (later, Midland Trail)

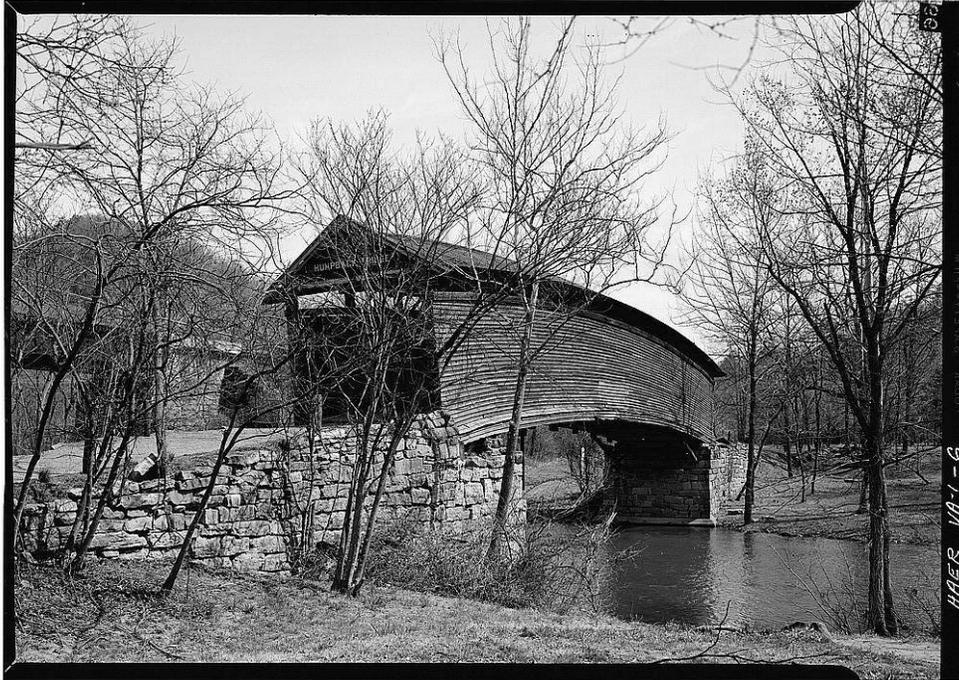
HUMPBACK BRIDGE. General view from southwest.
Photograph by Jack Boucher, 1971

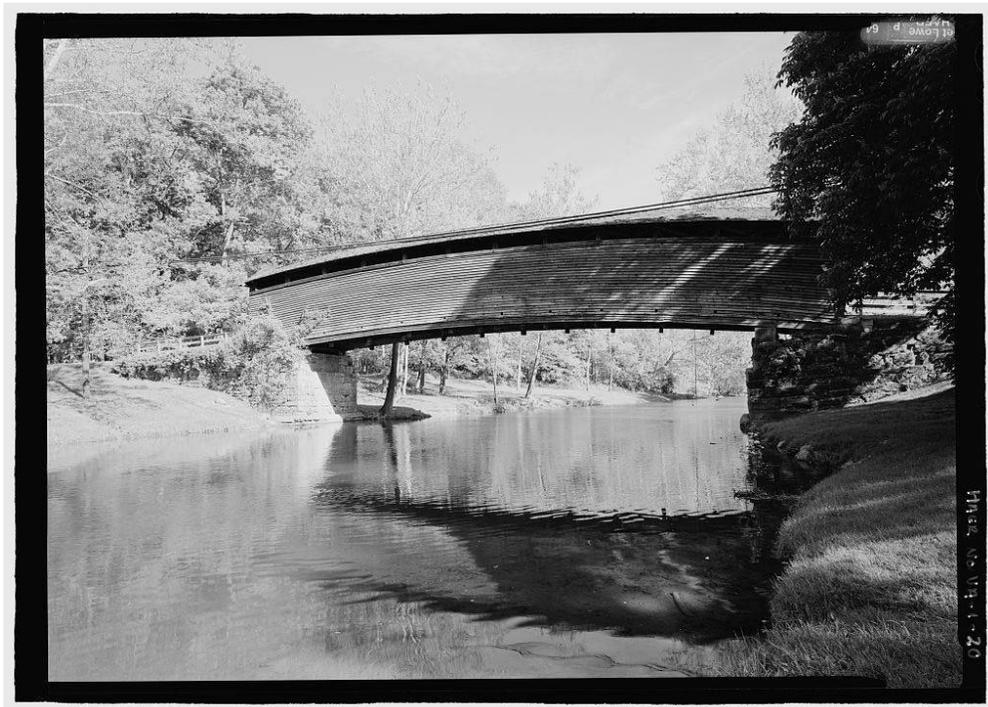
HUMPBACK BRIDGE. Southeast elevation.
Photograph by Jet Lowe, 2002

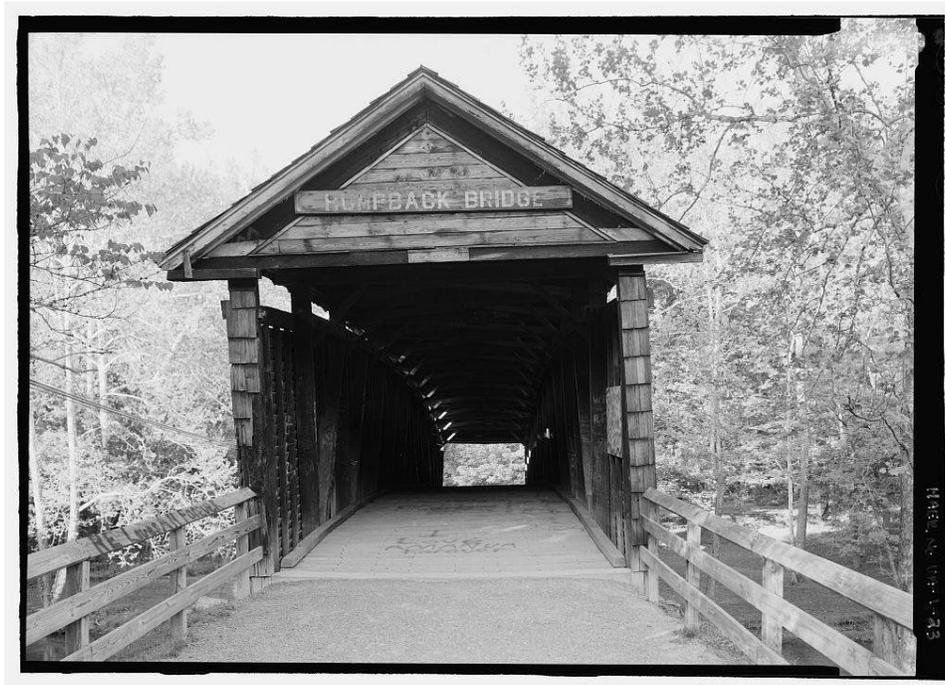
HUMPBACK BRIDGE. West portal elevation.
Photograph by Jet Lowe, 2002

The exterior of the bridge superstructure is covered with clapboard siding nearly to the eaves. The sheathing is fastened to vertical wood nailers on the outer faces of the trusses. The portals have projecting pediments and squared openings. The framing of the portals is set radially, creating an overhanging effect. A wood sign inscribed "HUMPBACK BRIDGE" hangs over each portal.

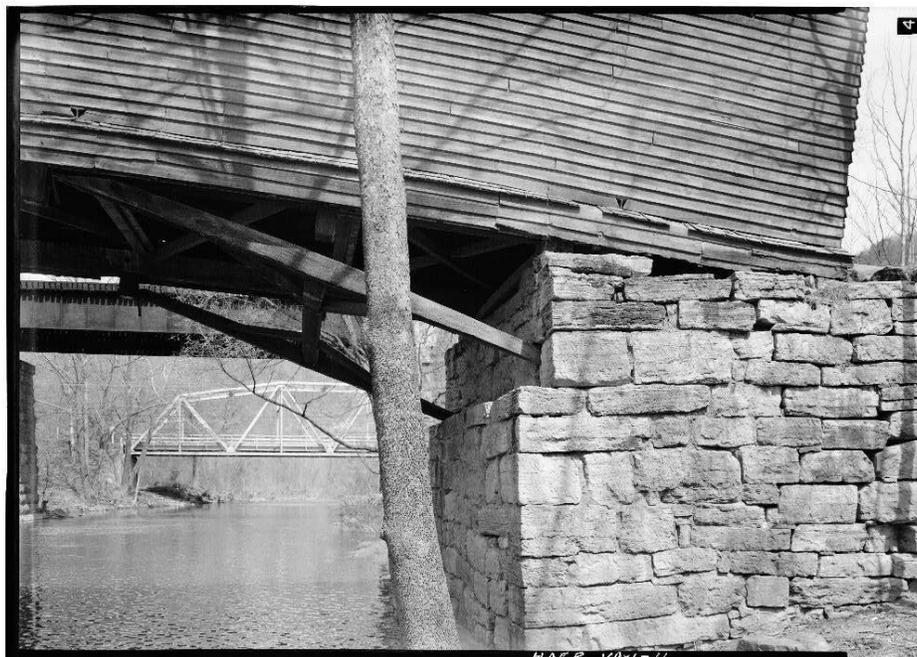
HUMPBACK BRIDGE. Detail of northeast abutment from east.
Photograph by Jack Boucher, 1971

The abutments are squared stone with mortared joints. A small section of the west abutment has been replaced with concrete, but the abutments are otherwise intact. The bottom chords of the bridge rest on bedding timbers on top of the abutment facewall. The backwalls above the abutments and behind the bedding timbers serve as retainers for the roadbed. Stone masonry retaining walls extend approximately 40 feet on each side of the inclined approaches to the bridge. The gravel road is flanked by 3-foot-high board fences, which replaced earlier post-and-cable fences at an unknown date between 1975 and 2002.⁸

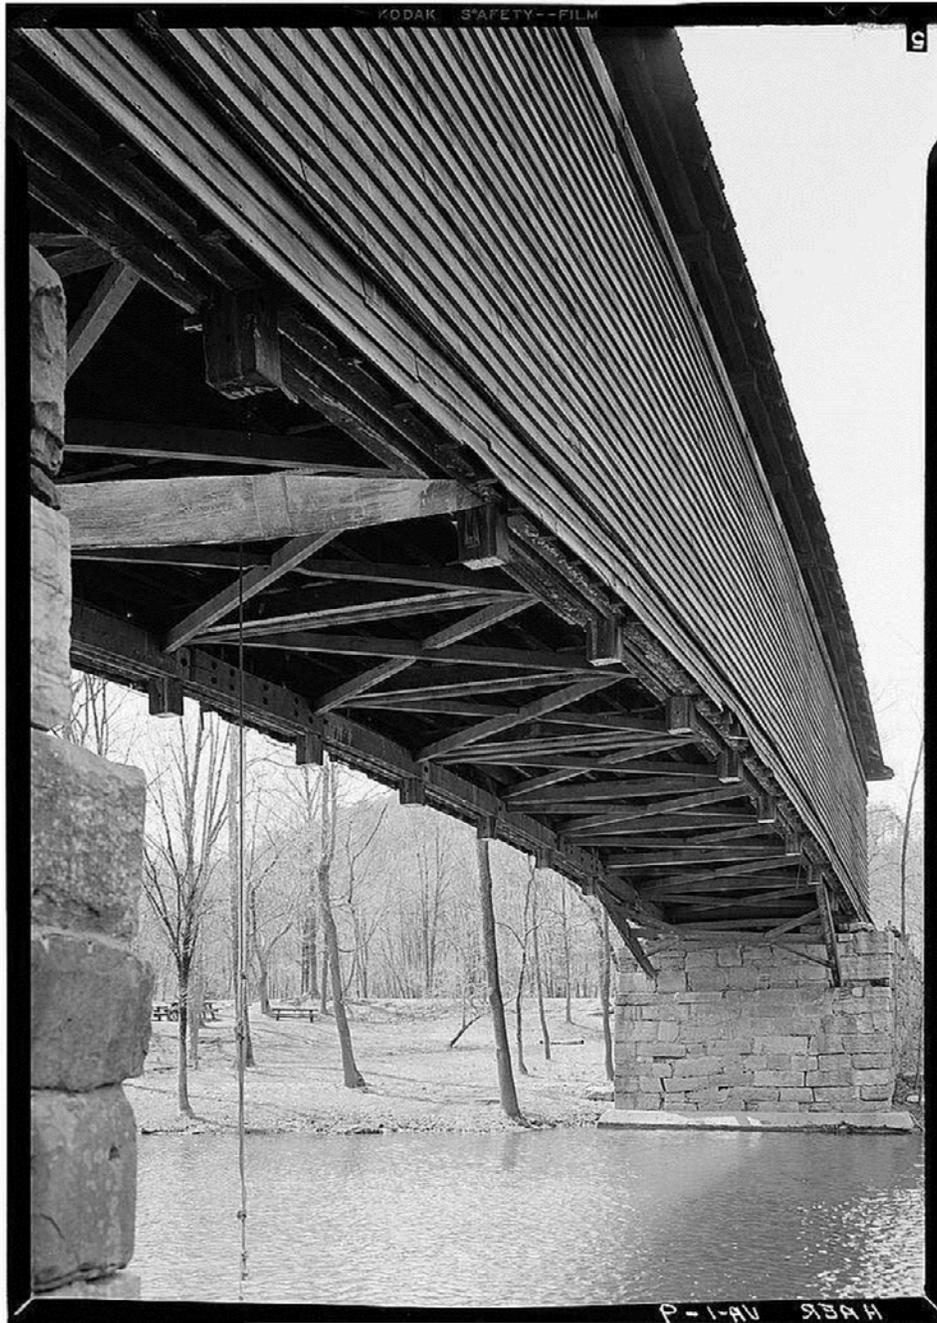
HUMPBAC BRIDGE. Abutments and floor system from southwest.
Photograph by Jack Boucher, 1971

The floor system follows the camber of the bottom chord. Timber 6" x 7½" floor beams are placed transversely at each panel point and rest on the bottom chords. The floor beams are reinforced by 5" x 10" steel I-beams installed as sisters. Lower lateral bracing, made of 4" x 4" sticks, is fastened diagonally between the floor beams. Stringers are laid on top of the floor beams to support the deck. The roadway surface is plank flooring laid transversely on the stringers. A timber brace at each end of the bridge assists in carrying loads back to the abutments. The braces bear on the abutments approximately 5' below the bottom chord seat and meet the superstructure behind the third bottom chord panel point.

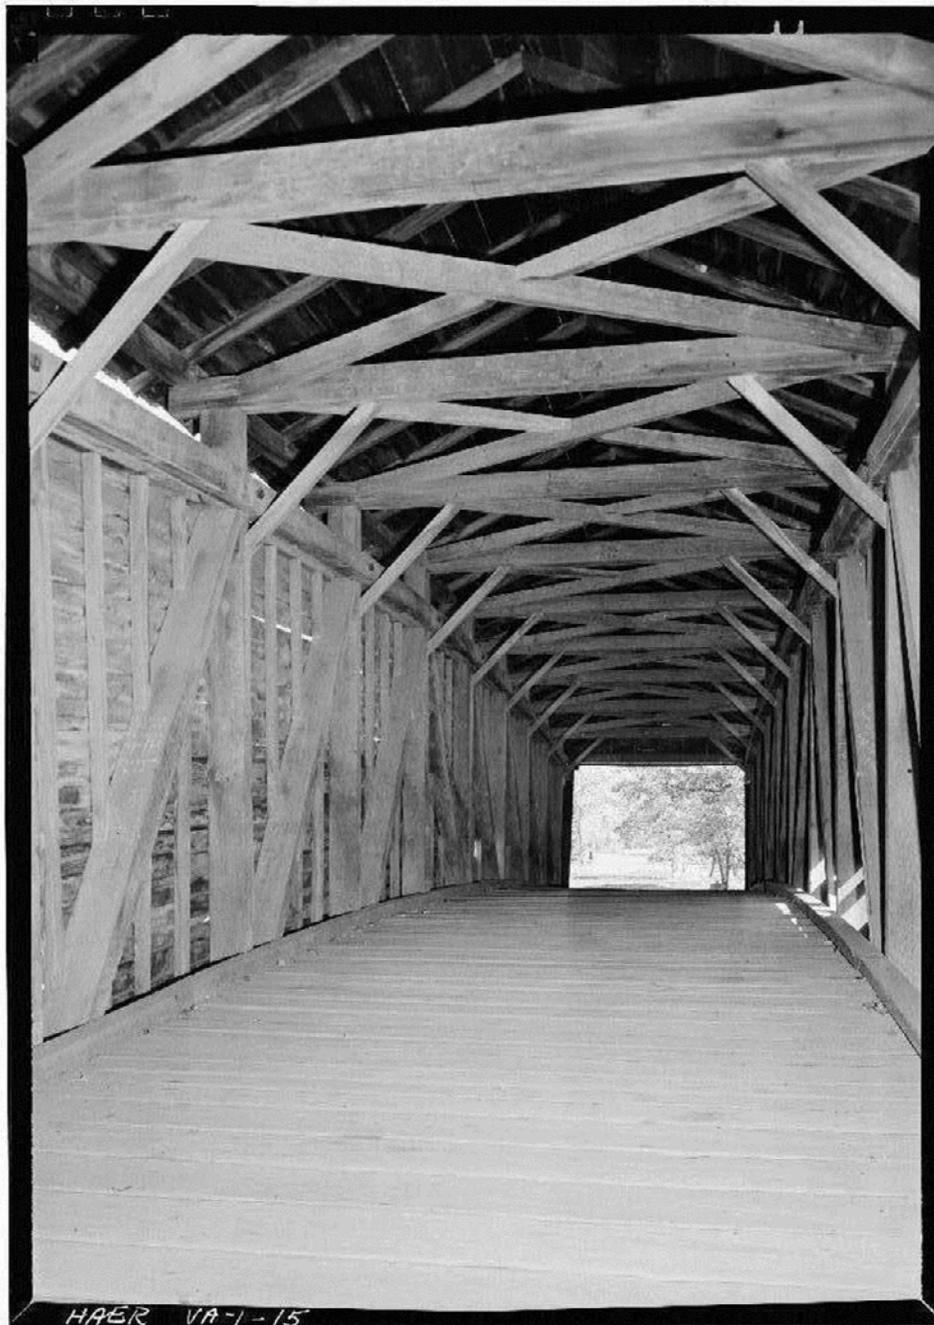
HUMPBAC BRIDGE. General interior view from east portal.
Photograph by Jack Boucher, 1971

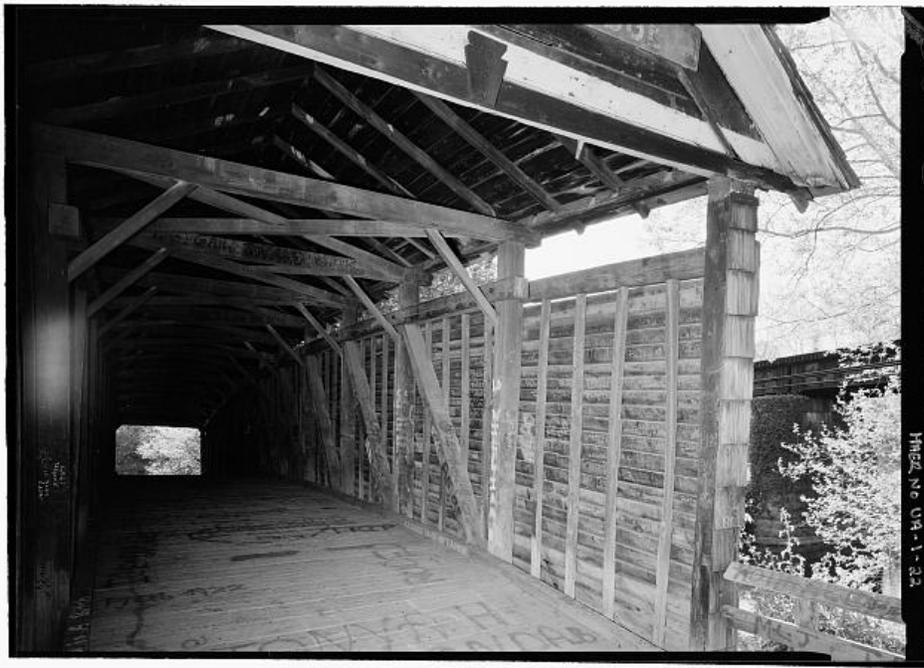
HUMPBACK BRIDGE. Interior view from east portal.
Photograph by Jet Lowe, 2002

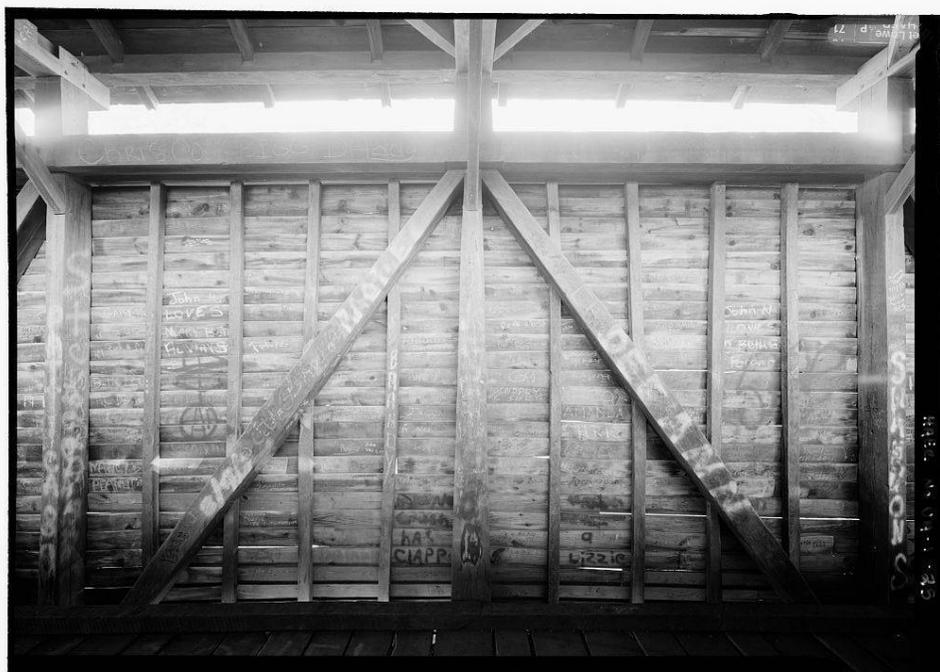
HUMPBACK BRIDGE. Truss detail.
Photograph by Jet Lowe, 2002

The trusses are framed as traditional multiple kingpost trusses, with four braced panels on each side of the central kingpost. There are non-braced shelter panels at each end of the bridge. The trusses are composed of top and bottom chords made of parallel 8" x 8" timbers, connected by 7" x 10" posts, spaced approximately 9' apart and arranged radially. Within each panel is an 8" x 10" diagonal member, which angles up from the bottom chords towards the mid-span of the bridge. The posts pass through the space between the paired chord members, and are fastened with bolts that pass through the chords and posts at each panel point.
