NATIONAL REGISTER OF HISTORIC PLACES
REGISTRATION FORM

historic name Silverbrook Methodist Church

Silverbrook Methodist Church
Fairfax County, Virginia

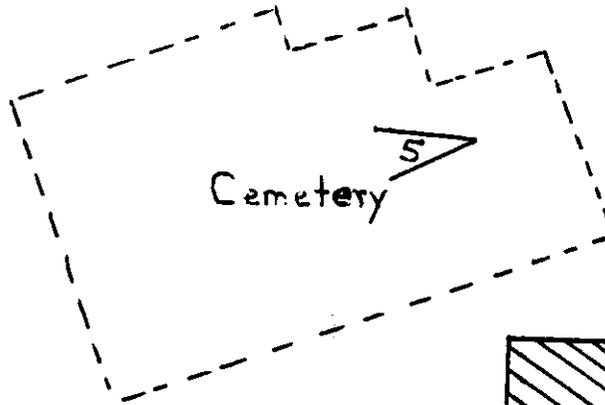
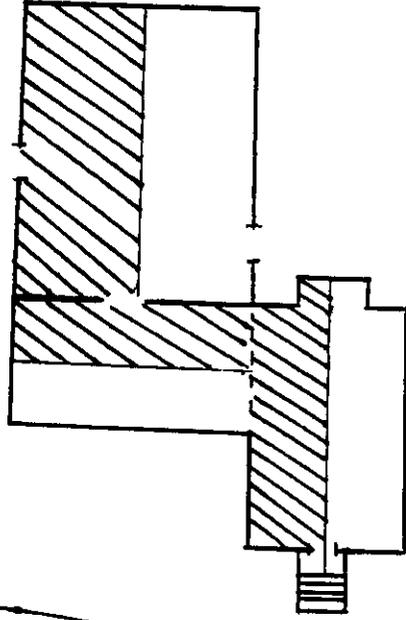
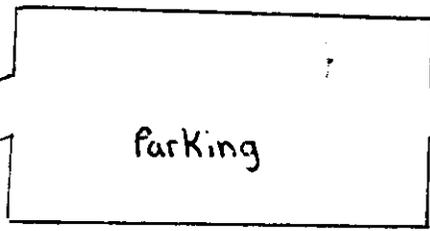
SILVERBROOK CHURCH

parking

Silverbrook Road
State Route #600

The boundary of Silverbrook United Methodist Church includes the original sanctuary with its later additions, two outbuildings, a graveyard, a picnic area, a parking area with driveways, an open grassy space and wooded areas around its perimeter. The boundary has not changed since its beginning.
