**NATIONAL REGISTER OF HISTORIC PLACES
REGISTRATION FORM**

historic name Brightly
other names/site number VDHR 037-0004

street & number 2844 River Road West (State Route 6) not for publication N/A
city or town Goochland vicinity N/A
state Virginia code VA county Goochland code 037 Zip 23063

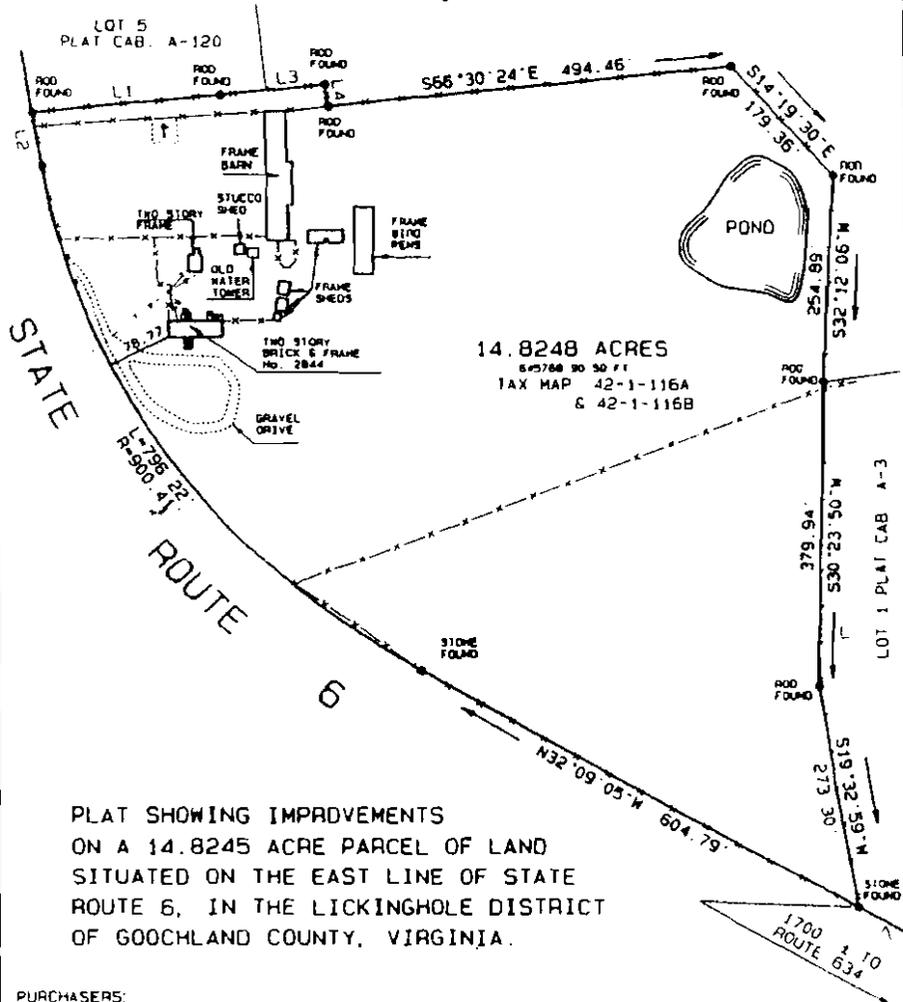
PLAT SHOWING IMPROVEMENTS
 ON A 14.8245 ACRE PARCEL OF LAND
 SITUATED ON THE EAST LINE OF STATE
 ROUTE 6, IN THE LICKINGHOLE DISTRICT
 OF GOOCHLAND COUNTY, VIRGINIA.

FRAME BARN

STUCCO SHED
(PUMP HOUSE)

SLAVE HOUSES

TWO STORY
FRAME - GUEST HOUSE

FRAM BIRD PENS
(NO)

OLD WATER TOWER

AVIARY (NE)

CHICKEN HOUSE

GRAINERY

4-HOLE PRIVY

TWO STORY
BRICK & FRAME
No. 2844

The boundaries of the nominated parcel are portrayed on the USGS Goochland Quadrangle topographic map, and are defined as Goochland County tax parcel numbers 42-1-116A (14.65 acres), 42-1-116B (.18 acres), 42-19-1 (5.28 acres), and 42-21-4 (This parcel takes in a portion of the old parcel known as 42-19-2, as of 2006, 8.76 acres and 2.13 acres). The total of these parcels currently adds up to 31 acres.
