National Register of Historic Places Registration Form

historic name Woodlawn Historic and Archaeological District
other names/site number DHR File No. 48-26

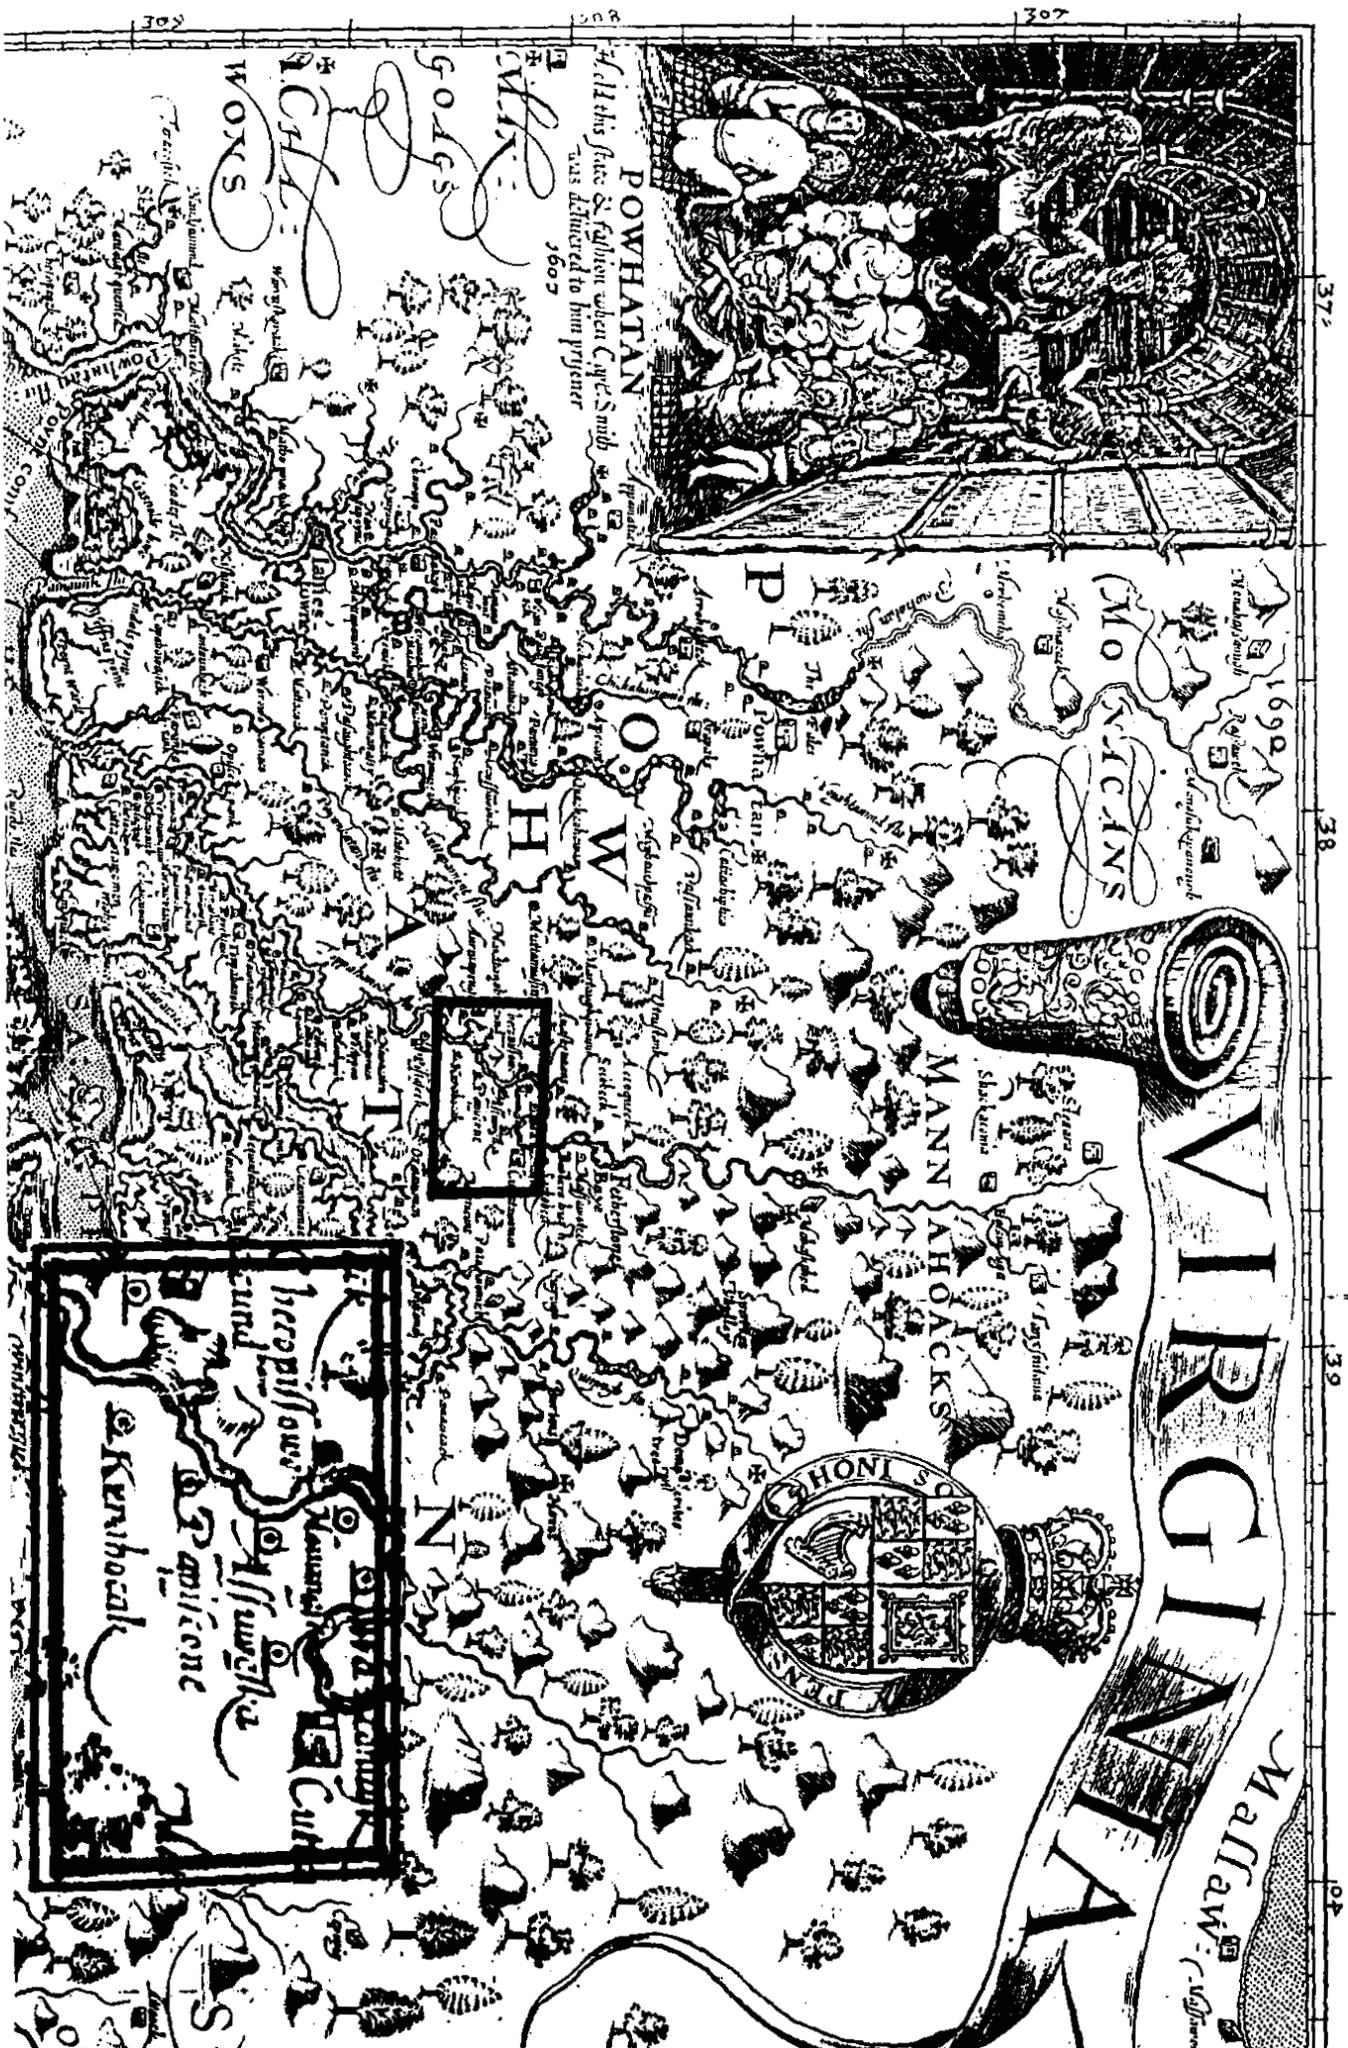
Fig. 1: Papsicone and Assuweska, Woodlawn vicinity, 1610.

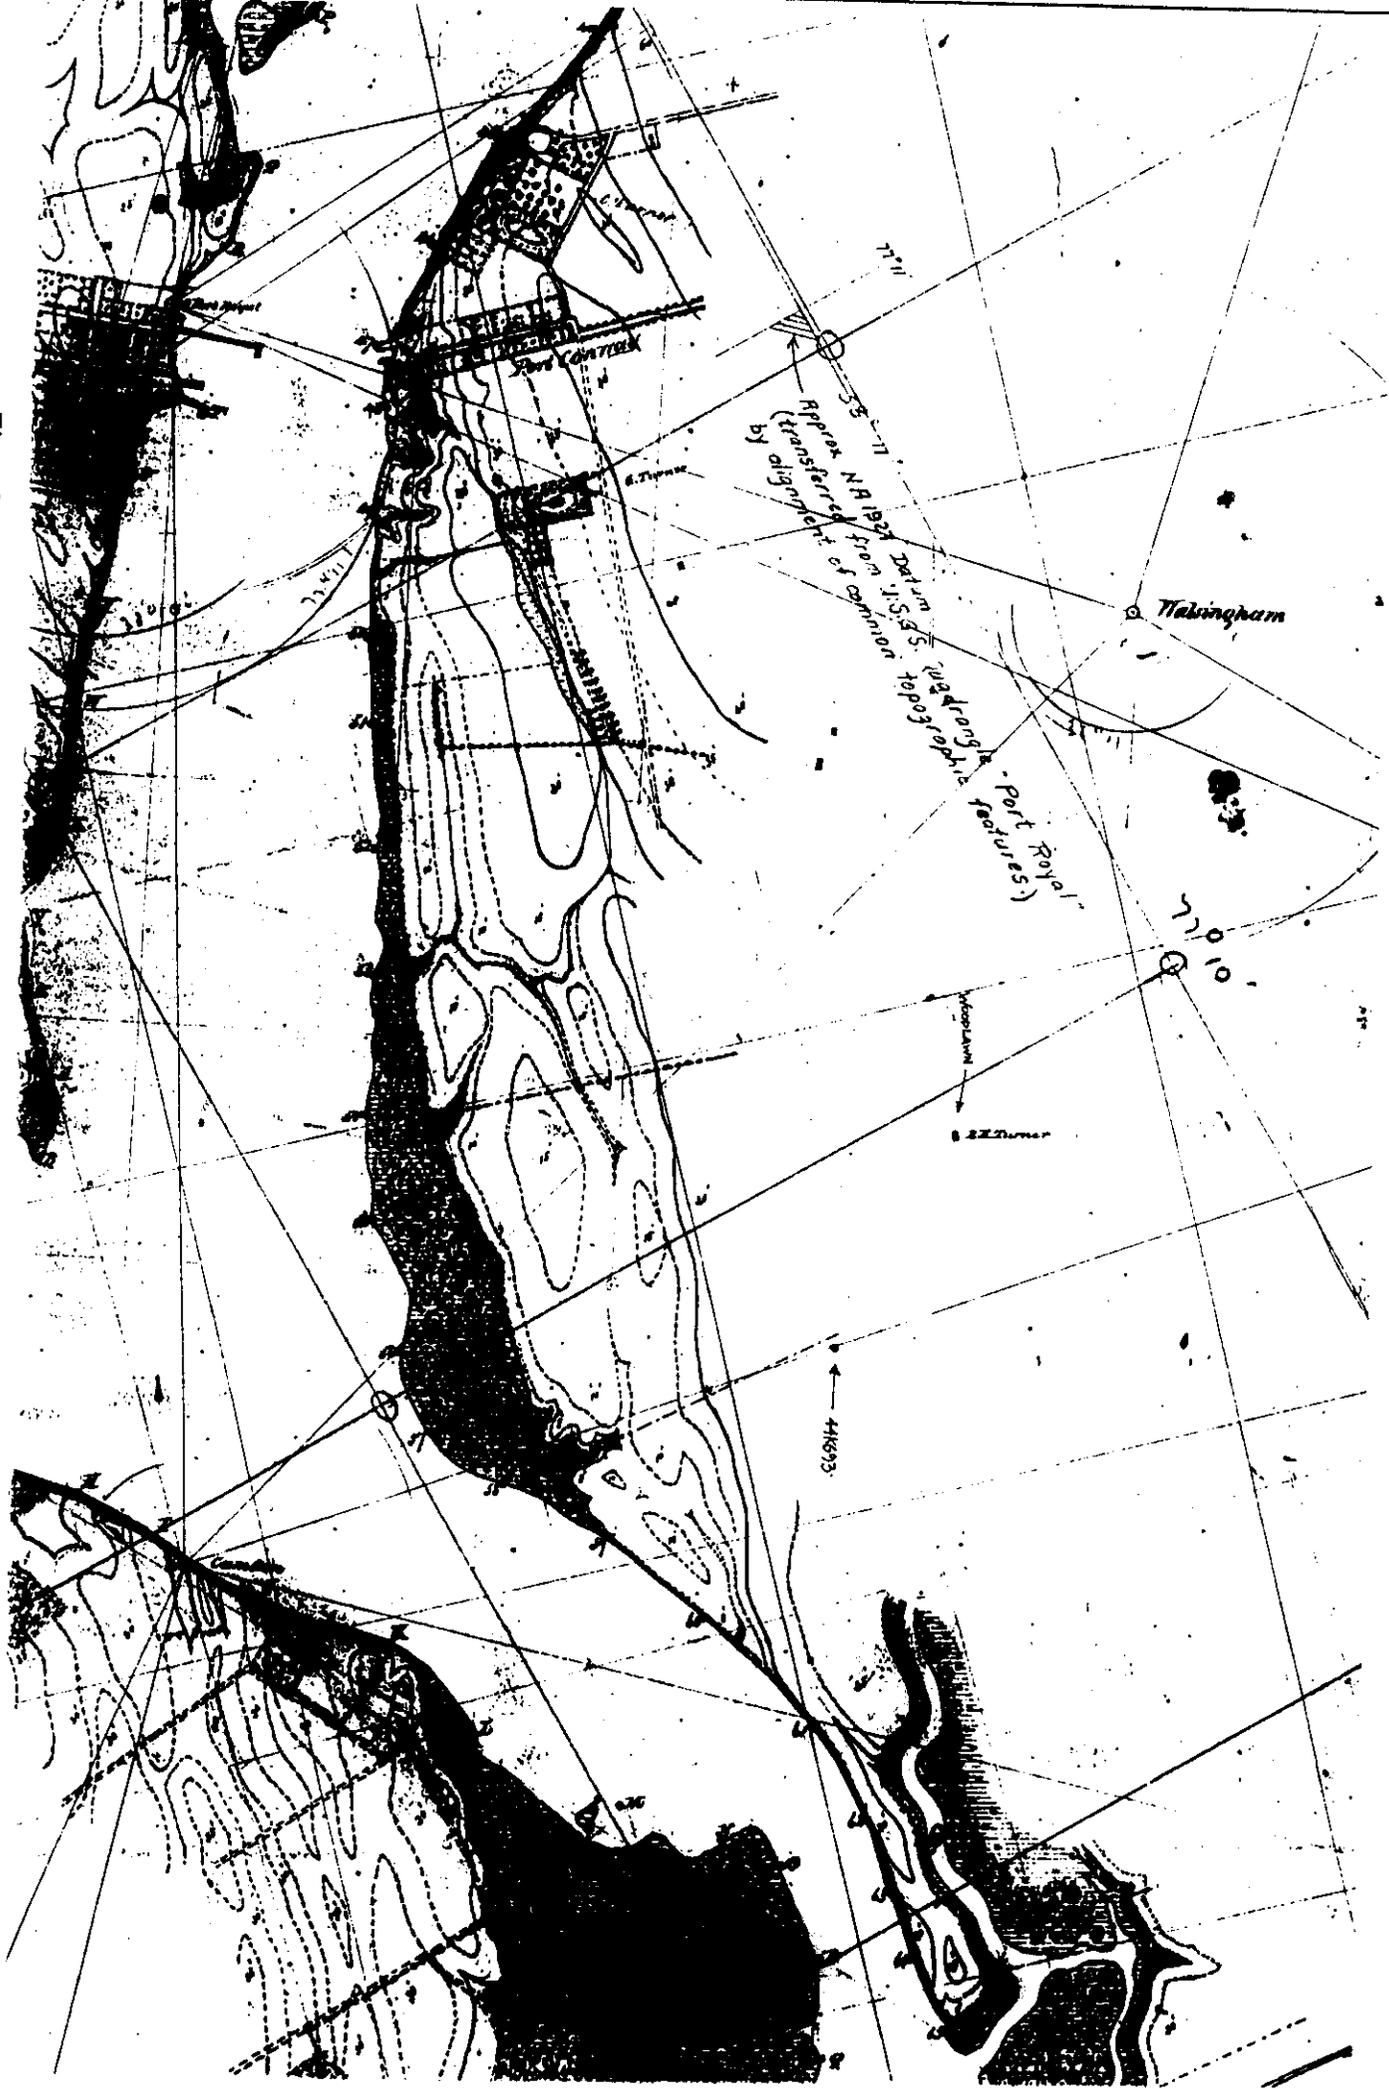
Fig. 2: Woodlawn and vicinity, 1854 coastal survey.

Main House Environs. The house with its primary facade oriented south towards the river is sited 120 meters (3960 feet) from the river, well away from the floodplain. A series of terraces lead to a pond, a landscape feature added in the 1982 rehabilitation. The existing prominent landscape elements are characteristic of those typically associated with a Colonial Revival-type landscape, and include boxwood plantings on the garden facade,¹⁵ a mortared brick patio, and brick walks. These elements probably were added when the house was refurbished in the 1930s. Prior to that time the grounds around the main house likely were more simply planted, as indicated by a series of maps of the Rappahannock River completed in 1856 for the Survey of the Coast of the United States.¹⁶
