# National Register of Historic Places Registration Form

historic name Sunnyside

city or town Clarksville  vicinity

state Virginia code VA county Mecklenburg code 117 zip code 23927

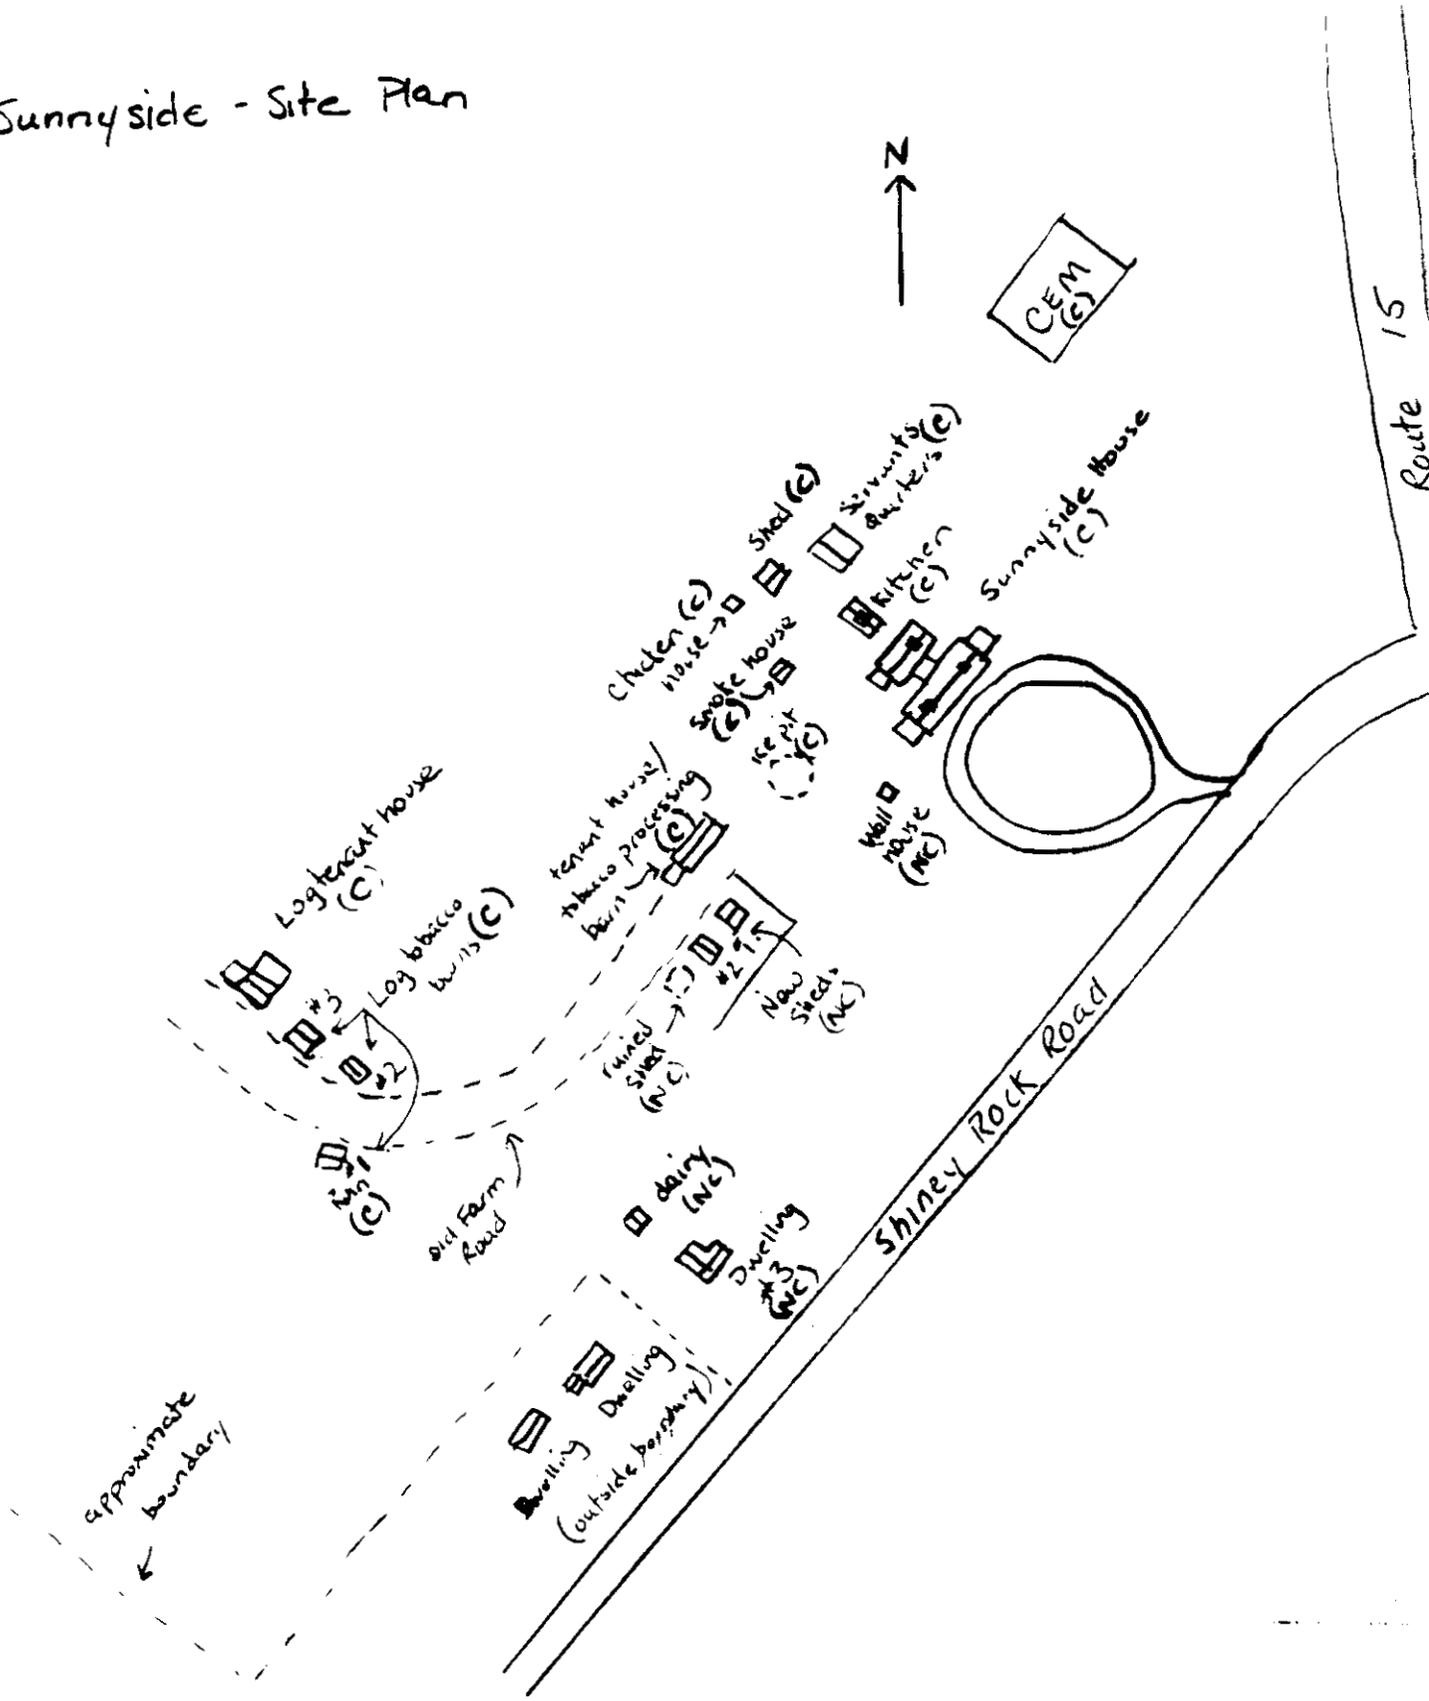
# Sunnyside - Site Plan

Sunnyside is a 25-acre estate which presently includes a plantation house built in stages between 1833-1837; a group of early-nineteenth-century outbuildings and a cemetery behind the house; and a group of nineteenth- and twentieth-century agricultural buildings west of the house along an old farm road.

The property also includes both domestic and agricultural outbuildings. Domestic outbuildings in the yard behind the house include: a late-nineteenth-century kitchen (contributing building); an early-to-mid-nineteenth-century servant's quarter (contributing building); an early-to-mid-nineteenth-century smoke house (contributing building); a mid-nineteenth-century shed (contributing building); an early-twentieth-century chicken house (contributing building); a mid-twentieth-century well house (noncontributing building); and the site of a nineteenth-century ice pit (contributing site).

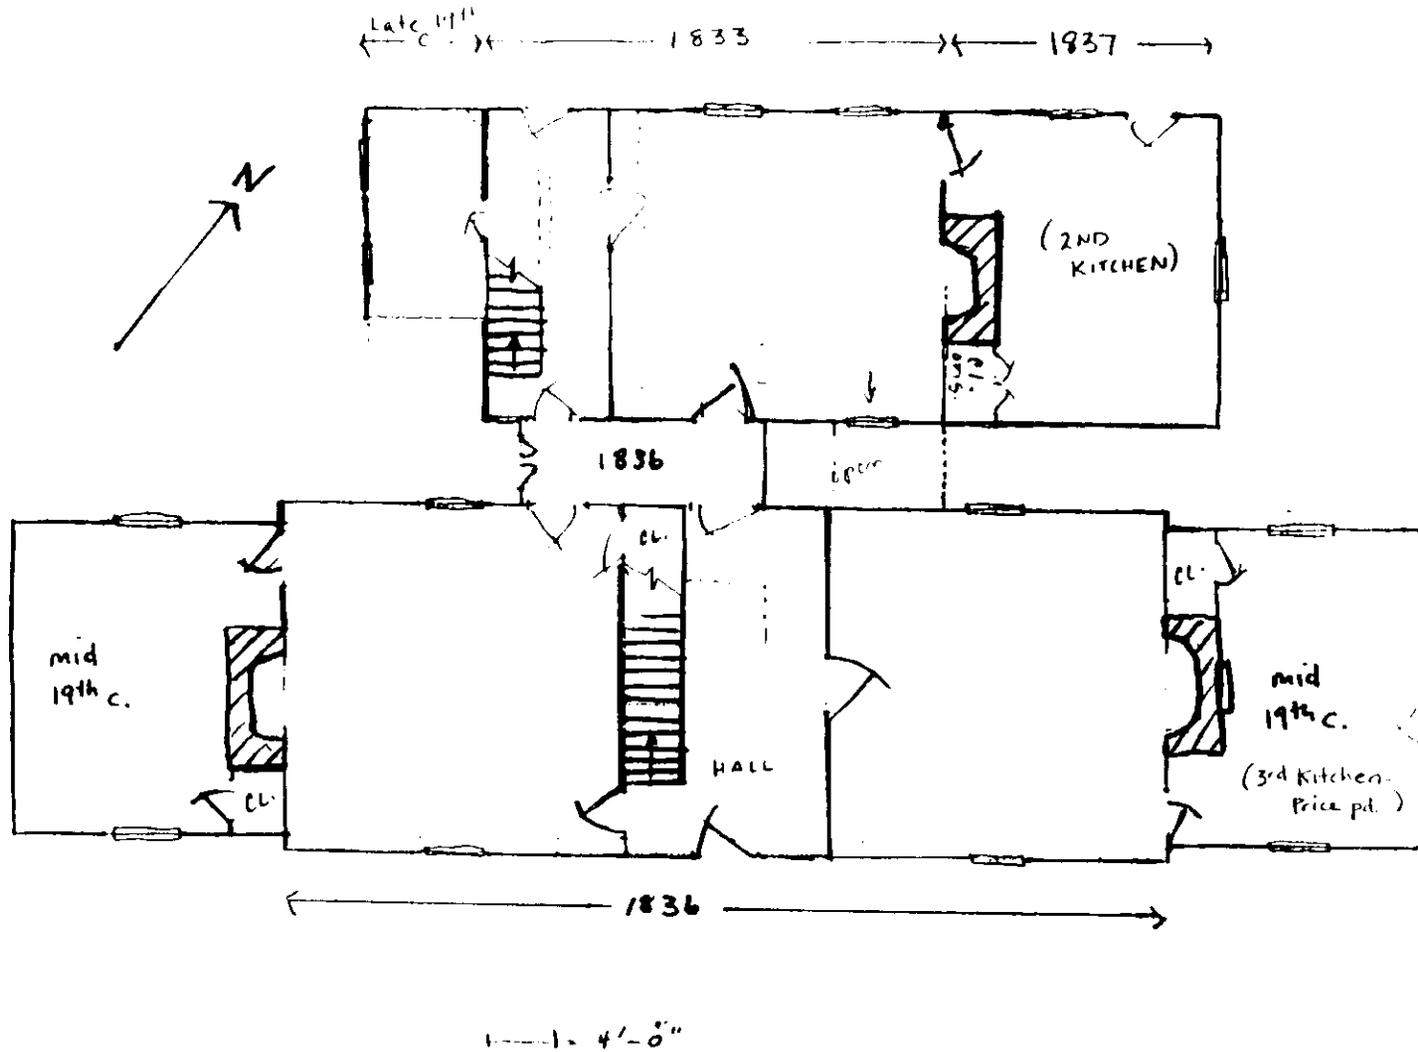
Sunnyside - First floor plan

The Sunnyside plantation house was built in three sections. The first section, begun in 1833, is a one-room, two-story, three-bay dwelling with a side passage. The second section, a two-story, three-bay I-house, was begun in 1836 in front of the first dwelling and connected to it by a one-story hyphen. The third section is a two-story, one-room, one-bay addition built in 1837 on the east end of the first dwelling.<sup>1</sup>

The 1836 I-house section of Sunnyside has a late Federal-style interior featuring high-quality, well-crafted woodwork. The large half-turn stair in the center hall has Federal-style details including a graceful molded walnut hand rail, turned newel, thin rectangular balusters, plain stringers, and a paneled spandrel. The paneled spandrel has evidence of two layers of painted faux wood graining. The front door was also painted with faux wood grain. Typical Federal-style sunburst reliefs are carved on the bottom ends of the baluster posts under the stair landing. The original plaster that covers the interior walls throughout is damaged in patches on the walls and ceiling revealing the split lathe beneath. The floors are covered in tongue-and-groove pine floorboards.

The two first-floor parlors feature similar, Federal-style pine mantels with molded pilasters, paneled friezes, and molded mantel shelves. The east parlor mantel is differentiated from the mantel in the west parlor by the consoles supporting the mantel shelf. Upstairs, the two bedrooms have similar mantels with fluted pilasters, molded architraves, plain friezes, and molded mantel shelves. While the mantel in the west bedroom is painted off-white, the east parlor mantel is painted in faux black marble, which is likely an early paint treatment, since paint sampling indicated no undercoats. The black, dark red, olive green, and off-white paint on the mantel matches early paint colors on the beaded baseboards and chair rails in the I-house section of Sunnyside.

The hyphen between the front I-house and the rear side-passage house consist of two rooms. One is a passage connecting the two houses, which has a door to the exterior on its west side. The second was a large bathroom, probably added in the 1920s, which had a door leading into the passage and a small window on the east wall. The end walls of the passage area are covered with wide, flush, tongue-and-groove, hand-planed planks. The planks on the west wall are in place, but those on the opposite wall against the bathroom have been removed but saved for reinstallation. The front and back walls of the passage are clad with the weatherboard that formerly served as the exterior cladding of the two sections of the house. The passage area was painted with faux wood graining which is now covered by several coats of paint. The present owners gutted this section because it was in poor condition. When the plaster was removed, marks on the west wall indicated that it had been covered with shelves, which confirmed the Price's claim that this area had been a butler's pantry. The present owners intend to build two bathrooms in the hyphen.<sup>6</sup>
