NATIONAL REGISTER OF HISTORIC PLACES REGISTRATION FORM

historic name Selma

other names/site number (DHR Number 065-0077)

**Selma
Northampton County, Virginia**

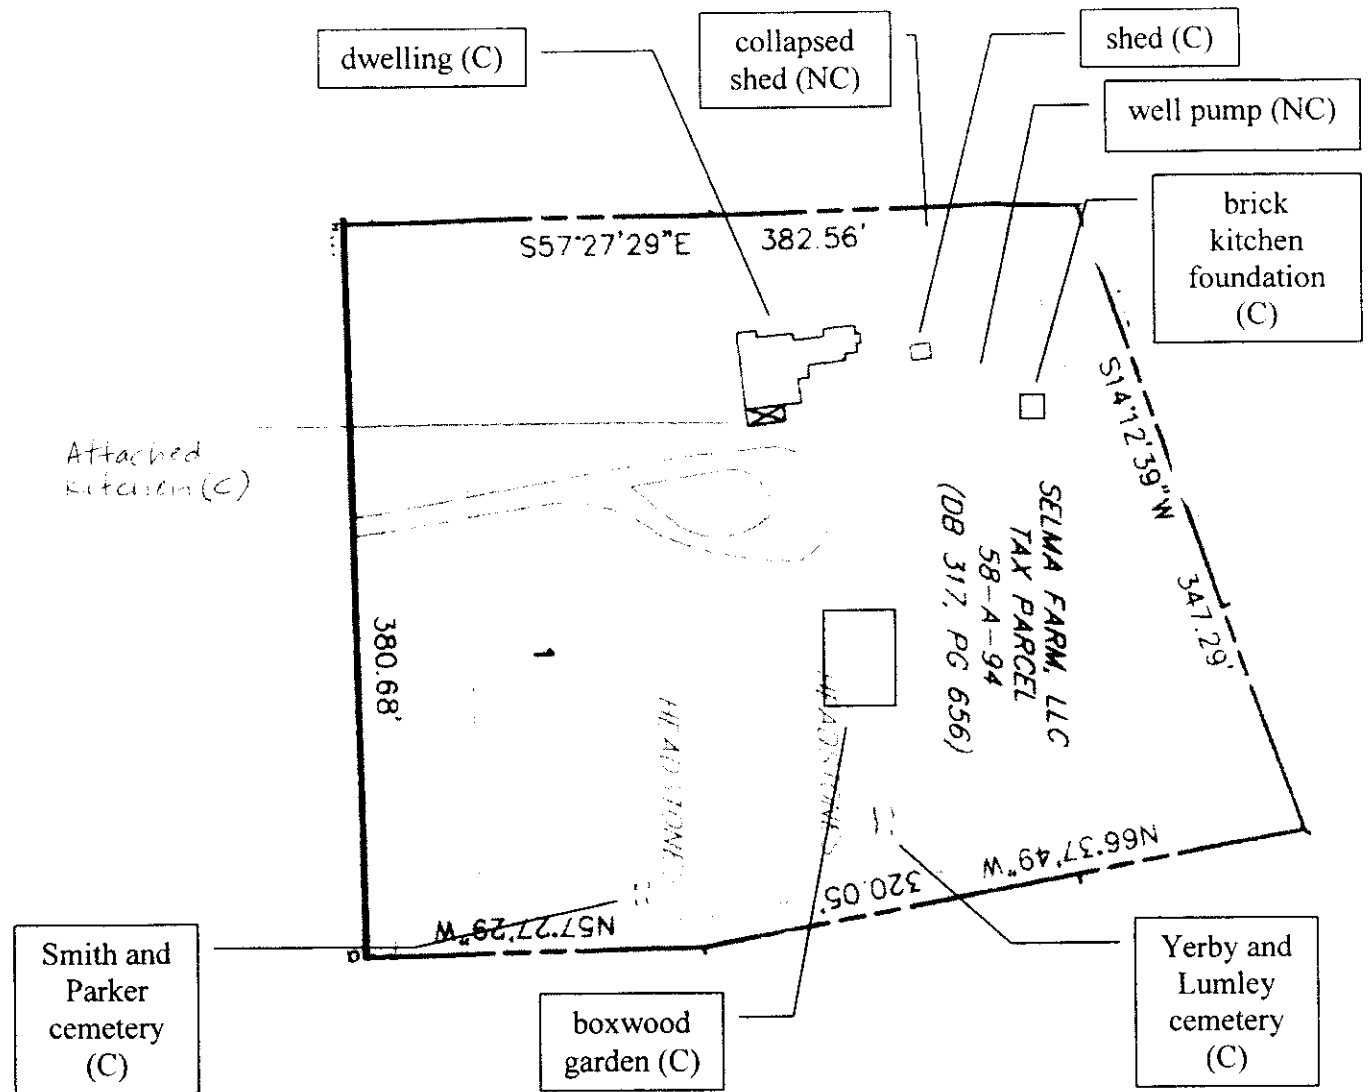
Site Plan

Selma
Eastville, Northampton County, Virginia

DHR Number 065-0077

1" : 100'

A collapsed shed is located in a tree stand north of the house at the cultivated field boundary. A smaller, frame shed is located east of the house. There is a well pump located southeast of the house. A remaining boxwood garden is located south of the house, and a cemetery is located southwest of the garden and south of the house at the south boundary of the uncultivated lands. There is another cemetery situated west of the cemetery south of the boxwood gardens. The site of the former kitchen is situated south of the shed.
