National Register of Historic Places Registration Form

Historic name: Harris Farm
Other names/site number: DHR No. 002-0878, Mount Eagle
Name of related multiple property listing:
N/A

Street & number: 2950 Thomas Jefferson Parkway
City or town: Charlottesville State: VA County: Albemarle
Not For Publication: N/A Vicinity: X

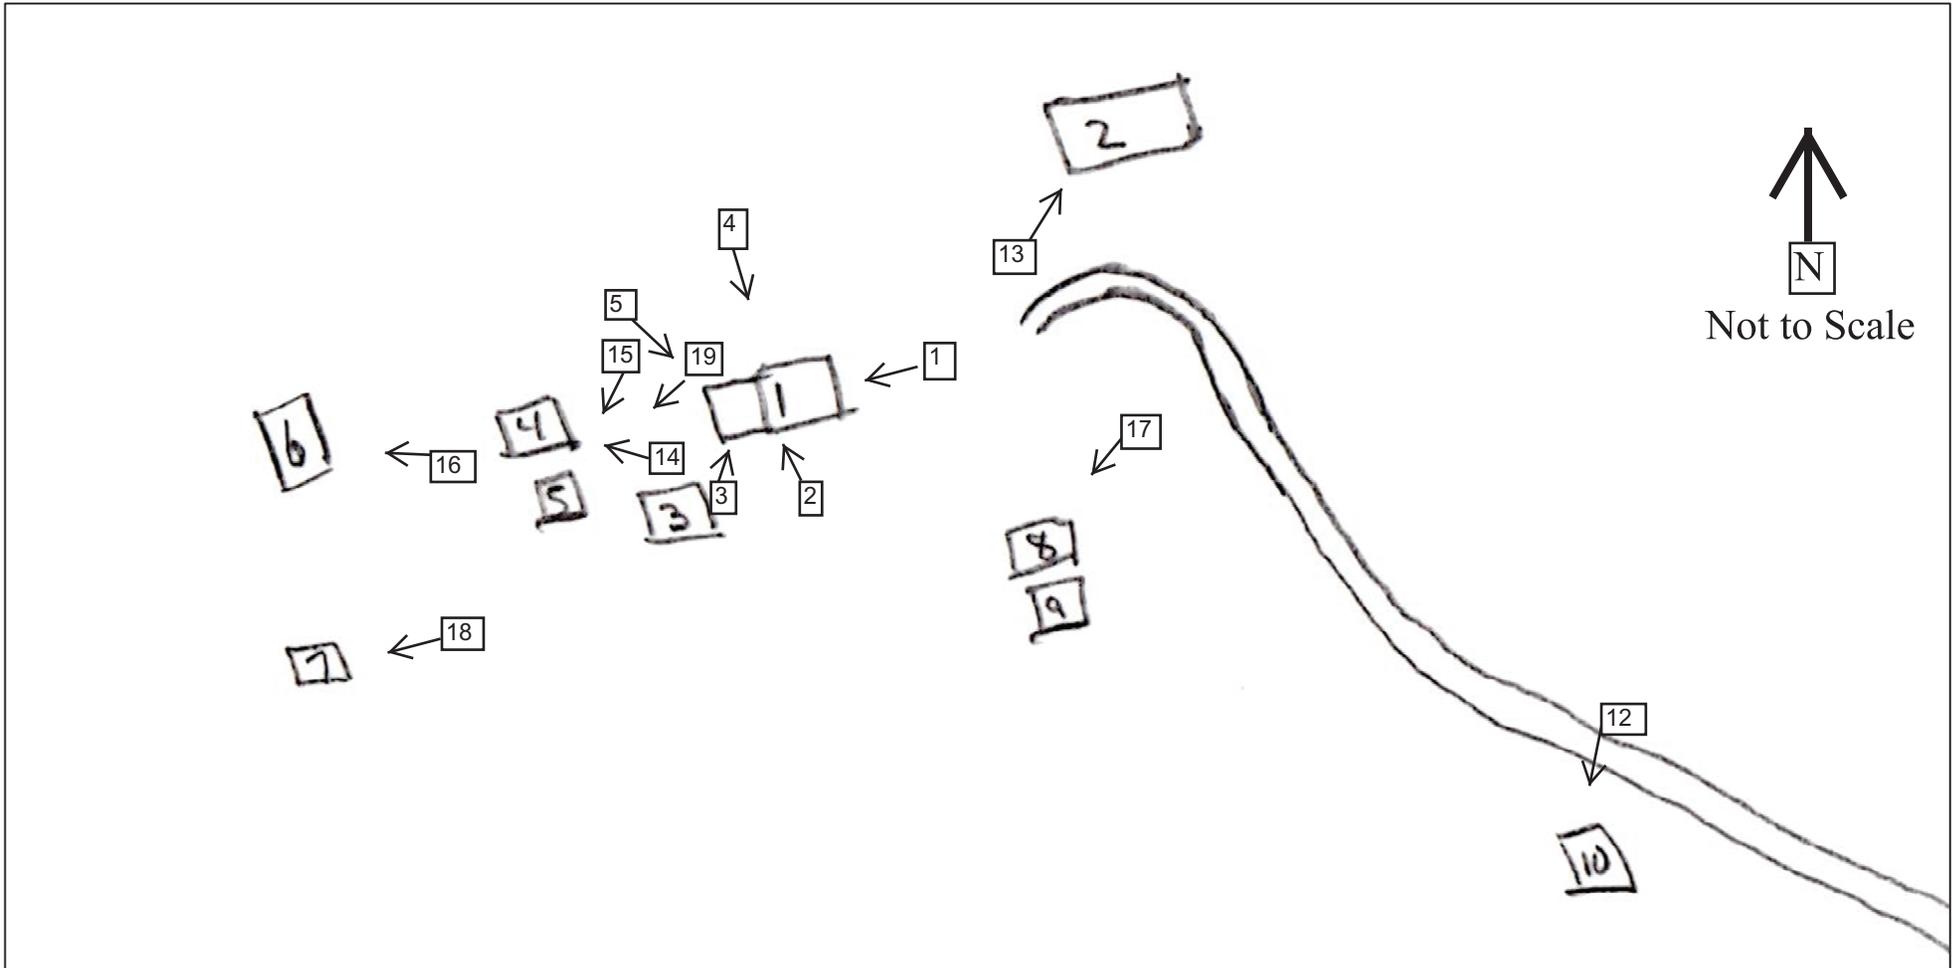
Sketch Map and Photo Key
Harris Farm
Albemarle County, Virginia
DHR #002-0878

1. Primary Dwelling, ca. 1850, 1898, and ca. 1900, contributing
2. Hay Barn - ca. 1850, contributing
3. Dairy - ca. 1898, contributing
4. Egg house - ca. 1910, contributing
5. Smokehouse - ca. 1850, contributing
6. Chicken house - ca. 1910, contributing
7. Woodshed - ca. 1960, contributing
8. Wagon Barn - ca. 1910, contributing
9. Machine Shed - ca. 1960, contributing
10. Corncrib - ca. 1898, contributing

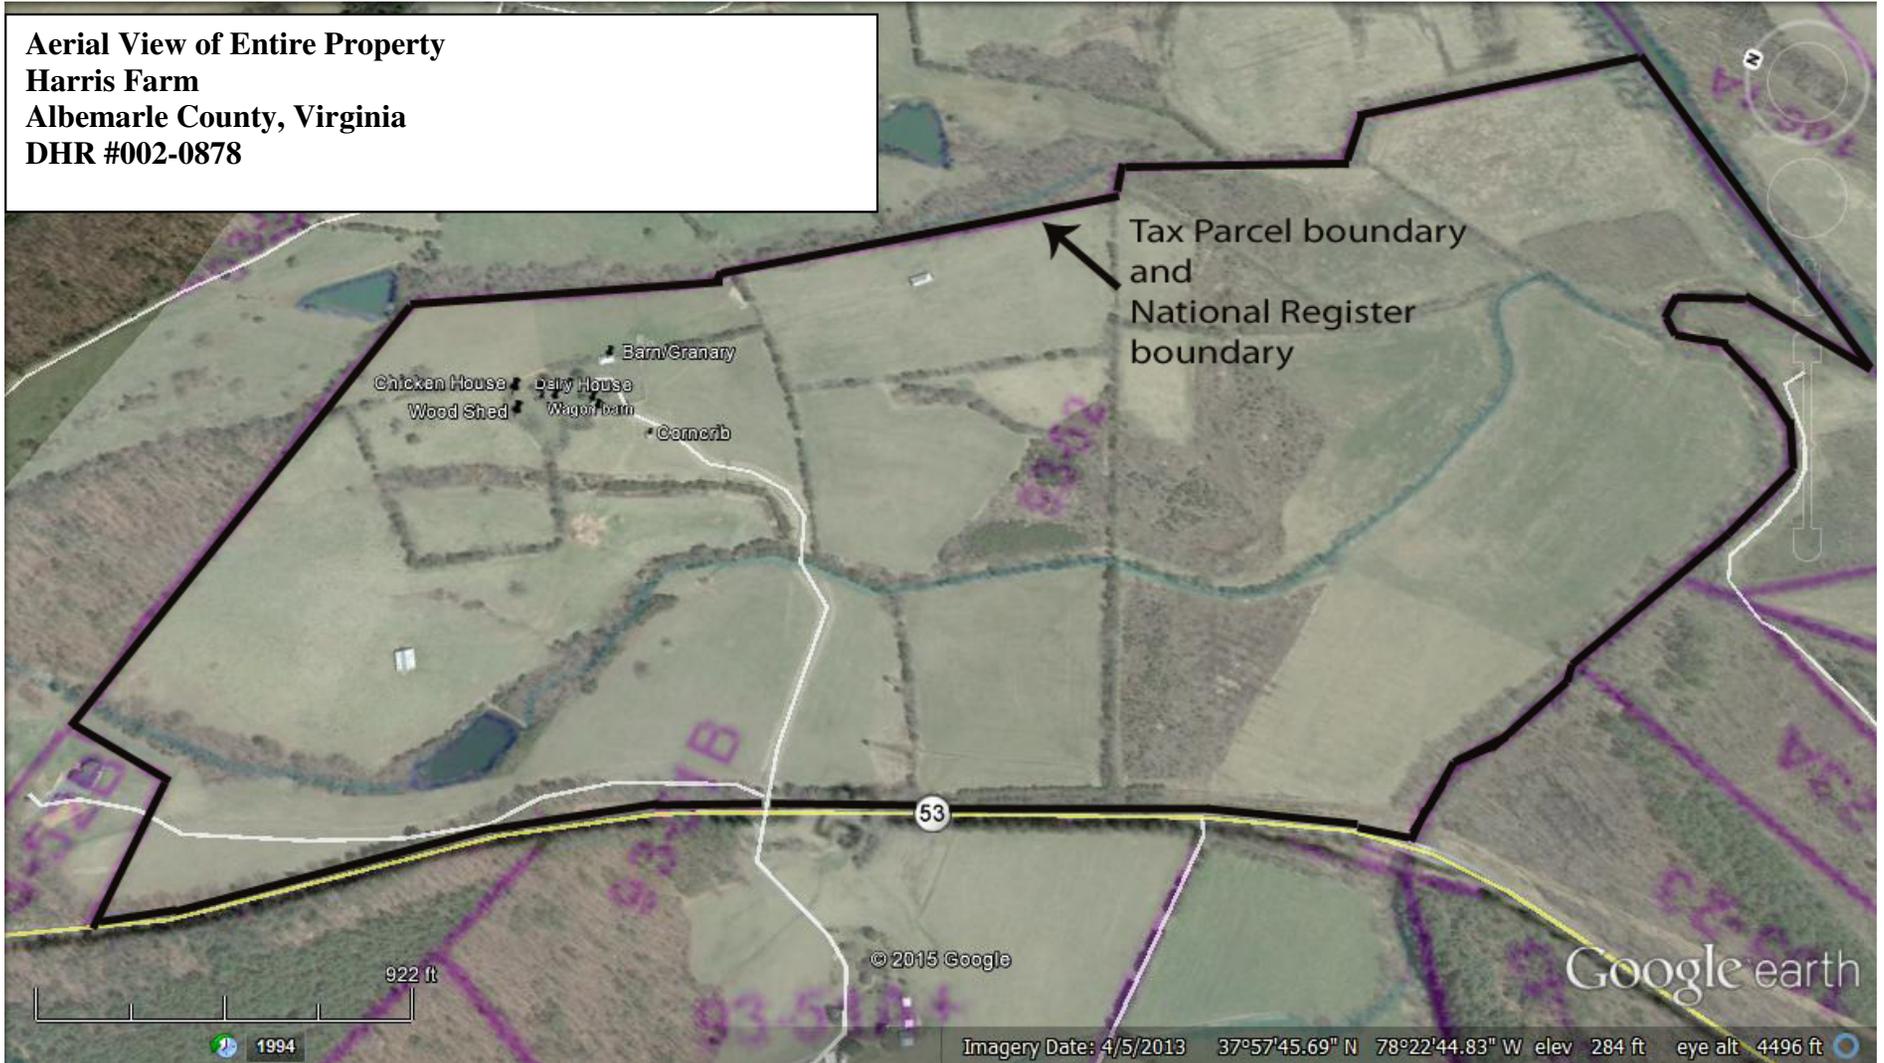
Detail View of Domestic Complex
Harris Farm
Albemarle County, Virginia
DHR #002-0878

The Harris Farm's historic domestic complex is intact, with ca. 1900 sidewalks around the house that connect the house to the dairy, egg house, and smokehouse. A chicken house and wood shed are a short distance beyond these buildings. The hay barn, wagon barn, machine shed, and corn crib are situated northeast and southeast of the primary dwelling. All of the outbuildings date to

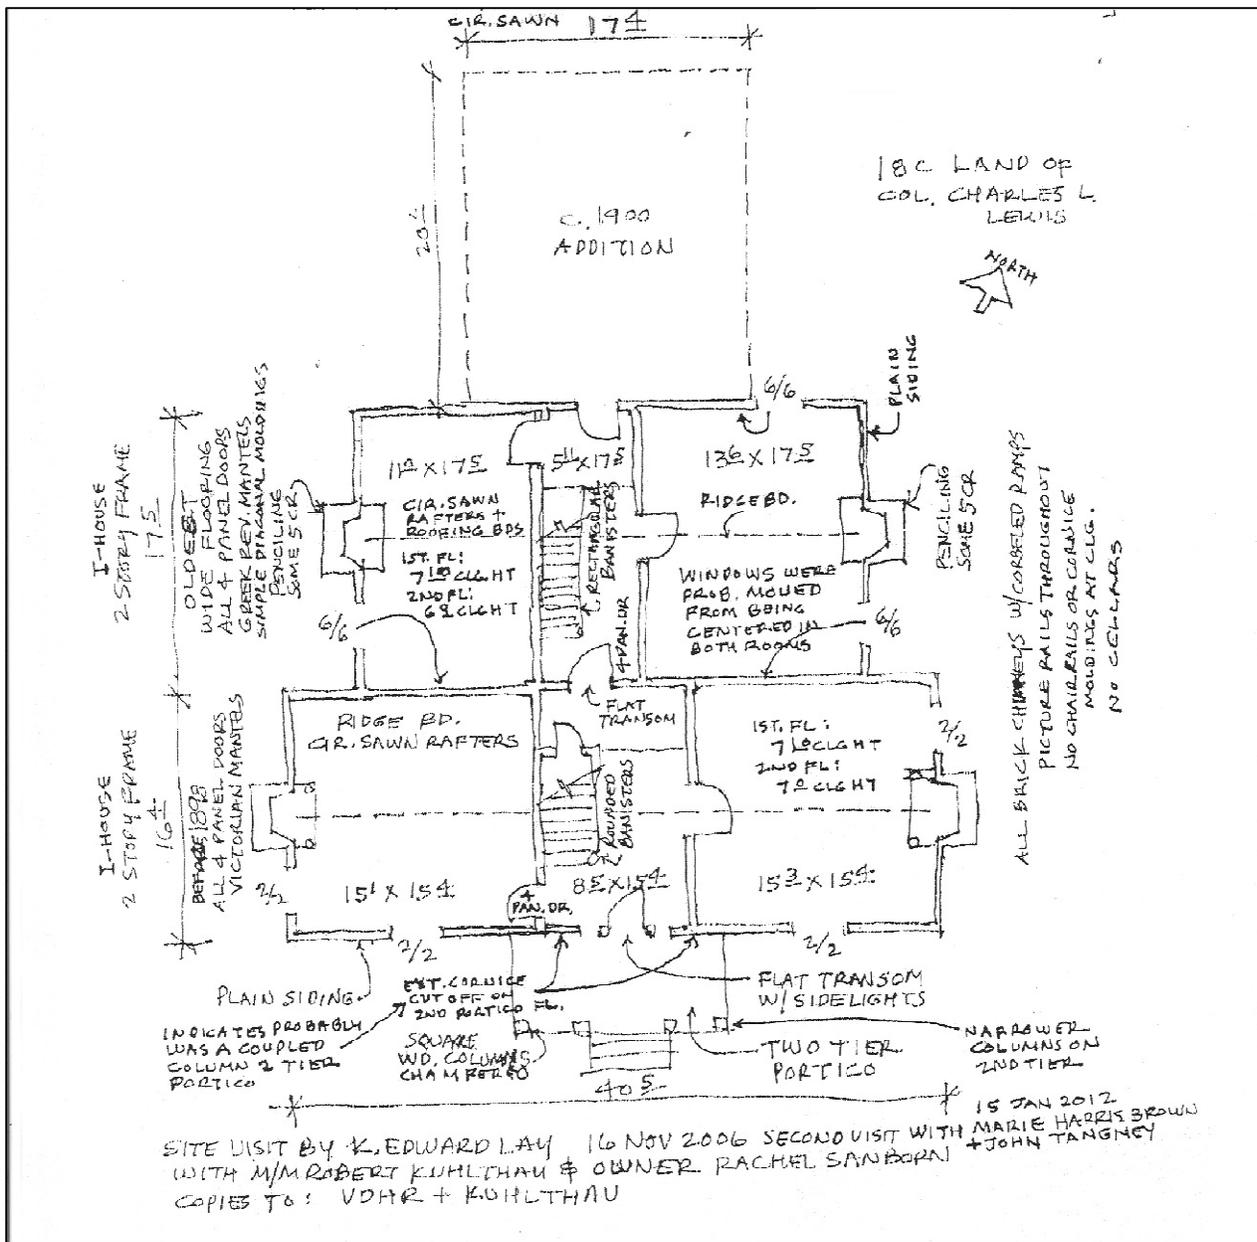
Harris Farm
 Albemarle County, Virginia
 DHR No. 002-0878
 Floor Plan of Primary Dwelling

The distinctive Harris Farm house features a double-pile plan composed of two, two-story, frame I-house sections and a ca. 1900 rear kitchen ell. Based on physical evidence, the rear I-house section appears to have been constructed ca. 1850, most likely by the enslaved African American population living onsite. In 1898, when the property was sold to the current owners' family, the second I-house was constructed directly in front of the ca. 1850 I-house and the two buildings share what is now an interior wall. Finally, at some point in the early 20th century, the rear ell was added, while bathrooms appear to have been incorporated in the mid- to late-20th century. Because of the location of the house, a swale has recently been added behind the ell to divert water away from the foundation.

The interior of each I-house section is similarly laid out, with a central stair hall flanked by two rooms on both floors. The ca. 1850 section has an open string staircase with rectangular balusters, while the 1898 section features an open string stairway with broad plain tread brackets, turned balusters, round rails, and a turned newel with an acorn-like cap. The ca. 1900 rear ell holds one large room on each floor, with a first-floor kitchen and second-floor bedroom accessed via an enclosed stairway. Historic interior finishes include the pine flooring, painted baseboard trim, window and door casing, and wood doors. The wood trim styles differ from section to section, indicative of the house's varied construction dates. The 1898 section features flat-board painted window trim, the ca. 1850 section has window casing with architrave trim, and the ca. 1900 rear ell has flat-board casing with butt joints and bull's eye corner blocks. The first-floor rooms in the 1898 section feature fireplaces with factory-made Georgian Revival mantels. A narrow picture molding extends along the walls of the first-floor rooms as well. In the ca. 1850 section, fireplaces are simpler, featuring Greek Revival mantelpieces with engaged pilasters and a mantel shelf with narrow cornice. An upstairs bedroom retains a Victorian-era mantelpiece. The wood doors include examples of 19th-century four-panel doors and ca. 1930 wood doors with three horizontal panels topped by six lights. Modern updates to the interior include bathrooms on the first and second floors and updates to the mechanical systems for plumbing, lighting, and heating and air conditioning.

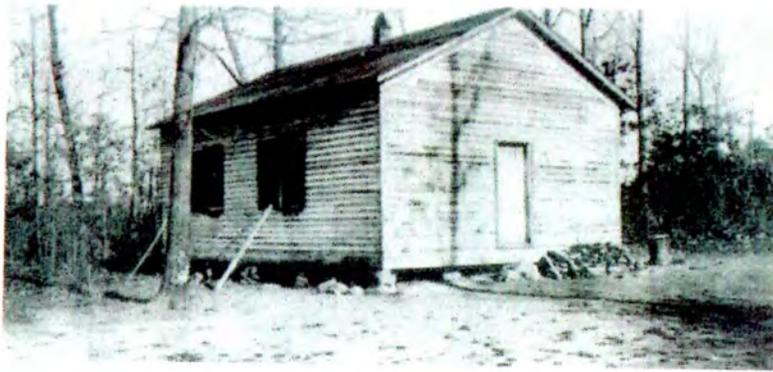
*Fig. 316. School at
Buck Island, 1200*

**Harris Farm
Albemarle County, Virginia
DHR #002-0878
Historic Figure 1. Buck Island School
(Lay, *The Architecture of Jefferson
County*, p. 250).**
