NATIONAL REGISTER OF HISTORIC PLACES  
REGISTRATION FORM

historic name LINDEN  
other names/site number VDHR File No. 28-24

Linden  
Essex County, Virginia

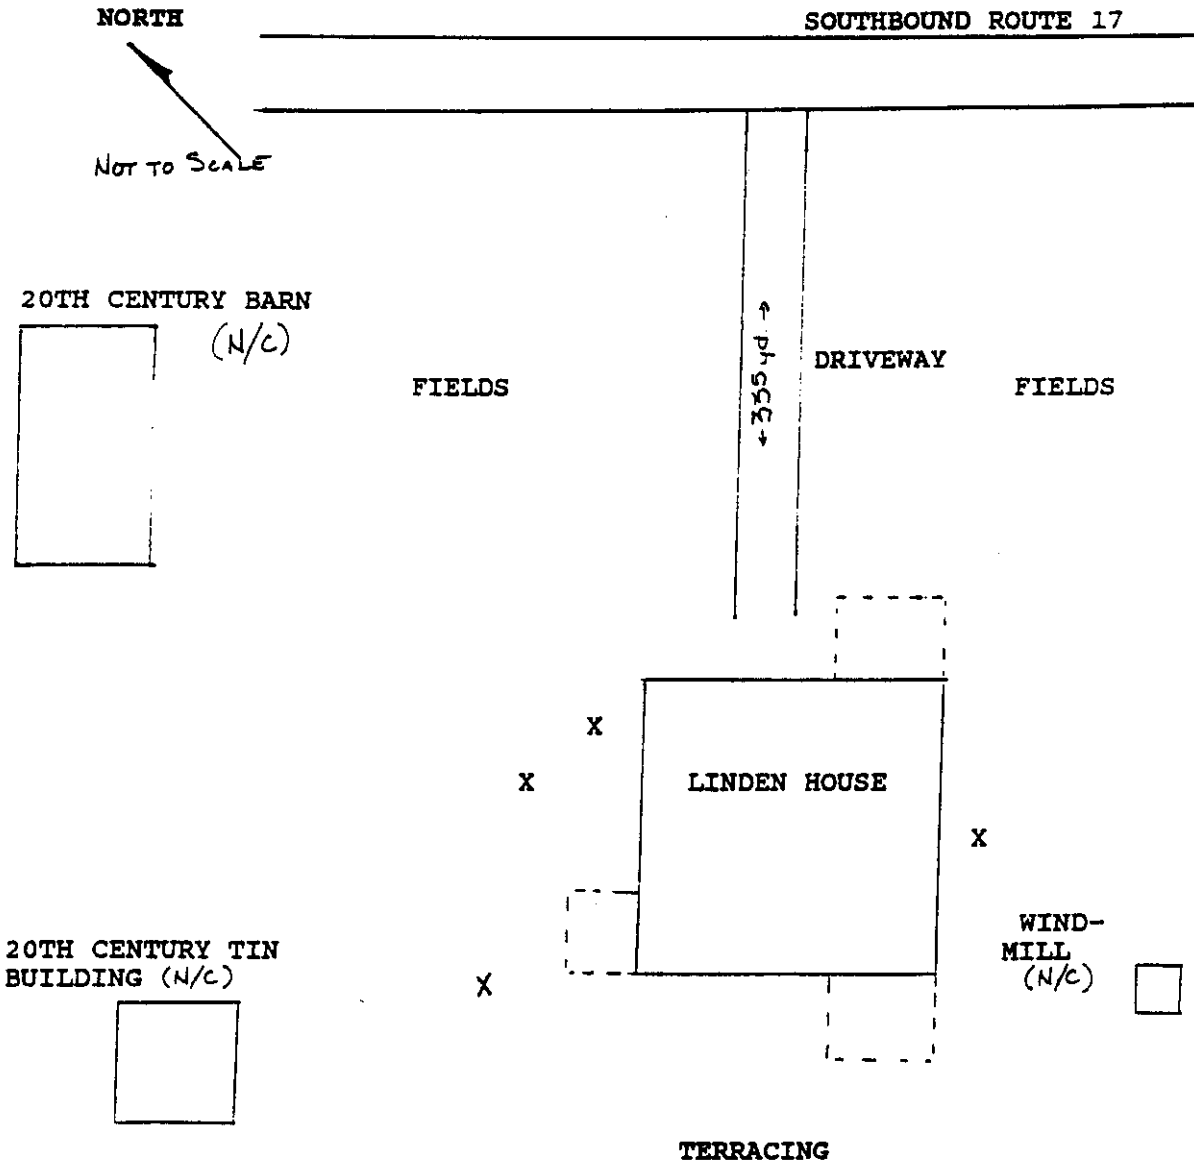
SITE PLAN FOR LINDEN PLANTATION

Just north of the house is the buried foundation of a small outbuilding, probably dating to the same period as the house. A brick foundation has been revealed about five yards west of the house. Because of its size and evidence of charring, it is thought to have been a smokehouse. Approximately fifteen yards from the northwest side of the house is what may be a stone foundation.

-----  
X=FOUNDATIONS OF EARLY OUTBUILDINGS

Three early twentieth-century resources stand at a distance from the house. About 130 yards north of the house is a 40'- 5" X 20'- 5" wooden barn. It is supported on piers of stone and wood. The barn is approximately eighteen feet tall at the peak and has a corrugated tin roof. Forty yards west of the house is a two-story, wood-frame shed with wood pier underpinnings. Corrugated tin sheets are bolted together to form the walls. The shed is 18'x 18' and has five six-over-six double-hung sash windows and a door on the second story. The first story has no partitions and may have been used for storage. The second story is divided into three rooms and there is evidence of a stove at the junction of the three rooms, which is located directly under a chimney. Approximately thirty-eight yards southeast of the house is a dilapidated metal windmill that stands about forty-five feet high.
