National Register of Historic Places Registration Form

Historic name: Springdale

Other names/site number: Babb, Thomas, Jr., and Lupton, Jonah H., House;

DHR #034-0103

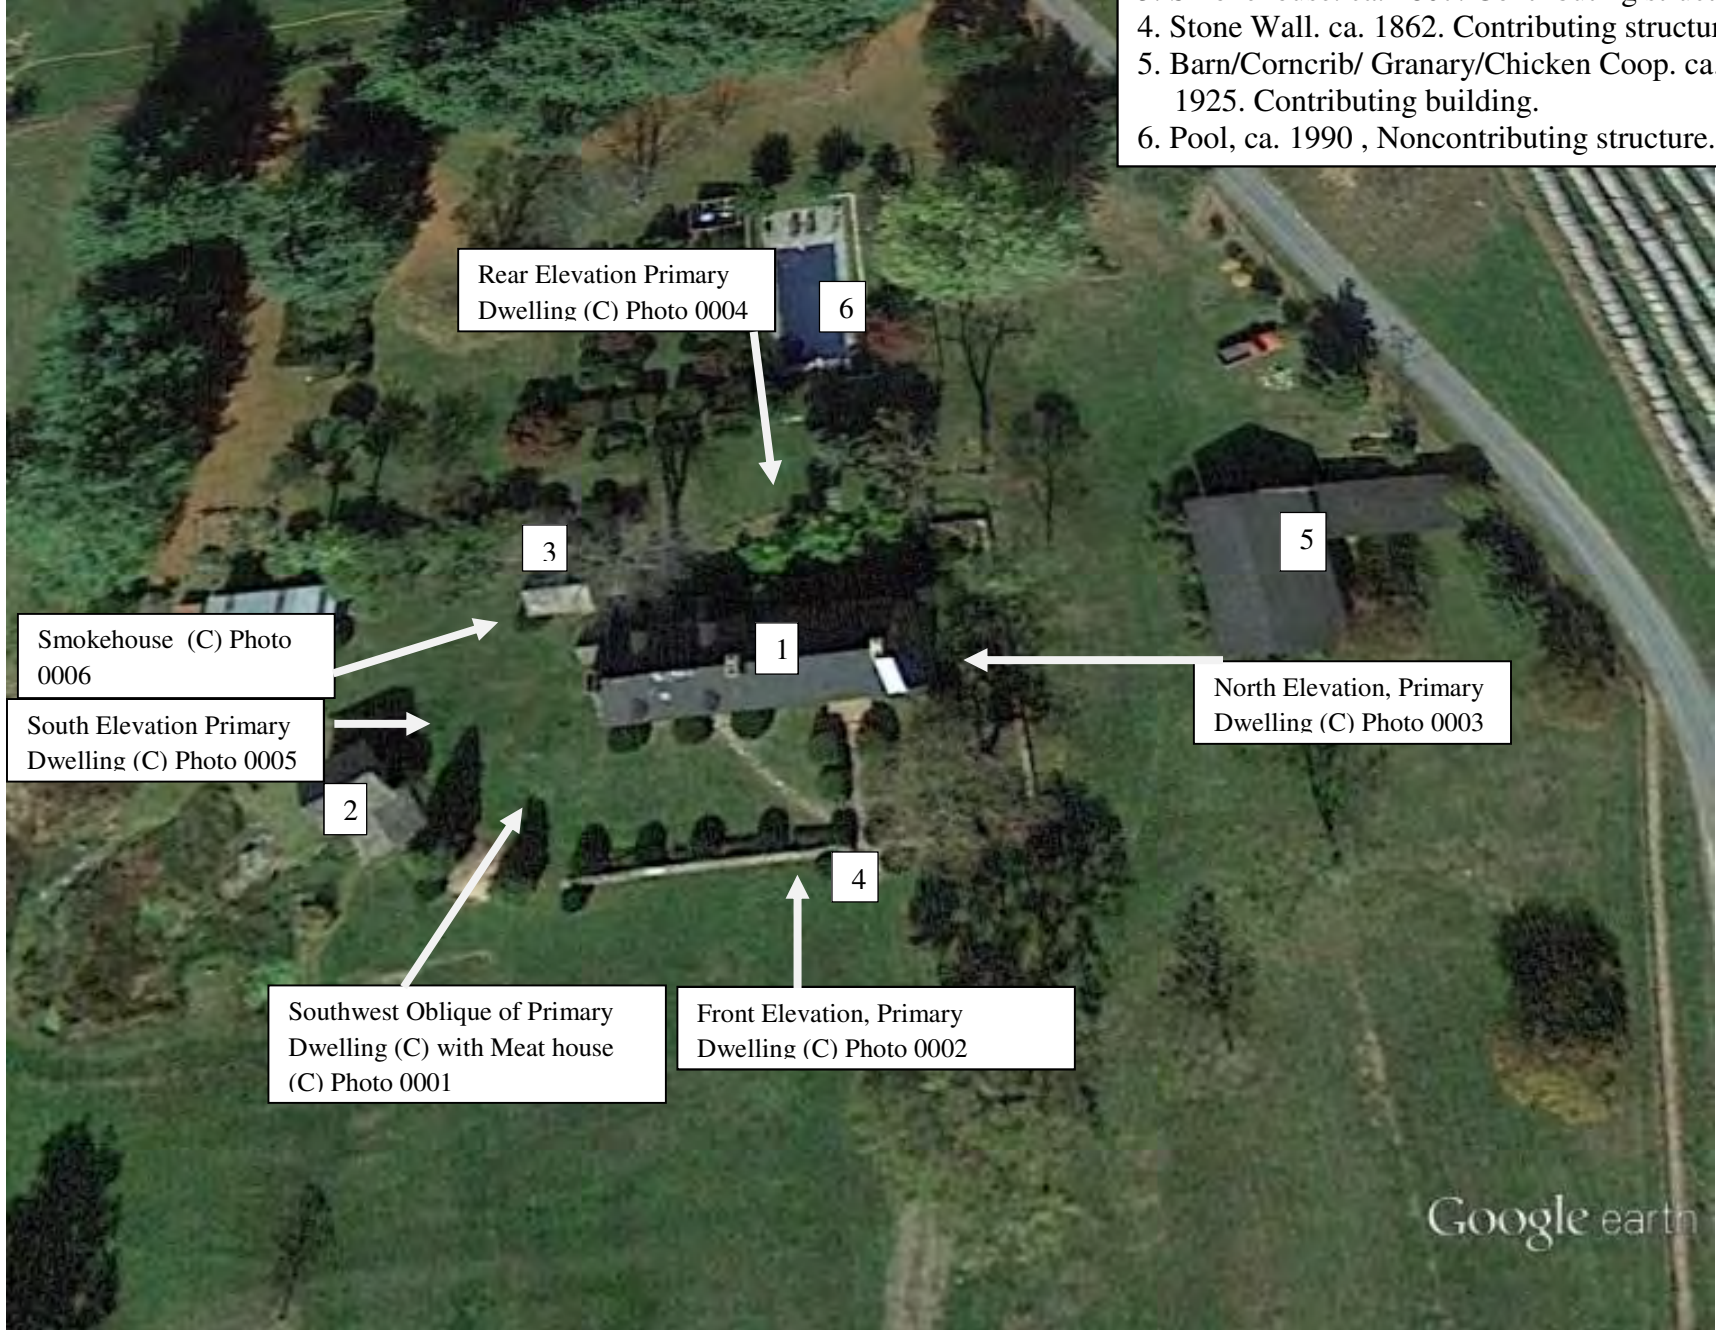
SKETCH MAP/ PHOTO LOG
SPRINGDALE, FREDERICK COUNTY
324-0103

- 1. House. ca. 1820. Contributing building.
- 2. Springhouse. ca.1807. Contributing structure.
- 3. Smokehouse. ca. 1807. Contributing structure.
- 4. Stone Wall. ca. 1862. Contributing structure.
- 5. Barn/Corncrib/ Granary/Chicken Coop. ca. 1925. Contributing building.
- 6. Pool, ca. 1990 , Noncontributing structure.
