National Register of Historic Places Registration Form

historic name BOLLING ISLAND other names/site number DHR-37-03

street & number Stokes Station Road city, town Goochland state Virginia code VA county Goochland code 075 zip code 23063

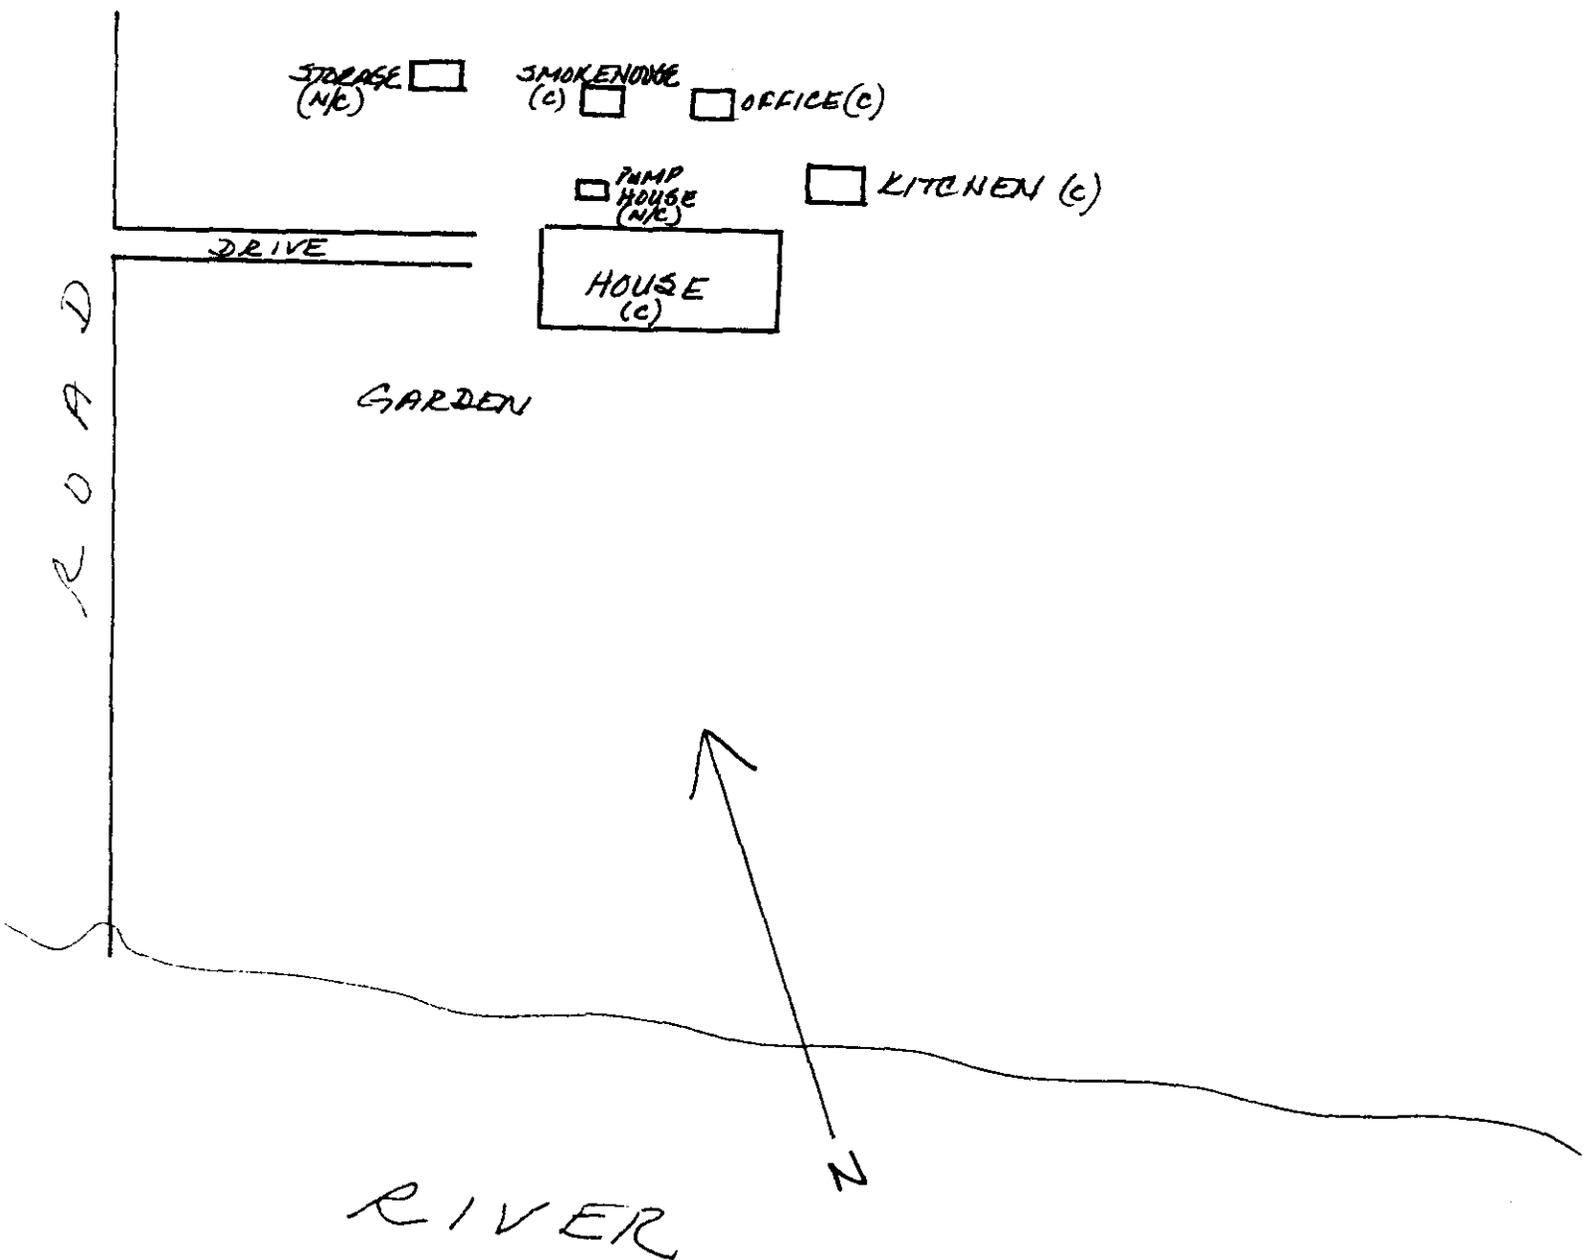
SKETCH MAP

BOLLING ISLAND, GOOCHLAND CO., VA.

Not to scale

Three historic dependencies are located on the north side of the house. These include a board-and-batten smokehouse that was built about 1845. This gable-fronted structure faces the house and has a louvered vent above the entrance. An office building with detailing identical to that of the west wing dates from about 1839. It is a square weatherboarded building with a hipped roof covered with asphalt shingles. This structure currently lacks its box cornice and has exposed rafter ends. Its entrance faces the house and has an eight-light transom. The windows are six-over-nine, double-hung. The brick kitchen is located to the northeast and faces west. It is covered by a slate, hipped roof pierced by two interior chimneys. Built into the side of a slope, the rear has a fully exposed basement level to the east. A frame addition on a masonry
