National Register of Historic Places Registration Form

historic name Southwest #8 Boundary Marker of the Original District of Columbia

Boundary Markers of the Original District of Columbia

SOUTHWEST NO. 8 MILE MARKER

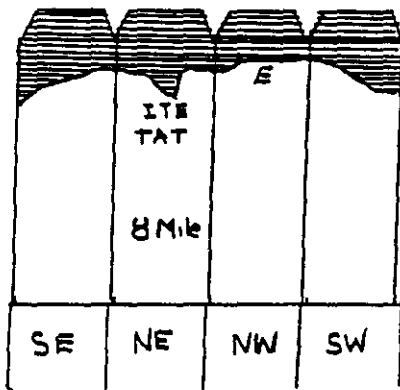
Visible Parts of Inscription

sections of marker missing

Located behind the Patrick Henry Apartments at the intersection of John Marshall Drive and Wilson Boulevard, the Southwest No. 8 Mile Marker of Aquia sandstone rests on a grassy area near the water tower, specifically at the corner of the parking lot behind 2921 McKinley Road. In poor condition, badly worn, gouged, and broken, it is no longer in the proper position. Having disappeared twice, this

stone was recovered and reset but rotated from its original placement.¹ The top of the stone is uneven and ranges from 25" to 30" in height. The wrought iron fence surrounding it is 45" in height but has been bent, probably from cars using the parking lot. The concrete on the base of the fence is eroding due to the erosion of the hill on one side of the fence though the surrounding area is well-maintained. The bronze plaque reads: ORIGINAL FEDERAL/ BOUNDARY STONE/ DISTRICT OF COLUMBIA/ PLACED 1791-1792/ PROTECTED BY/ DR. ELISHA DICK CHAPTER/ DAR/ 1950. The property is owned by Patrick Henry Apartments Limited Partnership. Stewardship of this stone belongs to Dr. Elisha Dick Chapter, VADAR, of Alexandria, VA, and was surveyed 30 November 1989, by Mrs. William Millman of that chapter.
