Gallison Hall (2020 Update)
Name of Property
Albemarle County, VA
County and State
90002013
NR Reference Number

Section number Additional Documentation Page 1

Gallison Hall, located in the Farmington area of Albemarle County, was listed in the Virginia Landmarks Register and the National Register of Historic Places in 1990. The property was listed under Criterion C in the area of Architecture with a broadly defined period of significance of 1931-1933, coinciding with the property’s design and construction.

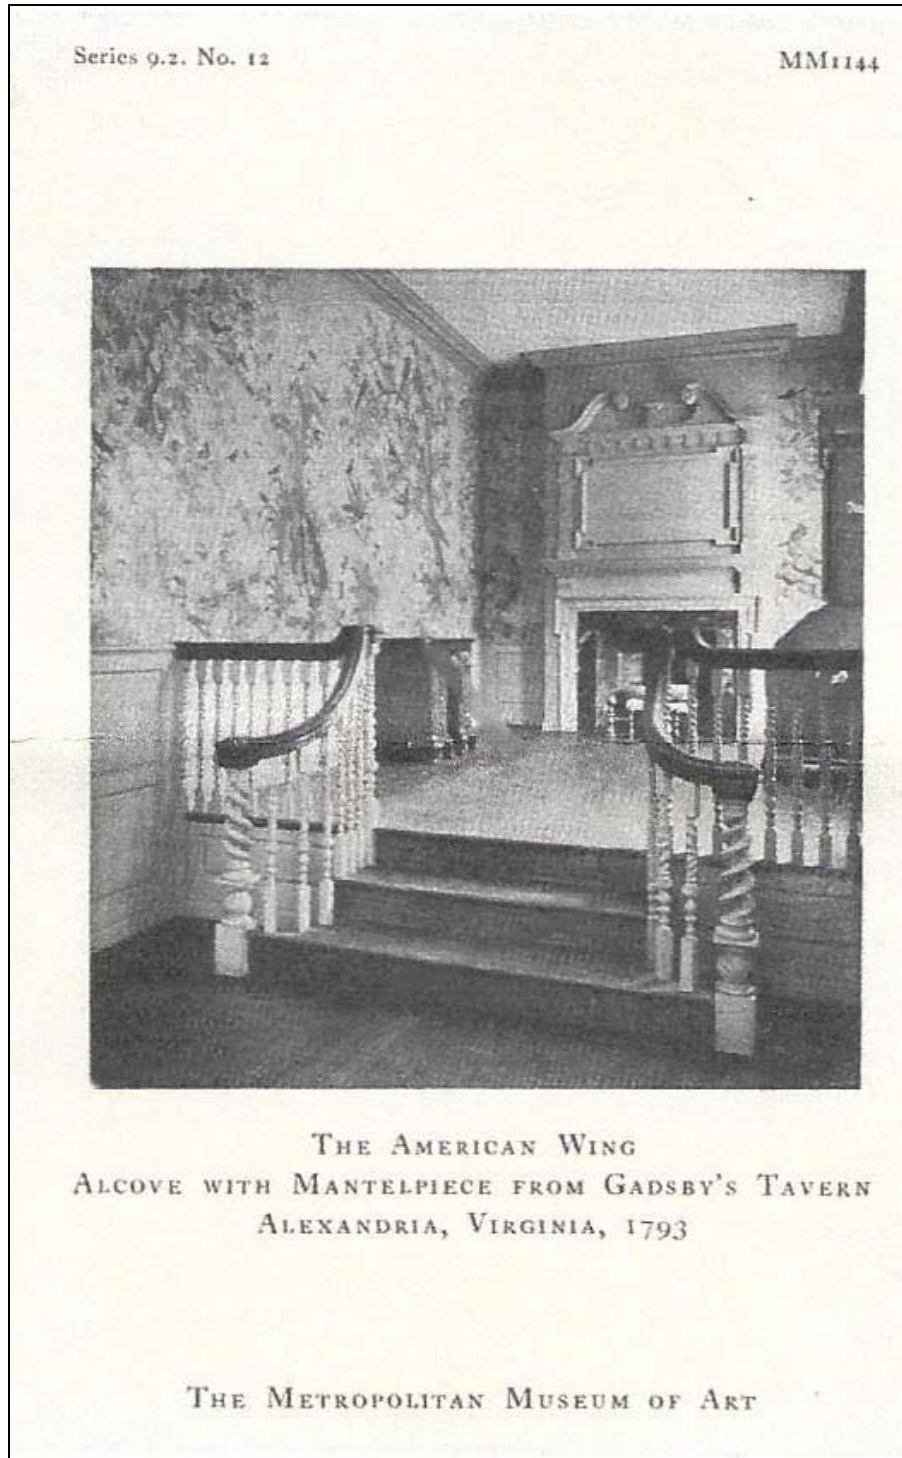
Figure 1. Image from *Bulletin of the Metropolitan Museum of Art* (Volume XIX, New York, November 1924, Number 11), p. 258.

Research conducted by Carolyn Gills Frazier, author of *Stanhope, Chronologically: The Work of Stanhope Spencer Johnson, AIA, 1881-1973* (privately published, 2018), has ascertained that the Met’s staircase had been acquired from a property in New England, but the Met’s display in question also featured a mantelpiece from Gadsby’s Tavern, thus likely accounting for Johnson’s error in recollection (Figure 1, below).

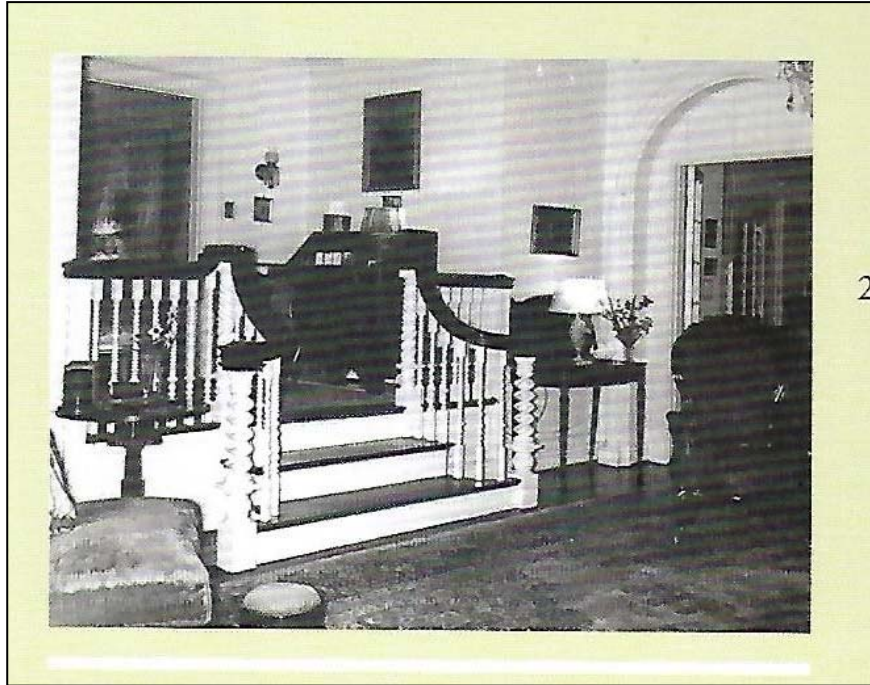
Figure 2. Undated photo of staircase at Brookside, Stanhope S. Johnson's home in Lynchburg.

Architectural drawings by Johnson, however, demonstrate that the design of the staircases at Gallison Hall and his own dwelling, Brookside, are his work as inspired by the New England staircase display at the Met (Figures 2-3). The staircase at Gallison Hall is very similar in character, although grander in scale and execution (Figures 4-5).

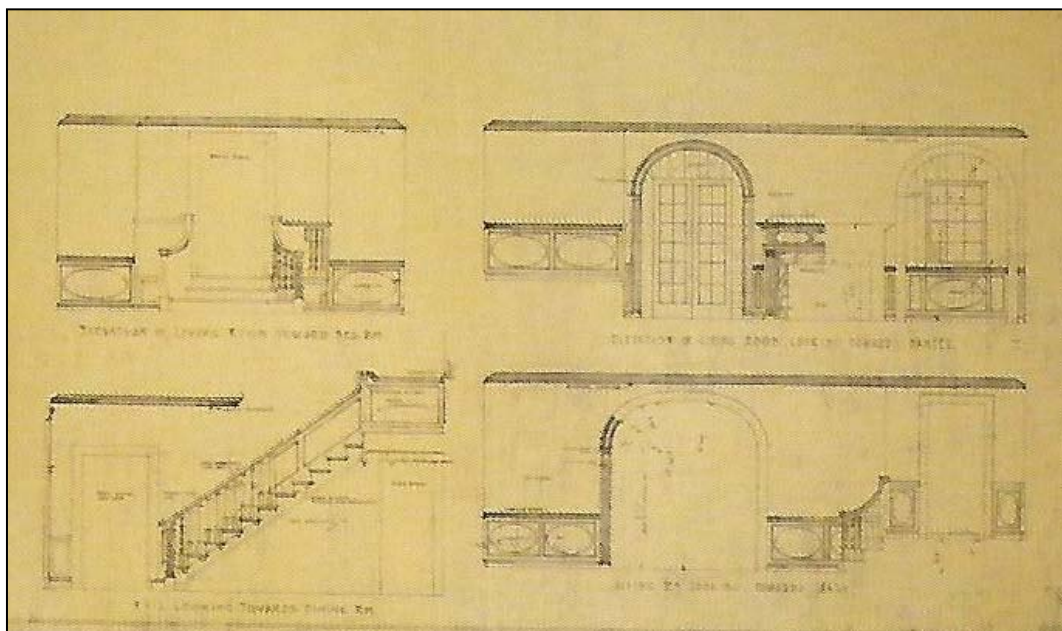
Figure 3. Architectural drawing by Stanhope Johnson of Staircase and Living Room at Brookside (original drawing held at the Lynchburg Architectural Archive, Jones Memorial Library, Lynchburg, Virginia)

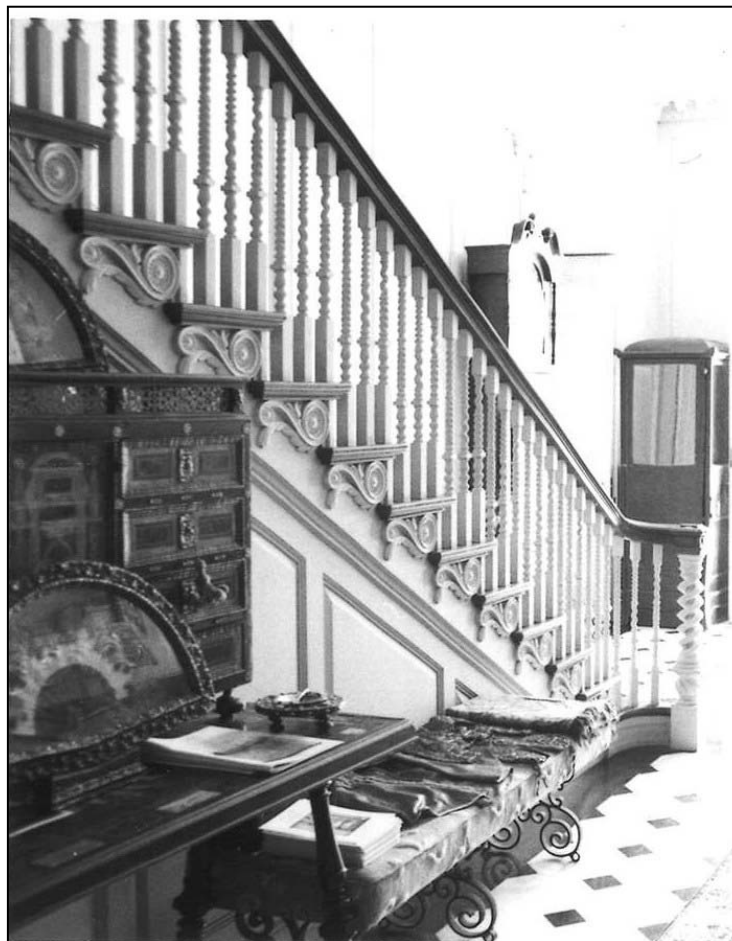
Figure 4. Staircase at Gallison Hall (1981 photo by Jeffrey M. O'Dell, collection of the Department of Historic Resources, Richmond, VA)

In the original nomination’s Section 7, the primary dwelling’s distinctive staircase with molded handrail, corkscrew newel post with square cap, and corkscrew balusters is alleged to be based on a staircase at Gadsby’s Tavern in Alexandria, Virginia.

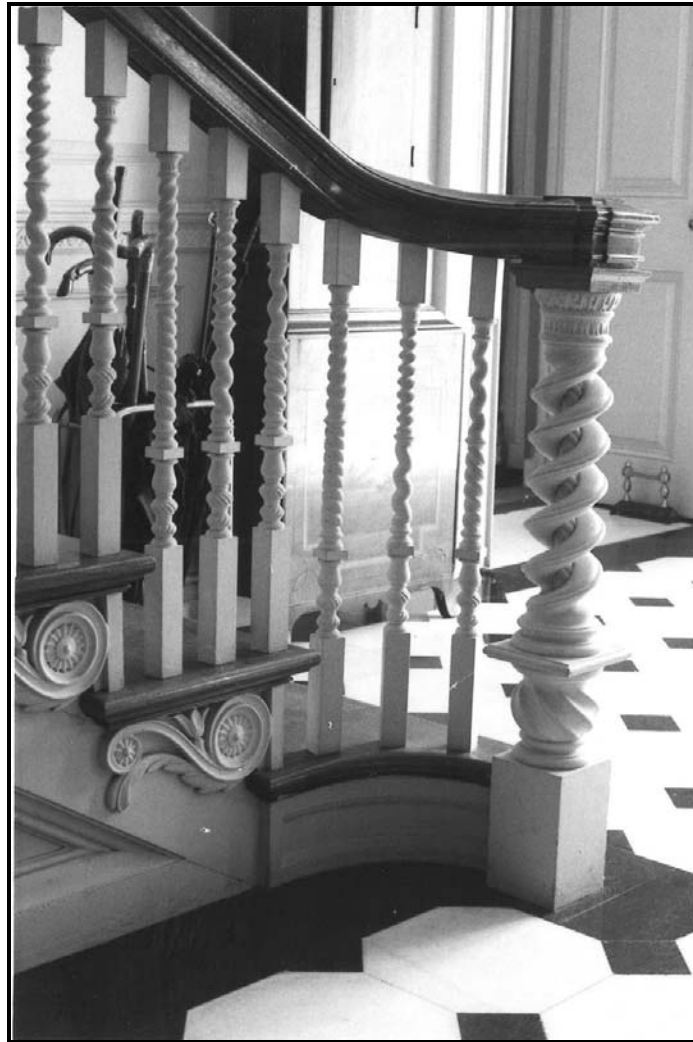
Figure 5. Detail of Staircase Newel Post and Balusters at Gallison Hall (1981 photo by Jeffrey M. O'Dell, collection of the Department of Historic Resources, Richmond, VA)
