NATIONAL HISTORIC LANDMARK NOMINATION

EYRE HALL

Historic Name: Eyre Hall

7. DESCRIPTION

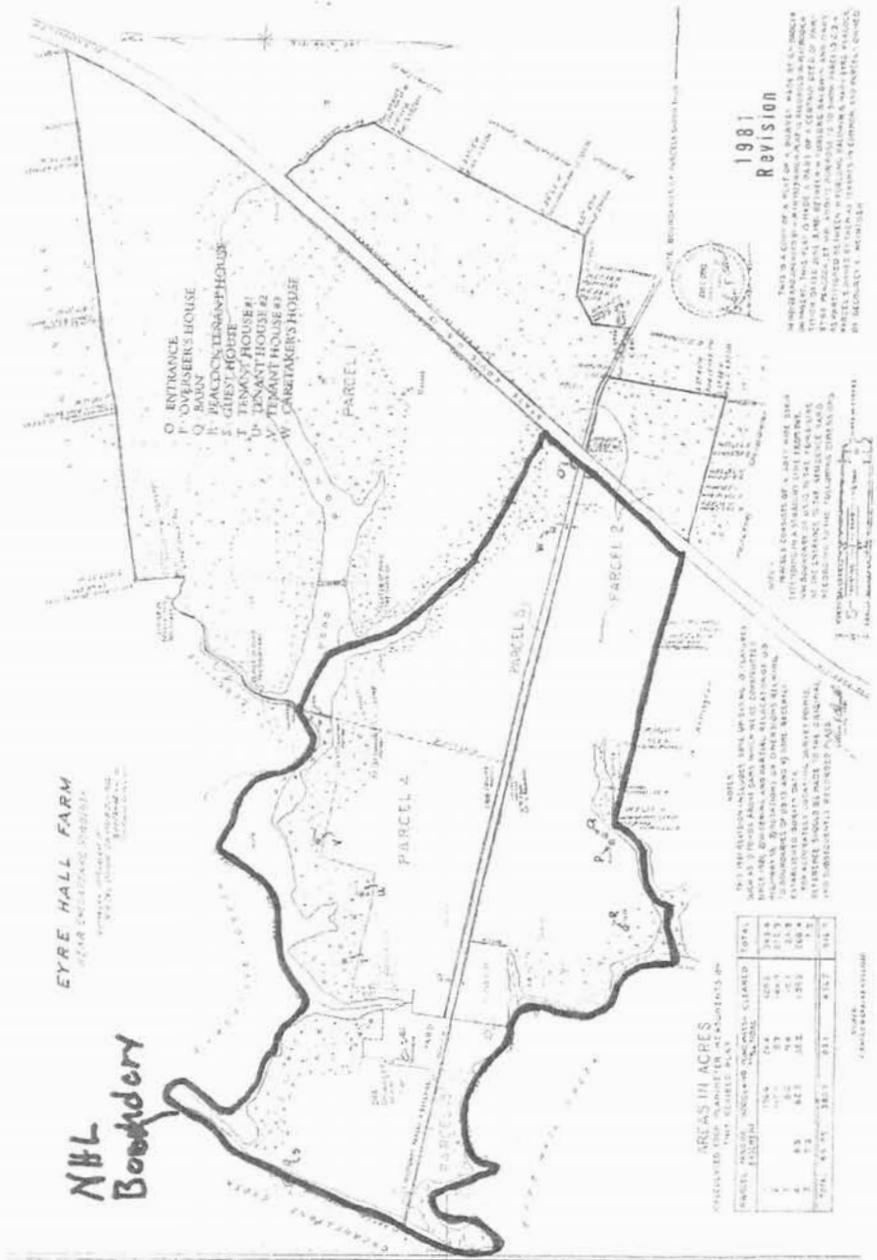
Site Plan

Eyre Hall, site plan and NHL boundary
Marilyn Harper, 2008

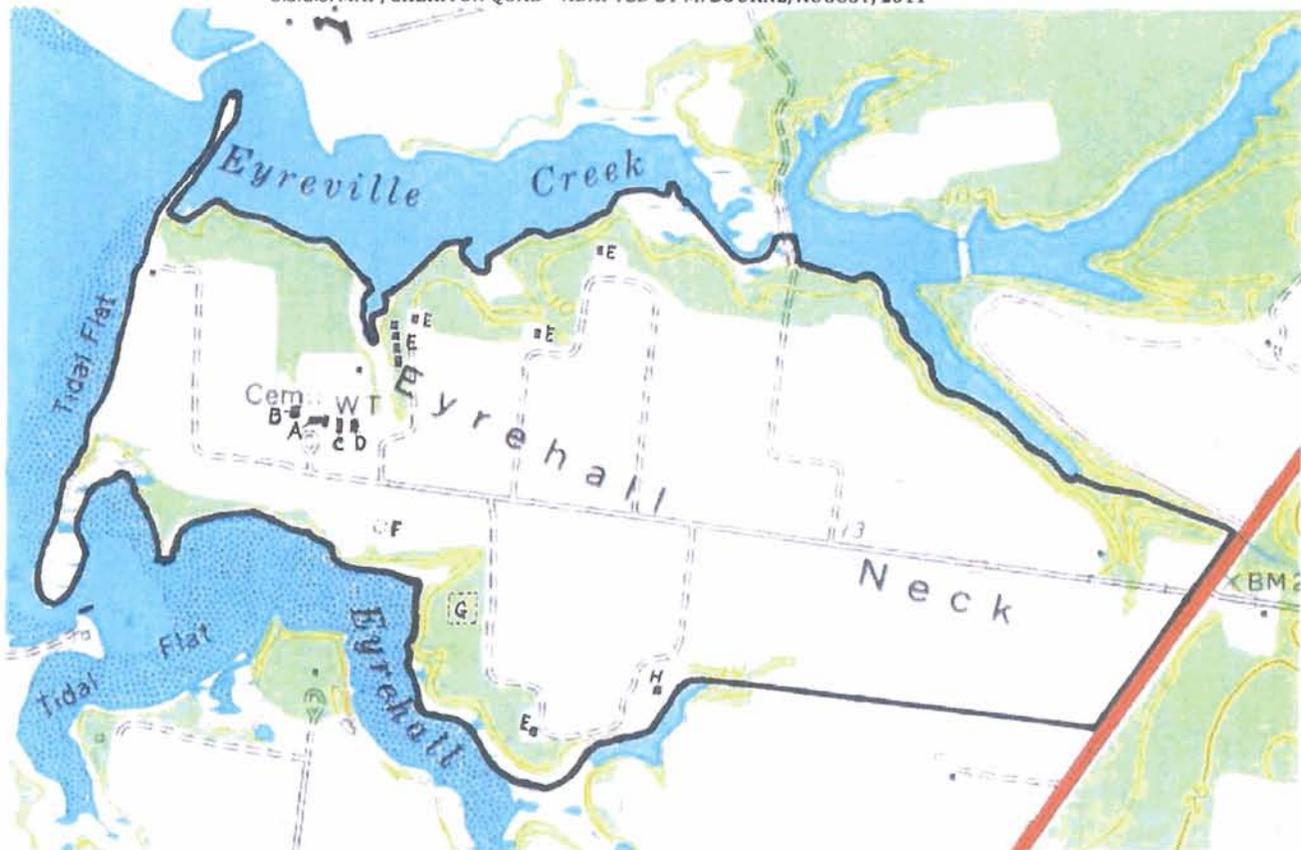
EYRE HALL - SITES PERTAINING TO SLAVERY - 1754 - 1855

- A - EYRE HALL; B - GREENHOUSE; C - KITCHEN SITE; D - KITCHEN QUARTER
- E - QUARTERS SITES; F - ROUND ICE HOUSE; G - SLAVE CEMETERY;
- H - OVERSEER'S HOUSE

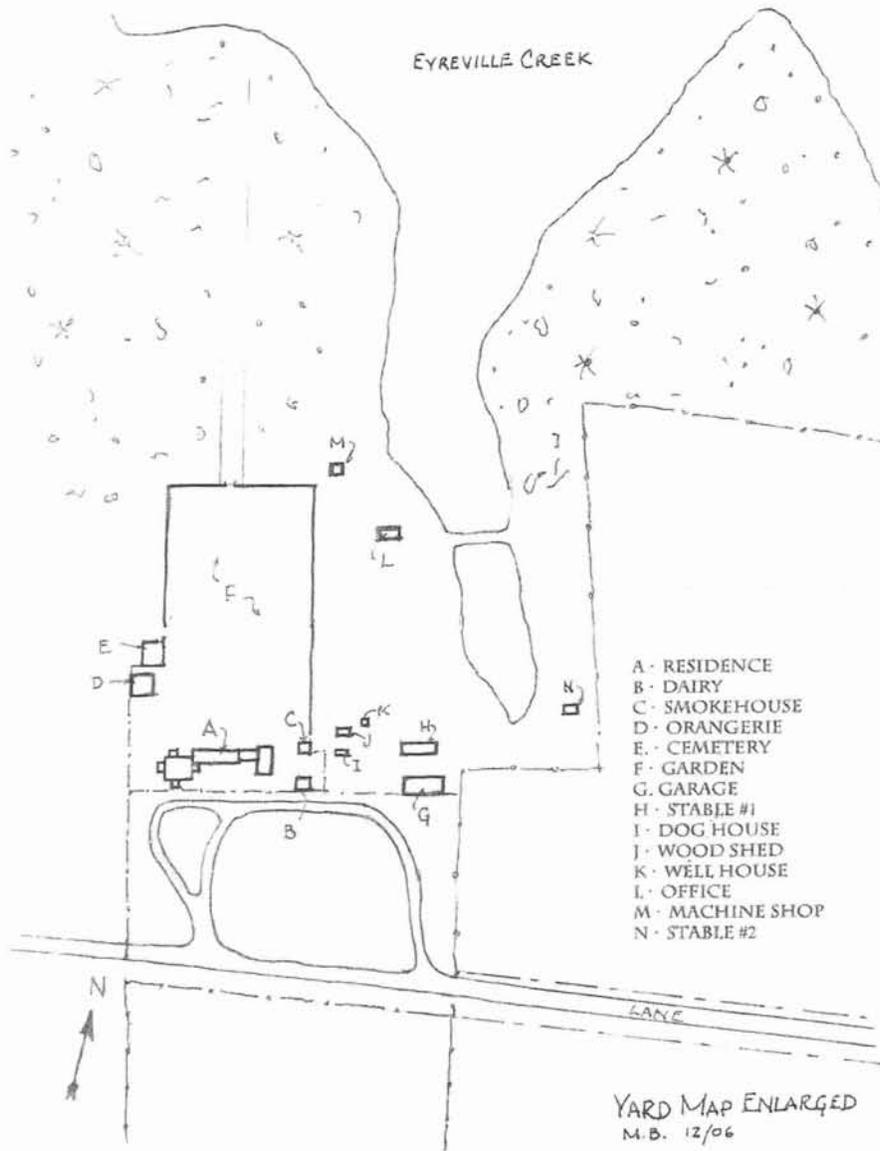
Yard Map
Michael Bourne, 2006

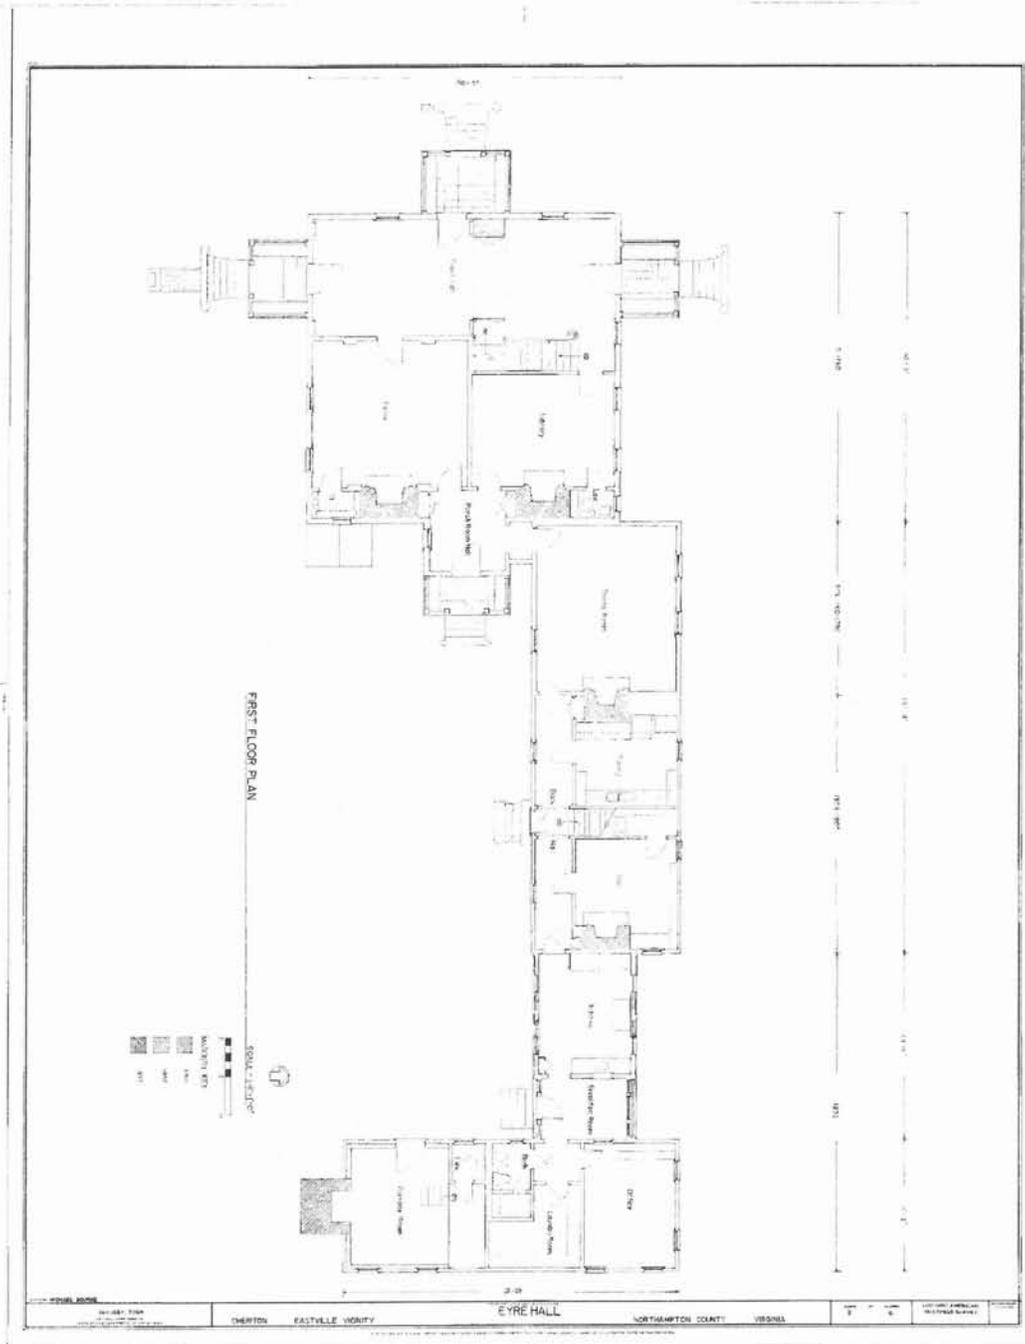
Eyre Hall, first-floor plan of house
Michael Bourne for the Historic American Buildings Survey, 2004

The first floor of the main block consists of three large rooms: a wide passage running the full depth of the house with two smaller rooms to the east. A wide elliptical arch divides the passage into a very elaborate **entry hall** and a less finely finished **stair hall**. The fully paneled entry is the most elaborately finished room in the house. Bold fluted classical pilasters rising from plain pedestals are located on the north and south walls near the corners of the room. The pilasters are exceptional in that they not only taper, but also have entasis. The five part Ionic cornice is approximately 19" deep. The heavy-fluted keystone over the south door indicates its importance as the main entrance to the house. This keystone, the keystone at the center of the arch, and the pilasters are expressed through all the elements of the cornice. The baseboard retains original marbling.

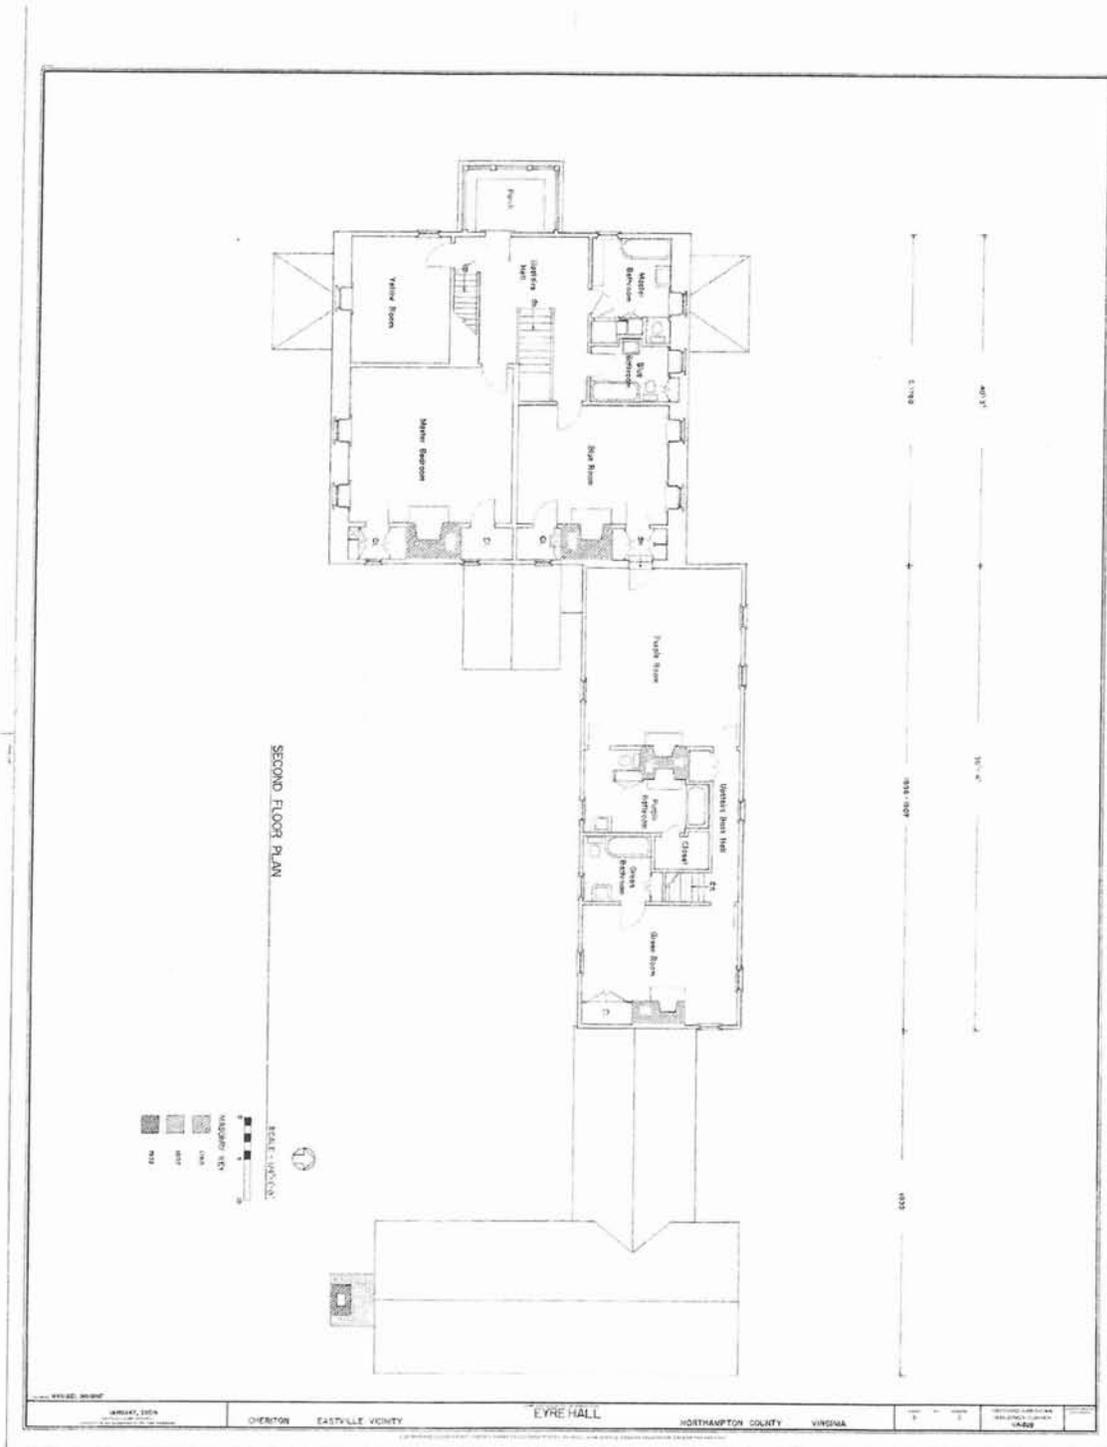
Eyre Hall, second-floor plan of house
Michael Bourne for the Historic American Buildings Survey, 2004

The **west (purple) bedroom** corresponds to the dining room. The flooring is generally unbroken for the length of this large room. Wallpaper presently covers the plaster walls. The baseboard and chair rail in this room resemble the ones at the west end of the passage. The fireplace has been reworked. The single window on the south wall and the two windows on the north are original, as are the three doors, though one of them is not in its original location. Their hardware has been altered or replaced. The single door on the west wall leads to the northeast bedroom in the main block. The door at the north end of the east wall leads to the upstairs back hall, the one on the south end to a bathroom created in the 1930s.

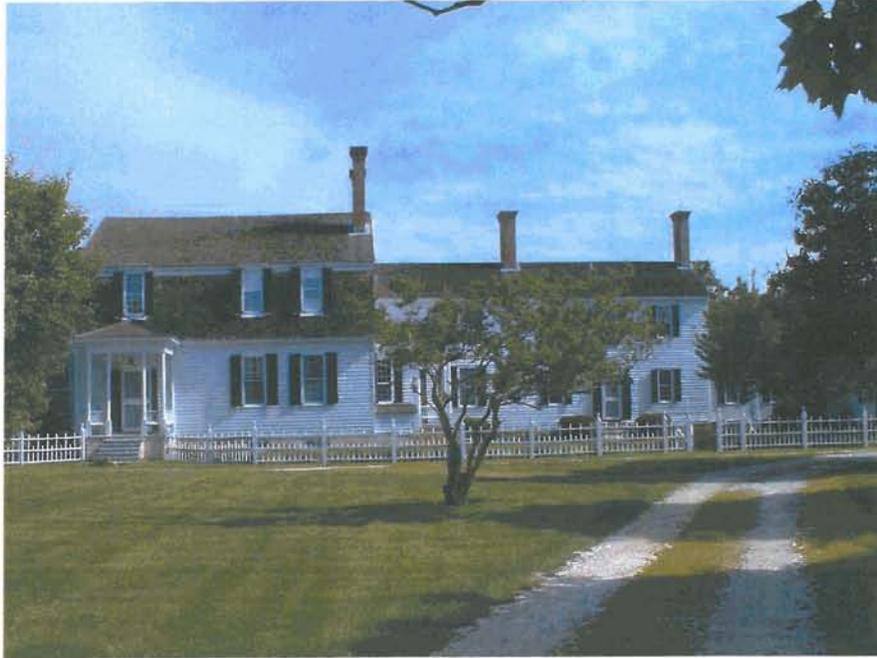
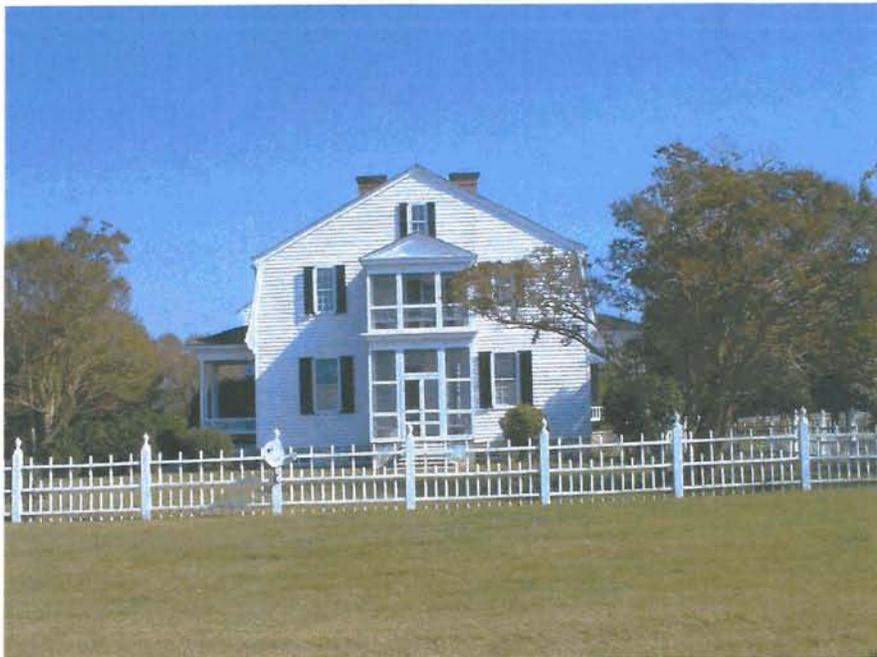
Eyre Hall, south elevation (top) and west elevation (bottom) of house Michael Bourne, 2006 and 2005

The **front (south) elevation** of the main block is divided into three bays. On the first floor the westernmost bay contains the main entrance under a one story hipped roof porch; large 9/9 sash windows fill the two bays to the east. The three bays on the second floor, set within the lower slope of the gambrel roof, contain shallow hipped roof dormers with smaller 9/9 sash windows. The cornice of the dormers is a continuation of the upper roof cornice. The entrance consists of a very large eight-panel door set into a massive frame. The lion-headed brass doorknocker was brought here in 1870 from Old Castle, the home of Margaret Parker Eyre, the second wife of Severn Eyre III.⁵ The door is protected with a recent storm/screen door. The door and the window frames are original. As is the case for most of the windows in the main block, the original Georgian window sash, with wide 1¼" muntins, was replaced with the present Federal-style sash, with slender ¾" muntins, by John Eyre in the early nineteenth century. Louvered blinds protect all openings on the first and second floor. Windows with original iron bars fill the two eastern bays in the brick foundation.

The south porch rests on a solid brick foundation and is reached by a short flight of steps. Two pairs of slender turned Doric columns support the low-pitched hip roof, with corresponding half columns against the wall. The porch cornice does not align with the main cornice and differs from it in profile. A balustrade of turned Doric colonettes encloses the porch and forms the backs of two benches flanking the door. The porch floor is covered with square white and gray marble pavers set in a gray marble surround. The marble steps have molded edges and flare outward as they descend to the lowest step, which is finished with volutes. There is a marble carriage step a few feet in front of the steps.

The **west elevation** is divided into three bays. The two end bays contain 9/9 light Federal windows. The doors in the middle bays on the first and second floors are slightly off-center, but this asymmetry is disguised by the symmetrical placement of the two-story portico. Because the west elevation is a gable, it rises a full two and one-half stories high. The sash of the single small attic window at the third floor level was not replaced in the early nineteenth century and retains the original wide muntins. Very boldly shaped bargeboards cover the eaves of the lower slope of the roof and the ends of the cornices. The foundations, weatherboard, and windows have the same details as the south façade. Four original cellar windows are symmetrically placed in the foundation. The west portico is supported on a brick half vault that differs from the foundations of the other porches and appears to date to the original construction. The west portico resembles the south porch in materials and details; the second floor columns are considerably shorter than the first, reflecting the lower ceiling heights of the second story inside the house. Full cornices are located between the first and second floor of the portico and define the pedimented gable; the tympanum is filled with beaded shiplap boards.

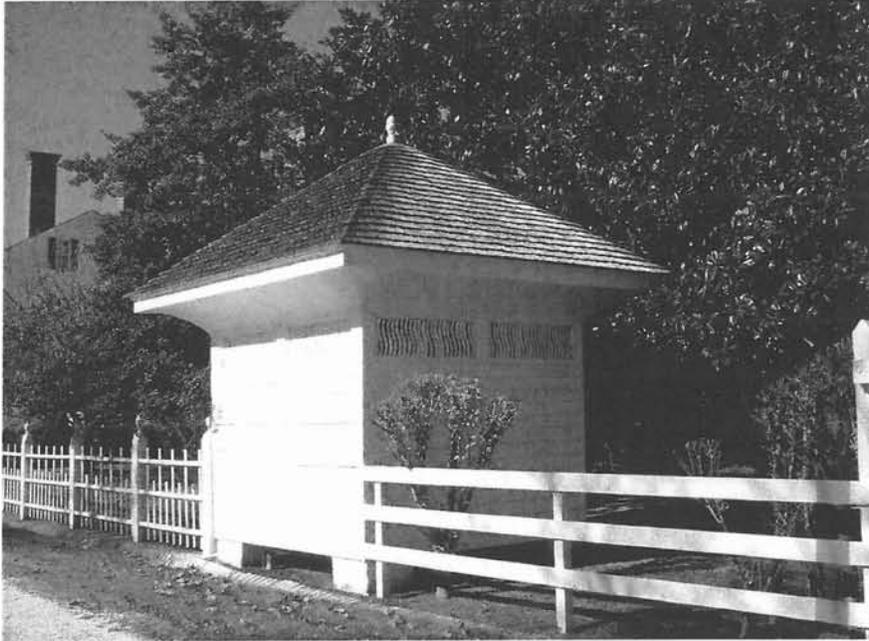
Dairy, looking northwest
Michael Bourne, 2004

Dendrochronology suggests that the frame dairy, measuring 10' square, was built ca. 1759 and moved to its present location ca. 1807.¹⁶ The north (front) elevation stands on a continuous brick foundation, while brick piers support the back of the building. Beaded weatherboard covers the lower part of the walls. Vents with vertical closely-set strigil-shaped slats fill the area between the weatherboard and the plaster cove cornice. There is a turned finial at the center of the hipped roof. A millstone step on the north side leads to a reproduction paneled door dating from the 1930s but set in the original frame and hung on original cross garnet hinges.

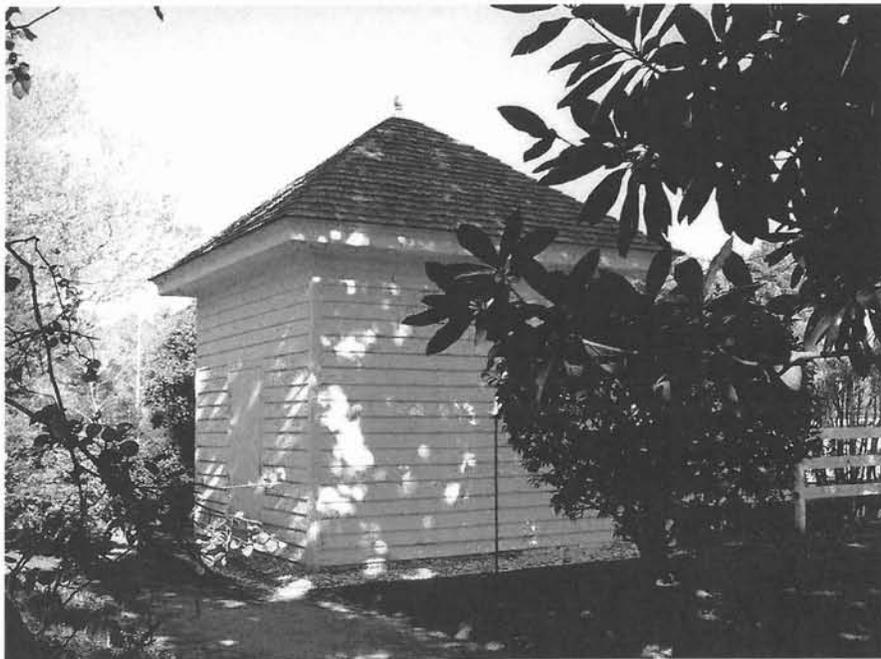
Smoke house, looking northeast
Michael Bourne, 2004

The frame smokehouse stands about 58' to the north of the dairy, with which it is aligned. According to the dendrochronology report, this building dates to 1807; it is identified on the insurance policy of that year as a "pantry." It measures about 12' square and stands on a low brick foundation. The walls are beaded weatherboard, but many coats of whitewash have obscured the detail. A wide, board-and-batten door centered on the west elevation is secured inside by a wood box lock and outside by a diagonal iron bar and staple. Slits cut into the soffit and the second weatherboard below the cornice allowed smoke to escape. The roof, like that of the dairy, is pyramidal.

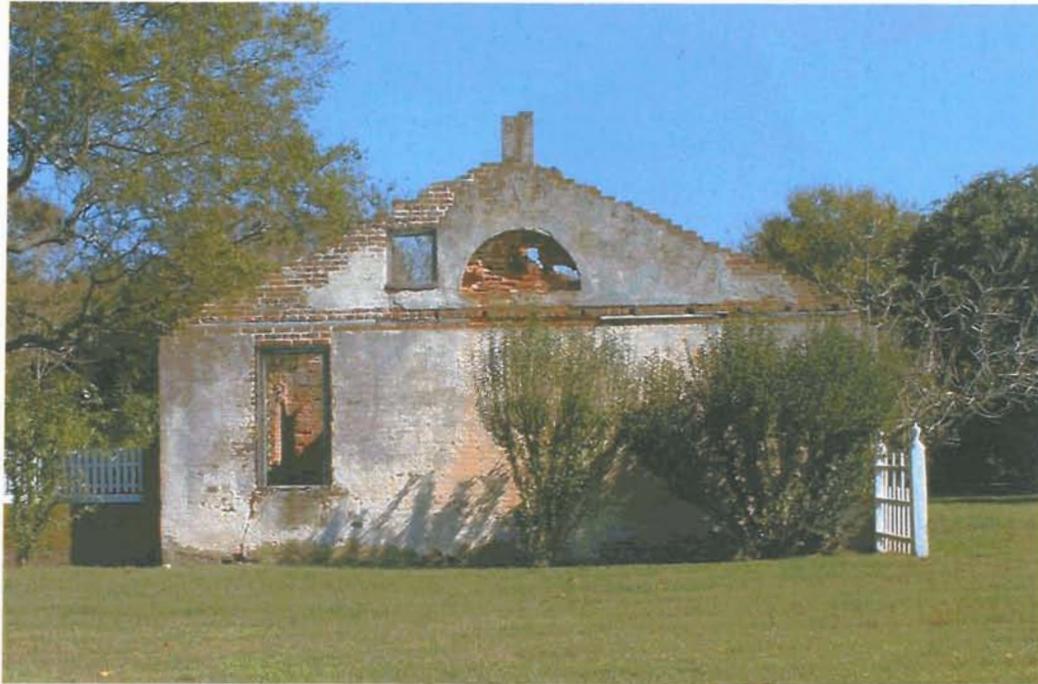
Orangerie, west elevation
Michael Bourne, 2004

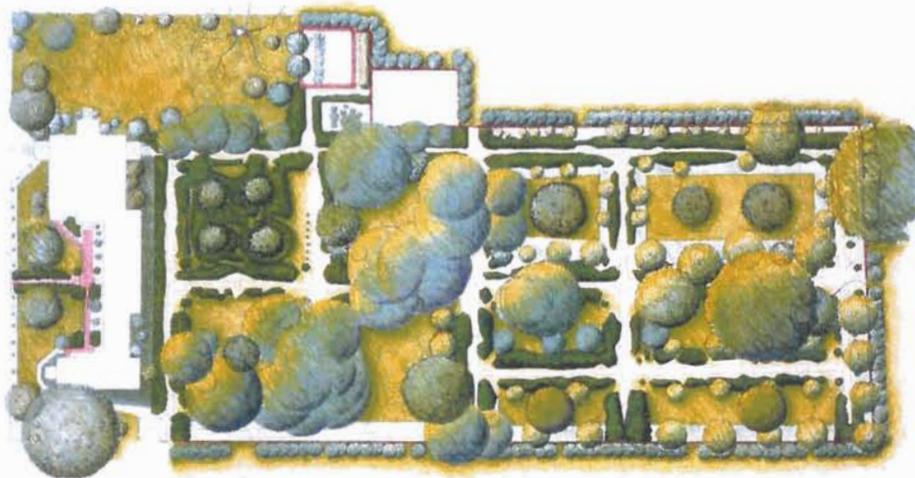
Eyre Hall gardens, schematic plan
Darrin R. Alfred for the Garden Club of Virginia, 1997
