**NATIONAL REGISTER OF HISTORIC PLACES
REGISTRATION FORM**

historic name : Lambert's Point Knitting Mill (#122-0934)
other names/site number The Knitting Mill; Old Dominion Paper Company

street & number: 808 West 44th Street not for publication N/A
city or town Norfolk (Independent City) vicinity N/A
state Virginia code VA county _____ code 710 Zip: 23508

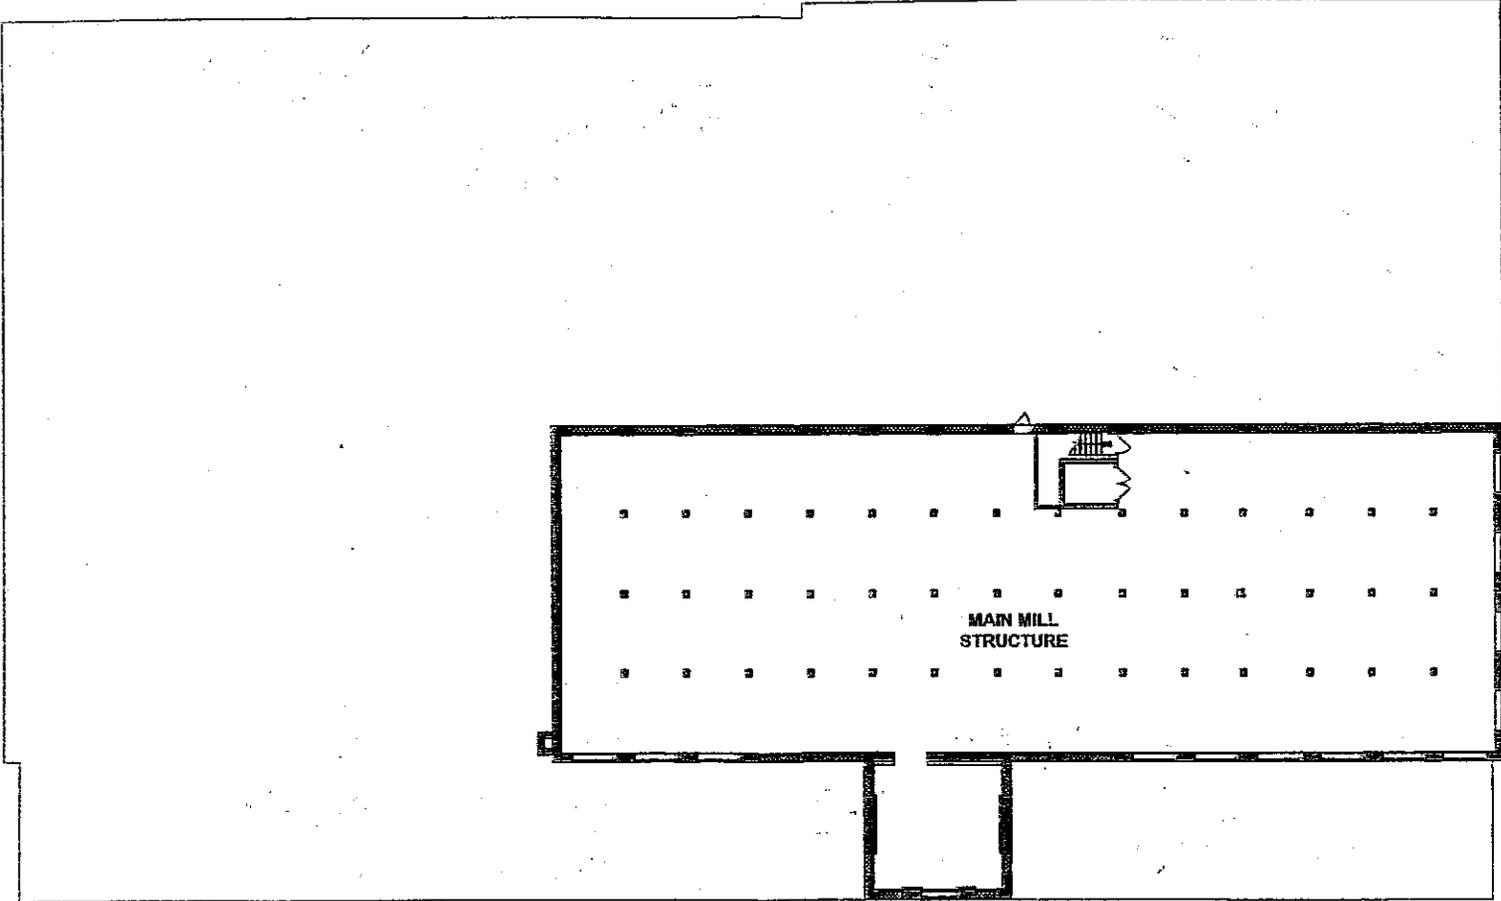
FLOOR 2

The original ca. 1895 main mill structure was characterized by an open plan on the first and second floors, typical of turn-of-the-century mill buildings. Over the years, the first floor was partitioned into a variety of spaces, and more rooms and structures were added on the south, west, and north sides of the original building. The main entrance for the building stands at the base of the central tower, on the south side of the structure. Modern offices are placed in the eastern end of the ca. 1950 one-story south addition, while an open-plan office area is located at the addition's western side. Modern offices are located at the southeast corner of the main building, and areas at the western end of the main building have been partitioned to form restrooms and storage rooms. A modern wood stairway and concrete block elevator shaft at the north side of the main building provides access to the second floor. The north portions of the complex are divided into six warehouse structures, dating from the original ca. 1895 construction date through ca. 1950. Interconnecting door openings are placed in the primary masonry dividing walls of the building, and most of the warehouse spaces at the northern portion of the building are free of interior partition walls. One of the warehouse spaces at the northeast corner, however, has been divided into small modern office spaces. The second floor of the main structure retains its open floor plan, interrupted only by the structural wood columns that define the space. The second, third, and fourth levels of the tower are open and undivided by partition walls. Paint ghosts on the beaded wood paneling of the second floor tower room, however, indicate that a partition wall may have been in place to enclose a now-missing stair to the upper levels of the tower. The paint ghost of the stair remains visible on the second floor tower room's west wall.
