National Register of Historic Places Registration Form

1. Name of Property Historic name: Nelson, Chief Otho S. and Sus	zie P. House
Other names/site number: Hutchinson Hor	
Name of related multiple property listing:	250, DIRCH 0 19 3 132
N/A	
(Enter "N/A" if property is not part of a multiple pro	operty listing

Chief Otho S. and Susie P. Nelson House King and Queen County and Essex County, VA DHR No. 049-5132

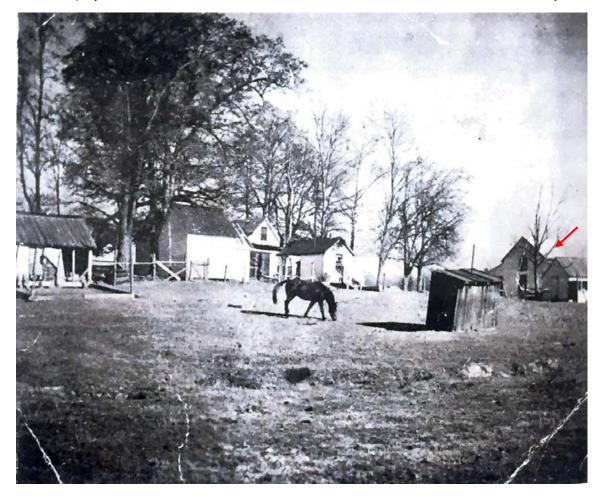
View of the Chief Otho S. Nelson House, 1919 or 1920. Red arrow points to east barn. Facing northeast (deShields Bastow 1975:42).

The second ruin is the east barn, a frame structure with a metal roof. The current state of the structure is a collapsed ruin that is in a considerably more dilapidated state than the west barn. The primary cause of the structure's collapse appears to have been a large treefall that landed across the center of the structure. Little recognizable shape remains other than part of the roof's ridgeline. The dimensions of the ruin in-situ are approximately 30 feet north-south by 20 feet east-west. The roof appears to contain at least two and possibly three distinct sections, with a ridgeline running in an east-west direction. The main core of the east barn appears to have measured approximately 20-by-20-feet, with a 10-foot shed addition on the north side. A historic photograph (following page) of the property indicate that there was also a shed of equal size on the south side of the east barn, the remains of which were not visible in the structure's current ruinous state. The same historic photograph, taken in 1919 or 1920, indicate that access to the main core of the building and sheds was on the west gable end. The photographs show two windows on the east gable end of the core structure.

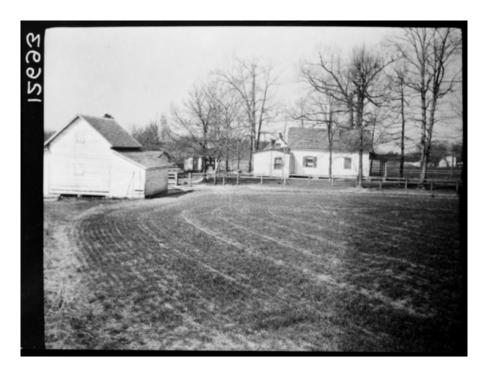
View of the Chief Otho S. Nelson House, 1919, by Frank G. Speck. Facing west (Smithsonian Institution).
