NATIONAL REGISTER OF HISTORIC PLACES
REGISTRATION FORM

historic name DeJarnette's Tavern

**DeJarnette's Tavern
Halifax County, Virginia**

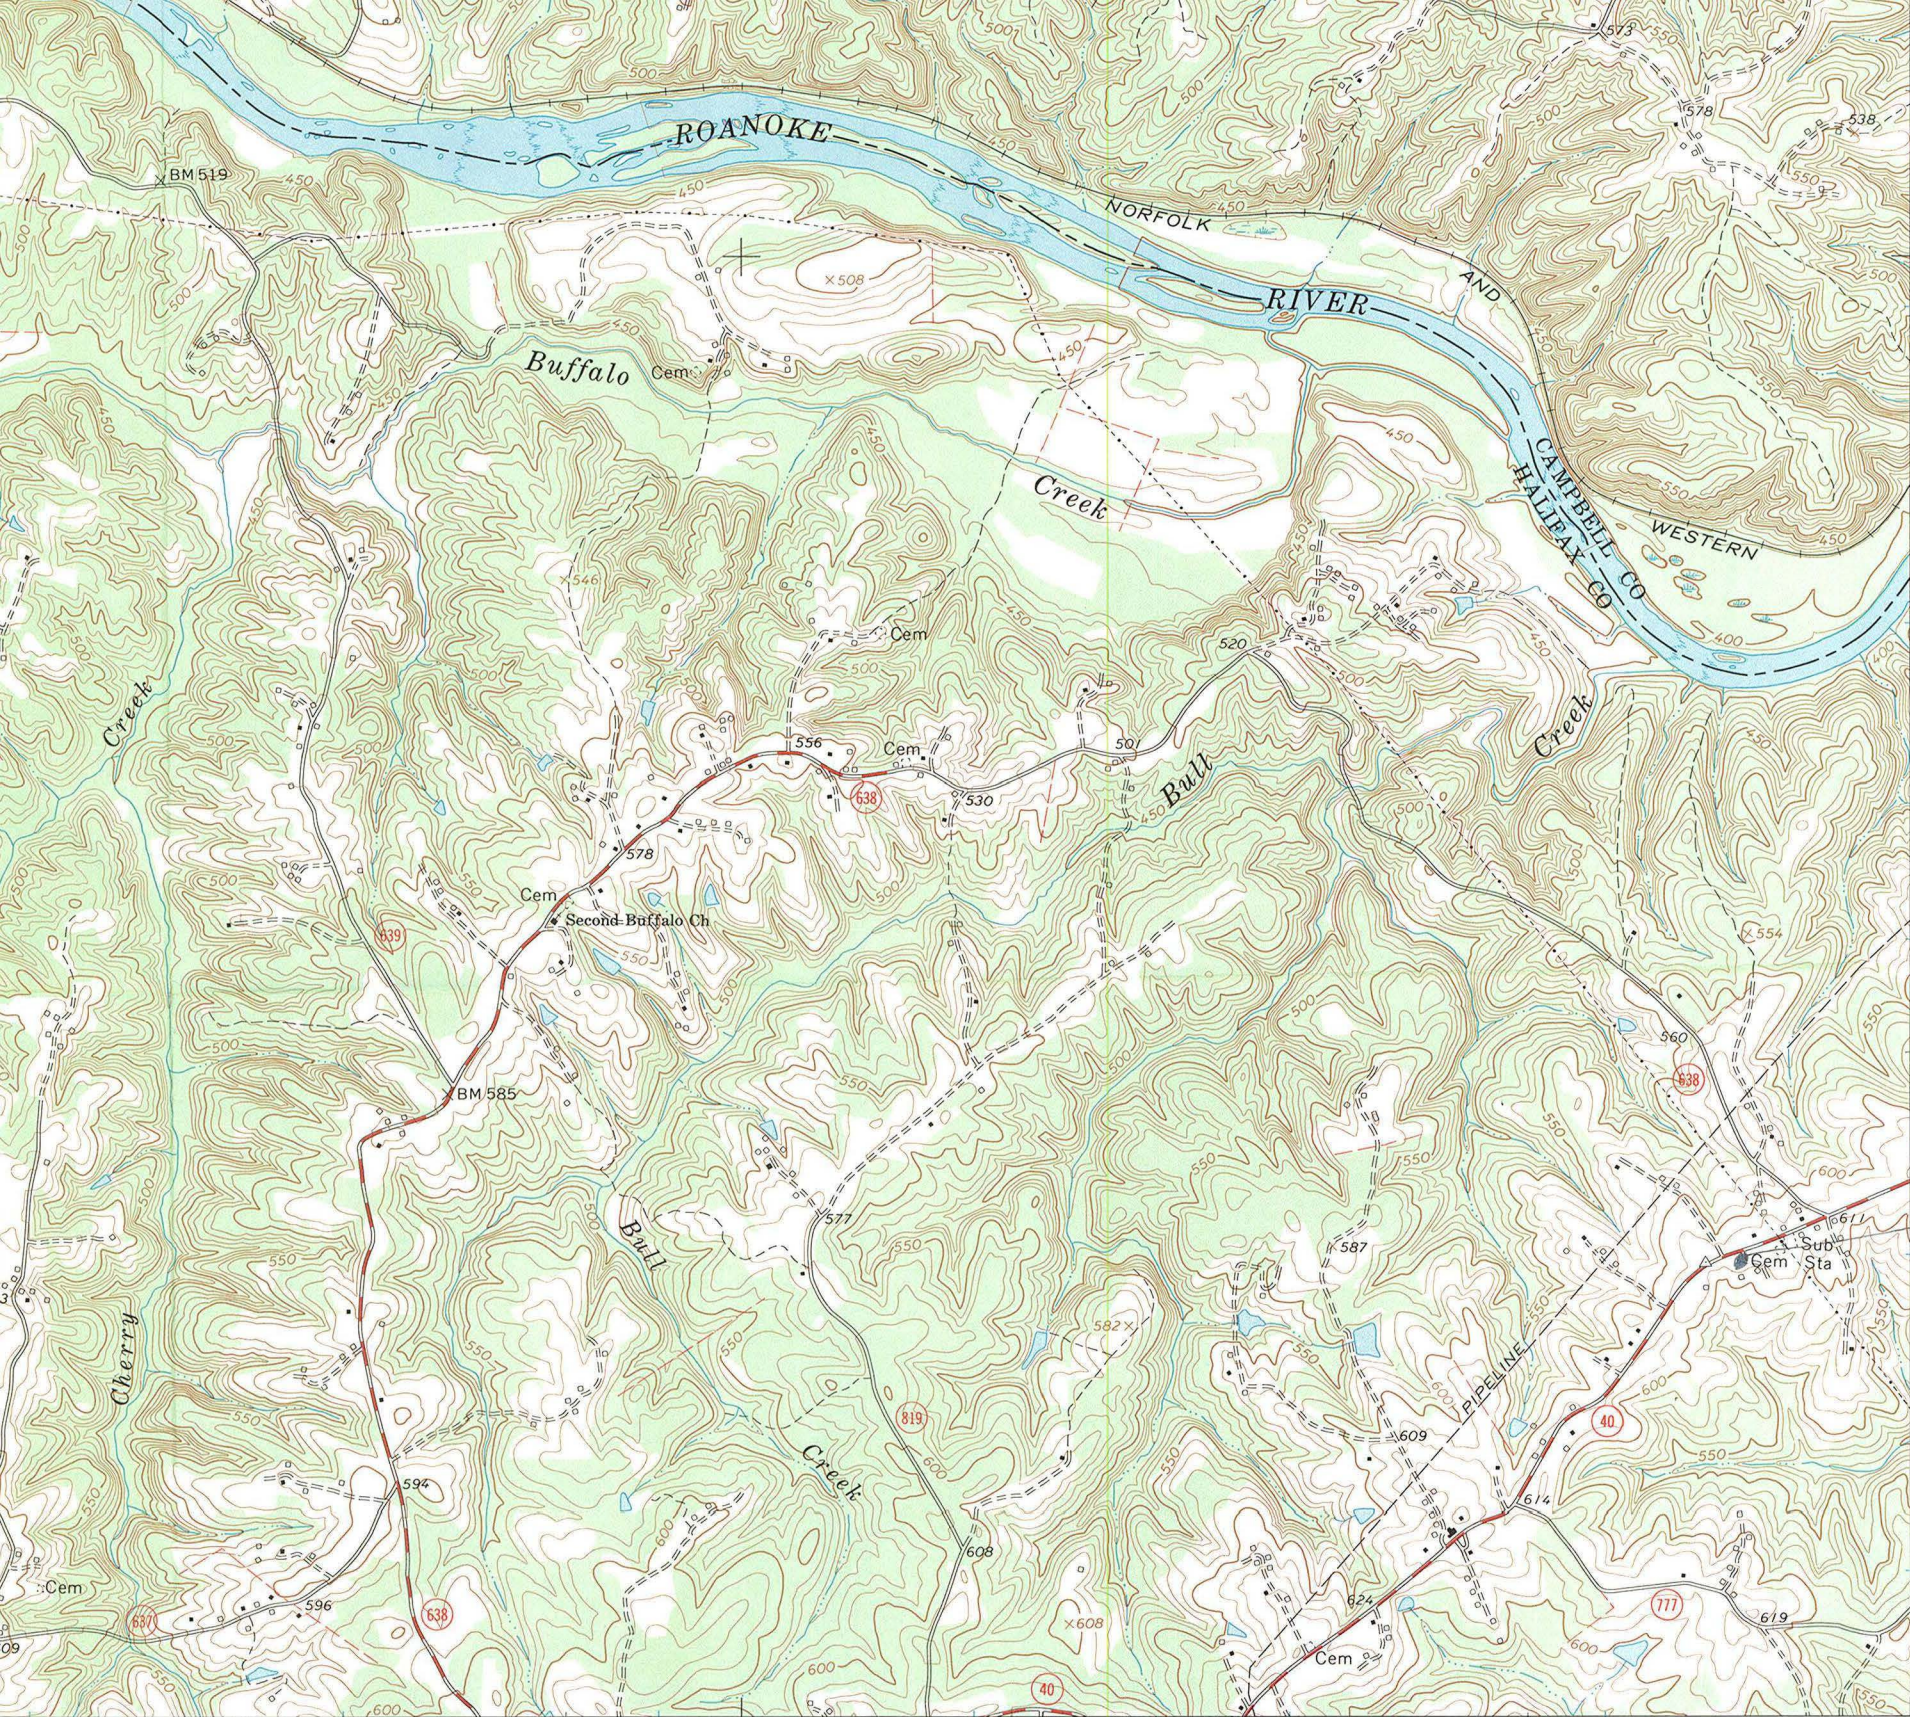
Frame Bldg.
'Old Tavern'

S11°00'00"E 435.05'

N10°59'46"W 433.98'

3.000 Acres

S80°04'22"W 300.02'

The property is bounded on the North by State Route 40 and on the South, East, and West by property owned by James L. Gibson and Frank R. Wood. The 3-acre tract is known as Halifax County tax parcel 31359, map# 3532-31359.
