United States Department of the Interior
National Park Service**National Register of Historic Places Registration Form**

1. Name of PropertyHistoric name: Oak HillOther names/site number: 071-0026; Oak Hill Archaeological Site, 44PY0440

2. LocationStreet & number: 5981 Berry Hill Road/ U.S. 311City or town: Danville State: VA County: PittsylvaniaNot For Publication: ☐ N/AVicinity: ☒ X**3. State/Federal Agency Certification**

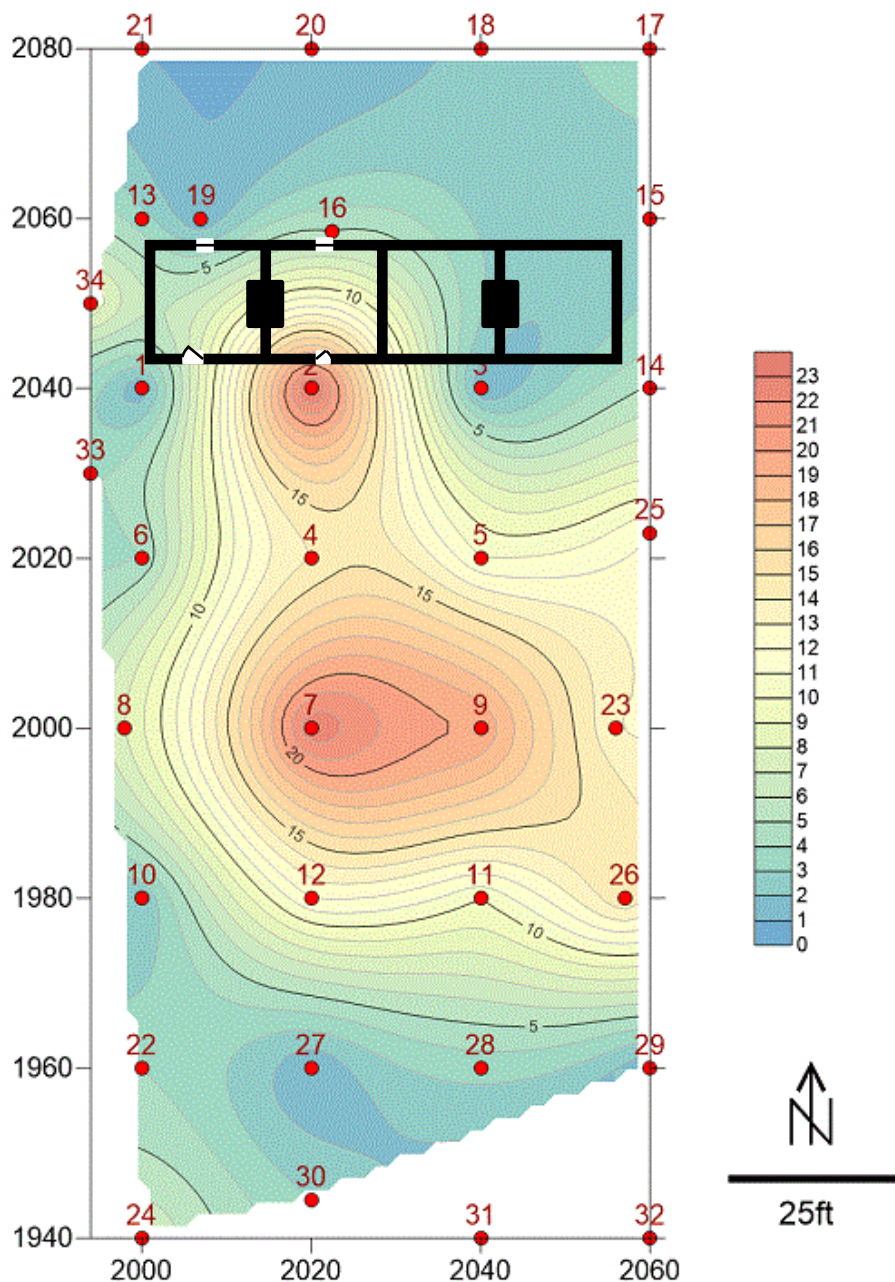
Figure 7. Distribution of ceramic artifacts.

Distribution of Ceramics Across Project Area

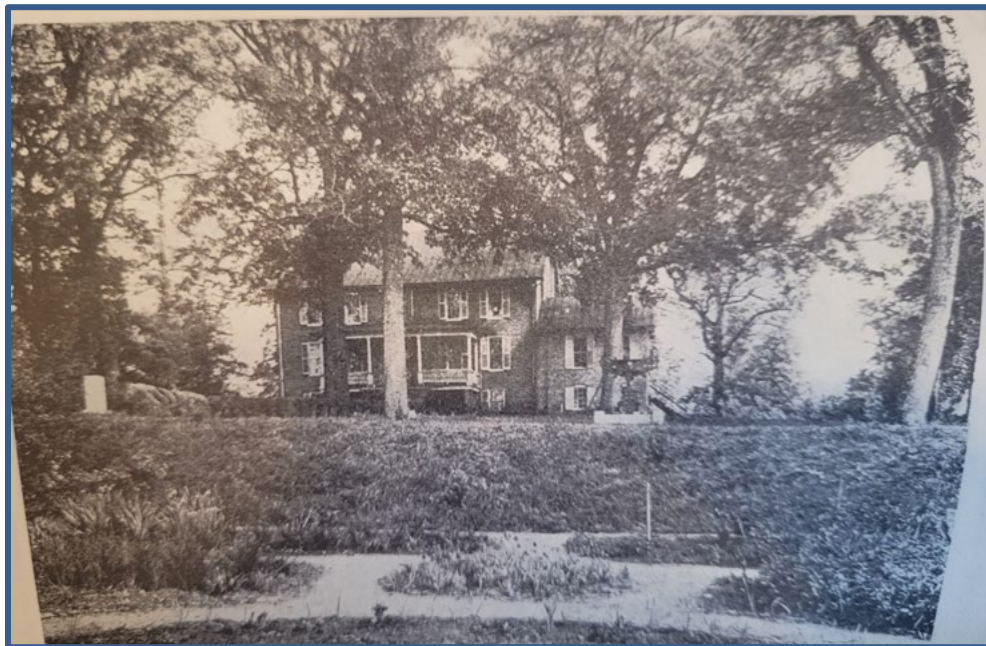
Figure 12. The gardens at Oak Hill. *The History of Pittsylvania County, Virginia.*

Currently, the gardens at Oak Hill are overgrown and not easily discernable; however, the LiDAR mapping utilized during the archaeological surveys shows that one garden sat to the west of the dwelling edged by hedgerows, and a terraced garden sat to the rear of the house and led down to the Dan River. Contemporary accounts write of the amazing gardens at Oak Hill. Designed by Agnes Hairston, the gardens favored a more formal eighteenth-century style. One writer for the *Richmond Whig & Public Advertiser* stated that he had “never seen anything comparable to his [Hairston] yard and garden. Mrs. Hairston has been beautifying it for years. .”⁵ Mrs. Hairston utilized the labor of seventeen slaves and an overseer to plan and build her gardens at Oak Hill (Figure 12).⁶

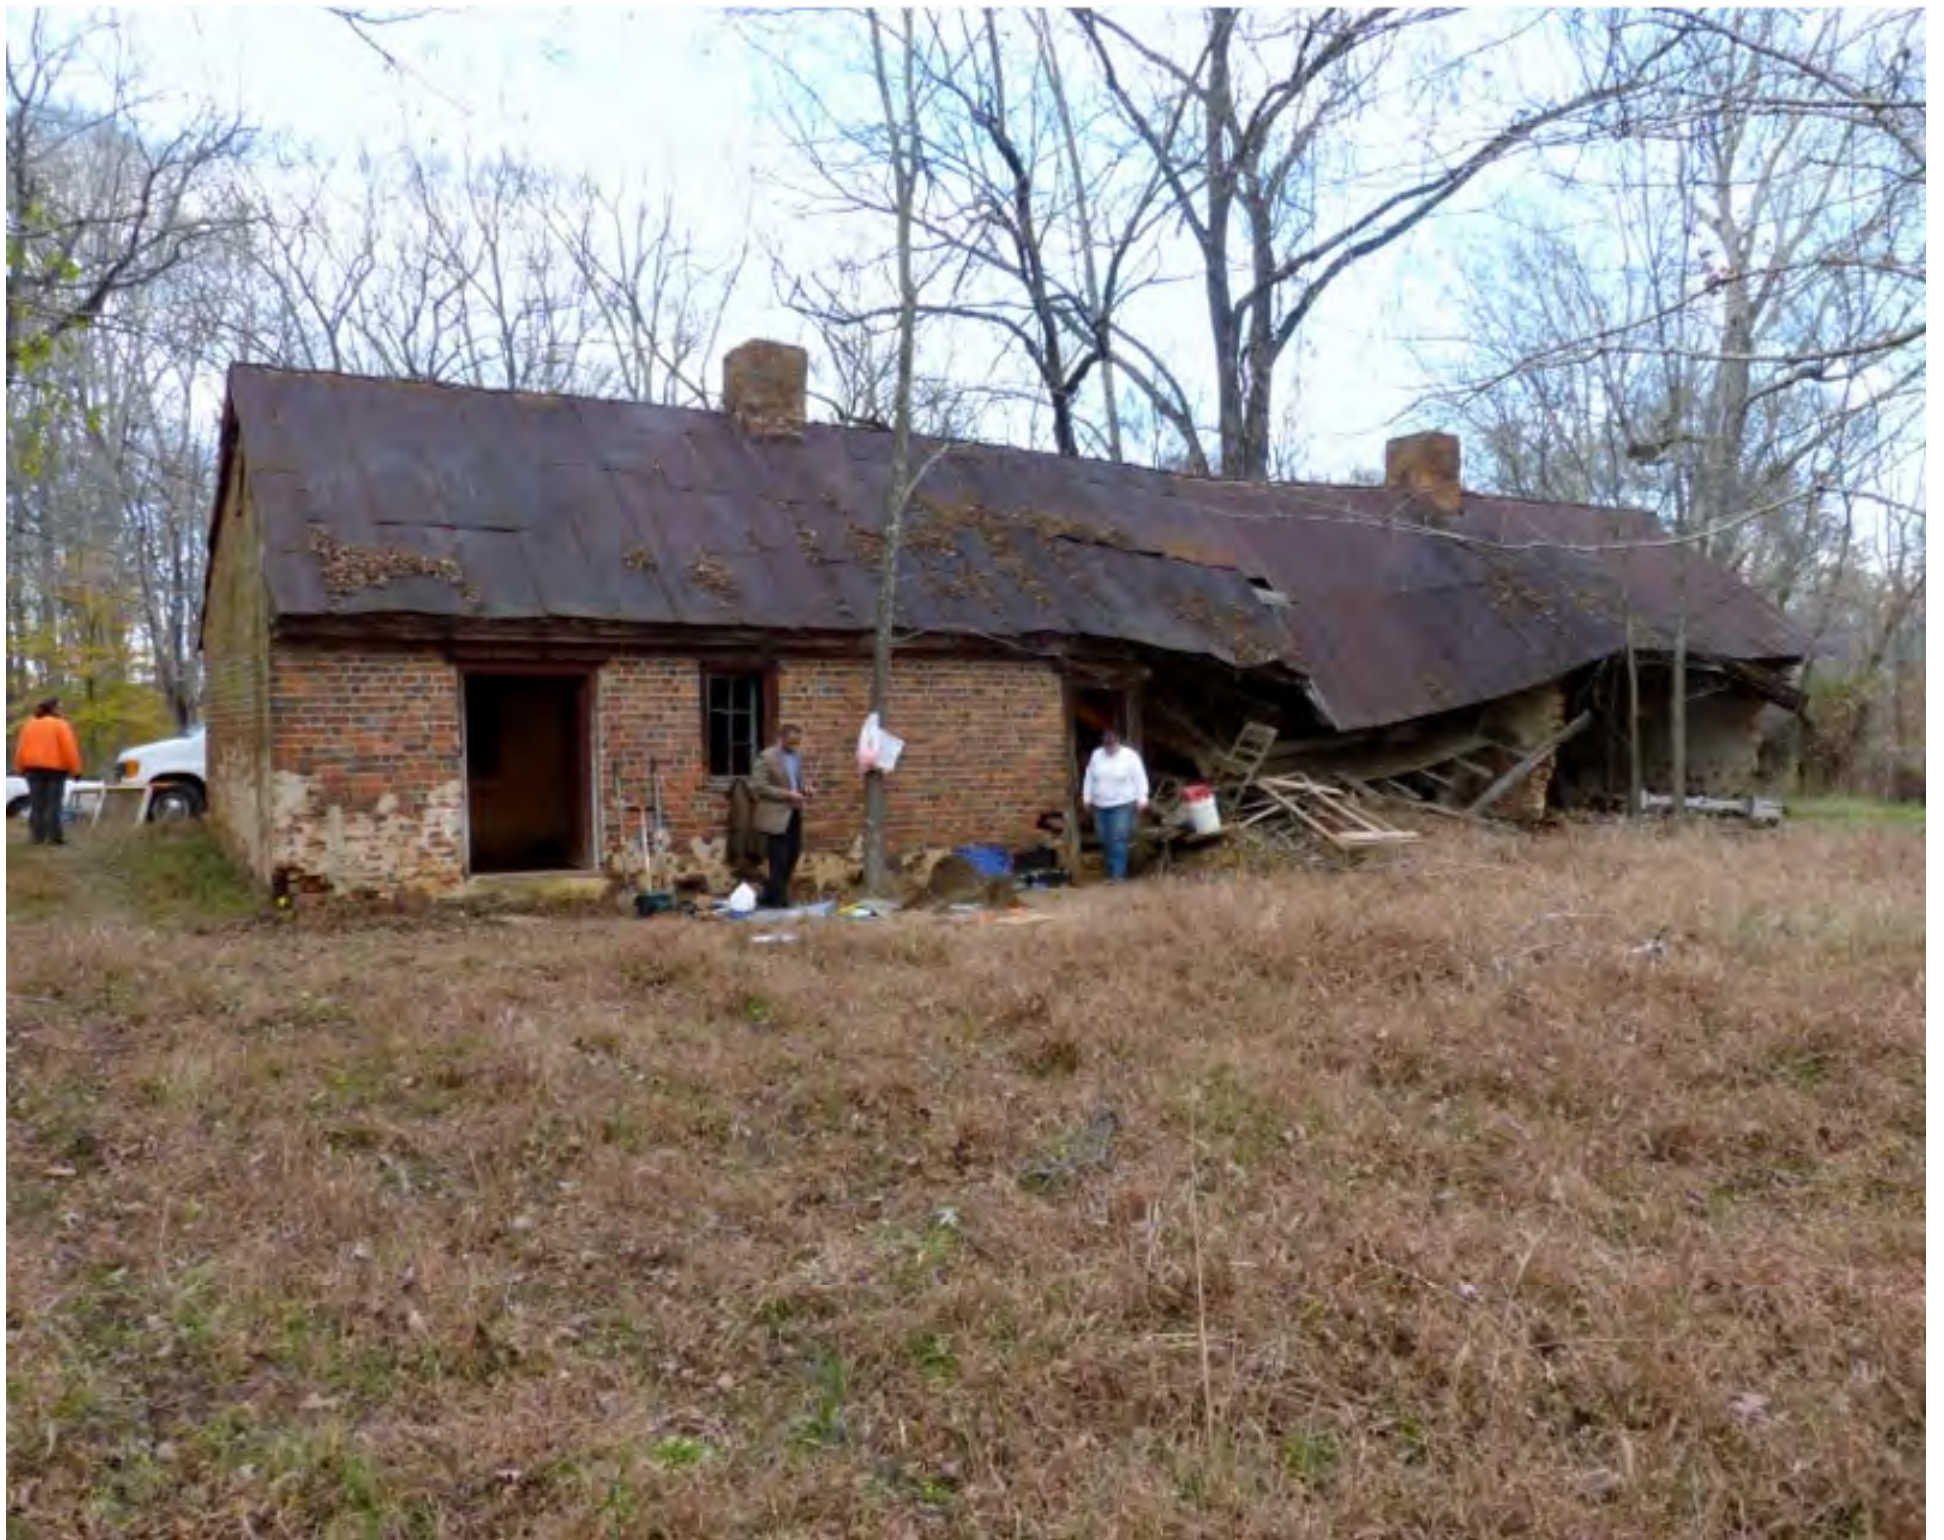
OAK HILL
ROOM 1
FEATURE 2
BASE OF LAYER B
11 15 2015
