United States Department of the Interior  
National Park Service**National Register of Historic Places Registration Form**

**1. Name of Property**Historic name: Laurel Hill FarmOther names/site number: DHR ID# 053-6244

**2. Location**Street & number: 16191 Hamilton Station RoadCity or town: Waterford State: VA County: LoudounNot For Publication: N/AVicinity: X**3. State/Federal Agency Certification**

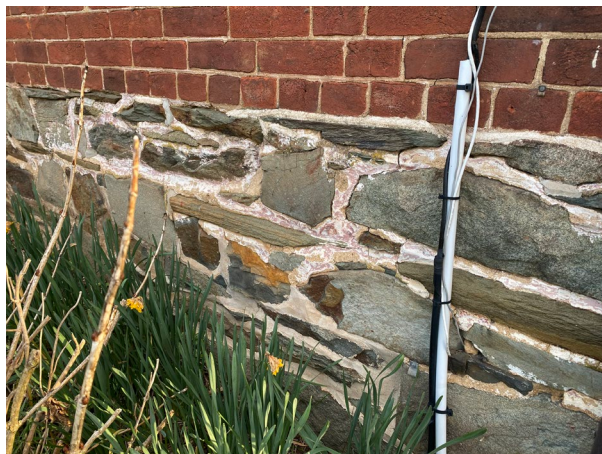
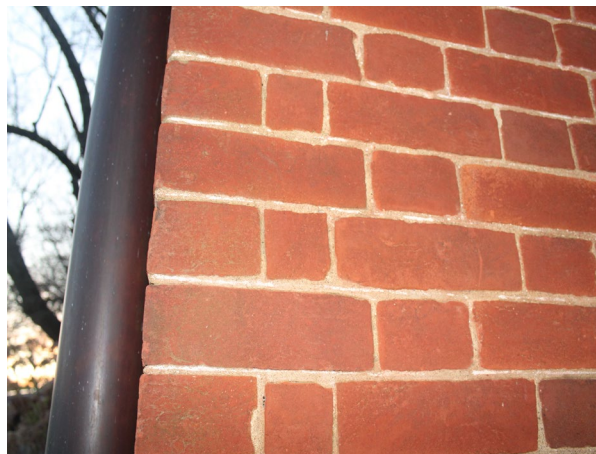
**Figure 1:** Ca. 1793 section- red wash on mortar joints of the foundation (left), penciling of mortar joints (right) both taken on or about April 7 and 8, 2024, by Greg Blaszc.

Despite the comparative lack of wealth, Laurel Hill Farm's ca. 1793 brick construction is remarkably fine. Although there has been minor cosmetic damage over time, the uniformity of the brickwork rivals that of later, larger constructions. The bricks themselves are hand molded and must have been a somewhat standardized dimension for the time since Rich Bottom Farm (DHR ID# 053-0422) has ca. 1820 bricks that are approximately the same dimensions as Laurel Hill Farm's three-bay section. The bricks may have been made on site, as there are two depressions in the nearby creek bottom that may have been the result of clay quarrying. One of these depressions, still located on the property, is the site of a later farm pond that no longer exists.

A particular one of the aforementioned houses, the Asa Moore House, is noted for the precision of the mortar joints between the bricks. This house was built before 1803. Despite this, few houses in Waterford can match the quality of the mortar.<sup>10</sup> It is possible the same brick mason constructed Laurel Hill, although Laurel Hill’s brickwork appears finer. The 1803 date for the Asa Moore House supports the early construction of Laurel Hill’s three-bay section. The Asa Moore House is also noted for its high-quality construction, which matches the interior of Laurel Hill well.<sup>11</sup> One conspicuous detail is the bottom of the window casements of the Asa Moore House do not match the height of the chair rail, which is slightly higher than the bottom of the windows.

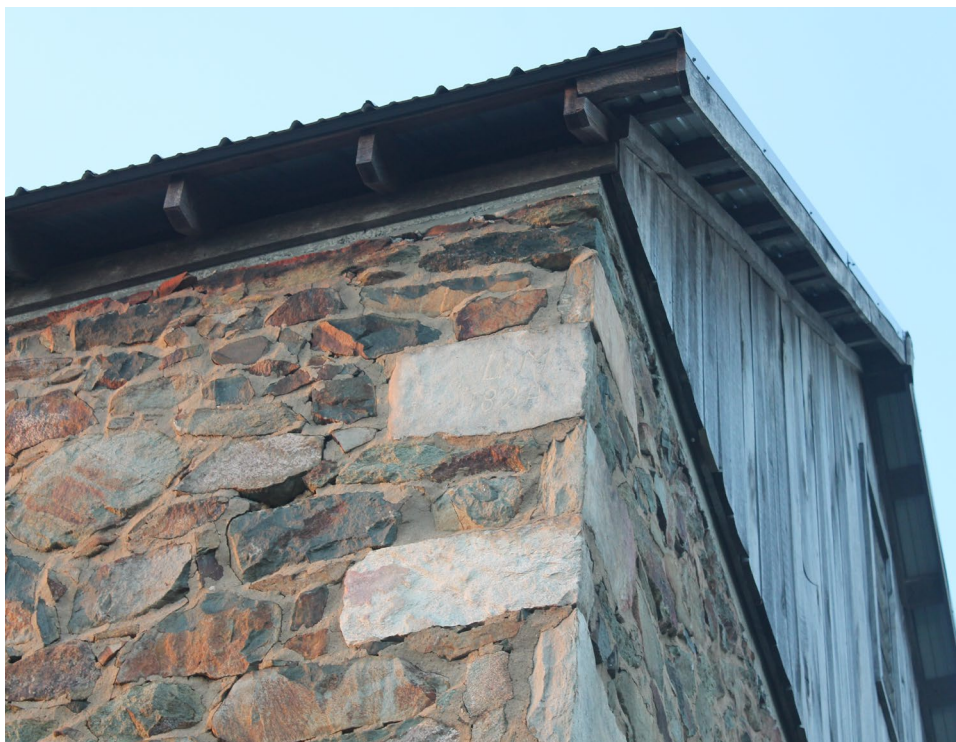
**Figure 2:** 1824 stone barn date stone with “LM 1824” engraving. Photo taken on April 7, 2024, by Greg Blaszc.

At the top of the hill sits a stone barn that measures 32 x 46 feet, constructed out of clay-silt lime mortar and irregularly coursed field stone with large Shorthill mountain quartzite quoins. A quoin near the peak on the corner of the southerly and easterly faces is carved with “1824 L.M.” (Figure 2). The initials are for Lambert Myers, who owned the house at the time of construction. The barn is a three-bay or “English” style barn. The roof is front gabled, and the ridge is oriented roughly east to west, perpendicular to the orientation of the house’s facade. The gable ends above the stone are wood planking. There is a single dormer window situated centrally on the northerly roof. The easternmost gable end has three doors all set at slightly different heights. The southern face has three windows, also at different heights, while the northern wall mirrors the window placement of the southern wall, minus the third window that would be in the way of the stairs. The west gable end has three openings, two at the ground level and one on the second floor that once served as a passthrough to get to the no longer existing ca. 1920 barn hayloft. The timber frame structure and roof are ca. 2015 replacements that were constructed after a structure fire destroyed the barnyard complex. Only the barn and silo and a section of an equipment shed remain standing. For having suffered such a fire, the stone barn is in remarkably good shape.

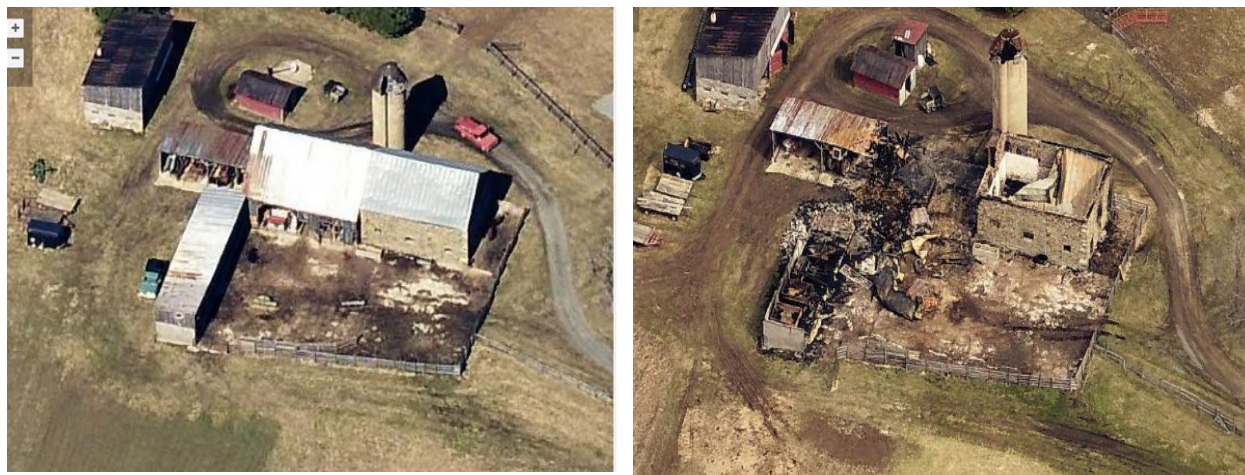
**Figure 3:** The barnyard ca. 2013 before the fire (left) and ca. 2015 image after the fire (right).  
Aerial images provided via Loudoun County GIS oblique imagery.

The noncontributing site consists of a ca. 1960 crushed stone concrete barnyard situated on the south side of the 1824 barn, measuring 100 x 60 feet. It is about two feet lower than the ground floor of the 1824 barn (likely due to excavation of manure and mud during construction) and slopes away from the foundation of the barn. It is surrounded on the west and north by the concrete foundations of the ca. 1950 concrete block loafing barn, measuring 15 x 65 feet, and the field stone and brick foundation of the ca. 1920 barn, measuring 36 x 40 feet. Both no longer stand. Included is the still standing but no longer structurally sound ca. 1950 run-in machine shed, which was once connected to the exterior of the ca. 1920 barn. The foundations are not considered contributing because of the lack of historic integrity stemming from extensive damage attributed to the firefighting efforts and the subsequent exposure to the elements (Figure 3).

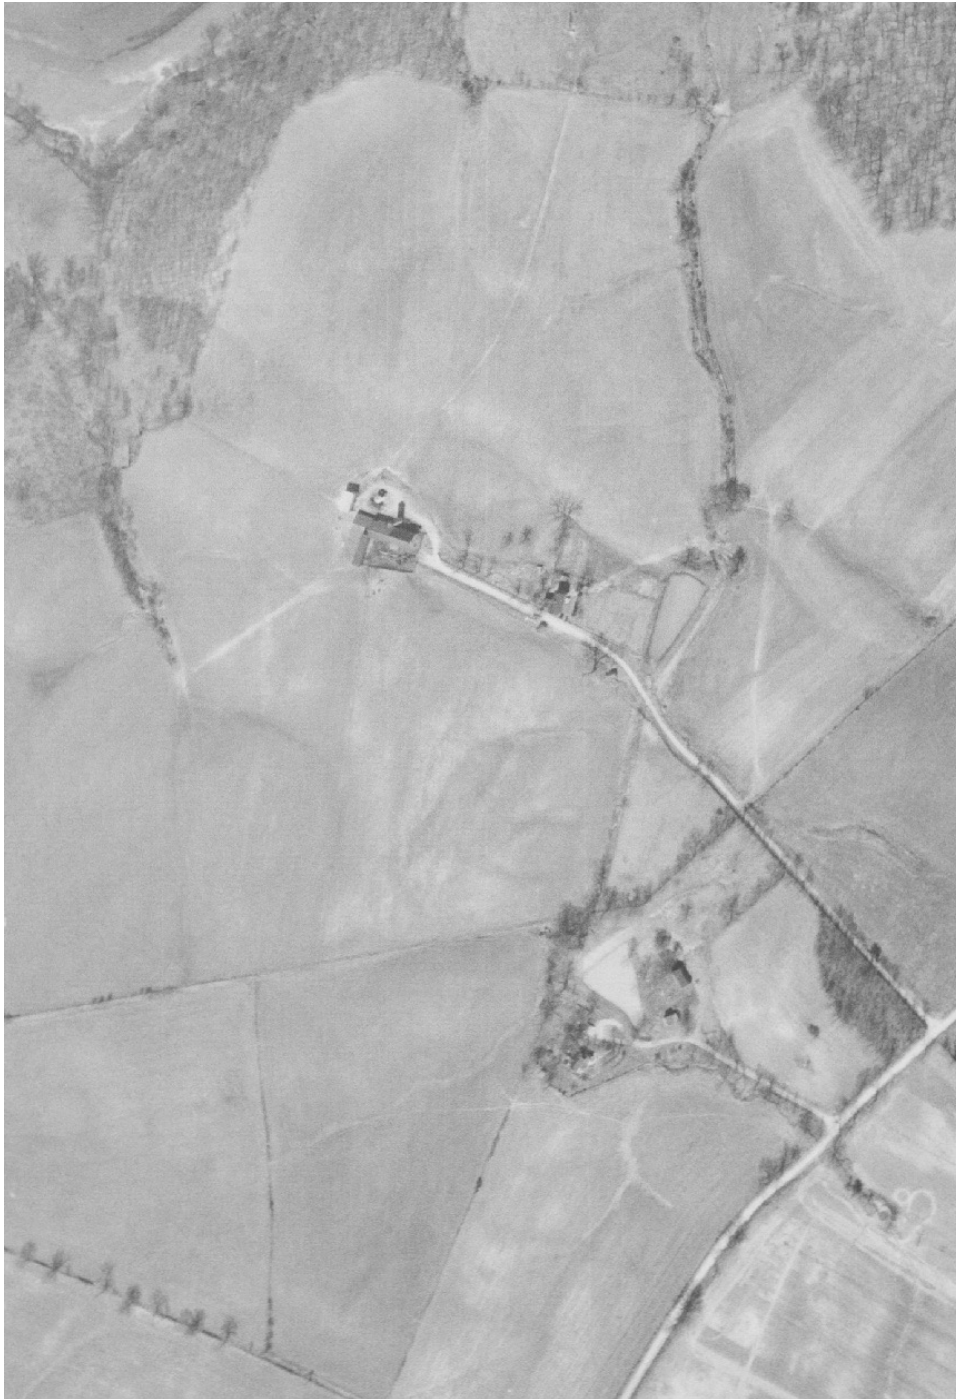
Figure 5: Laurel Hill satellite photo ca. 1964 showing farm pond, house, agricultural outbuildings and horizontal silo (near bottom). Note the relative lack of trees near the fence lines. Image from USGS Earth Explorer EROS archive.
