National Register of Historic Places Registration Form

Historic name: Ames-Old Farm

Other names/site number: DHR ID# 133-0058

Street & number: 6700 Knotts Neck Road

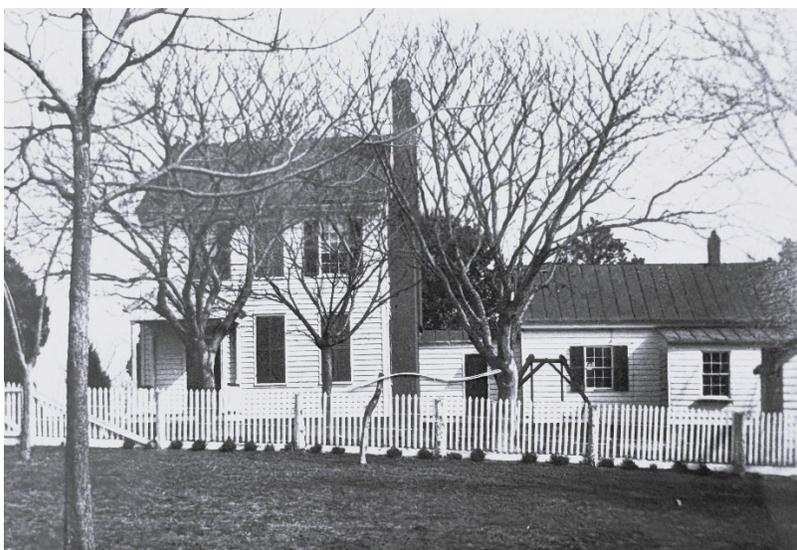
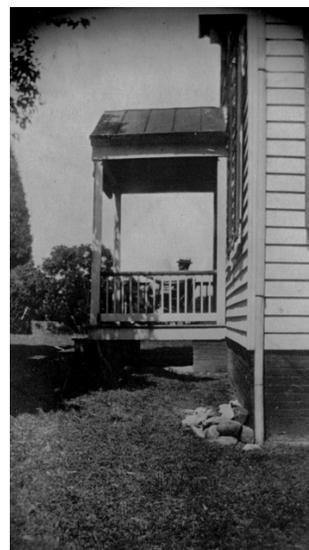
Figures 1 and 2: The main block and part of the south wing circa 1900 (left), and the gable-front portico pre-1900 (right).

The dwelling has a side-hall plan and thus an asymmetric façade, with the front entry located on the north side of the elevation and two nine-over-nine double-hung wood-sash windows on the south side. Though asymmetric, the façade maintains a sense of balance, as the three second-story windows—which are nine-over-six double-hung wood sash—align with the first-story fenestration. Louvered wood shutters flank the windows on the façade. The front entry is a six-panel wood door, topped by a divided-light transom. Small brick steps with modern iron handrails lead to the screened-porch door. Likely added in the early 20th century, the porch replaced a small gable-front portico (pictured in Figures 1 and 2).

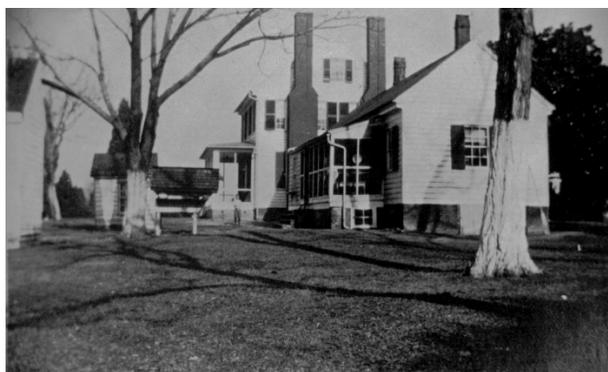
Figure 3: The west elevation and south wing circa 1920. Note that the portico has been replaced with a hipped-roof screened porch.

Figure 3: Figure 3: The west elevation and south wing circa 1920. Note that the portico has been replaced with a hipped-roof screened porch.

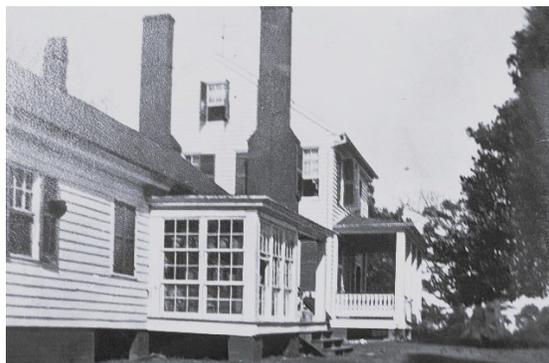
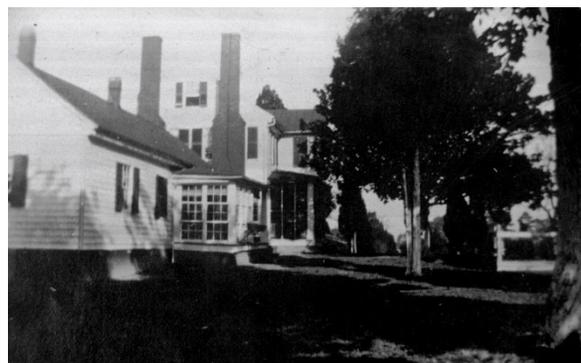
Figures 4 and 5: The east elevation circa 1920 (left) and circa 1930 (right). Note that the bathroom addition is visible in the circa 1930 photograph and that the porch has been screened in. Note, too, the greenhouse or “flower room” with triple-hung windows.

The south wing was constructed circa 1875 to house the dining room and kitchen and was built on the site of an older free-standing kitchen. The wing has undergone several alterations throughout the years. In photographs from circa 1900 and 1920 (Figures 1 and 3), the wing's front (west) elevation is pictured with a shed-roofed porch, which, in the circa 1920 photograph, appears half enclosed and half screened (Figure 2). In another circa 1920 photograph, the wing is pictured with an enclosed greenhouse on the north side of the rear (east) elevation (Figure 4 and

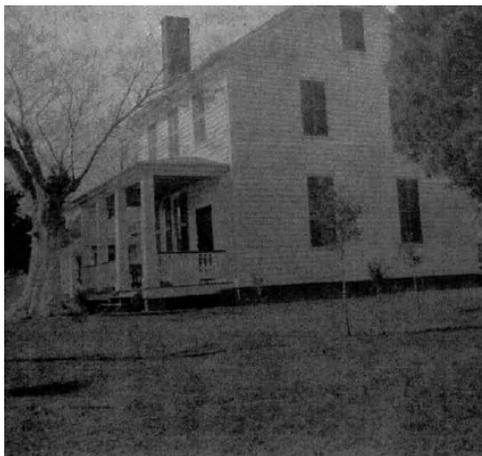
Figure 6: The north elevation pre-1900. Note that the first-floor west window has not yet been replaced. Note, too, the Victorian-era pattern-sawn porch pickets (seen also in Figure 4).

A six-over-six double-hung wood-sash window occupies the gable end of the north (side) elevation. The elevation features two first-story windows and two second-story windows that are aligned in their placement but are not symmetrical. On the west side of the first story there is a six-light, wood casement window. The window's small size (which is accounted for by its placement above the stairs) contrasts the surrounding double-hung windows, which include a nine-over-nine window on the east side of the first story and two nine-over-six windows on the second story. A pre-1900 photograph (Figure 6) showing four symmetrical window openings on the north elevation indicates that this smaller window is not original.⁴

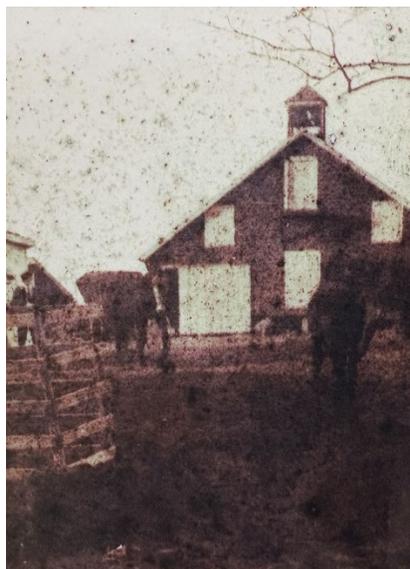
Figure 6: The barn pre-1900. Note, the additions have not yet been constructed and that the fenestration has since been altered.

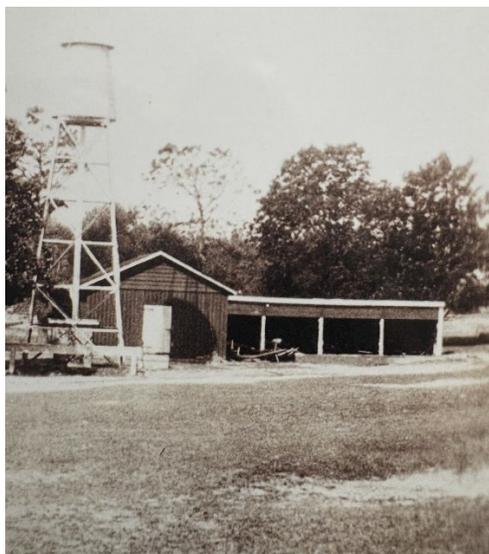
Figure 7: The corncrib pictured with the well windmill and additional stalls, which are no longer standing, n.d.

Water for the house was originally sourced from an artesian well. Around the 1890s, a new well was placed near the original well. The original well was then used for barnyard animals, including a small herd of cattle whose manure was used to fertilize the fields. The new well had a windmill that pumped water into a reservoir, providing the pressure needed to pump the water to the house.
