National Register of Historic Places Registration Form

Historic name: Gibson Farm

Other names/site number: VDHR ID 052-5163; Gibson Cemetery

City or town: Ewing State: VA County: Lee County

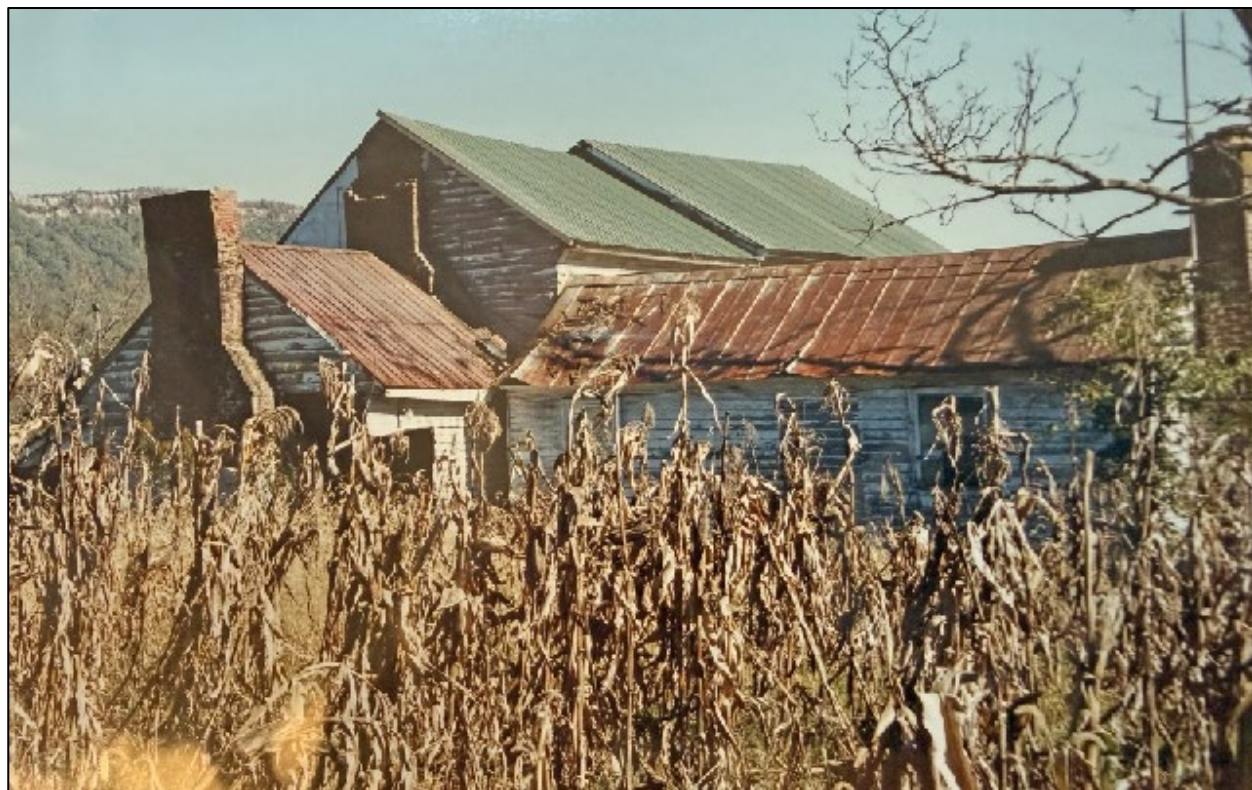
Fig. 1 Gibson Farmhouse with kitchen (left) still intact, circa 1991; looking northeast.

The house is in fair condition, but the kitchen extension on the west end of the house's main block is now gone except for its chimney. The one-story, one-room kitchen wing (figures 1, 2) was demolished circa 1991. It was built partly of frame construction and partly of plank construction, all of it externally clad with weatherboards. The gable roof is tucked between two masonry chimneys, both of which still stand, though in deteriorating condition. The kitchen had pole rafters, hewn flat on the upper surfaces, that met at a ridge board, and a square-hewn top plate that projected outward to form shallow eaves. The fairly steep roof pitch allowed for functional space in the loft. The kitchen's frame construction was limited to its west gable end, consisting of a common stud wall finished with regular-sized flush-mounted boards on the inside wall. These boards measured 1-2 inches thick by about eight inches wide. The two front and rear (north and south) walls of the kitchen, however, were built of heavy planks, about three inches thick, a foot or more in width, and three feet or more in length, without the use of studs. These planks were fitted tightly together by means of tongues or grooves along all four edges and fastened by cut nails. The usage of such planks and this type of plank construction have not been documented elsewhere in southwestern Virginia. The planks are stored the south wing's south room.

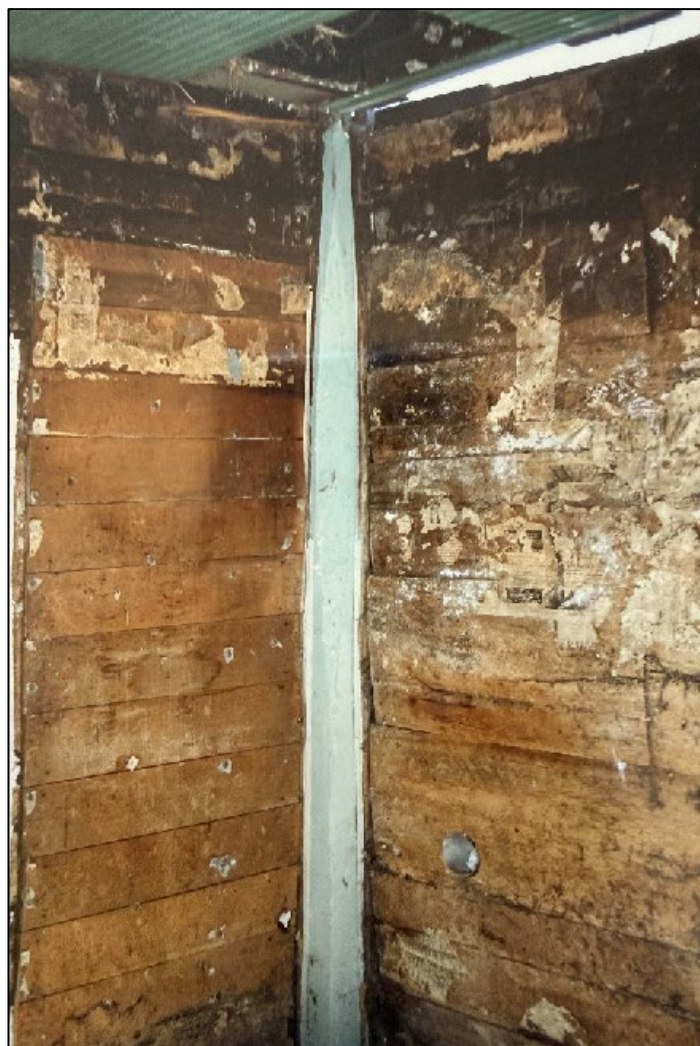
Fig. 2 Plank north wall (right) of kitchen before being dismantled ca. 1991.

long planks that extended the full length of a wall, corner to corner, and were greater than three inches thick (five or six inches on average). The planks were usually pegged or notched together without tongue-and-groove or similar joinery. As far as can be determined, there are no other recorded examples of tongue-and-groove short-plank buildings in Virginia. The Gibson farmhouse's two-story four-bay timber-frame lateral wing was built at an unknown date, in a very unusual fashion, using pegged mortise-and-tenon joinery rather than nails, with the framing semi-exposed on the inside of the building. The corner posts and diagonal down braces, which are chamfered to an octagonal shape, are all partly visible within the rooms. Considering its use of three entirely different construction methods, two of them with possibly unique details among recorded properties, the Gibson Farmhouse is the only known survival of its kind in Lee County or elsewhere, and is therefore of exceptional historical importance at the local and regional levels. Although combination log-and-timber-frame buildings continue to exist in southwestern Virginia, survivals are exceptionally rare, with only a few examples recorded.²

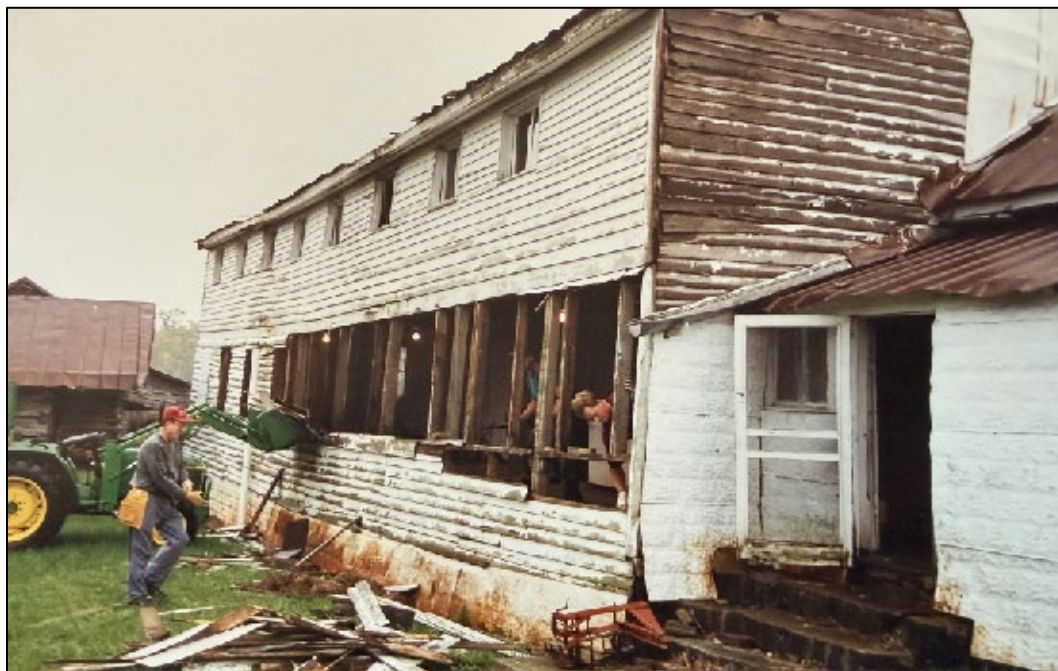
Fig. 3 Rear porch being dismantled, circa 1991.

The main block of the house formerly had a two-story full-width porch (figure 3) across its rear (north) elevation, eventually enclosed with weatherboards and seven windows evenly spaced across its second story. The porch, built on stacked limestone piers, deteriorated and was taken down, with only pieces left inside the house, and the main-block rear doors and windows, of which there were few, infilled/covered. Family photos show the deconstruction of both the kitchen and the back porch of the house in progress, after it was decided that deterioration had rendered demolition necessary. The light framing of the porch suggests it was built in the late nineteenth or early 20th centuries.
